# Initial report on Golap Solar PV plant

Prepared for Zilla Parishad, Ratnagiri

By Priya Jadhav, Narendra Shiradkar

IIT Bombay, 20 February, 2025

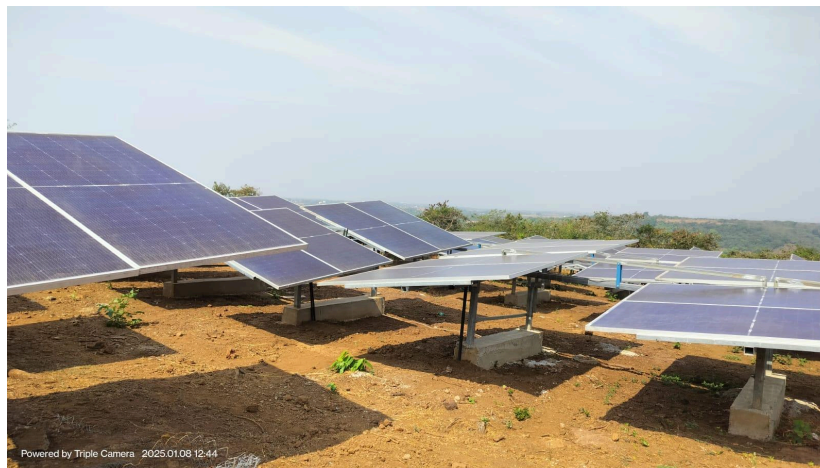
Figure 2. Pictures taken at the plant on January 8th 2025

Observations showed that the tracking mechanisms were not functioning properly - see figure 2. With the various tables at different angles. The loss due to tracking issues can be high and are the likely reason for the low energy generated.

Since these installations are quite near the ocean and in hot and humid areas, we would like to recommend that you do not use trackers (which can be highly prone to corrosion and in case of Golap plant also mis-alignment) but go with fixed latitude tilt systems.
