# Flight Readiness Review (FRR)

Tethered Satellite 2 Mission A

*Knight's Satellite Club*

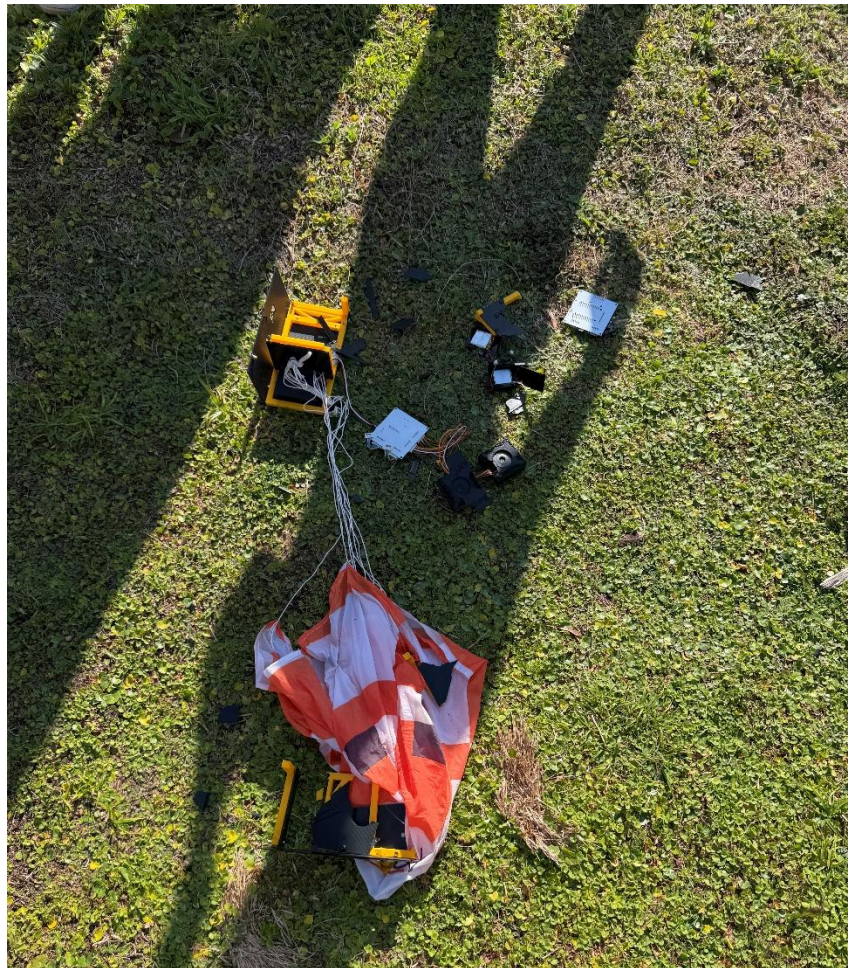
*Figure 3: The Remains of T-Sat 2A*

The recovered housing showed substantial structural damage. One section of the 2U wall remained attached through its screw connection to the approximately 1.5U top panel and a portion of the bottom-panel connection. Two panels were cracked, while the opposite wall was split into two pieces. Despite the structural damage, the cameras were not damaged, and the two PCBs appeared to remain physically intact. The onboard modules also appeared undamaged based on the team's initial inspection. The SD card remained present and usable, while some components had become disconnected from their standoffs and crimp connections. The camera crimp connections remained attached to the PCB boards.

The postflight inspection identified a tear in the parachute that appeared to be associated with the parachute's attempted exit from the housing. A portion of the 3D-printed support infill was found to remain attached to the parachute. This observation provided evidence that the remaining printed material may have interfered with the parachute during deployment. The team believes that the retained support material contributed to the parachute becoming caught as it attempted to exit the housing. This explanation is consistent with the observed tear and the presence of printed material on the parachute, but it should be treated as a suspected cause rather than a conclusively demonstrated root cause without further testing.

Future T-Sat teams should prioritize a complete final configuration inspection after any replacement, modification, or repair performed during the final days before launch. In particular, the entire parachute exit path should be checked for support material, sharp edges, protrusions, and other features that could interfere with deployment. This inspection should be performed with the parachute installed in its flight configuration rather than only evaluating the cutting mechanism independently.

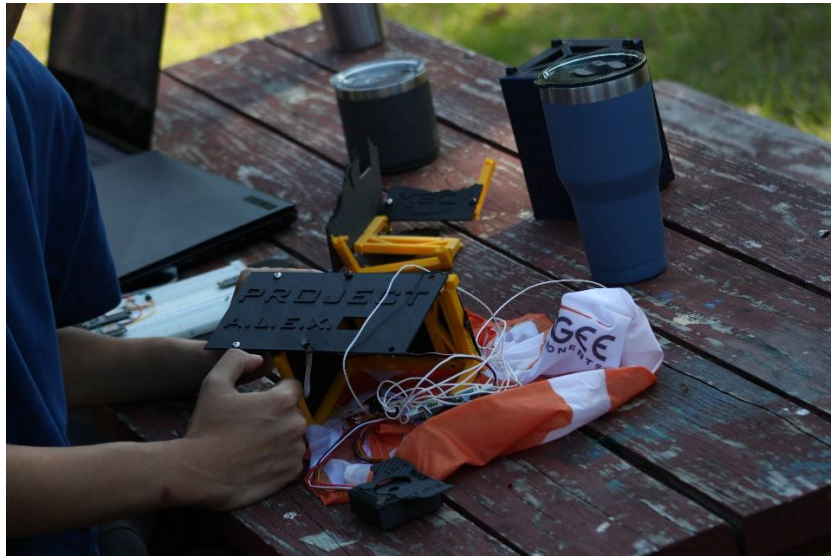
The panel identified as Project A.L.E.X. remained undamaged during the recovery. This component was retained along with the other recovered parts for inspection and documentation. The condition of the vehicle demonstrated that the printed housing experienced significant damage during the fall, while several internal electronic components and data-storage elements remained sufficiently intact to allow postflight data retrieval.

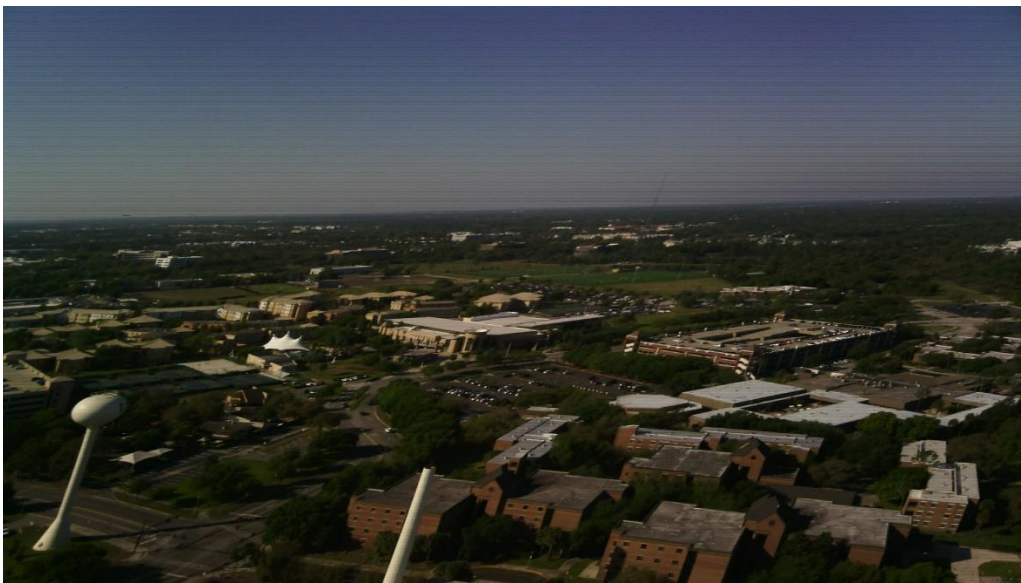
*Figure 4: Images Captured by T-Sat 2A*
