2019

HERBERT HOOVER DIKE (FL36001)

INSTRUMENTATION REPORT NO. 17

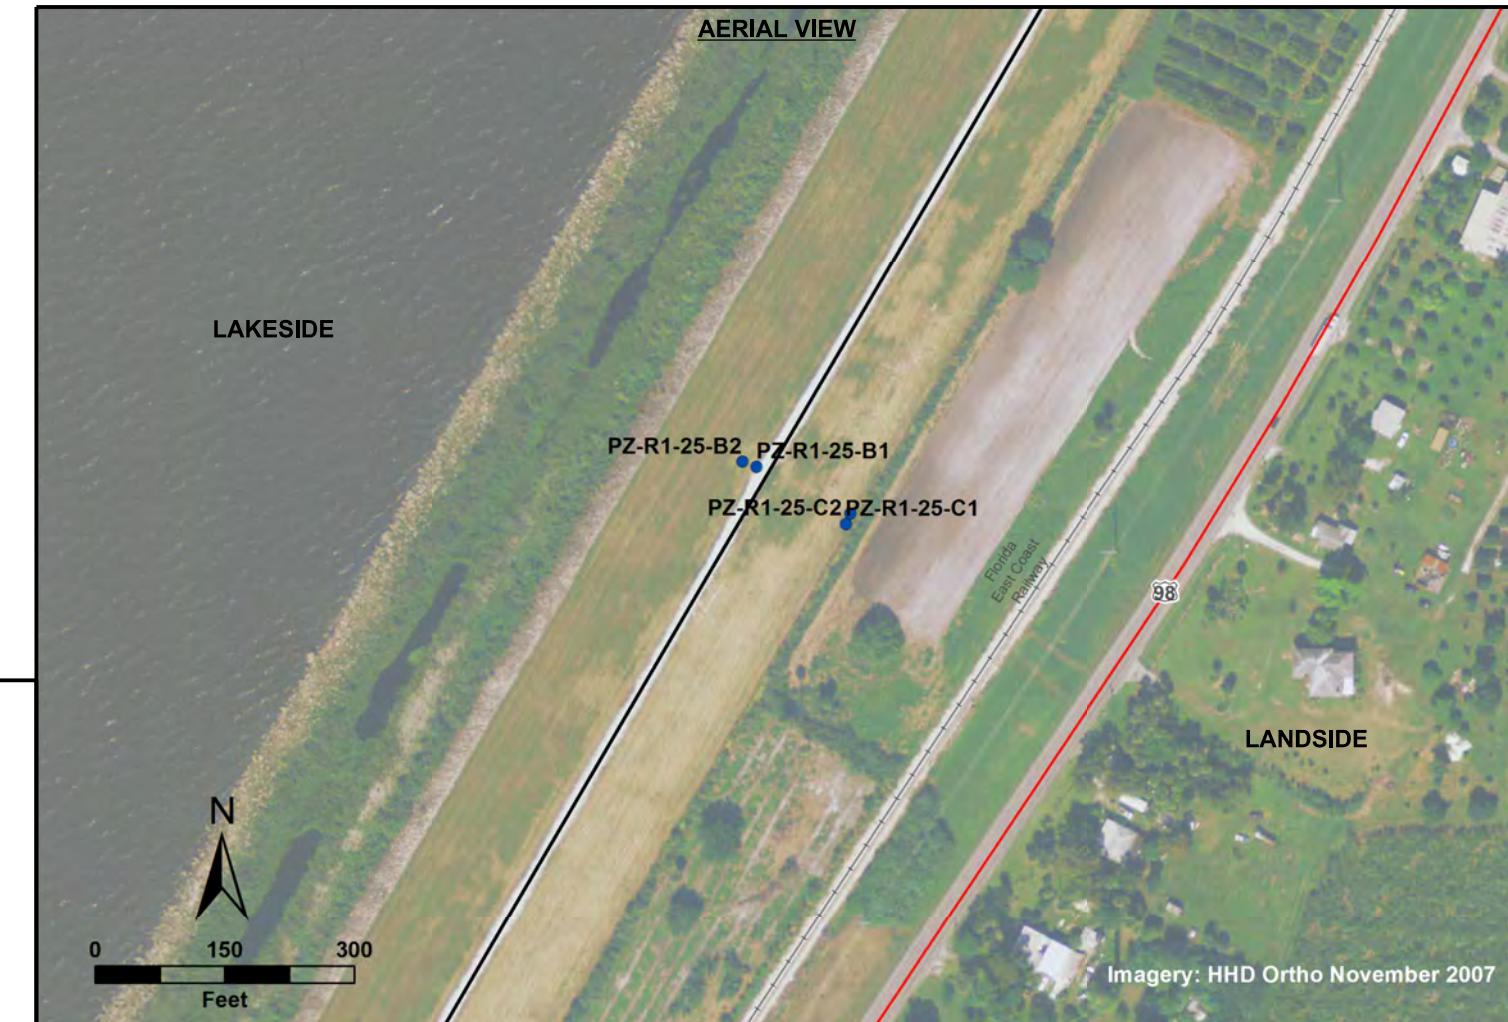
R1-12

NOTES:
 1. TOPOGRAPHIC SURVEY FROM SURVEY 07-016.
 2. HYDROGRAPHIC SURVEY FROM SURVEY 09-127.
 3. PZ-R1-25-B1 & PZ-R1-25-B2 WERE REMOVED
DURING CUTOFF WALL INSTALLATION
 4. CUTOFF WALL INSTALLED TO EL. -40 (NAVD88)
DECEMBER 2011.
 5. PIEZOMETERS PZ-R1-25-B1 and PZ-R1-25-B2 were decommissioned on 09/16/2011

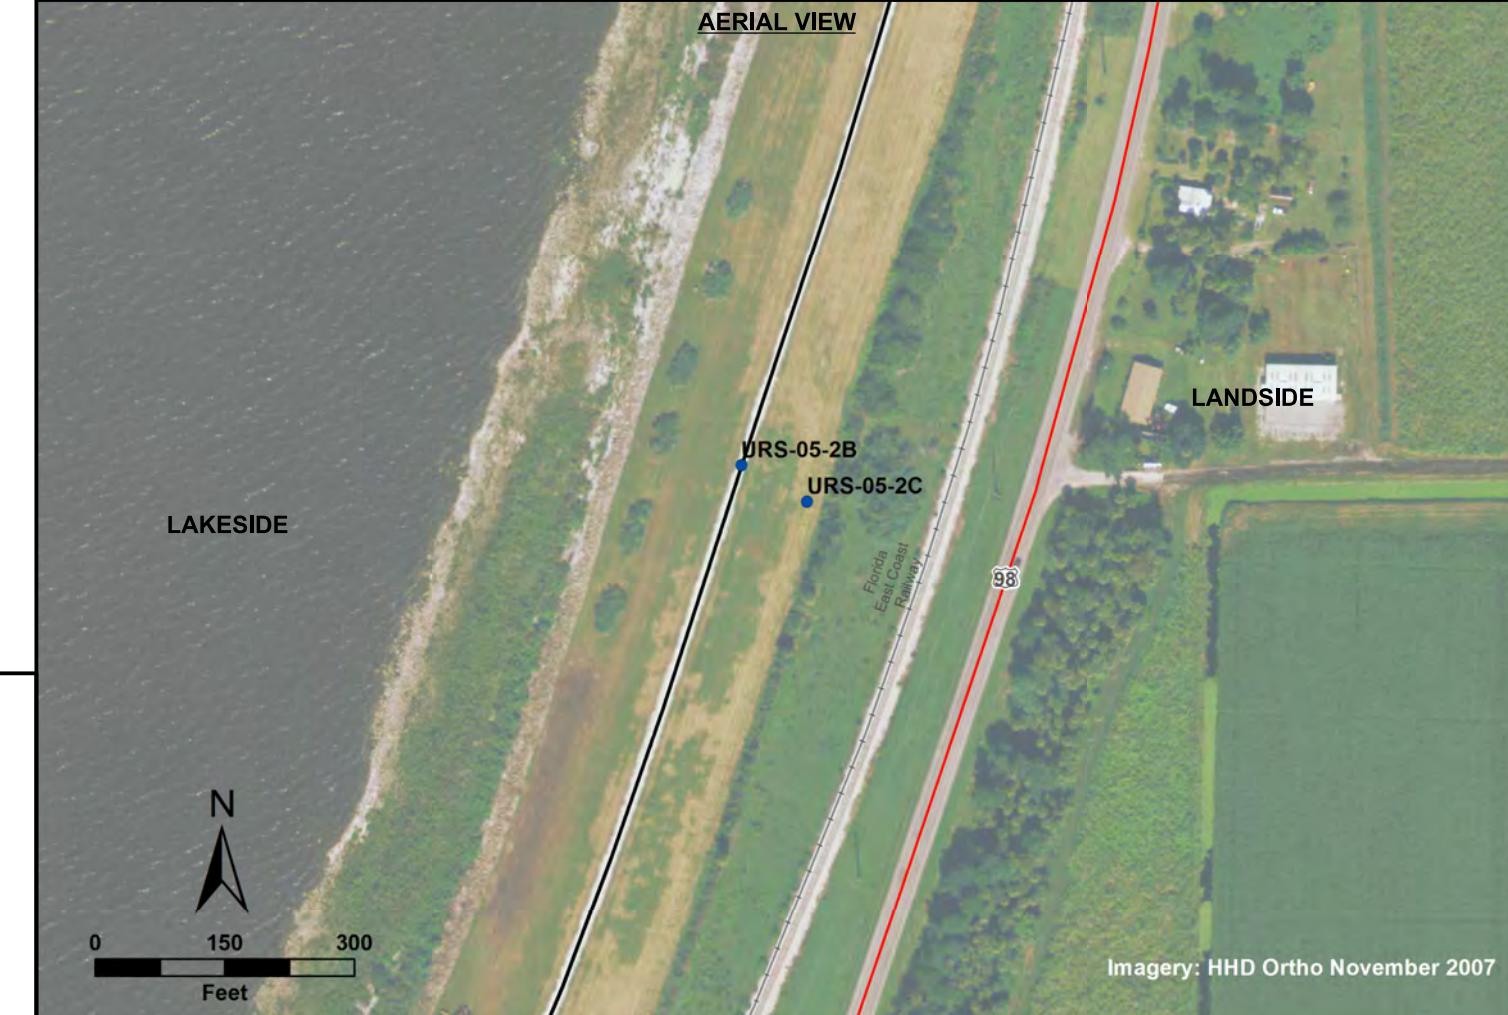
R1-12A

- NOTES:
1. TOPOGRAPHIC SURVEY FROM SURVEY 07-016.
 2. HYDROGRAPHIC SURVEY FROM SURVEY 09-127.
 3. PZ-URS-05-2B WAS REMOVED DURING CUTOFF WALL INSTALLATION.
 4. CUTOFF WALL INSTALLED TO EL. -40 (NAVD88) MAY 2011.
 5. PIEZOMETER URS-05-2B was decommissioned on 02/16/2011
