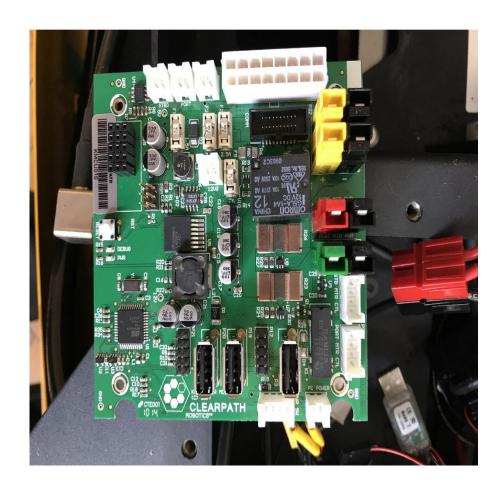
Working.

MCU on the Kingfisher acts like a power distribution board. It is activated by the push button. It consists of USB extension ports, 5V, ESC, LED and PC power adapter. The on-board Arduino handles serial and analog signal from Atom PC, radio receiver and motor controller.

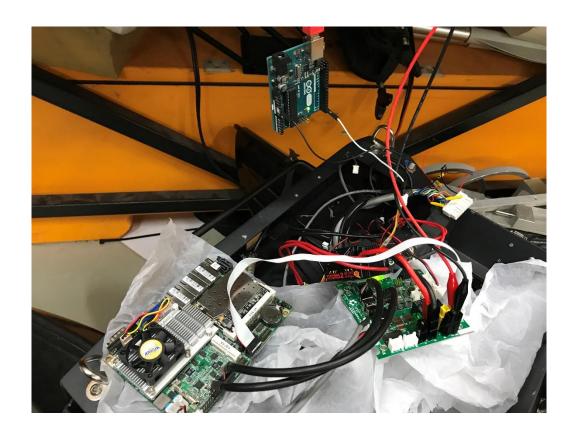
Working (requires more testing).

The ESC powers up correctly with LED and fans activated. Still in progress to figure out the communication protocol, tried using PPM and Castle link serial as described in manual using an external Arduino with no luck yet. We need to implement the communication ourselves as there is no compatible support packages available.

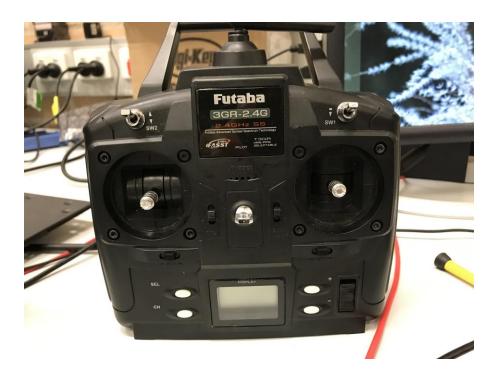
Futaba radio transmitter

Working.

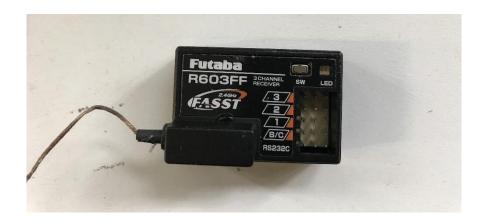
Futaba radio receiver

Not working.

The antenna for the receiver is broken, and this unit must be replaced.
