ACCESSIBILITY RECOMMENDATIONS – ACTED DISTRIBUTION POINT
DARASHAKRAN CAMP - ERBIL – DECEMBER 2014
TO PROMOTE INCLUSION OF PERSONS WITH DISABILITIES, INJURIES AND OTHER VULNERABILITIES

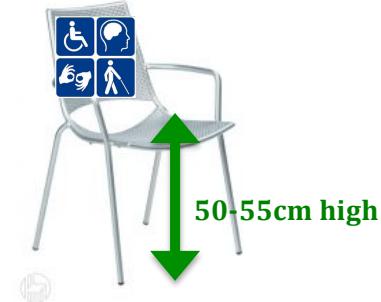
BARRIER AND DIFFICULTIES	PICTURE	Potential Solution
Long wait line with no place to sit for those with mobility issues.		<p>As discussed with ACTED, fast-track system to be used. Adding chairs with Disability Logo for some PWD is a good idea. Ensure they keep their place within line by agreeing with person behind them to keep space. Chair height to be at least 50-55cm.</p>

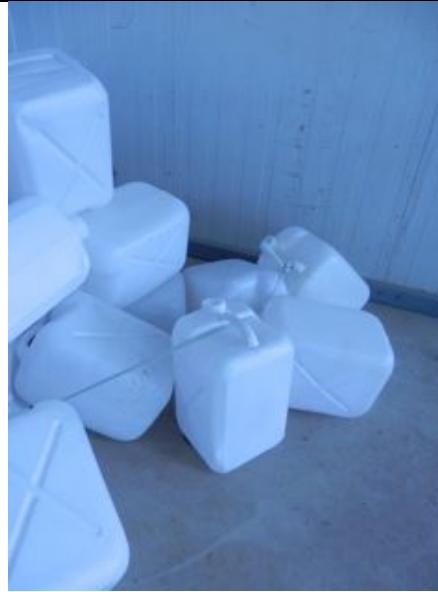
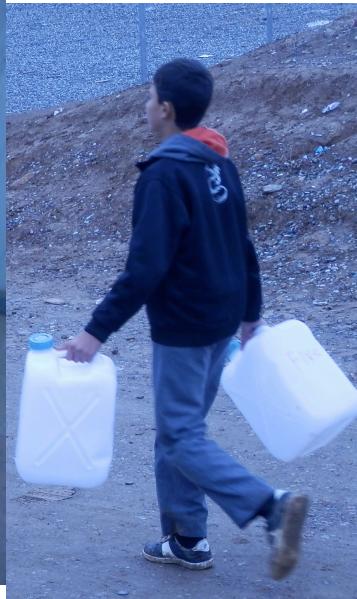
Jerry cans carrying-system not accessible to all. Consider providing carts to persons with hand impairments or others who cannot carry current jerry can system.

Consider distributing carts and alternative jerry can carrying systems that can be used by persons with disabilities. See picture below however wheels of cart can be made much bigger to handle rough terrain of camp.
