ACCESSIBILITY RECOMMENDATIONS – CENTRAL PLAYGROUND ON MAIN ROAD

DARASHAKRAN CAMP - ERBIL- DECEMBER 2014

TO PROMOTE INCLUSION OF PERSONS WITH DISABILITIES, INJURIES AND OTHER VULNERABILITIES

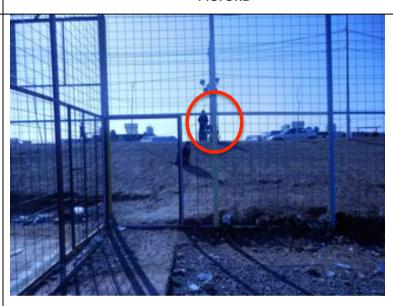
PICTURE

Playground is at the bottom of a steep hill. Persons using wheelchairs or mobility aids cannot come down safely. As you can see in picture, a boy with a disability is crawling down the hill and his mother has parked his wheelchair at the top of the hill (red circles).

Need to have an accessible path that has 1:12 incline (for 1 cm of height, 12 cm of length of ramp) that can be used by wheelchair users, as well as having a handrail. Will need to have a zig-zag pathway with platform (green square) for persons to rest while coming to access space.

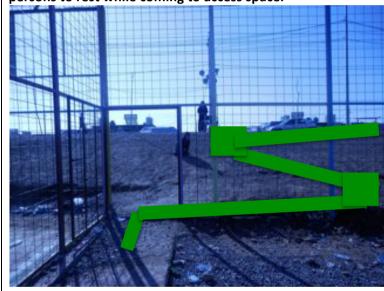
Due to lack of accessible pathway in playground areas (as well as inaccessible entry path/door), you see a mother carrying her son around playground.

Need to have a continuous pathway from door to various playground equipment (slides, swings) that is accessible).

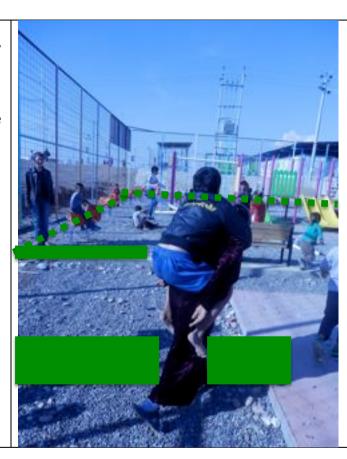
The concrete pathway of playground is interrupted in some areas and not in other areas, this is not a good design for children who use mobility aids or who have visual impairments and who need to follow a path.

Consider installing a CONTINUOUS path (1.5m width or 90cm minimum) from door to connect with rest of concrete path (see green lines).

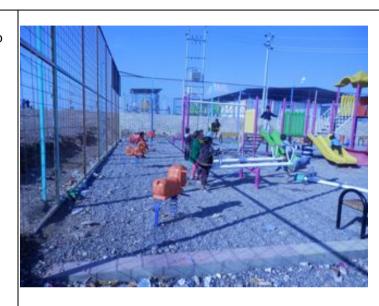
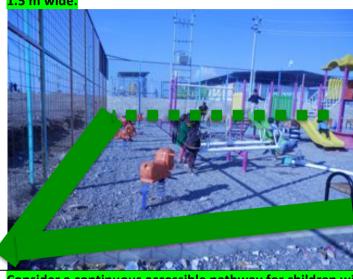
Lack of accessible playground due to lack of accessible path.

Ensure perimeter of playground has paved path that can access various areas of it. 90cm minimum in width, ideally 1.5 m wide.

Key parts of playground should be accessible by path (green lines)

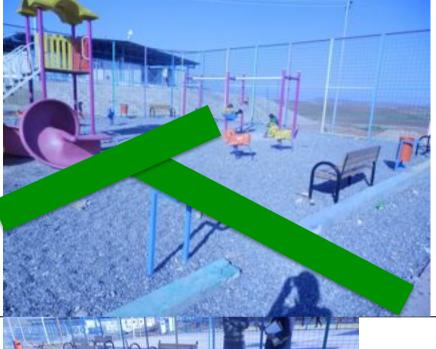
Lack of accessible pathway within playground where children with disabilities can use.

Consider a continuous accessible pathway for children with mobility issues/equipment to be able to use.

Must be minimum 90cm in width, but ideally 1.5 metres.

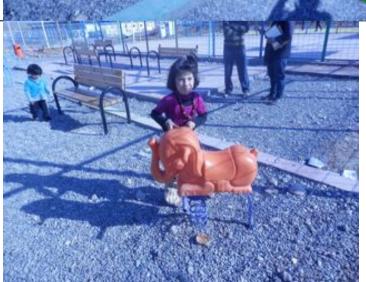
Rocking elephant not accessible for all children with disabilities.

Have various 'ROCKING' EQUIPMENT, that provides hand hold, body support and foot hold for children with less ability to sit up (see picture below).

Also make rocker equipment with a longer and deeper seat so that an adult can sit behind child and rock with child for support, if needed. Rocker should be able to handle the weight of an adult.

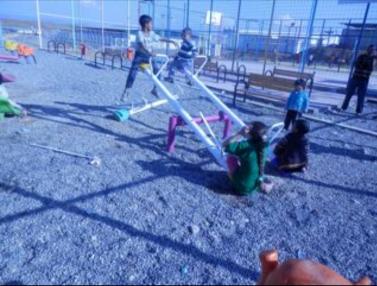
Rocking equipment not universal and not accessible by all children.

Consider having rocking equipment used in group play, where children with less mobility sit inside the rocker area in the middle – see picture below.

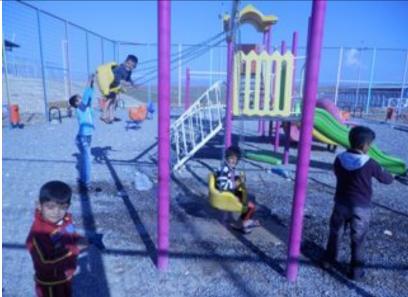
The yellow swing seat is a nice design to support children with sitting balance difficulties.

Pink columns are bright and visible color (good feature)

As seen later in this report, can consider swings of other designs. Large bowl shaped swing below with circular swing is good. It can be accessed by children with many different abilities.

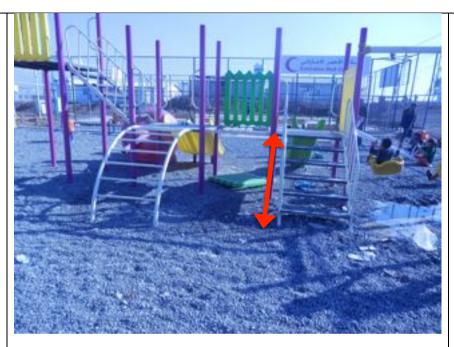
When designing steps in playground, consider children with mobility issues who will be using these steps (can be good form of physical therapy if stairs are not too challenging). Stairs of this playground are TOO STEEP (redarrow)

Rocky terrain of playground hard for children with balance issues to use.

Consider paving playground with soft cork-like surface (instead of rocks)

When building stairs, try to make them as short as possible, so children with different abilities can use them and also climb them using their bums (see picture below). Ideally steps should be 10cm high only (if not possible, no higher than 16cm with 28cm of depth and a handrail to accompany).

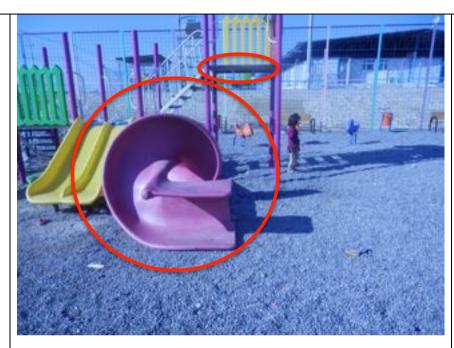
Circular slide is broken and has fallen over (large red circle). There is large platform that can be fall hazard for child (small red circle).

Do regular maintenance of playground.

If NGO has left ensure that someone take responsibility for its maintenance if it will be used by children (as a protection mechanism).

Fix broken pieces immediately or remove them and block of hazardous areas where children may fall.

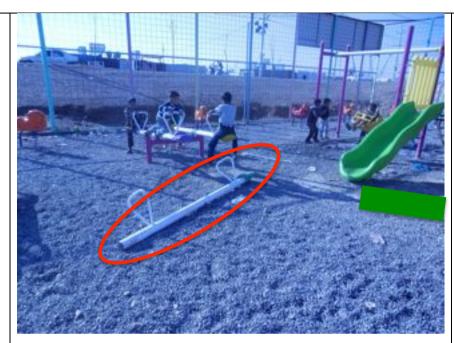
Broken teetertotter, is a trip/fall hazard.

No accessible pathway to green slide area of playground

The NGO that made the playground left and now there are various hazards that are concerns to safety of children with and without disabilities.

The white beam, which is a broken piece of teeter-totter, should be removed as it is a fall/trip hazard. Discussions with camp management on safety of playground should be had.

Next to green slide, have a space where children can park wheelchair/pathway that leads to bottom of slide (to make it easier for caregiver to access)- as per drawing below and green color on picture.

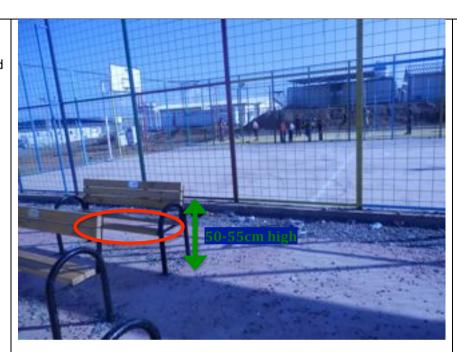
Benches are missing parts/damaged and are to low.

Ensure bench height is at least 50-55cm high for parents with disabilities who may come to watch children play.
