Mold Assessment Report

**Conducted for:
Copeland Residence
405 Crawford Street, Apt. 2145
Fort Worth, TX 76104**

Copeland Residence
405 Crawford Street, Apt. 2145
Fort Worth, TX 76104

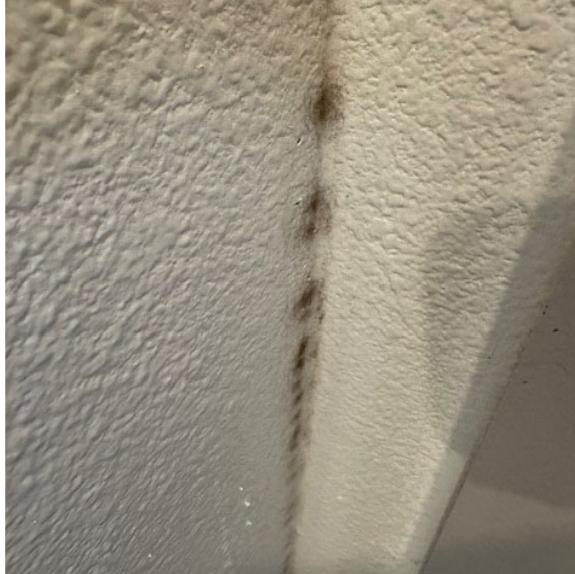
- i. **Front Entry Drywall (Sample B1)** resulted in Condition 2: contaminated with settled spores, which requires remedial action to Condition 1 status.
- ii. **Guest Bedroom Baseboard (Sample B2)** – resulted in Condition 3: actual fungal growth, which requires remedial action to Condition 1 status.

A swab sample was conducted on the apparent mold growth at the front door which tested positive for Stachybotrys & Alternaria.

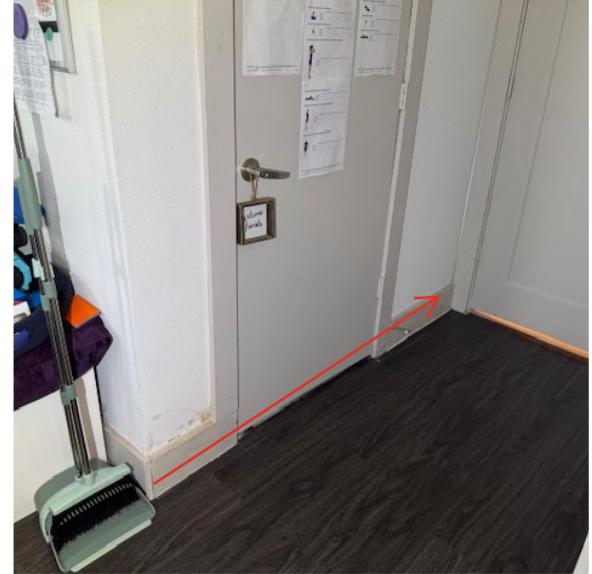
A previous leak coming from the HVAC closet has resulted in extensive water damage and mold growth in the guest bedroom and areas surrounding the HVAC closet (see photos below for reference). Mold growth was observed on the baseboards, drywall and carpet tack strip at the time of the mold assessment.

Water damage and mold growth was found around the HVAC closet which is likely due to a previous HVAC leak.

Biotex Inspections recommends that a licensed Mold Remediation Contractor be retained for the removal of the impacted materials. Additionally, a Mold Assessment Consultant should be retained to prepare the appropriate mold protocol and conduct final air clearance testing upon completion of the remediation. However, all sources of water intrusion, water damage, humidity, and/or moisture content, including but not limited to any built-in mechanical systems, water systems and/or structural elements, should be properly repaired before beginning the remediation to help prevent the re-occurrence of damage and mold growth. The Residence's maintenance records and reports may help reveal additional sources of water intrusion that may have impacted this Residence and/or surrounding properties, which may have contributed or may be contributing to the mold identified within this report.

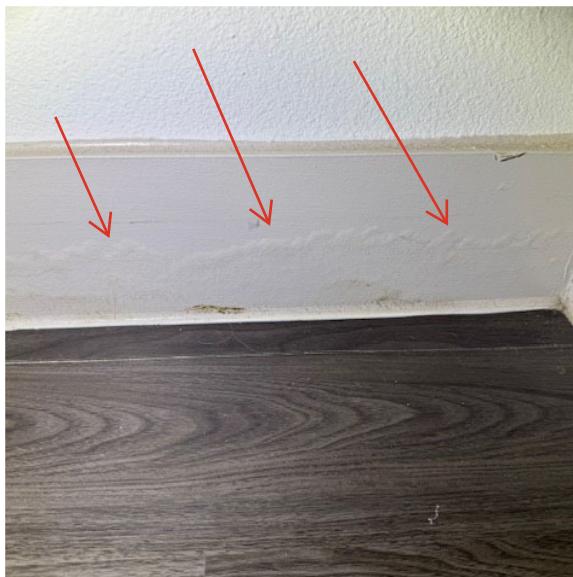
Close up of the baseboards adjacent to the HVAC closet with water damage.

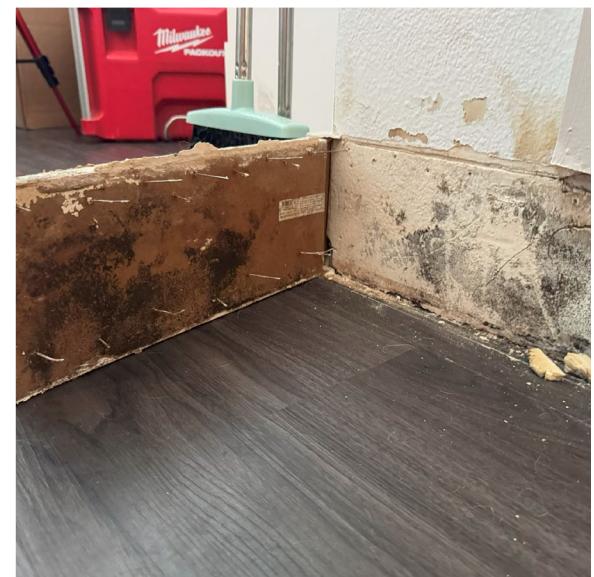
The baseboards next to the HVAC closet were pulled out and mold growth was observed behind them and on the drywall.

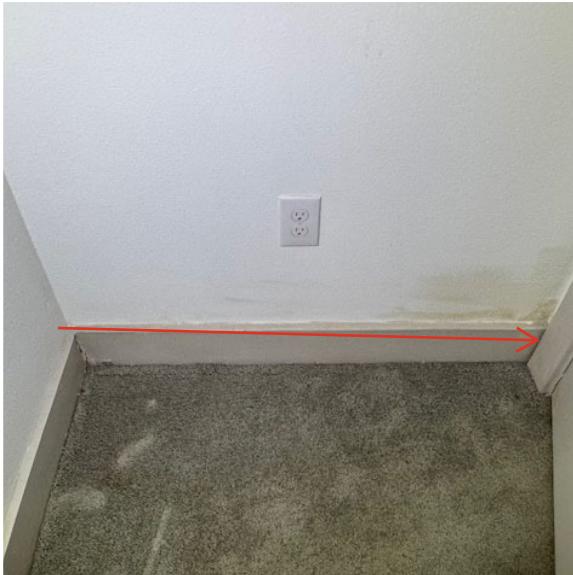
Water damage and mold growth was observed on the guest bedroom baseboards and drywall adjacent to the HVAC closet.

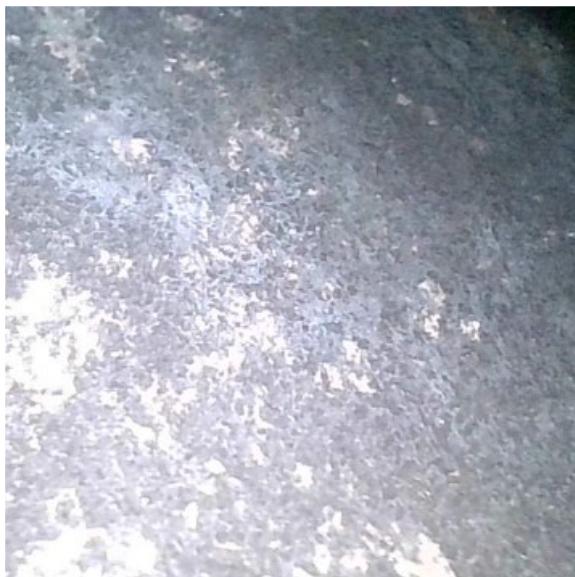
A borescope camera was utilized inside of the guest bedroom wall cavity and rampant mold growth was observed.

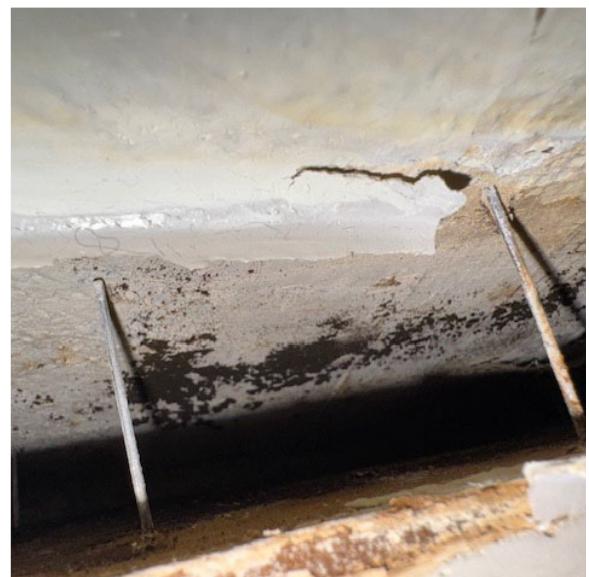
Mold growth was observed behind the baseboards in the guest bedroom and a swab sample tested positive for Chaetomium.
