**Subject:** Re: Follow-Up on September 8 Mold Assessment Report  
**Date:** Thursday, October 23, 2025 at 12:05:13 PM Central Daylight Time  
**From:** Dayna Boor  
**To:** Katie Copeland  
**Attachments:** Weinstein-090425\_Mold\_Remediation\_Protocol.pdf, Weinstein-090425\_Reinspection\_Report.pdf, Weinstein-090425\_Air\_Samples\_Full\_Lab\_Report.pdf, Weinstein-090425\_Tape\_Lift\_Full\_Lab\_Report.pdf, Weinstein-090425\_Entry\_Surface\_Swab\_Sample\_Full\_Lab\_Report.pdf

PROJECT INFORMATION  
Weinstein- 090425  
220 E Broadway Ave #2145  
Fort Worth, Texas 76104  
Project No.: Not Provided

**MOLD REMEDIATION PROTCOL**

**Project No: Weinstein-090225  
Inspection Date: 09/02/2025  
Remediation Protocol Date:  
09/08/2025**

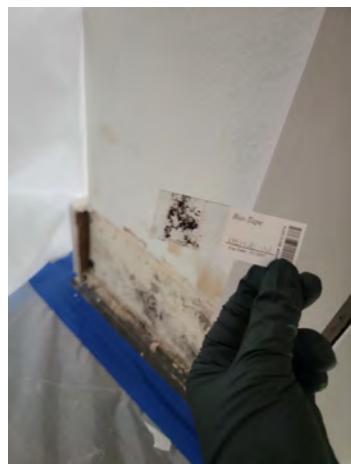
**Guest Bedroom Drywall  
Tape Lift Sample**

At the time of inspection the humidity is ~63% Rh and there is visible growth on the inside of the utility closet, behind baseboard in the hallway, and behind baseboard in the guest bedroom behind the utility closet.

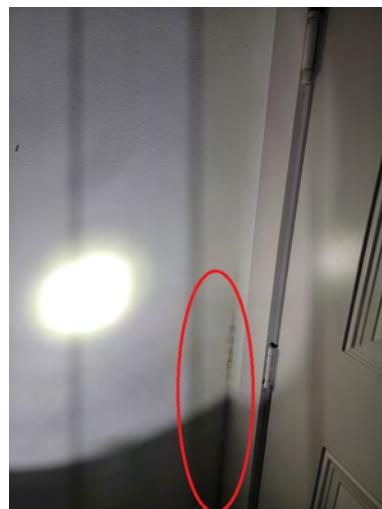
The drywall does not have elevated moisture readings.

A swab sample was collected from the area which revealed normal fungal ecology. To further rule out water damage and mold growth inside the wall cavity, exploratory measures such as removal of baseboard/door trim and removal of the drywall could be taken.

A surface swab sample collected from this area identified minor concentrations of Alternaria, Ascospores, Bipolaris, Curvularia, Myxomycetes, Nigrospora, and Pithomyces.

These minor concentrations are not indicative of mold growth on the drywall but rather normal fungal ecology on a surface.
