**DALLAS MOLD
CONSULTANTS**

MOLD REMEDIATION PROTCOL

**Project No: Weinstein-090225
Inspection Date: 09/02/2025
Remediation Protocol Date:
09/08/2025**

**220 E Broadway Ave. #2145
Ft. Worth, TX 76104**

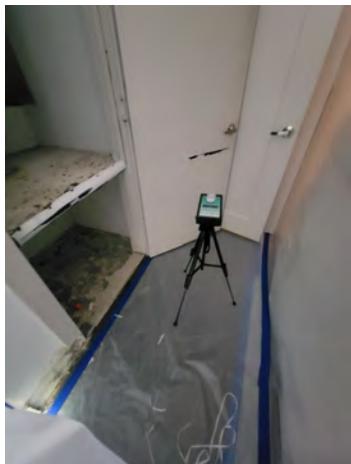
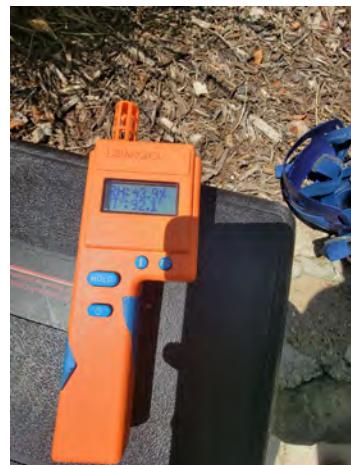
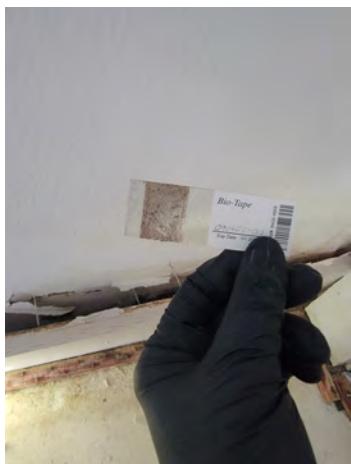
Air Samples - Temperature - Humidity Readings

At the time of inspection the humidity is ~63% Rh and there is visible growth on the inside of the utility closet, behind baseboard in the hallway, and behind baseboard in the guest bedroom behind the utility closet.

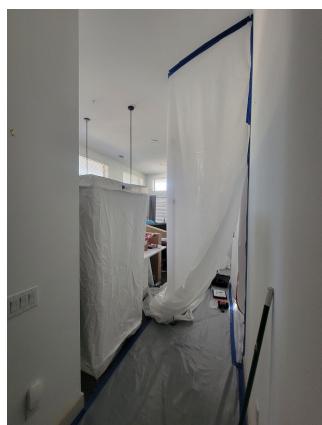
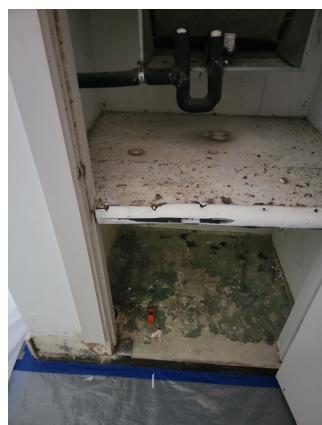
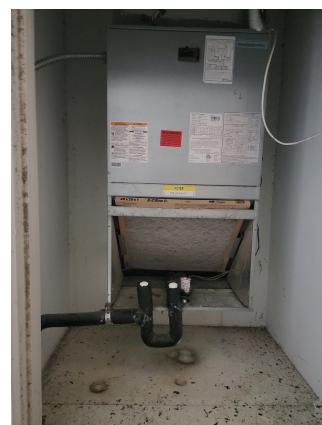
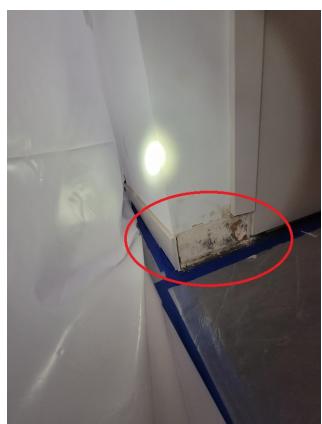
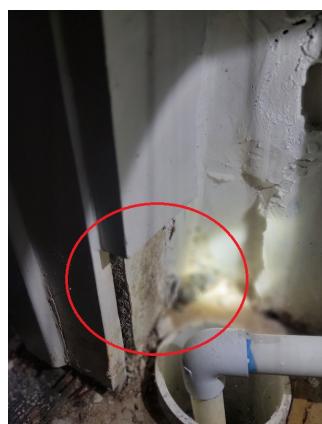
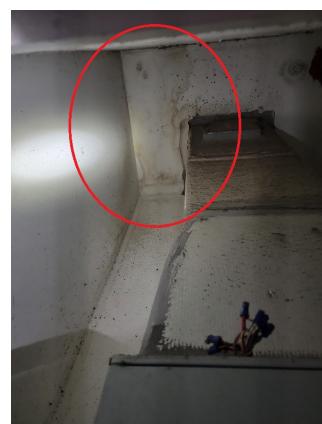
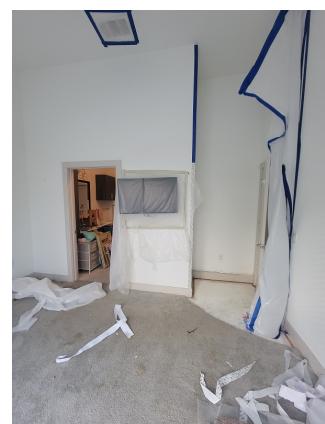
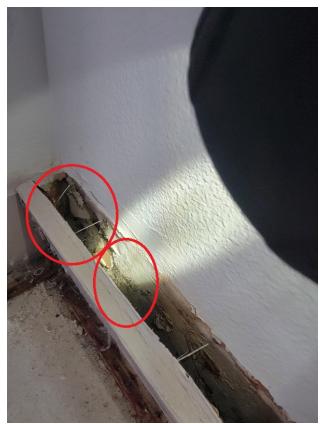
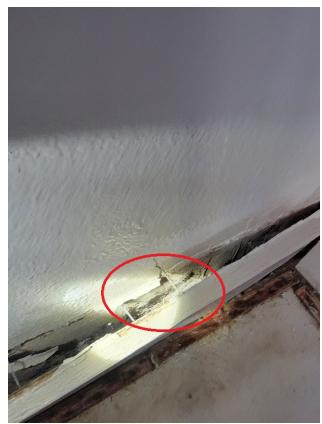
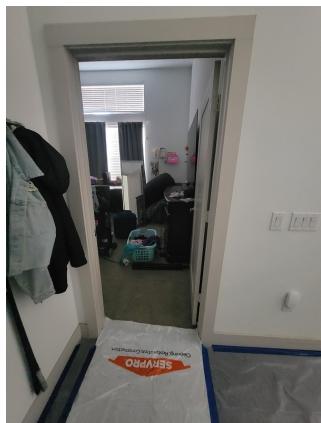
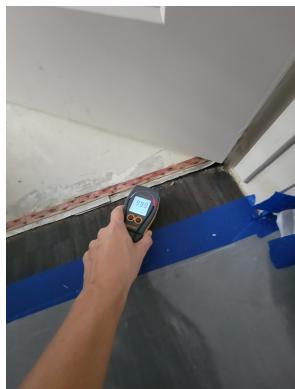
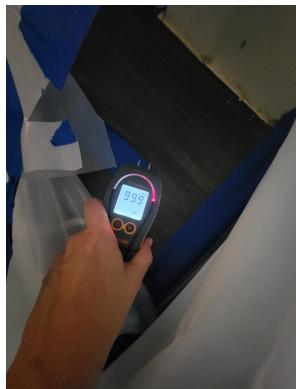
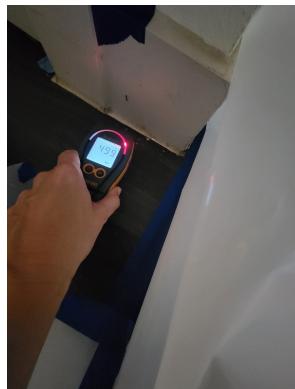
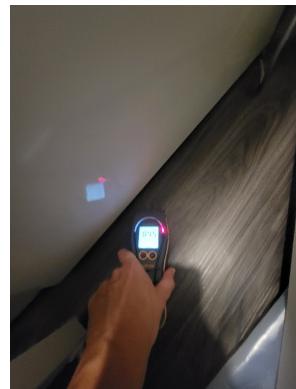
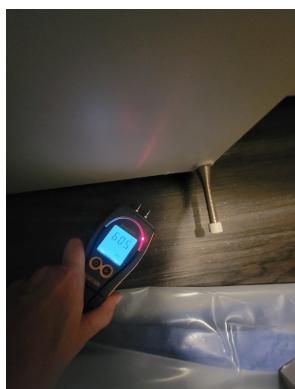
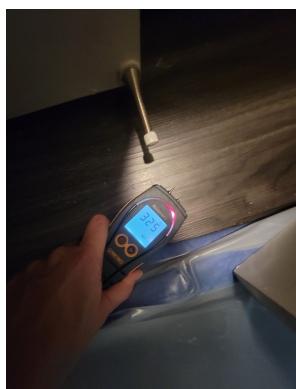
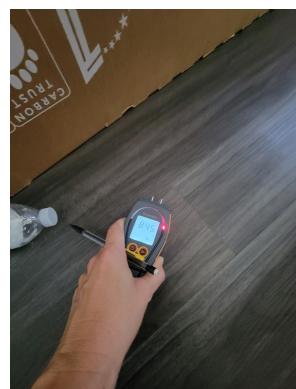
6.1 Photographic Documentation (Continued)

The laminate flooring surrounding the area has elevated moisture readings.

Recommending mold remediation, content cleaning, environmental cleaning, and HVAC cleaning as outlined in this protocol on **pages 7-11**.
