**Dallas Mold Consultants Report and MAC Protocol,  
September 8, 2025: Chaetomium contamination**

### **MOLD REMEDIATION PROTOCOL**

**Project No: Weinstein-090225  
Inspection Date: 09/02/2025  
Remediation Protocol Date:  
09/08/2025**

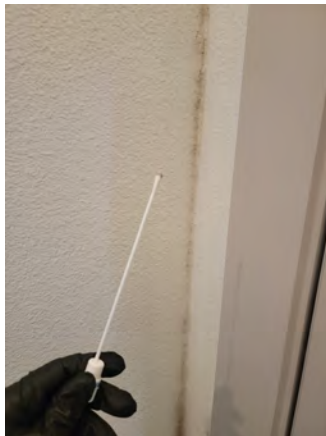
A surface swab sample collected from this area identified minor concentrations of Alternaria, Ascospores, Bipolaris, Curvularia, Myxomycetes, Nigrospora, and Pithomyces.

These minor concentrations are not indicative of mold growth on the drywall but rather normal fungal ecology on a surface.

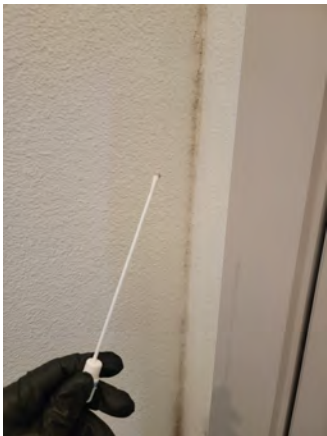
A surface swab sample collected from this area identified minor concentrations of Alternaria, Ascospores, Bipolaris, Curvularia, Myxomycetes, Nigrospora, and Pithomyces.

These minor concentrations are not indicative of mold growth on the drywall but rather normal fungal ecology on a surface.
