SERVICE REPORT

<u>Customer Name:</u>	Synohydro Corporation Ltd.	Date:	Aug 14, 2024
Contact Person:		File #	
Location:	Saudi Aramco SPARK Project		
References:

LN	Description/Activities	Remarks
1	Electric Fire Pump Controller with Automatic Transfer Switch Functional Test	For Information & Action
	Controller Make: Hubbel Model: MPT700H-50-415C MTS-225A; S/N: 24715555 Electrical Rating: 125HP; 415Volts; 3 Phase; 60Hz; FLA 208A Max

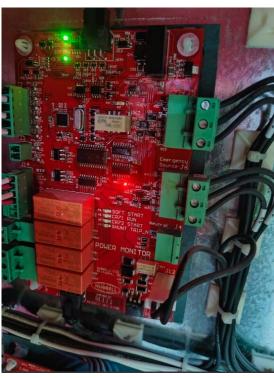
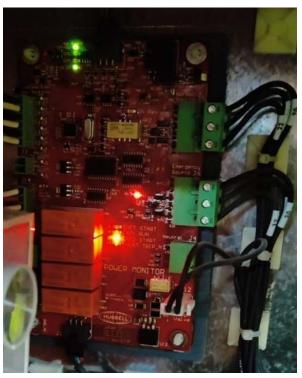
- Verified Motor Contactor MC45, MC44 and MS42 not latching.
- Verified the Control Relay CR72 and CR71 are not latching.
- Verified Power Monitor Board K5 (CR71 RUN) & k7 (CR72 Start) Led indicator is healthy
- Check cable connection and cable continuity from Power Monitor board to CR71 (A1/A2) & CR72(A1/A2) all are okay.
- Power supply 24vac from J14 to CR71 & CR72 not verified but the control relays CR71 & CR72 creates a buzzing or humming noise.

CR71 and CR72 initially suspected with a coil problem, Or source from Power Monitor Board. *Please Advise*
