# Investigations of rock anchor corrosion and its influence factors by exhumations in four typical field sites

With the abundance application of rock and soil anchors in high slope and underground projects, more concerns have been paid to the working condition and durability of the anchorage system. To effectively evaluate the corrosion of anchors in service and the influence factors, field exhumations were performed in four typical application sites and tests of samples were conducted in laboratory. Chemical composition, metallurgical structure and mechanical performance of anchors are tested. Microstructure and component of corrosion byproducts and grout were analyzed. The environmental influence factors are also assessed. The results demonstrate that the anchor head is most liable to corrode in comparing to other section of the anchor. Presence of damaging ions can accelerate the initiation and development of corrosion. Chemical and mechanical properties of anchors remain basically unchanged after 1.5 to 20 years' service. Groundwater and stray currents in the underground do not induce noticeable influence on the corrosion of anchors. This research accomplished a set of evaluat

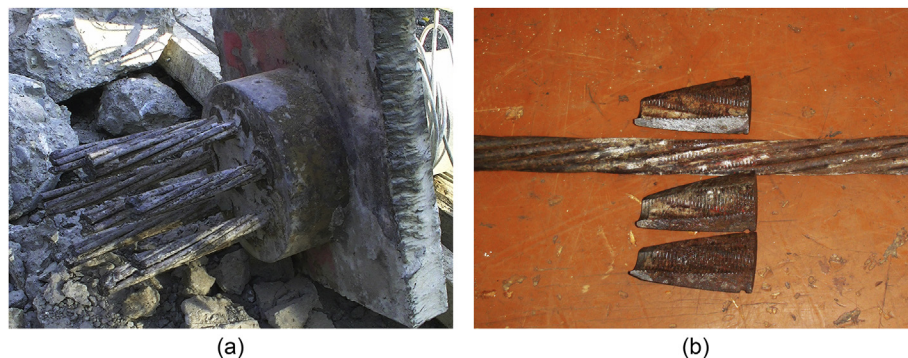
Removal of the anchor head covering concrete exposed a rusted anchor head, as shown in Fig. 8(a). The corrosion of the anchor head indicates that a concrete cover cannot prevent corrosion of the anchor head well.

Corrosion of steel strands at different burial depths is different. Steel strand samples are bent, which might be the result of long-term high stress. The concave side of the strand displays morphological corrosion characteristics that are different from those on the convex side (Table 10).

The steel strand surface indicates that the grout thickness varies greatly with anchor burial depth. In the bonded length, grout cover is thicker on the concave side than on the convex side. Steel strands without grout cover are usually covered with brownish-yellow rust or a bluish-grey surface. Basically, there is no grout bonded on the surface of steel strand at a burial depth of 2 m and 11 to 18 m. Some grout is present on the concave side of the steel strand at burial depths of 6 and 7 m. Grout is found on the convex side of steel strand at burial depth of 1 m. In view of the overall situation, corrosion products distributed the whole surface of the steel strand. And in some depth, corrosion products have permeated to the surface of the residual cement mortar. It thus appears that grout

**Fig. 8.** Corrosion of anchor head of Manwan exhumation: (a) anchor head corrosion, (b) corrosion of wedges and steel strand.
