## High Plains Property Maintenance

# Irrigation Billing Detail

Monthly service documentation for Woodglenn Squares HOA

INVOICE #82883

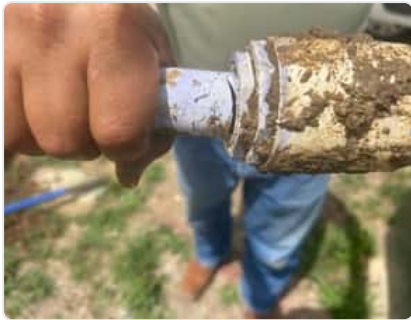
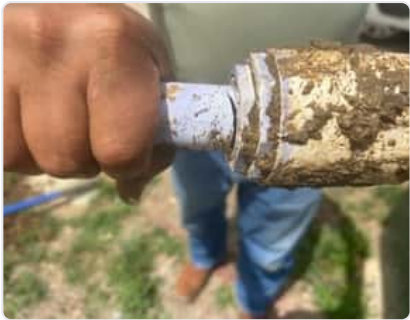
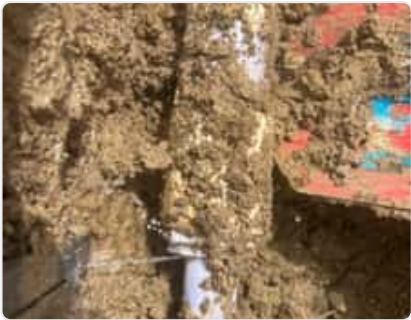
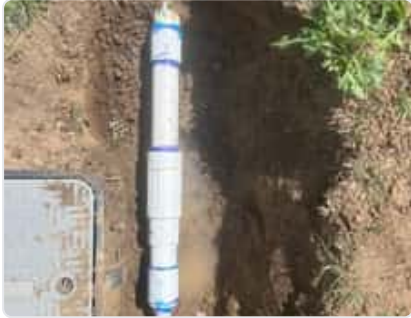
## Billing Sheet #BS-2026-0167 | Invoice #82883

- The mainline was expertly repaired after sustaining damage, likely caused by direct boring.
- Our team ensured that the system was restored to optimal functionality, addressing the issue promptly and efficiently.

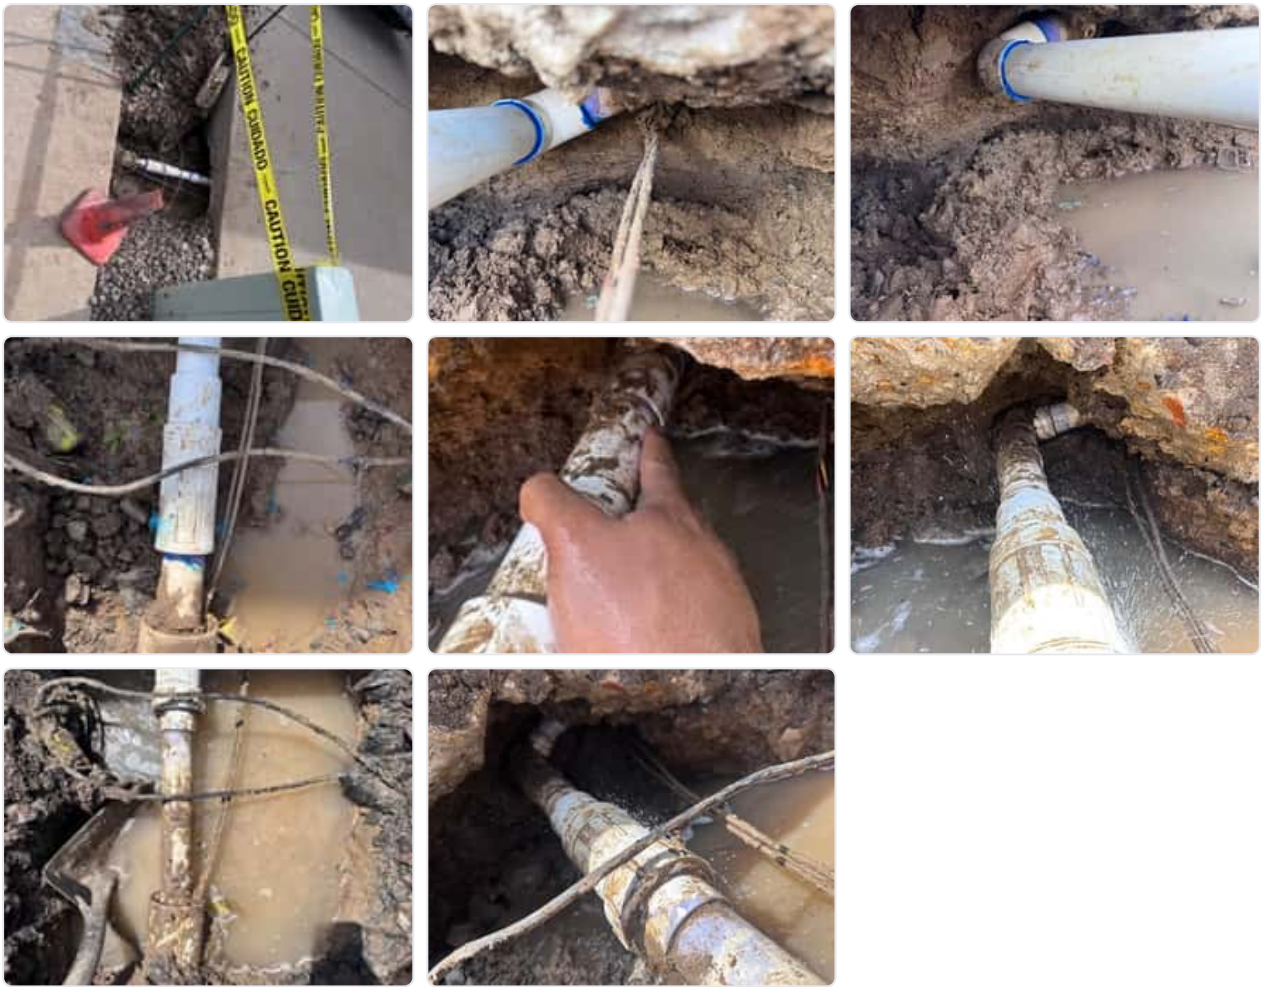
## Billing Sheet #BS-2026-0156 | Invoice #82883

- A broken main line located beneath the driveway's cement was repaired.
- The damaged section, including the coupling and slip fix, was replaced with a new slip fix, a 90-degree elbow, a coupler, and additional PVC piping to ensure no further leaks.

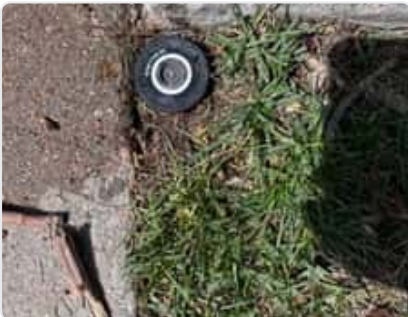
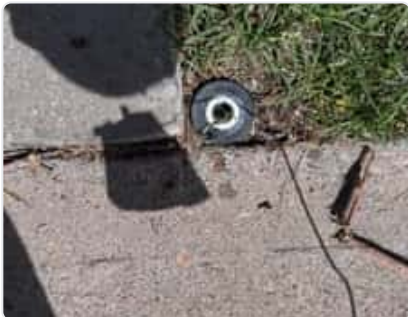
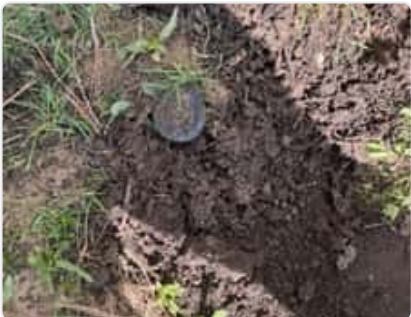
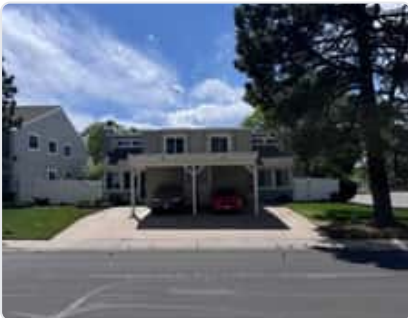
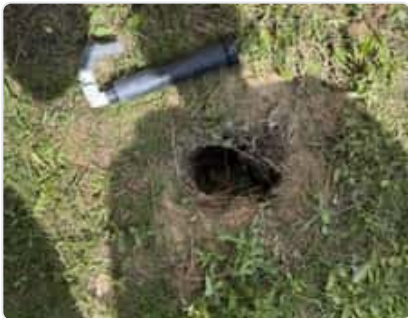
**Billing Sheet #BS-2026-0155 | Invoice #82883**

- Two sprinkler heads were addressed during the service. One head had detached completely and was reinstalled, while the other was missing its internal components and was repaired accordingly.

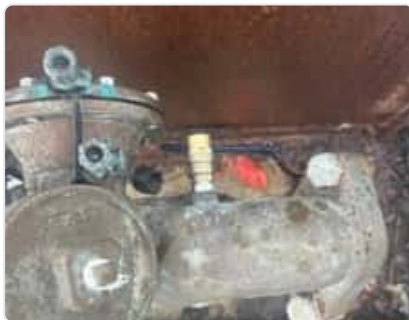
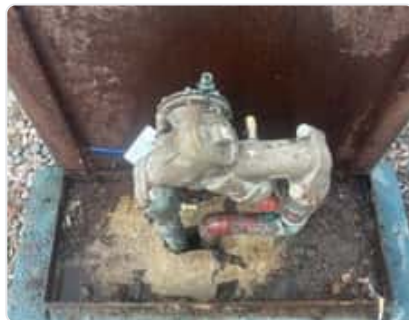
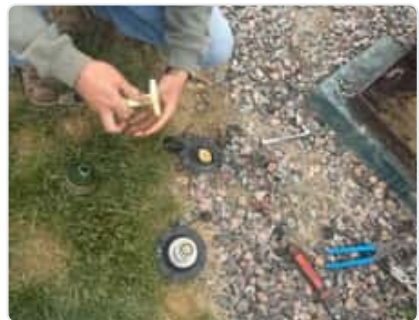
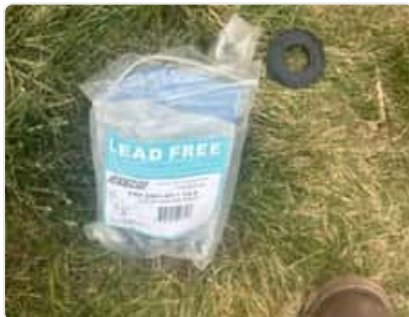
## Billing Sheet #BS-2026-0152 | Invoice #82883

- An emergency service was conducted to address a significant leak in the backflow preventer.
- The seal kit was replaced to resolve the issue, and the test cock was also replaced to ensure proper functionality.

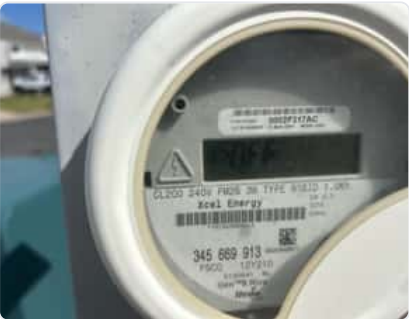
**Billing Sheet #BS-2026-0117 | Invoice #82883**

- The irrigation system controller was successfully rewired following the activation of the meter, with assistance from the Property Manager.
- This ensures optimal functionality and efficient water management for the property.

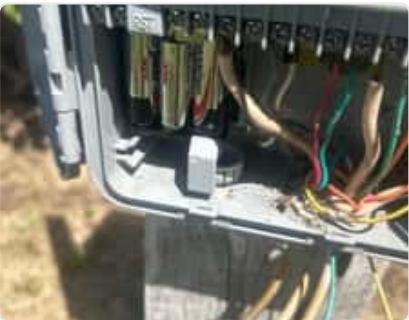
**Billing Sheet #BS-2026-0114 | Invoice #82883**

- Replaced the batteries on the DC operating controller to ensure optimal performance and reliability. This maintenance task helps in maintaining consistent irrigation scheduling and functionality.
