Property Inspection Report #11/16/20231605 Beaconshire Road
8616 Daffodil St. Houston, TX 77063

PROPERTY INSPECTION REPORT FORM

Sabrina Strauss <i>Name of Client</i>	11/16/2023 <i>Date of Inspection</i>
1605 Beaconsire Road, Houston, TX 77077 <i>Address of Inspected Property</i>	
Jovan Martin <i>Name of Inspector</i>	PI 25649 <i>TREC License #</i>
<i>Name of Sponsor (if applicable)</i>	
<i>TREC License #</i>

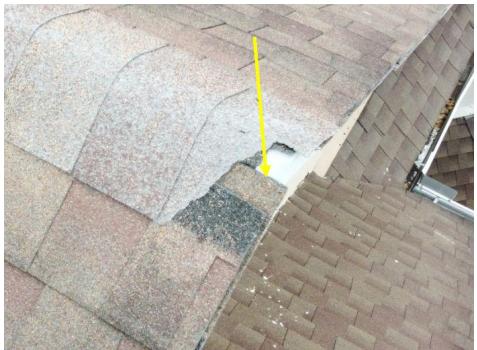
Observed scuffed/damaged shingles. Scuffing the mineral surface off of a composition shingle exposes the asphalt to ultraviolet light which causes it to deteriorate and can greatly reduce the life of the shingle. Replace scuffed shingles.

Damaged shingle

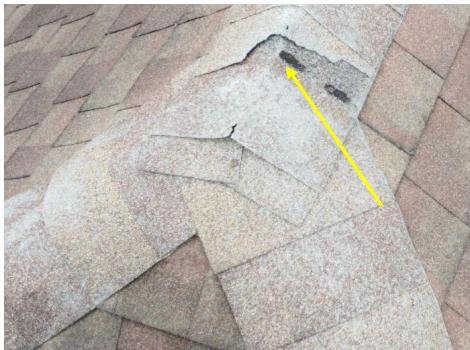
Damaged shingle.

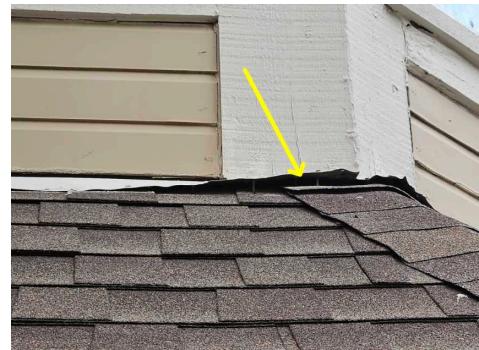
Lower side of flashing is not sealed down, wind-driven rains can cause water penetration.

Lower edge of the flashing needs to be sealed.

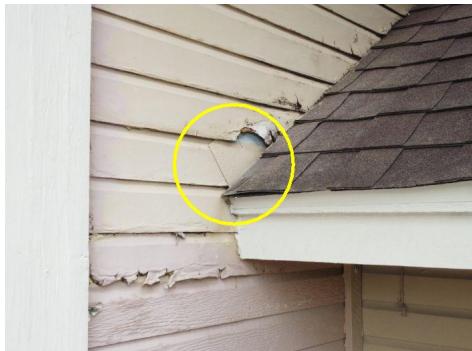
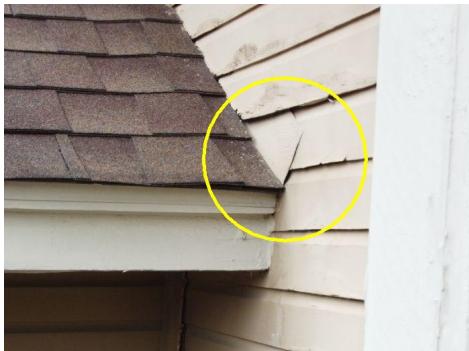
Kickout flashing missing.

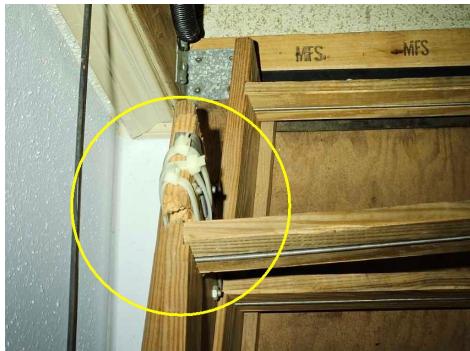
Stairway improperly field/job site modified/alterred/repaired against the manufacturer's installation instructions which increases the chance of injury. Recommend replacement.

Modified/damaged attic ladder

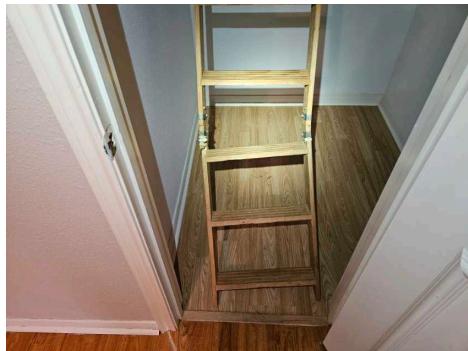
**Damaged stairway observed, dangerous/hazardous condition exists.
Recommend replacement of stairway to attic.**

Damaged attic ladder. DO NOT USE LADDER, SAFETY HAZARD, REPLACEMENT LADDER IS NEEDED BEFORE USE.

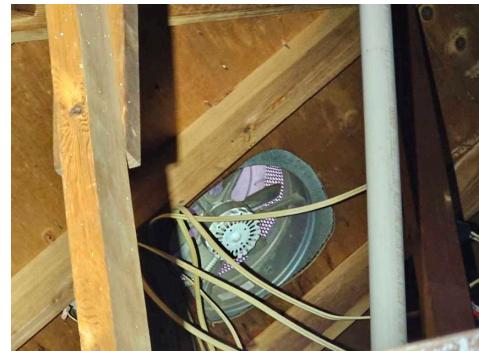
Attic power fan thermostat control is not manual testable type, was unable to verify operation.

The power exhaust fan was not checked or inspected at the time of the inspection.

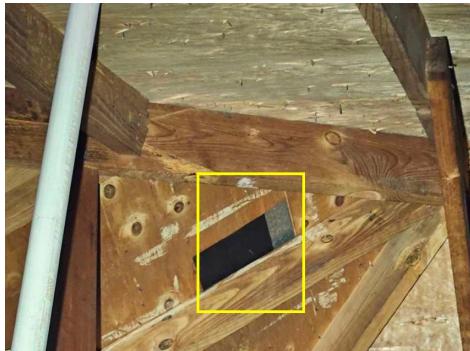
Hole and/or damaged roof decking observed in the attic. Recommend repair to prevent damage/injury from a person walking on the roof.

Hole observed in the roof decking.

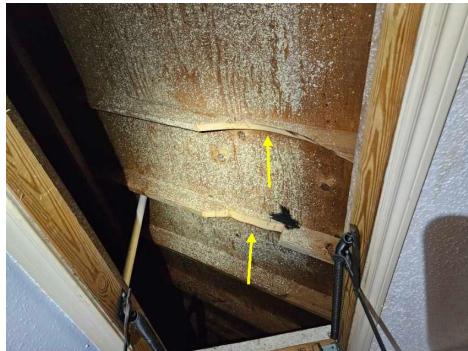
Observed excessive notching / boring of one or more framing members.

Excessive notching observed on the rafter

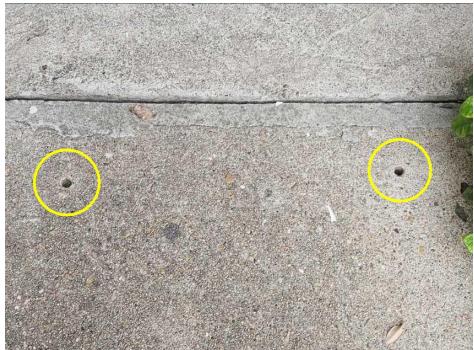
Indications of previous WDI Treatment Observed at the Front entry.

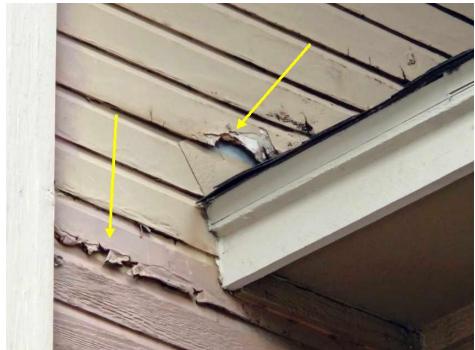
Damage siding observed on the West side dommer window.

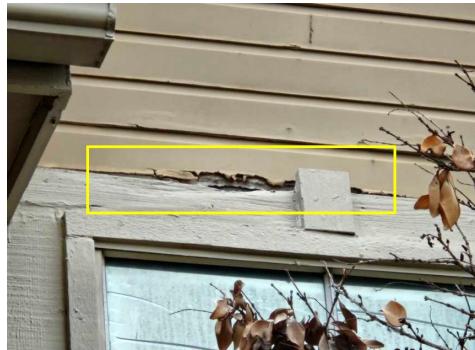
Damage siding was observed on the West exterior wall of the home.

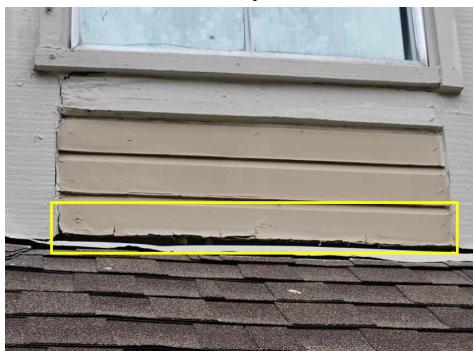
Wood rot under the window of the West exterior side of the home.

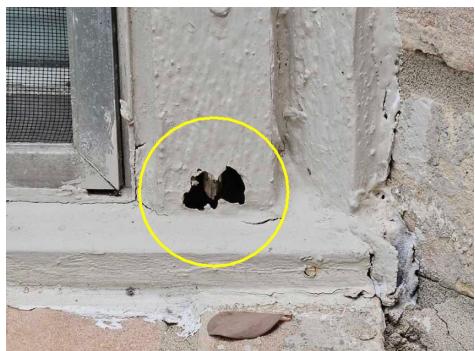
Wood rot observed on the West exterior wall at the home.

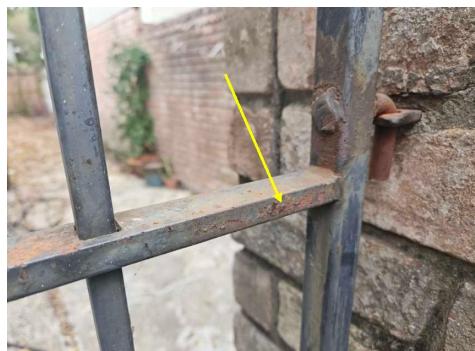
Recommend painting the exterior side gate to prevent further corrosion.

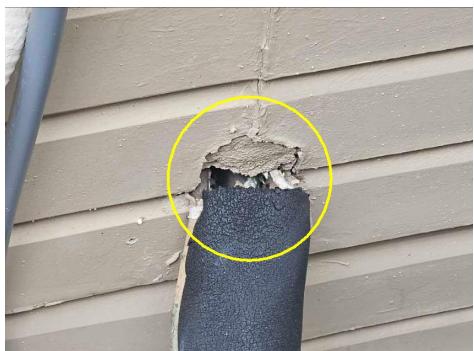
Recommend sealing AC line wall penetration area.

Recommend sealing/foaming exterior where AC lines enter the house. A weatherproof hood can be added for maximum prevention of water penetration.

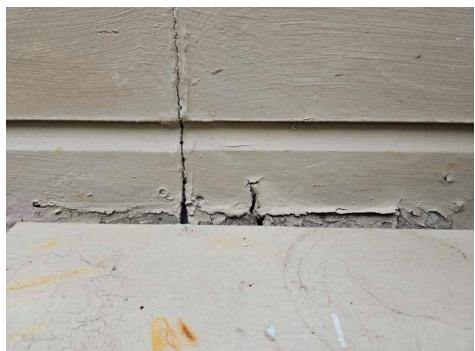
Wood rot was observed at the electrical meter and the electrical panel.

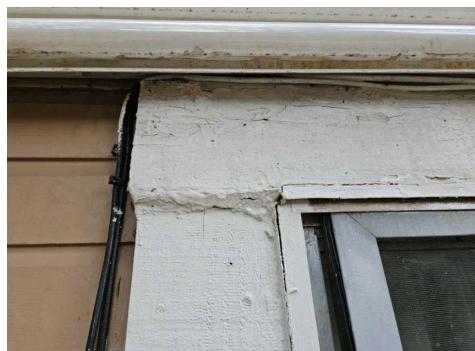
Wood rot observe on multiple window and door trims.

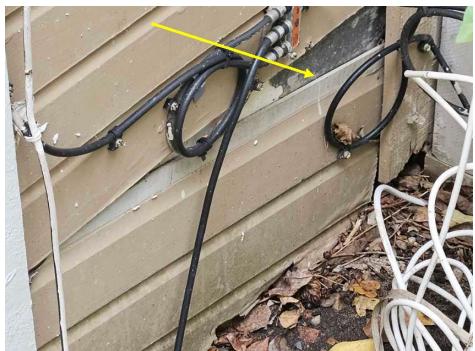
Damage siding observe on the North exterior wall of the home.

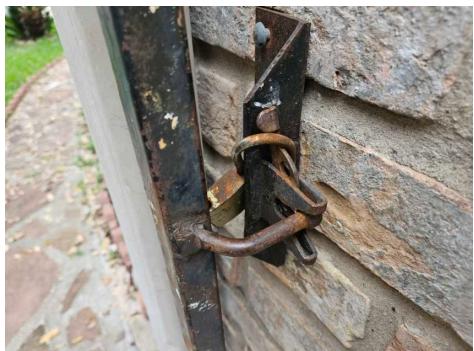
The side gate needs adjusting.

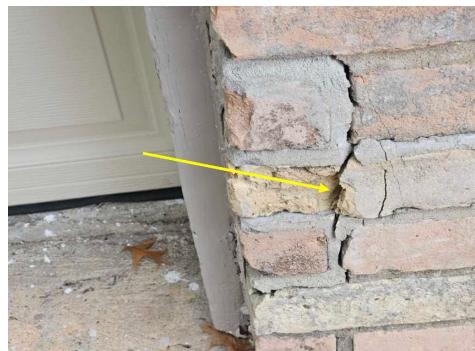
A brick crack was observed at the front of the garage area.

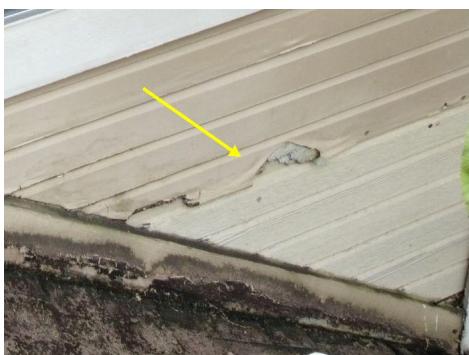
Wood rot observed on the south exterior wall.

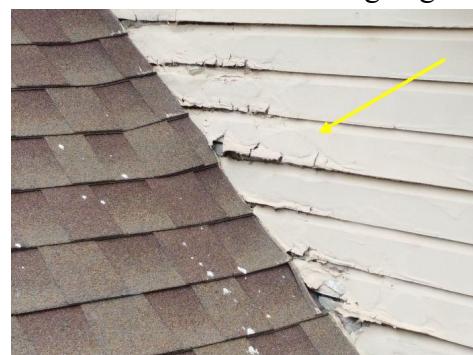
Wood rot observed on the North exterior wall.

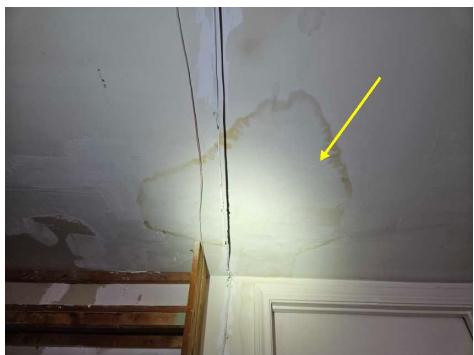
Moisture stain was observed on the garage ceiling.

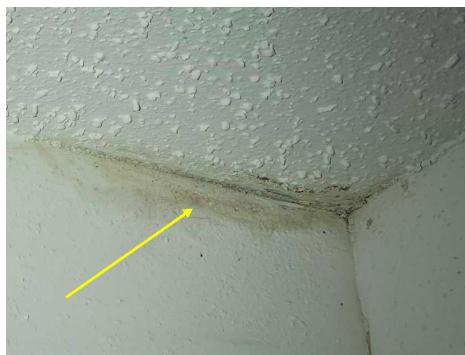
Moisture stain observed in the primary bedroom closet.

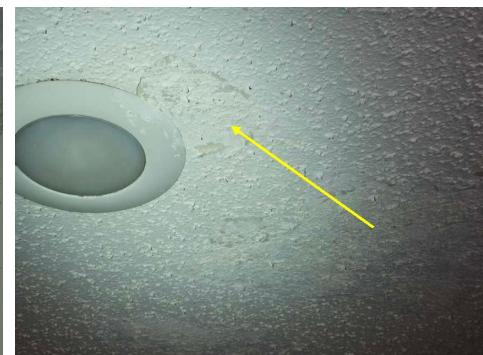
A moisture stain was observed above the primary shower.

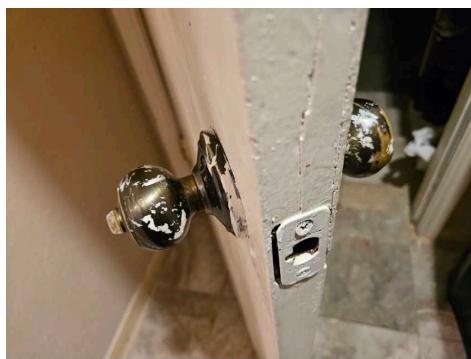
The garage door was missing hardware at the time of the inspection.

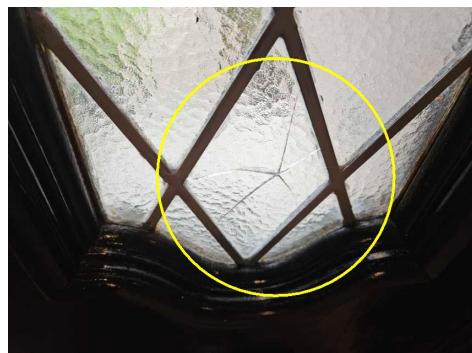
Door window cracked; front entry door.

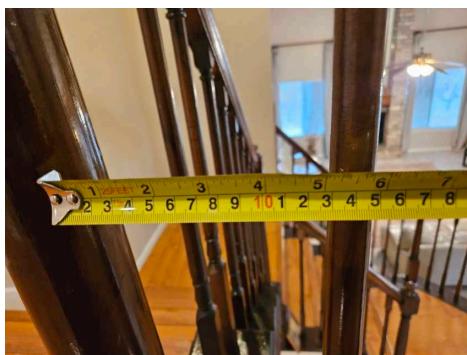
Space between railings does not comply with current industry standard, Per IRC 312.2, UBCA 421.1.1, Requires spacing between intermediate rails do not allow passage of an object four inches in diameter. Recommend covering large openings in stair rails with temporary type nylon netting if small children are present in the house to prevent injury.

The balcony guardrail spindle spacing is improper/

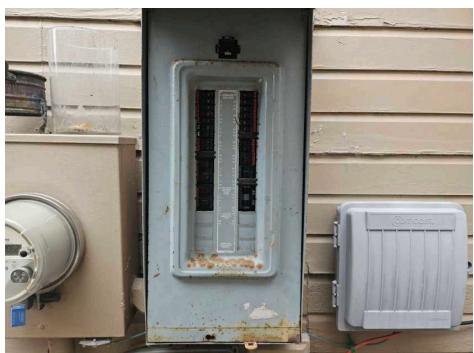
The brand of the electrical service panel is Federal Pacific . This make of panel is known for difficult to find and more costly to replace breakers. Also, this panel is associated with a higher incidence of failures/safety problems. If additional information is needed, recommend a qualified electrician be consulted.
Replacement of panel highly recommended as an upgrade/safety improvement.

Federal Pacific electrical panel was installed at the time of inspection. recommend replacement.

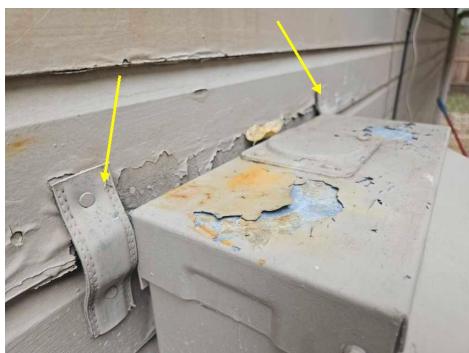
Service panel and the electrical meter were not secured to the wall properly at the time of the inspection. - shock hazard.

The main electrical panel was not secure properly at the time of inspection.

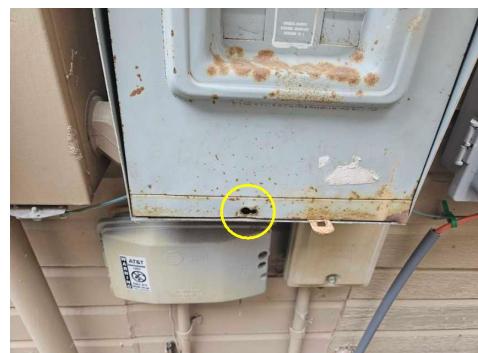
Dead front missing one or more securing screws. Need to ensure screws used do not have sharp/pointed ends that can penetrate live electrical wiring behind the dead-front and cause shock, fire, serious injury.

The dead front cover was not secure properly; missing attachment screw.

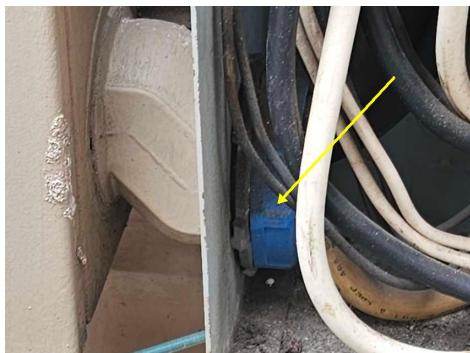
Metal conduit chase not properly bonded or concentric circle is missing. NEC 250.92(B)

The concentric bonding ring was missing at the time of the inspection.

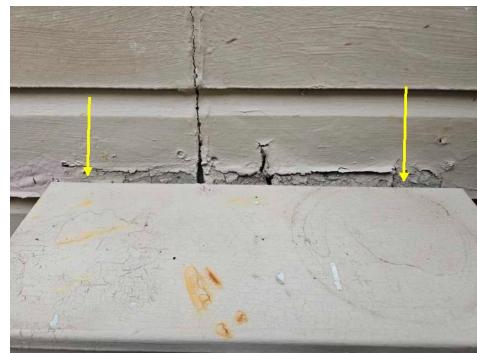
The electrical meter was not secured properly at times of the inspection.

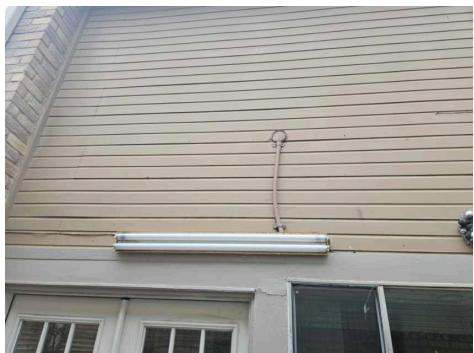
The East exterior light was missing it's diffuser at the time of the inspection.

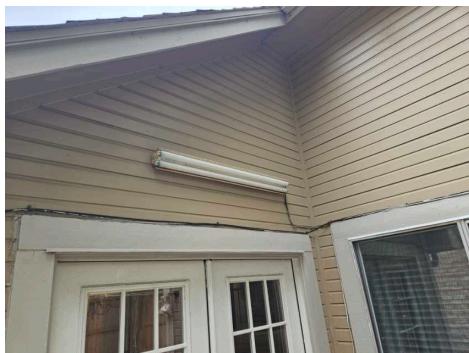
The North exterior light fixture missing diffuser at the time of inspection.

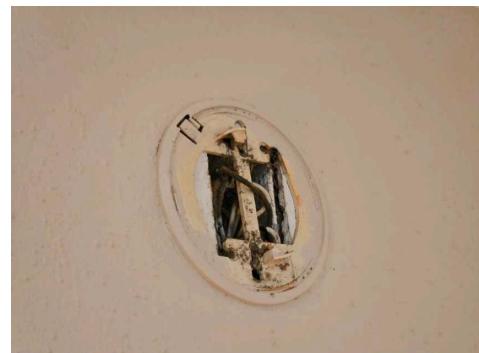
The hallway smoke detector was missing at the time of the inspection.

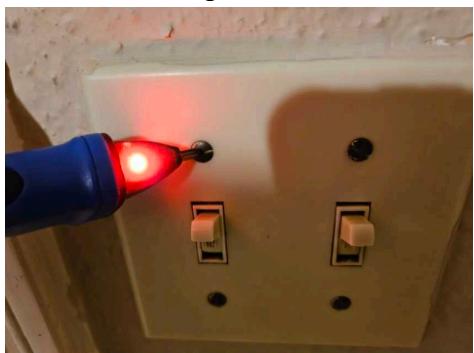
The light switches were not grounded at the time of the inspection.

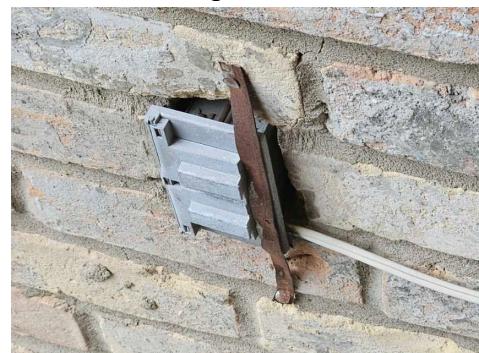
The outdoor outlet was not secured properly at the time of the inspection; front entry

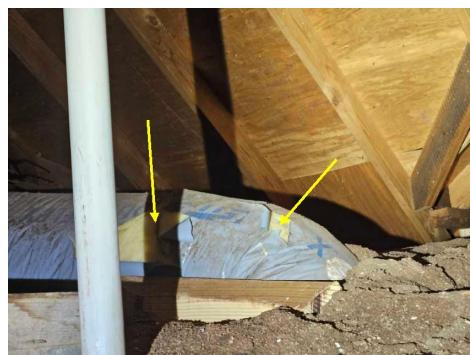
Damaged ducting.

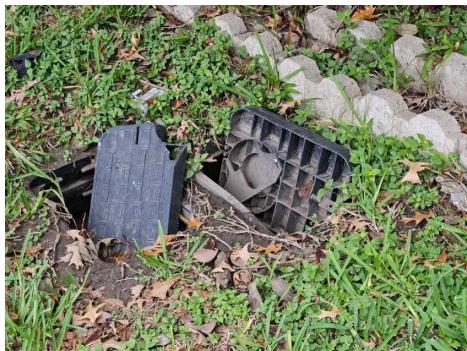
The water meter cover was not installed properly at the time of the inspection

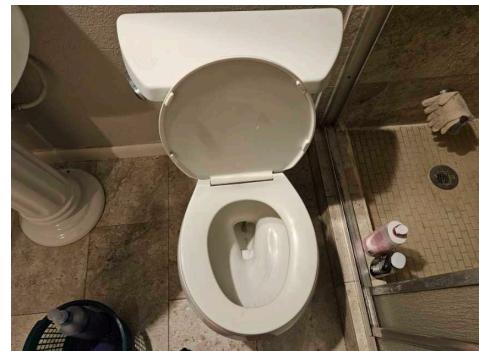
The water was turned off at the second floor commode at the time of the inspection.

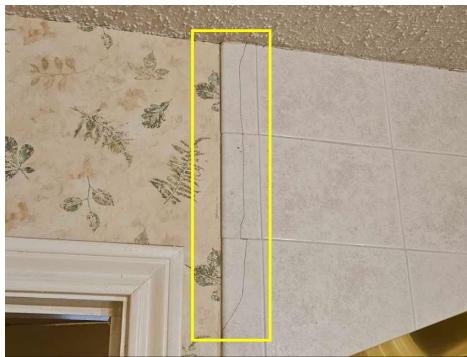
Crack tiles observe at the primary bathroom shower.

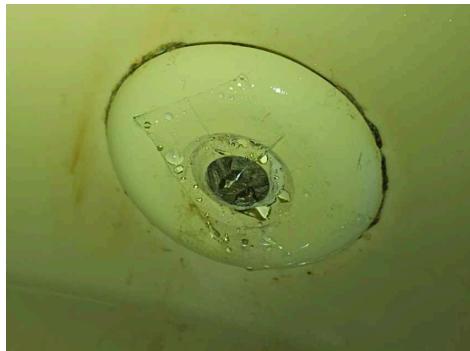
Cause of deficiency was unknown at the time of inspection; the primary bathroom tub recommends further investigation by a qualified professional to determine the root cause and possible remedy.

Tape was covering the hydro massage jets at the time of inspection.

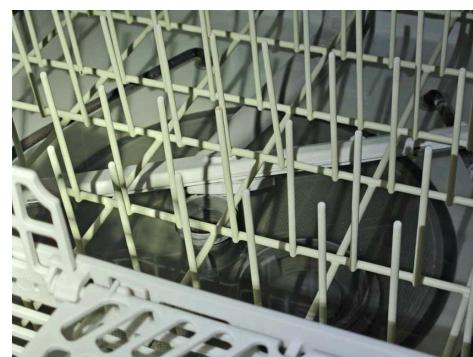
Standing water observed in the dishwasher at the time of the inspection.

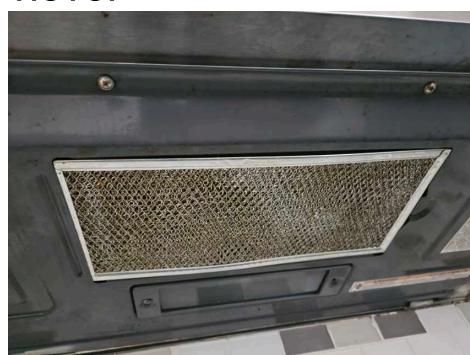
Excessive grease buildup on vent screen or screen improperly positioned.

Greasy screens were observed on the range at the time of inspection.

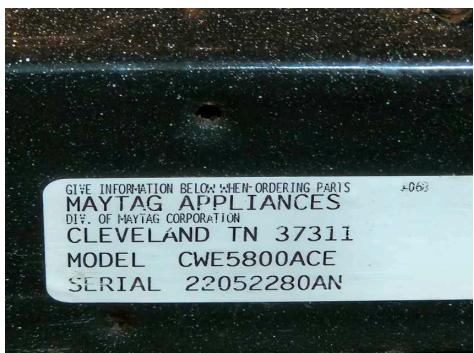
Oven data plate.

Thermostat/knob needs adjustment/replacement, when it is set at 350 degrees oven heats to approximately 325 degrees.

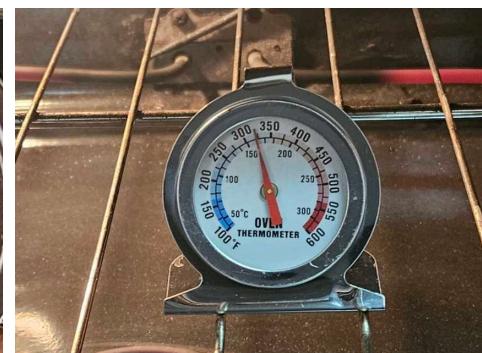
The lower oven needs adjustment.

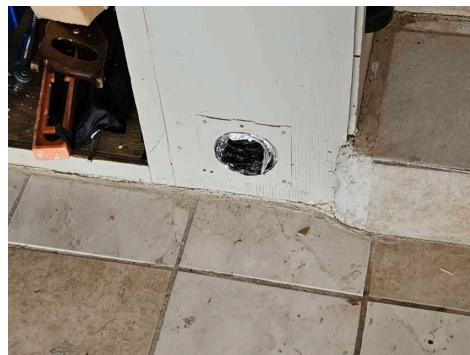
Recommend adding a dryer vent door in the dryer exhaust.
