# REDSTAR PROFESSIONAL HOME INSPECTION, INC

## REDSTAR RESIDENTIAL INSPECTION REI 7-6

816 Lester St  
Houston, TX 77007

# PROPERTY INSPECTION REPORT FORM

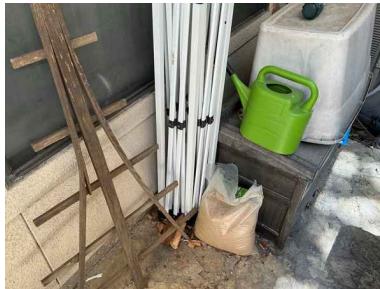
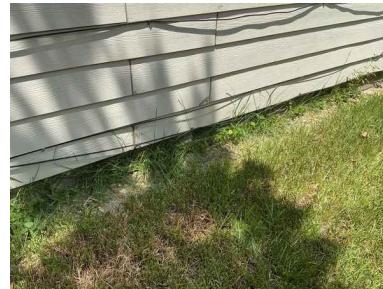
### 1: Plumbing Drain Line: Exposed at Foundation Wall

A Plumbing drain sewer line was observed exposed at the right exterior foundation wall. Recommend sealing area to prevent possible damage and deterioration.

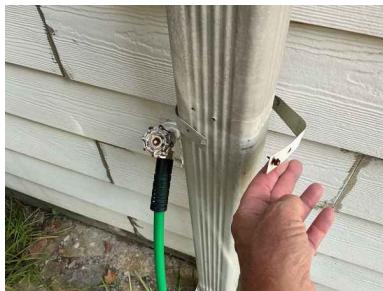
Rear Right Exterior

**1: Gutters: Minor damage/not secured**

Minor damage from typical wear and tear was observed on the gutter system at some locations. This damage does not appear to be affecting the performance of the gutter, but I recommend correction to prevent further deterioration.

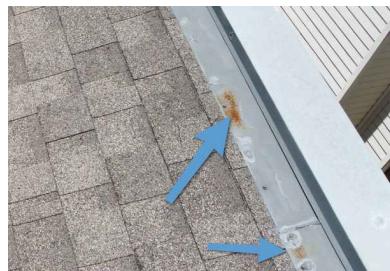
**1: Rusted Flashings**

Sections of the exposed flashing and/or other areas were observed to be displaying rust. This condition can result in failure of the covering/flashng and I recommend further evaluation and correction as needed to prevent further deterioration or potential moisture penetration.

Recommendation: Contact a qualified roofing professional.

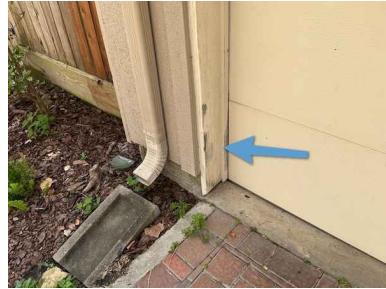
Garage Front Multiple Locations

### 1: Minor cosmetic/maintenance Issues

Exterior Walls dirty, Paint finish damaged or worn -

The above stated issues were observed at the home at time of inspection. These items are related to cosmetic issues or maintenance due to expected wear and tear. Recommend you budget for repair of these issues for cosmetic reasons, or to avoid further deterioration.

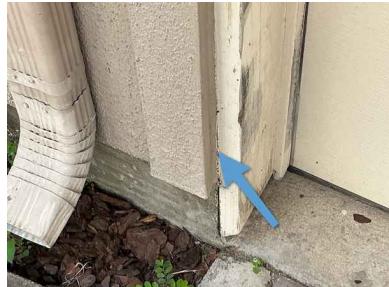
Front Left Exterior

The above stated locations were identified as areas in need of proper caulking and sealing, or maintenance to the existing sealant. Examples of locations needing sealing are pictured for your reference. Recommend further evaluation of these areas and all others to determine the extent of needed repairs.

Recommendation: Contact a qualified handyman.

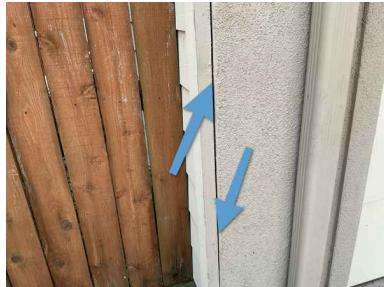
Front Left Exterior Multiple Locations

Various locations on trim and siding -

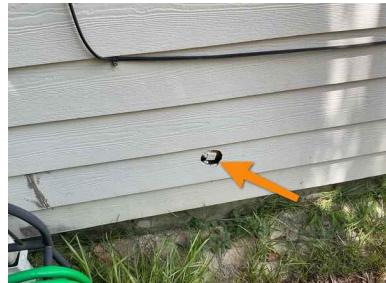
Rear Exterior

The inspector observed one or more excessive gaps or openings in the exterior finishes that could be potential points of pest intrusion. Recommend these locations be properly sealed or that you contact a qualified pest control company to perform a proper exclusion on the property.

Recommendation: Contact a qualified pest control specialist.

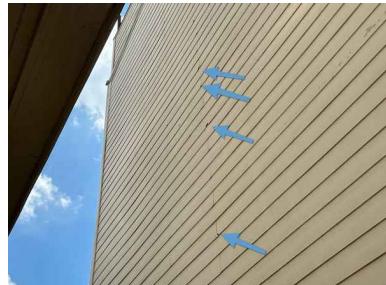
Left Middle Exterior Multiple Locations

**4: Siding: Minor Damage/Maintenance Recommended****● Maintenance Item**

The siding displayed sections with minor damage or maintenance issues. Common maintenance items include: minor damage, separation at joints and trim, finishes that are worn, etc. While these conditions do not appear to be contributing to any larger issues, recommend you consider correction to avoid further deterioration and as apart of normal maintenance.

Recommendation: Contact a qualified handyman.

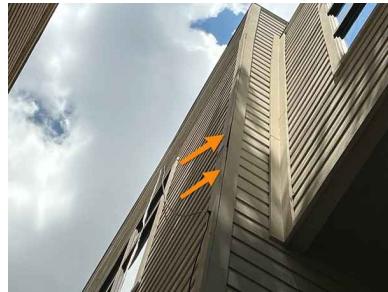
Rear Right Exterior Multiple Locations

**I=Inspected****NI=Not Inspected****NP=Not Present****D=Deficient****I NI NP D****5: Siding: Trim issues** **Recommendation**

Sections of exterior trim were either missing, loose, deteriorated, or damaged. Remedy as needed.

Recommendation: Contact a qualified professional.

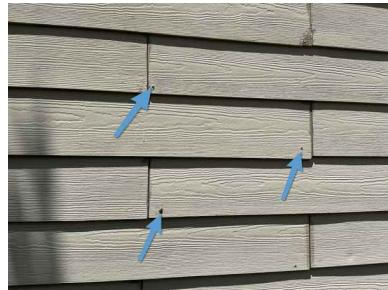
Rear Exterior Multiple Locations

**6: Siding: Exposed Fasteners** **Maintenance Item**

Exposed fasteners were observed on the siding. This can cause water penetration into unpainted areas of the siding causing water damage. Remedy as needed.

Recommendation: Contact a handyman or DIY project

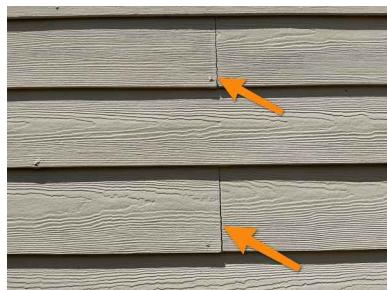
Rear Exterior Multiple Locations

**7: Siding: Caulking Missing at Buttress Joints** **Recommendation**

The inspector observed caulking deteriorated or missing at the joints where the siding butt up against each other. Recommend to caulk all joints to prevent moisture damage.

Recommendation: Contact a handyman or DIY project

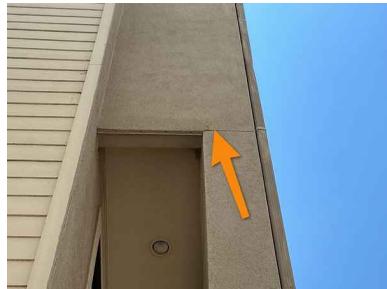
2nd Floor Front Left Exterior

**8: Stucco: Cracks at Joints****● Recommendation**

Cracks were observed at stucco joints. This could allow water to penetrate behind the stucco and cause premature rot of the stucco system. Recommend further evaluation by a stucco contractor for remedy.

Recommendation: Contact a stucco repair contractor

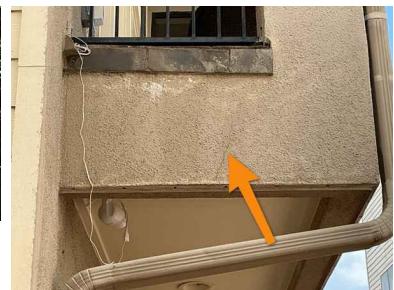
Front Left Exterior

**9: Stucco: Cracks****● Recommendation**

The inspector observed cracks in one or more areas of the house. It is important to seal any cracks in stucco walls to prevent moisture from penetrating into the wall. Recommend further evaluation by a stucco professional.

Recommendation: Contact a stucco repair contractor

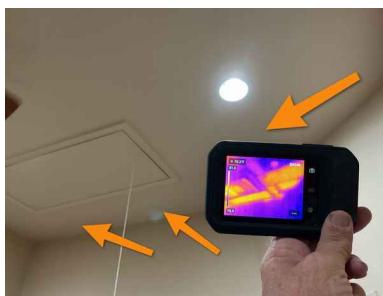
3rd Floor Left Bedroom Multiple Locations

**1: Ceiling: Missing Insulation****➡Recommendation**

The thermal imaging camera showed an indication of missing insulation at the ceiling. Repair as needed for energy efficiency purposes.

Note: The yellow/orange color in the thermal image shows where this missing insulation is located.

Recommendation: Contact a qualified professional.

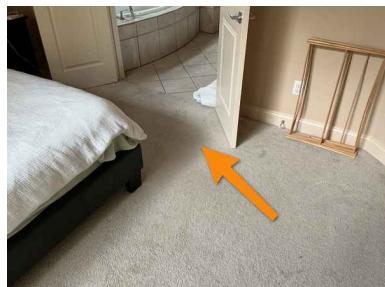
3rd Floor Master Bedroom

**2: Flooring: Squeaky Subflooring****➡Recommendation**

The flooring on the second floor was observed to pop and squeak when walked on. Squeaky flooring is not uncommon and is usually caused by subflooring that is beginning to loosen from the joists. Recommend

further evaluation and repair as needed.

Recommendation: Contact a qualified flooring contractor

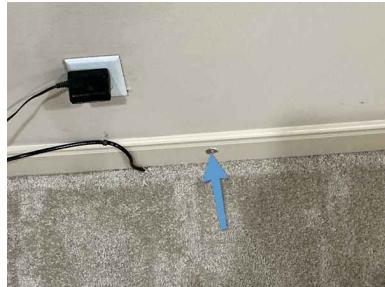
1st Floor Bedroom

##### 1: Interior Door Hardware: Missing Door Stops

One or more door stops were observed to be missing. Recommend adding door stops to prevent damage to drywall finish.

Recommendation: Contact a qualified professional.

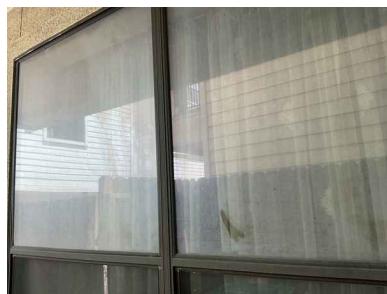
Multiple Locations

The windows were observed to be excessively dirty at the time of inspection. This condition can obscure potential issues, and proper cleaning may reveal hidden defects. Recommend cleaning and further evaluation as needed.

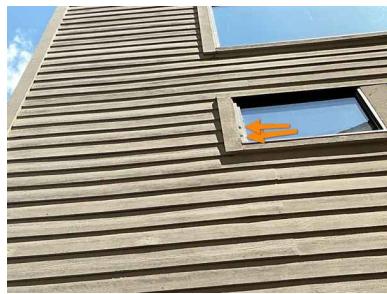
2nd Floor Right Exterior

**1: Trim Damaged**

Observed damage to the trim on one or more windows. This can cause UV damage to the glass caulking or contribute to moisture intrusion issues. Remedy as needed.

Recommendation: Contact a handyman or DIY project

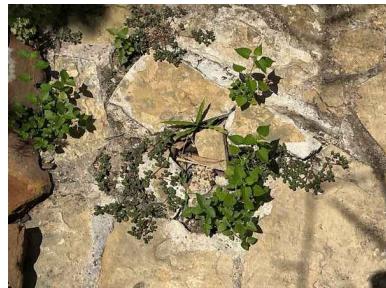
**1: Porches: Damaged / Cracked Exterior Flooring & Walkway**

Rear Patio flooring & walkway were observed to be damaged / cracked. Recommend a contractor to evaluate and repair.

Recommendation: Contact a qualified concrete contractor.

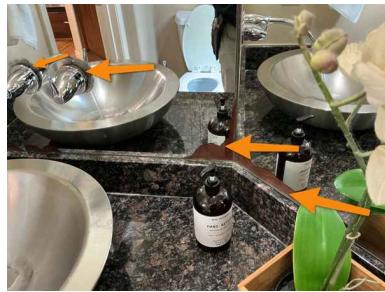
2nd Floor Half Bathroom Multiple Locations

**1: Vanity mirrors**

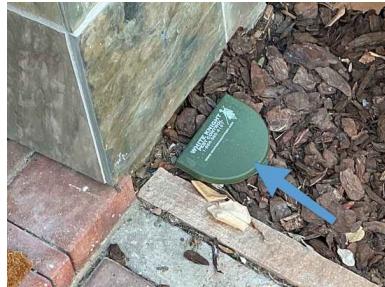
Front Middle Exterior

Inspector observed termite monitoring/bait stations around the perimeter of the foundation. Recommend consulting with the seller regarding these items to determine why the system was installed and if the system is currently being monitored or is under warranty. Recommend consulting with a qualified pest control to evaluate the system or removal as desired.

Recommendation: Contact the seller for more info

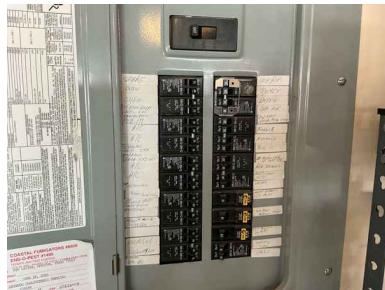
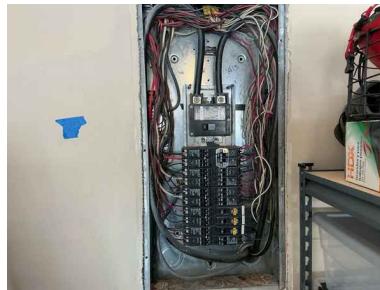
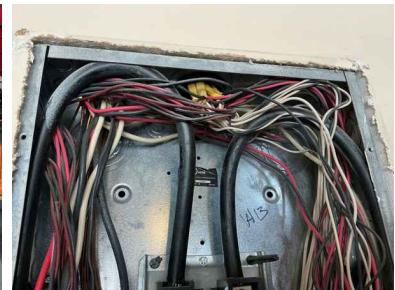
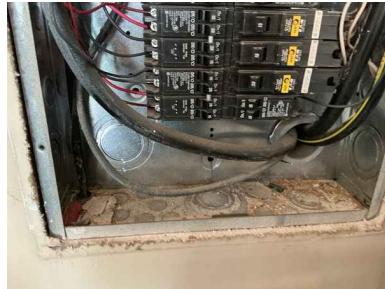
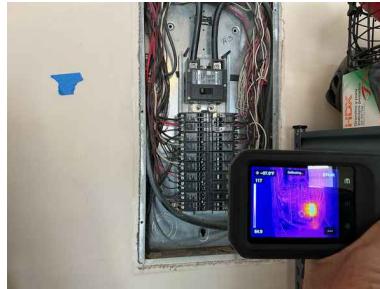
*Photo of Panel:*

All portions of the service entrance and panel were performing as intended at the time of inspection.

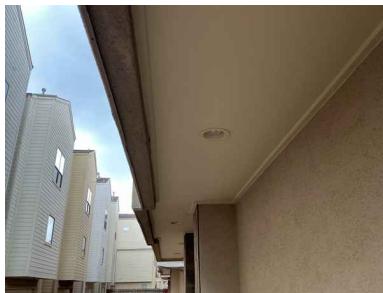
Portions of the exterior light fixtures could not be tested due to them being photo sensor and as a result the inspector could not verify functionality.

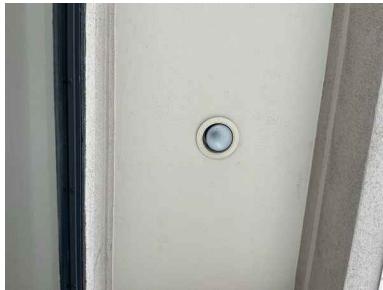
2nd Floor Front Balcony

## **1: Multiple Electrical Fixture Issues**

Recommendation: Contact a qualified professional.

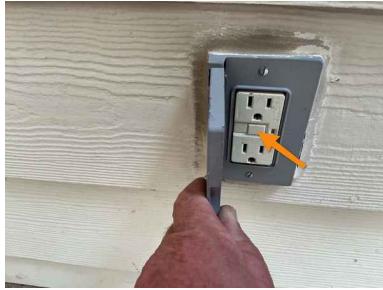
2nd Floor Rear Balcony

**2: Outlet: GFCI Does Not Reset as Designed****Recommendation**

Recommendation: Contact a qualified electrical contractor.

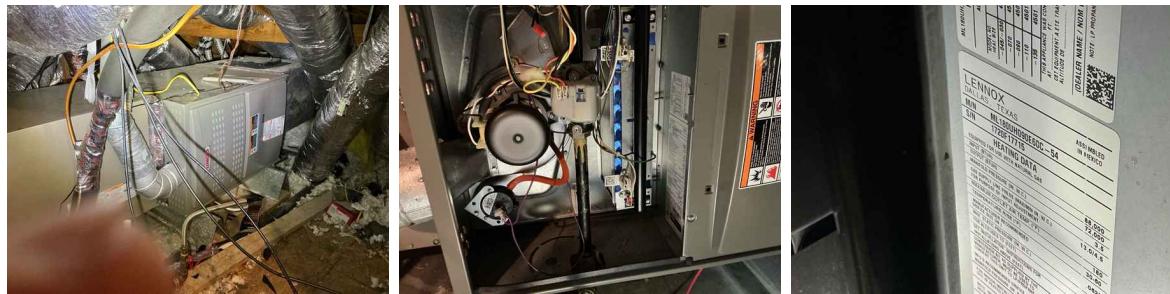
1st & 2nd Floor Unit / 2020

All portions of the heating equipment appeared to be performing as intended at the time of inspection.

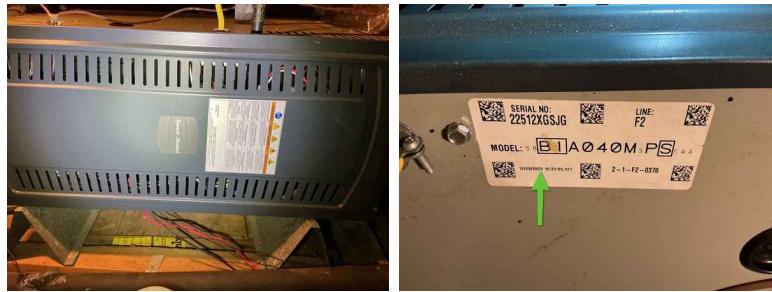
3rd Floor Unit / 2022

All portions of the heating equipment appeared to be performing as intended at the time of inspection.

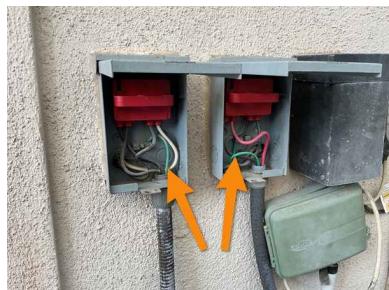
Both Units

**1: Condenser Disconnect(s): Missing Deadfront Cover(s)****►Recommendation**

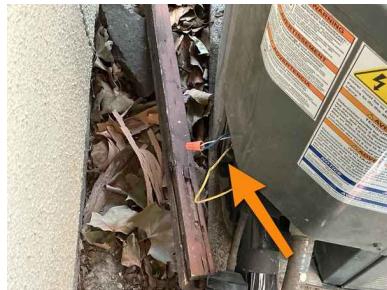
Rear Unit

**2: Condenser: Exposed Wires****⊖ Recommendation**

Recommendation: Contact a qualified HVAC professional.

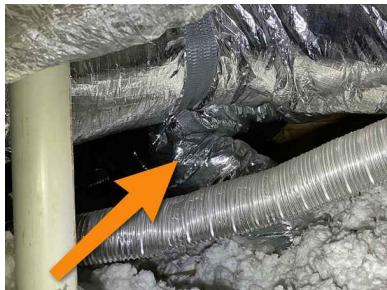
Master Bathroom Attic

One of the upstairs ducts was turned sharply at a 90° angle. This can cause a restriction of airflow through the duct. Recommend to have further evaluation and repair as needed by a licensed professional.

Recommendation: Contact a qualified professional.

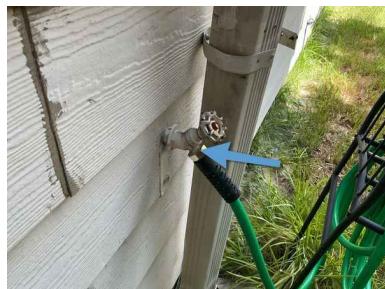
Rear Exterior

One or more hose bibb(s) Missing a backflow preventer. These devices are inexpensive, easily installed and help prevent contamination of potable water. Repair as needed.

Recommendation: Contact a handyman or DIY project

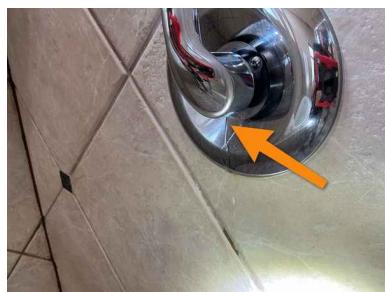
3rd Floor Master Bathroom Shower

**2: Fixture: Stem Leaking**

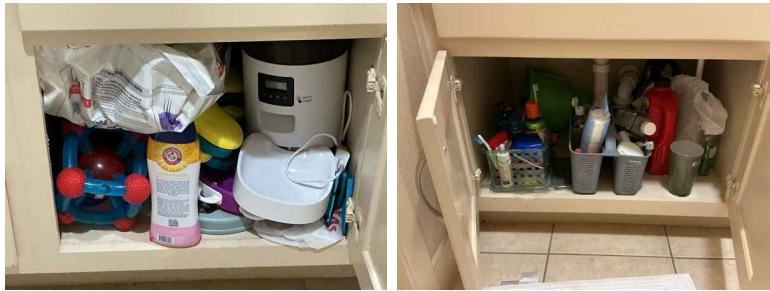
Multiple Locations

Note: Inspection of the drain assemblies under the sinks were severely limited due to excessive amounts of stored items at the time of inspection. Recommend further evaluation of these locations once items are removed. Removal of these items may reveal hidden defects.

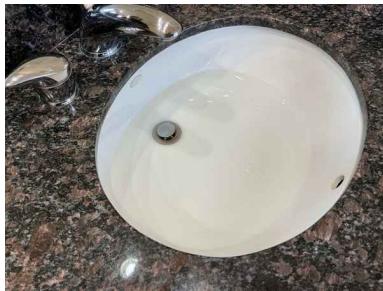
3rd Floor Master Bathroom / Right

**1: Drain Piping: Poor/Slow Drainage****● Recommendation**

Recommendation: Contact a qualified plumbing contractor.

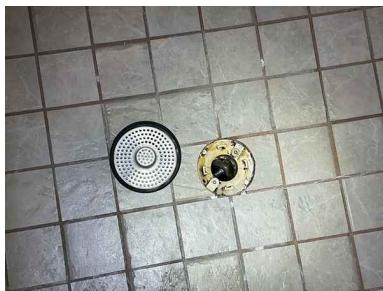
**2: Shower Drain Cover: Missing****● Recommendation**

Recommendation: Contact a qualified plumbing contractor.

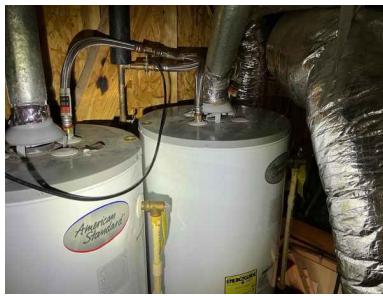
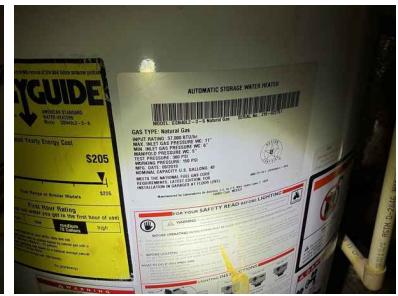
All portions of both the water heating equipment(s) were observed to be performing as intended at the time of inspection.

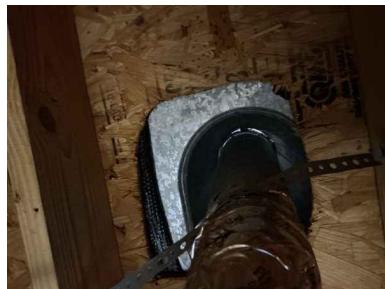
**1: Venting: Daylight Visible**

Recommendation: Contact a qualified roofing professional.

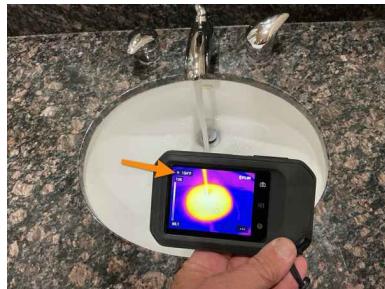
**2: Water Temperature: Above 120 Degrees Fahrenheit****⊖ Recommendation**

The water temperature at multiple fixtures was observed to exceed 120 degrees Fahrenheit. This can be a potential scalding hazard for small children and the elderly. Recommend adjusting the temperature settings on the unit to prevent a potential hazard.

Recommendation: Contact a qualified professional.

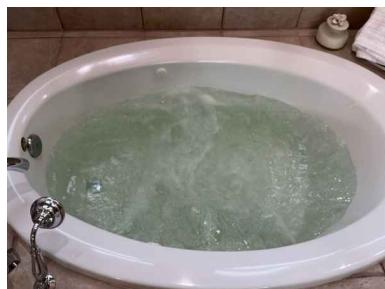
The tub appeared to be operating properly at the time of inspection.

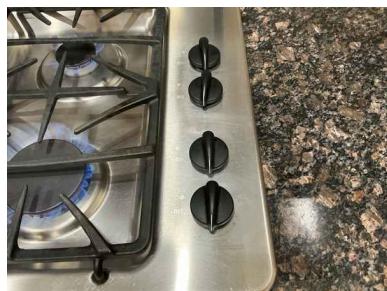
**1: Worn Control Knob Settings**

Recommendation: Contact a qualified professional.

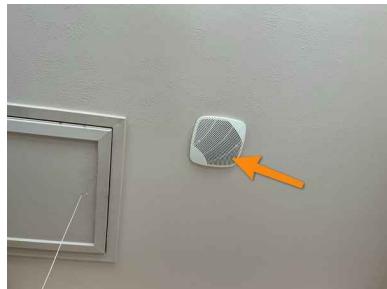
3rd Floor Master Bathroom

One or more exhaust vent fans were observed to be noisy. Recommend to have a contractor evaluate for remedy.

Recommendation: Contact a qualified professional.

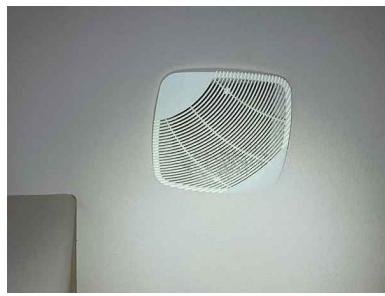
2nd Floor Half Bathroom

One or more vent covers were observed to be dirty. Recommend to clean as needed.

Recommendation: Contact a qualified professional.

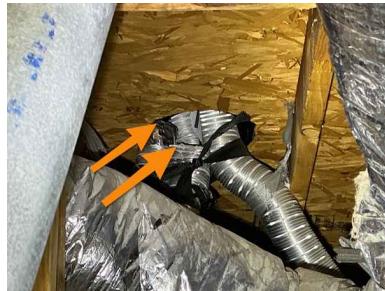
**3: Vent Ducts Terminate in Attic****● Recommendation**

Recommendation: Contact a qualified professional.
