HEDDERMAN ENGINEERING, INC.

STRUCTURAL REPORT

2121 Bolsover St
Houston, TX 77005

NOVEMBER 12, 2024

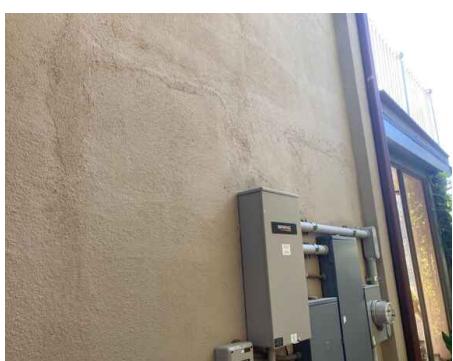
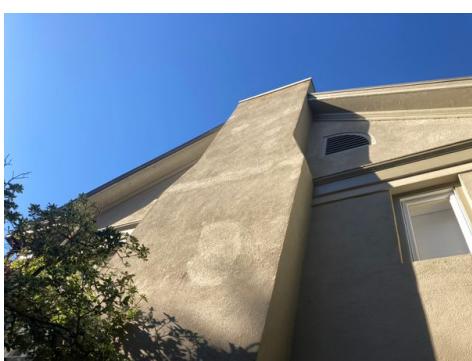
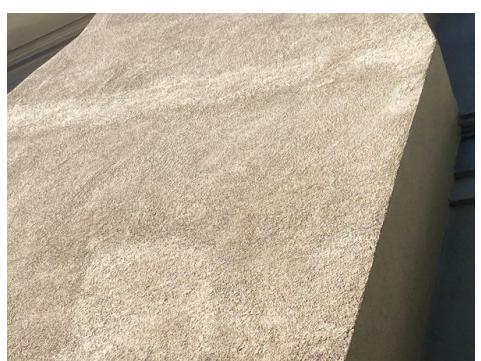
Veneer - Stucco Cracks-OK

Cracks and/or patches were observed in the exterior stucco veneer at the time of the inspection, including at the above locations. It appears that the cracks are related to the normal drying/shrinking/cracking of a cementitious product, rather than being related to excessive or unusual movement of the foundation.

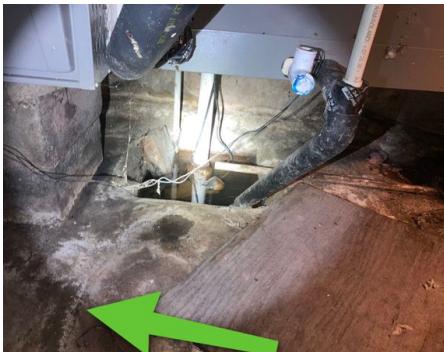
Basement

Concrete Cracks - Observed

The foundation concrete was observed to have hairline cracks, including at the above locations.

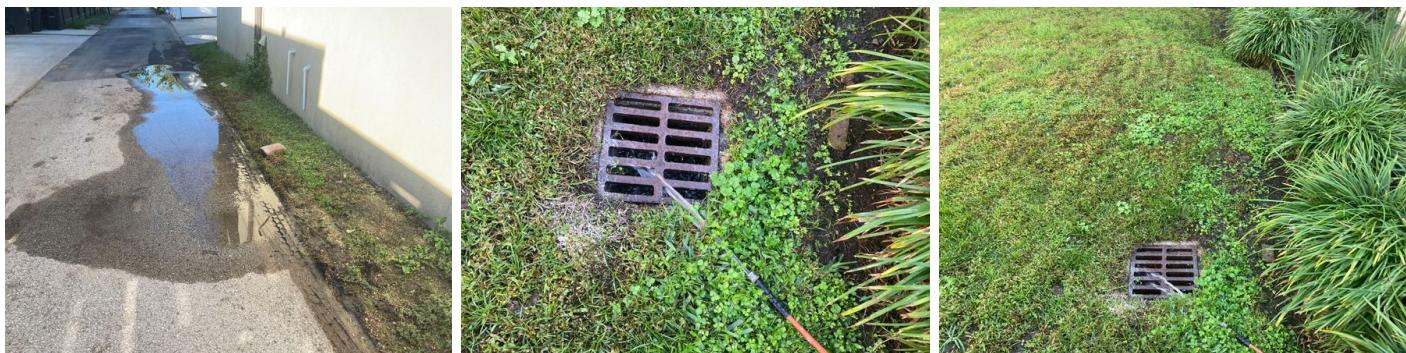
Perimeter Grading/Drainage: Underground drainage to back street

The underground drainage system at the rear of the house was checked by running water into the drain for approximately 10-15 minutes, and the system was observed to be draining properly to the alley street.

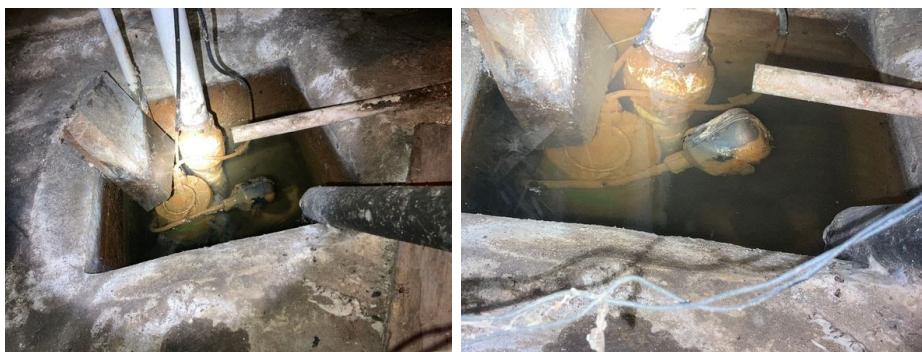
Perimeter Grading/Drainage: Sump Pump Basement - Functional - Exit Point Not Visible

We observed a sump pump installed at the basement. The pump was operationally checked by manually lifting the float switch, and the pump was observed to come on, and evacuate the water in the sump. However, we were not able to determine the exit point of the discharge, and further investigation with the homeowner and/or a service company is recommended.

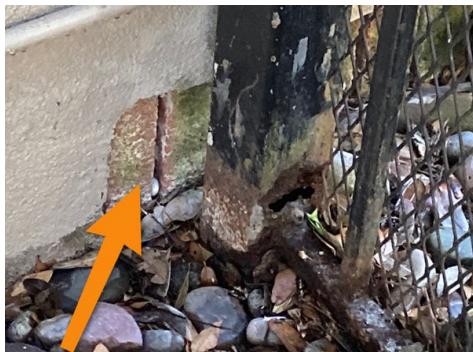
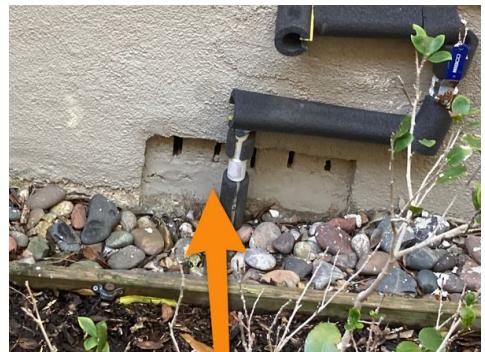
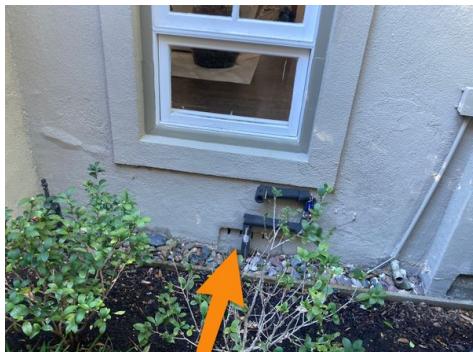
INADEQUATE VENTILATION

The amount of ventilation for the crawlspace was limited. Vented crawlspace areas should have a minimum of one square foot of vent for every 150 square feet of crawlspace area. Lack of proper ventilation can cause deterioration to the structural members due to rotting and the growth of fungus on the wood. It is recommended that additional ventilation be provided.

One or more if the vents to the crawlspace was blocked and will prevent air flow, and repair is needed.

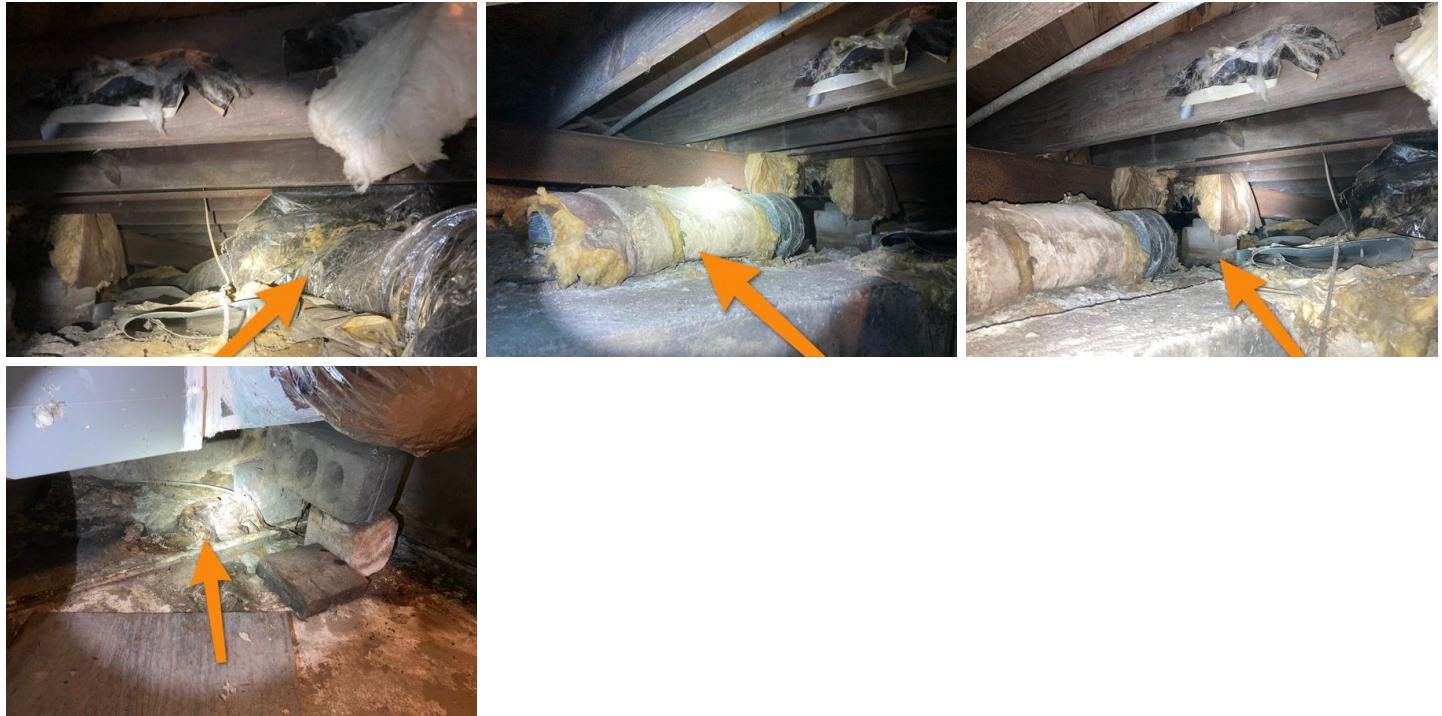
4.4.3 Crawlspace

DEBRIS - REMOVE

We observed debris on the ground at the crawlspace, and it is recommended the debris be removed.

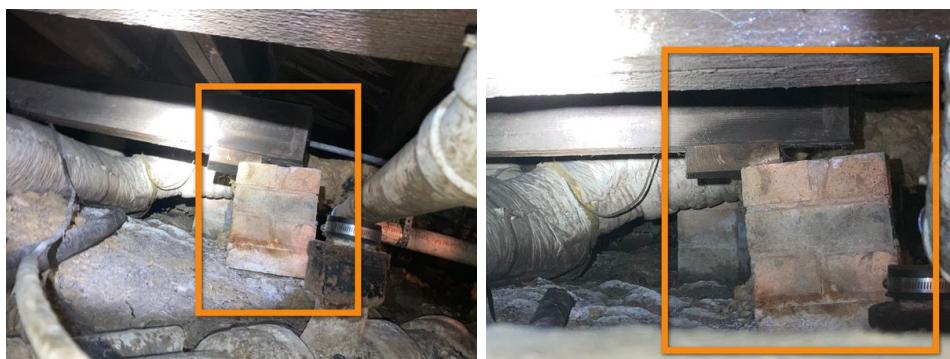
4.4.4 Crawlspace

PIERS LEANING - REPAIR

We observed a pier under the house that was leaning out of a vertical position and the beam over it was barely in contact with the pier. Further investigation with a foundation repair contractor is recommended to obtain a cost estimate to make the needed repairs.

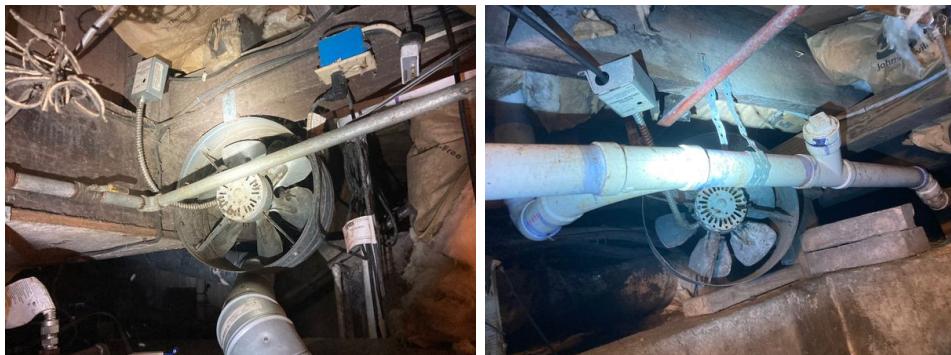
4.4.5 Crawlspace

VENT FAN IN CS-NOT FUNCTIONING

We observed a vent fan in the crawlspace with a duct that extended to a vent at the exterior wall to vent to the outside. The vent fan was not functioning when we observed it in the crawlspace. Further investigation with the homeowner is recommended to verify the operation of the fan or to make any needed repairs to the fan so that it is functioning.

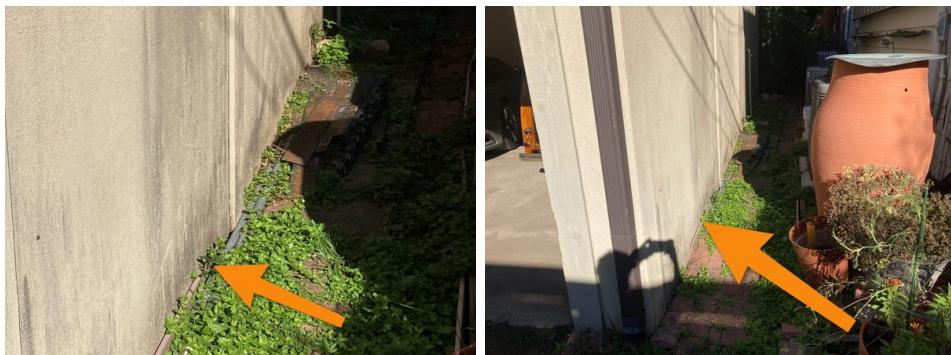
The perimeter grading and/or flower beds was too high at some areas, and was graded near or above the top of the foundation. It is recommended that the beds/soil be regraded as needed to prevent water penetration into the house, and to allow for proper drainage.

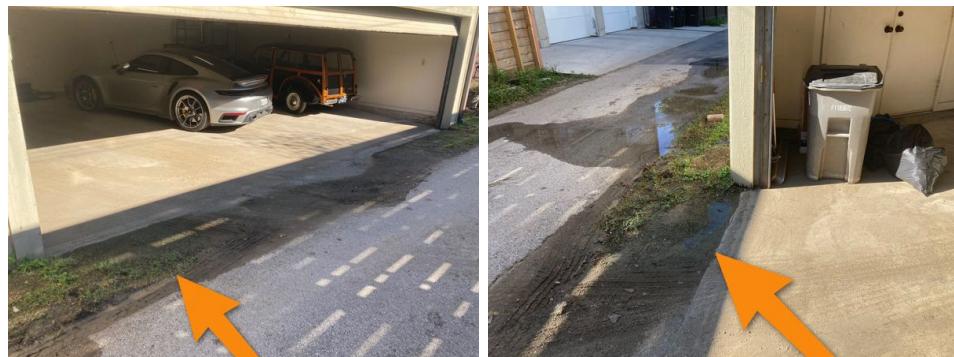
The drainage was observed to be poor at some low areas where it appears that water will pond. It is recommended that a company specializing in drainage solutions be contacted to provide a recommended solution, along with a cost estimate to provide proper drainage.

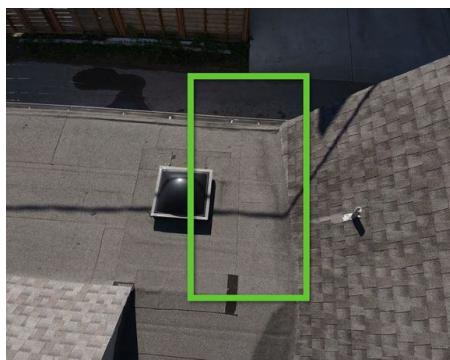
Wear and Deterioration: Modified Bitumen - Some

Discoloration

The modified bitumen roof surface was showing a moderate amount of deterioration, including the items as described above and shown below.

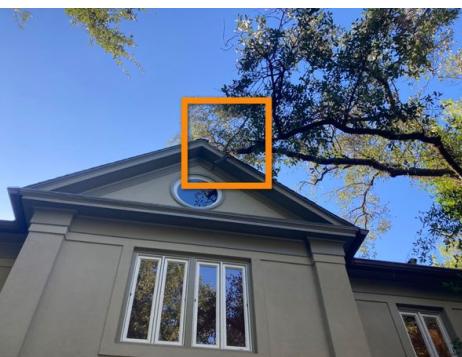
SHINGLES DAMAGED

Shingles were observed to be damaged and the roof is in need of repair. Contact a roofing contractor to obtain a cost estimate for repairs.

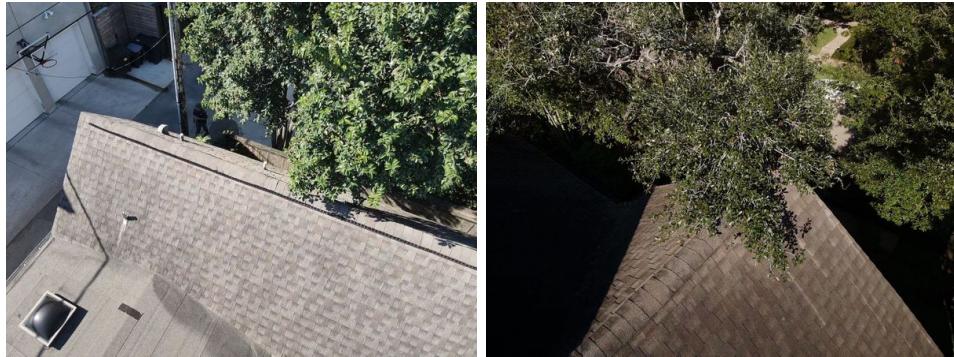
5.8.2 Roof Details

ROOF: MISCELLANEOUS

We observed some miscellaneous items related to the surface of the roof, including the items listed above. Have a roofing contractor provide a cost estimate to make any needed repairs.

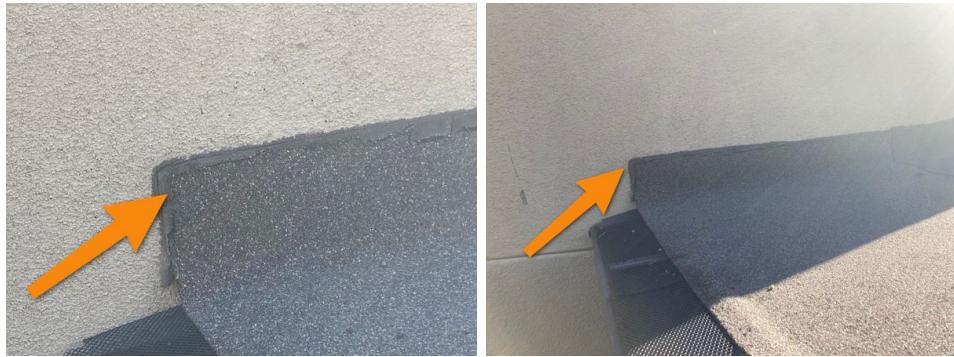
5.8.3 Roof Details

FLASHING/COUNTER FLASHING

Counter flashing was missing

We observed one or more conditions with the roof flashing as pointed out above. Have a roofing contractor provide a cost estimate to make all needed repairs.

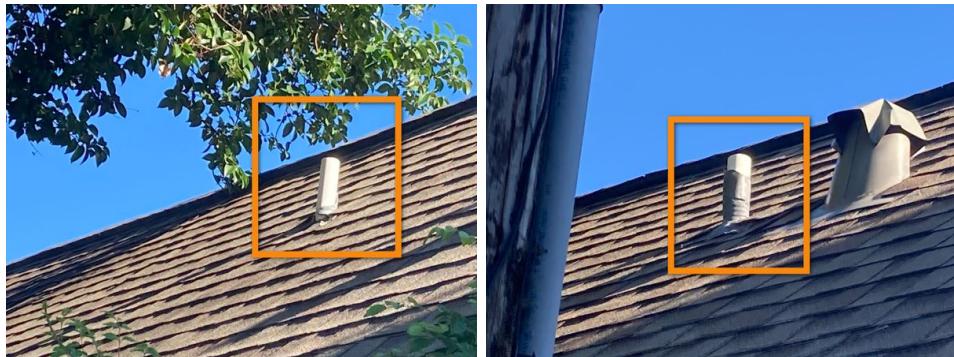
5.8.4 Roof Details

ROOF JACKS

Lead - Squirrel Damage

The roof jacks at the plumbing vent pipes were observed to have the conditions as described above. Further investigation with a roofing contractor is recommended to make all needed repairs.

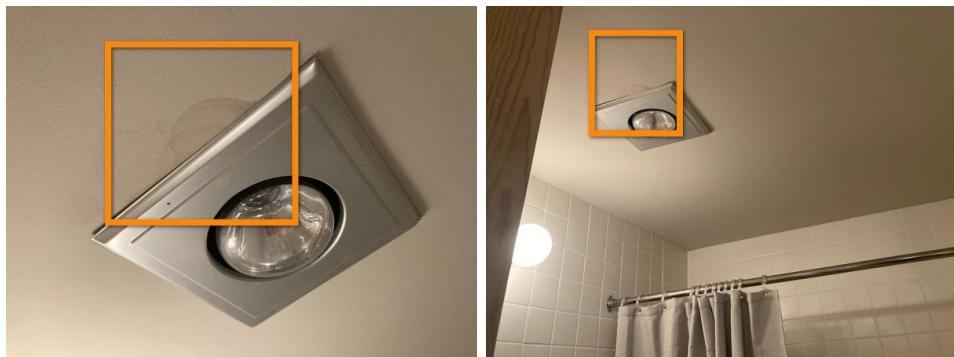
5.9.1 Roof Leaks

OBSERVED ON CEILING

After observing the interior of the structure, evidences of roof leaks were visible, where the ceiling was water stained. It is recommended that a roofing contractor be contacted to find the source of the leaks, and to make any needed repairs.

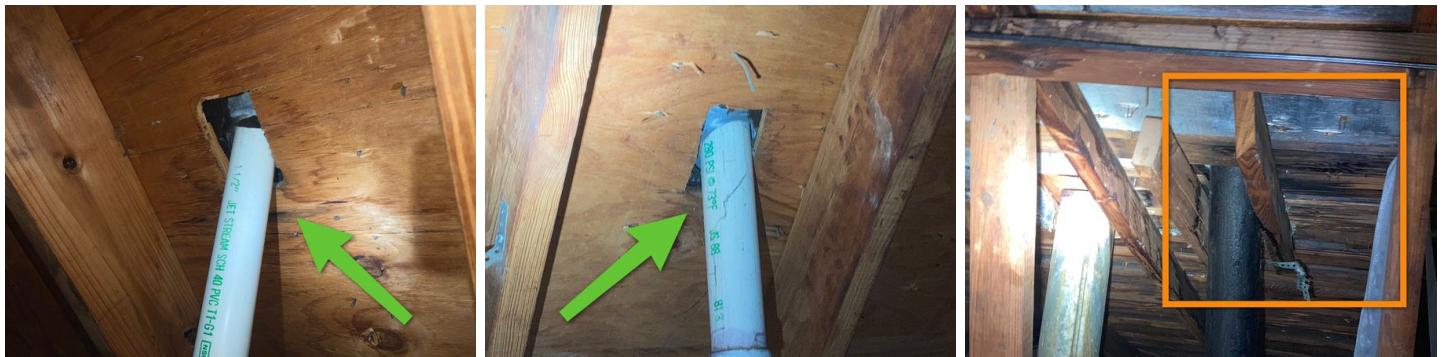
5.9.2 Roof Leaks

ATTIC ROOF DECKING AND/OR FRAMING MEMBERS

After observing the interior of the structure, evidences of roof leaks were visible in the attic, where the roof decking and/or roof framing members were water stained. It is recommended that a roofing contractor be contacted to find the source of the leaks, and to make any needed repairs.

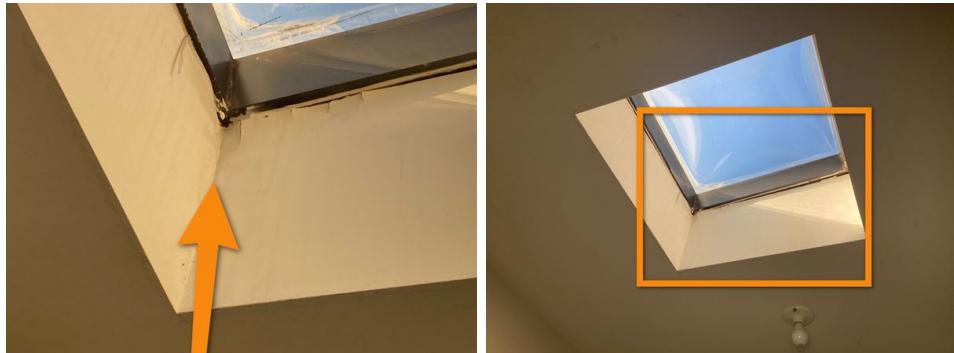
5.9.4 Roof Leaks

SKYLIGHT - STAINS ON SR

After observing the interior of the structure, evidences of roof leaks were visible at the skylight(s) where water stains were observed on the sheetrock. It is recommended that a roofing contractor be contacted to find the source of the leak(s), and to make any needed repairs.

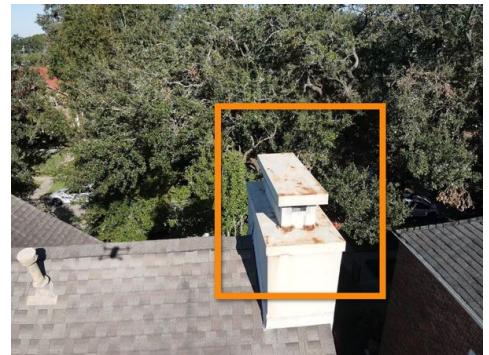
WEATHER CAP - RUSTED

The top of the chimney flue had a metal spark arrester/weather cap installed in the flue to prevent water penetration down the chimney. The cap was rusted and needs to be cleaned and sealed to prevent further deterioration.

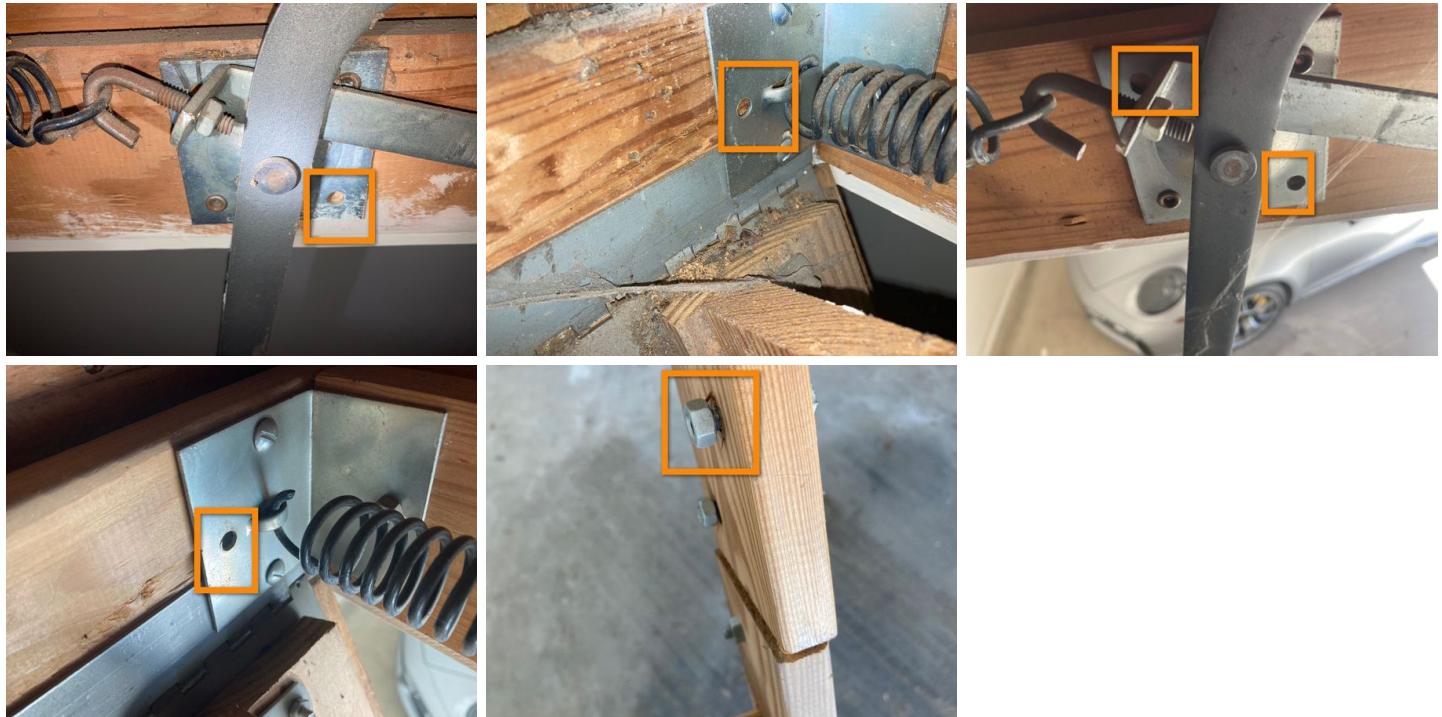
9.2.2 Ladder

LADDER ATTACHMENT IMPROPER

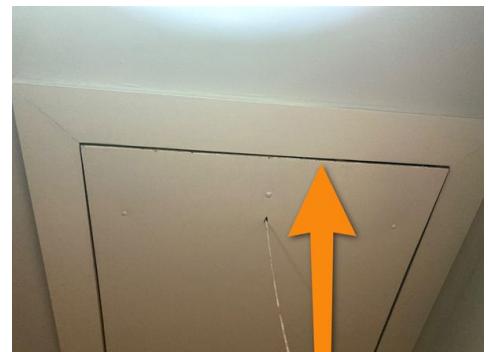
9.2.3 Ladder

LADDER NOT CLOSING PROPERLY

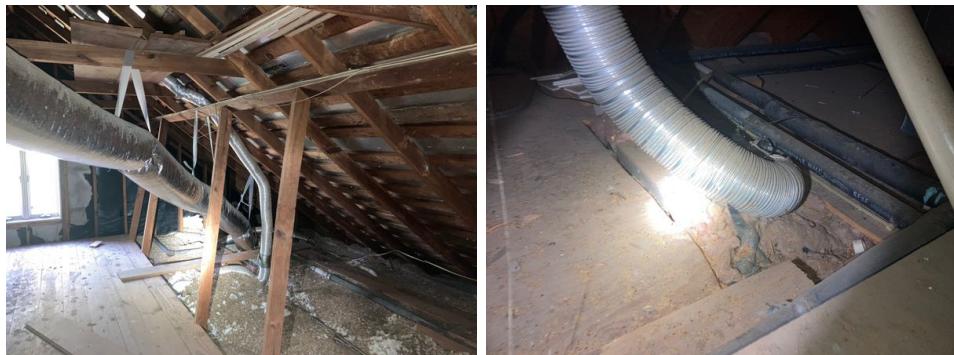
9.6.1 Insulation

THIN 3-5 INCHES

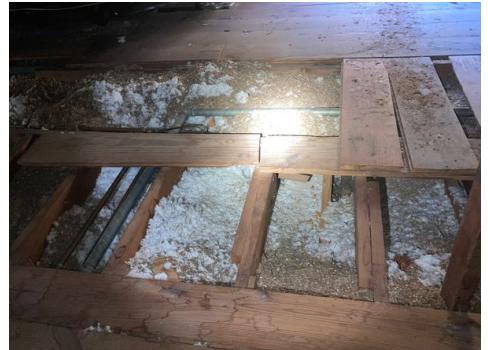
9.6.2 Insulation

INSULATION MISSING - BETWEEN JOISTS

The insulation in the attic was missing from between some of the joists. Have a service company provide a cost estimate for repairs.

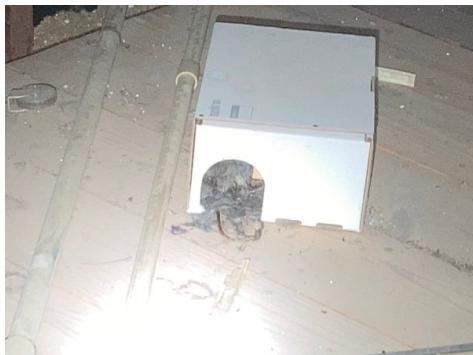
9.7.1 Gable vents

GABLE VENTS SCREENS TORN

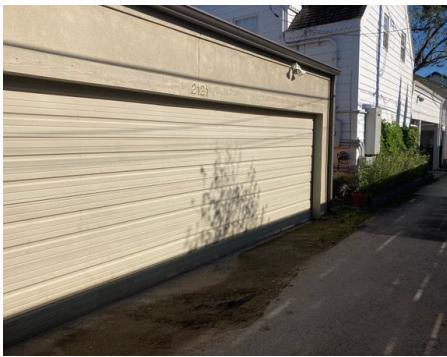
Garage Door: Garage door - OK

The garage door was in generally good condition at the time of the inspection, and no significant repairs needed.

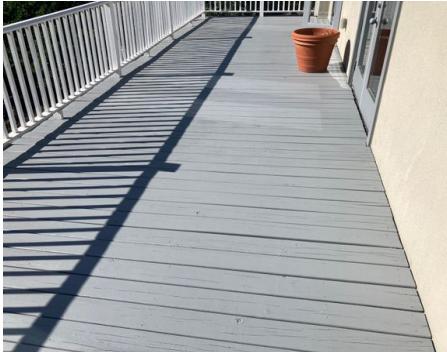
Balcony: Positive Slope

The surface of the balcony was observed to have a positive slope away from the house for good drainage.

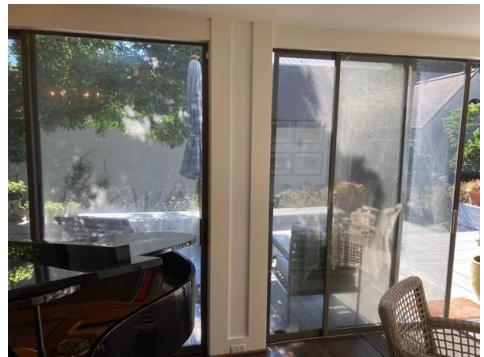
SUNROOM

One or more double pane windows were observed where the seal has been compromised and allowed moisture between the two panes. It is pointed out that we were not able to view the door under differing lighting conditions at different times of the day, and we may not be able to see discoloration that may become visible under different lighting and/or weather conditions, other than at the locations listed below. Further investigation with a window specialist is recommended concerning the window(s) to determine the extent of the condition throughout the house, and to make all needed repairs.

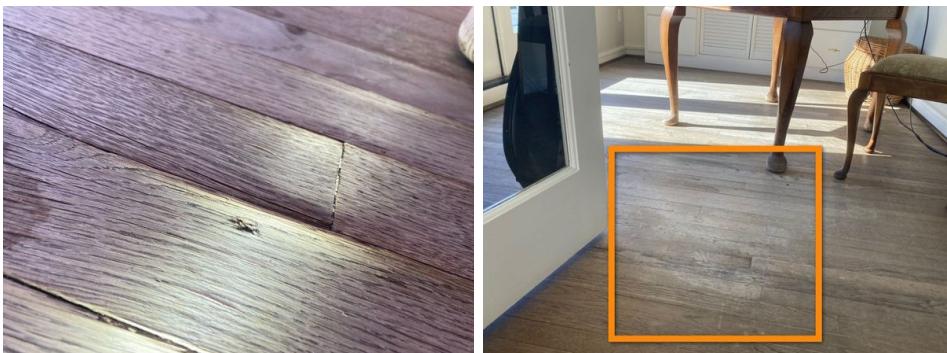
12.4.3 Floor coverings

WOOD FLOOR WASHBOARD

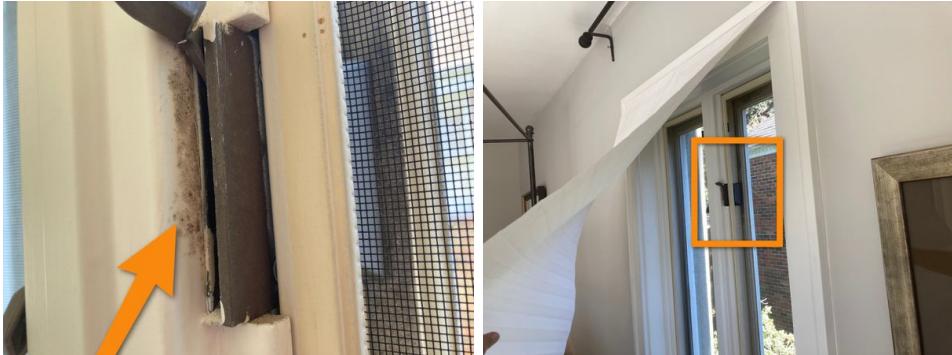
12.6.1 Smoke alarms

SMOKE ALARM(S) MISSING
