HEDDERMAN ENGINEERING, INC.

STUCCO REPORT

2121 Bolsover St
Houston, TX 77005

NOVEMBER 12, 2024

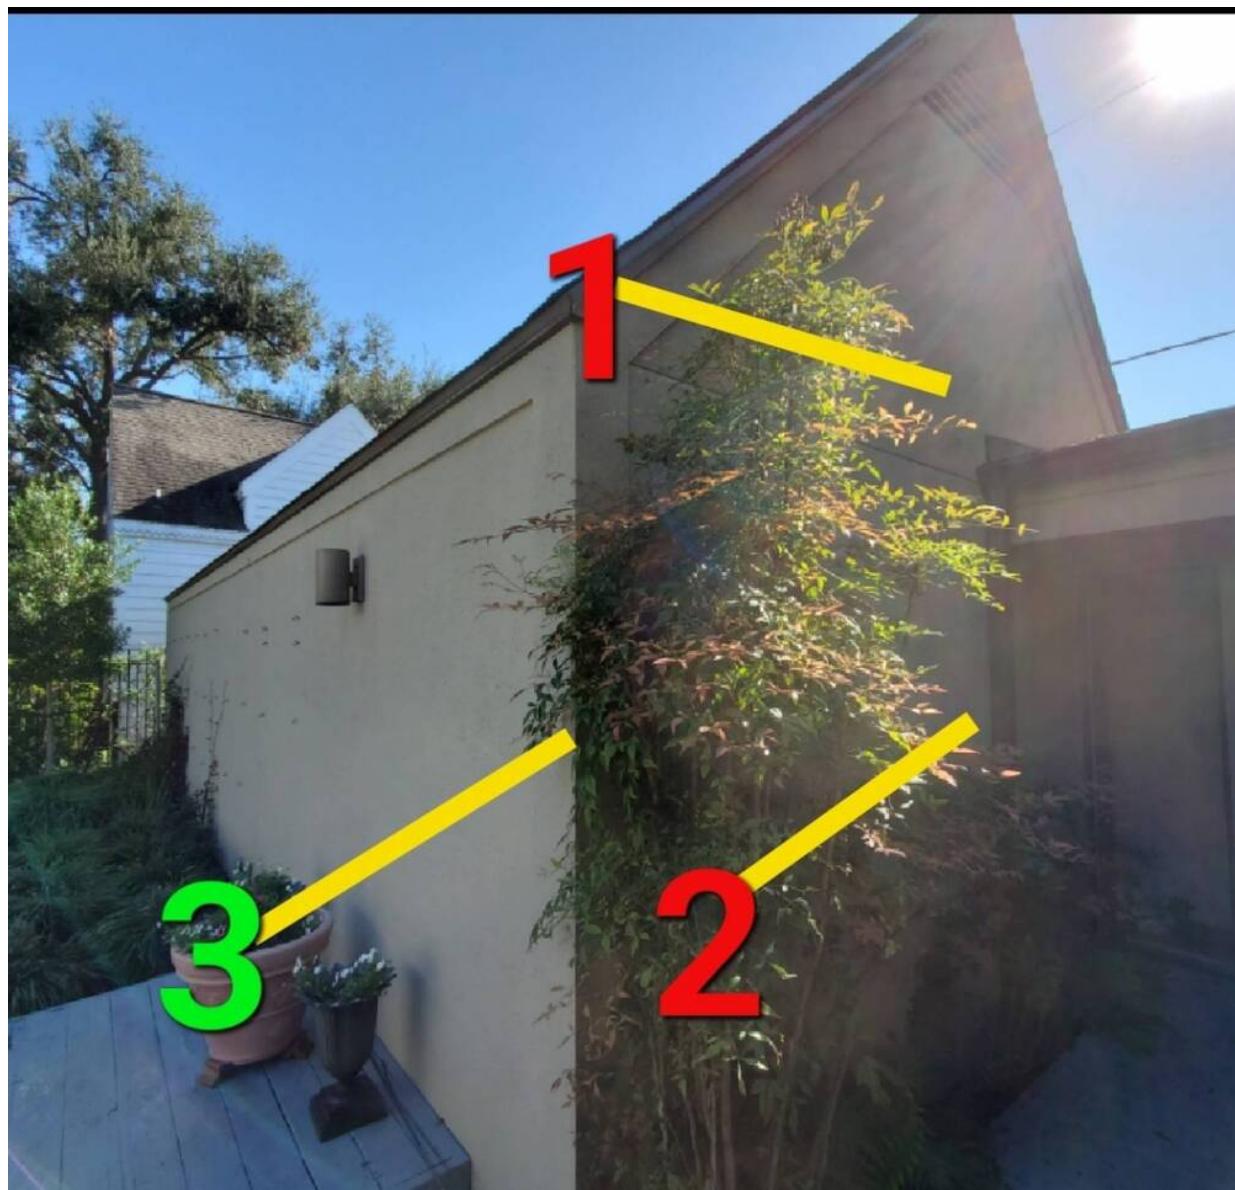
General: Elevation 1

| Point | % | Level | Substrate | Notes |
|---|---|---|---|---|
| 1 | N/A | N/A | Deteriorated | #1 - Damaged substrate visible from attic |
| 2 | N/A | N/A | Deteriorated | #2 - No resistance beyond stucco |
| 3 | 12 | Low | Firm | |

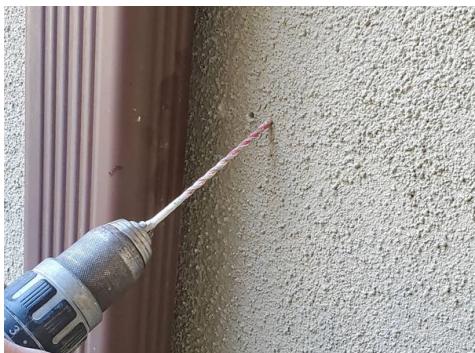
No resistance beyond stucco

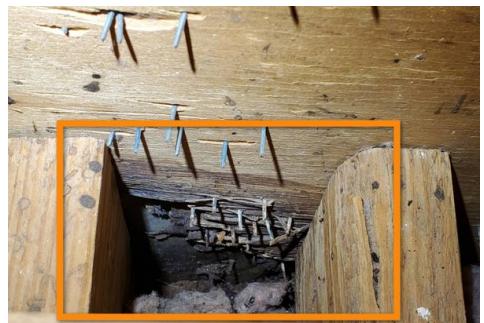
Deteriorated substrate visible in attic

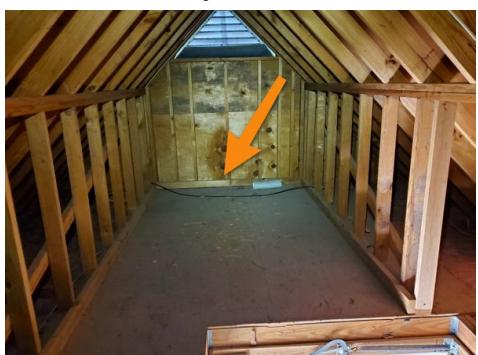
Deteriorated substrate in attic

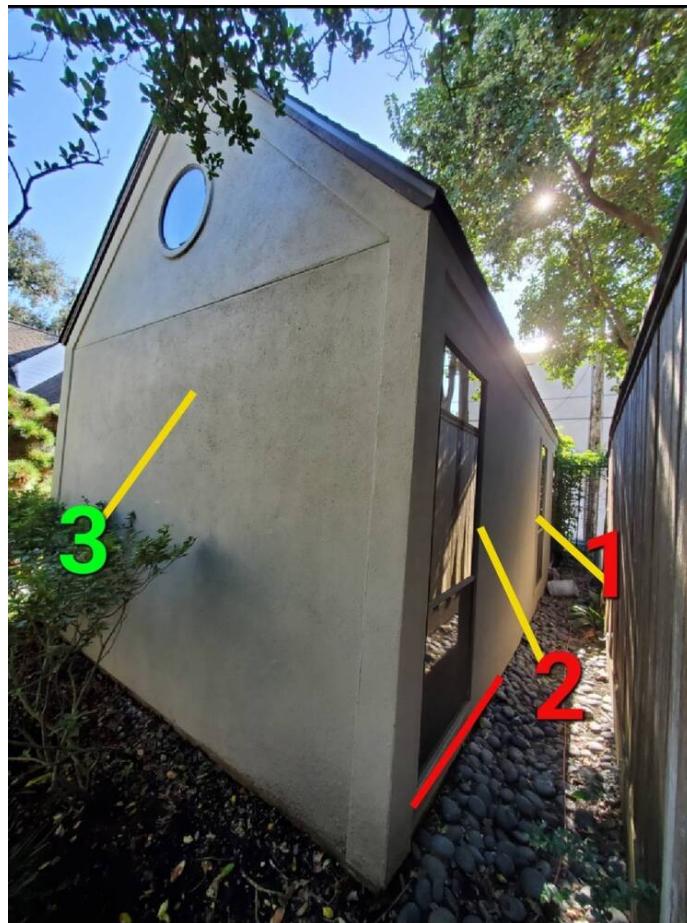
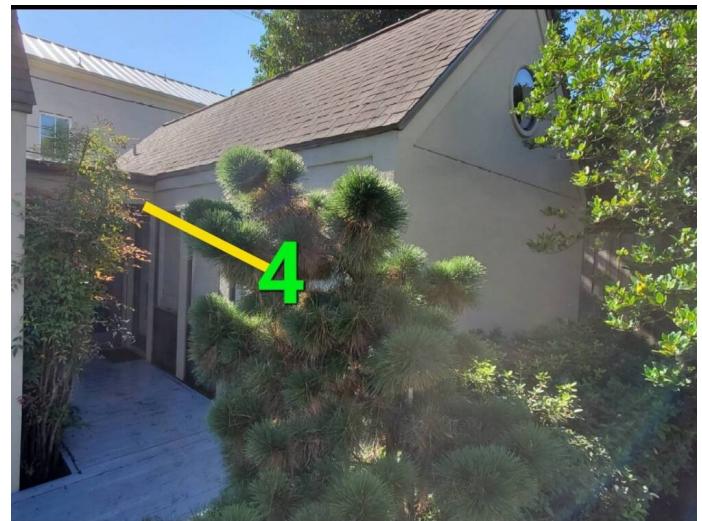
General: Elevation 2

| Point | % | Level | Substrate | Notes |
|---|---|---|---|---|
| 1 | N/A | N/A | Deteriorated | #1&2 - No resistance beyond stucco |
| 2 | N/A | N/A | Deteriorated | *Red Line - Deteriorated substrate felt by hand |
| Line | N/A | N/A | Deteriorated | at bottom of wall |
| 3 | 12 | Low | Firm | |
| 4 | 10 | Low | Firm | |

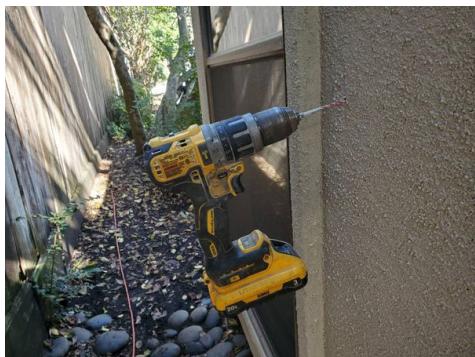
No resistance beyond stucco

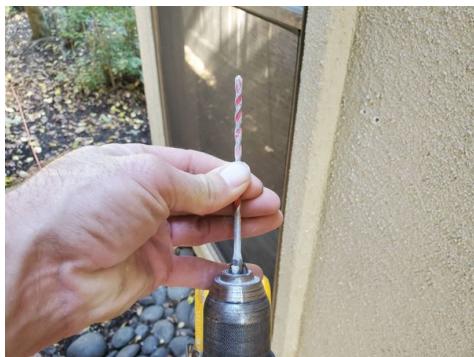
No resistance beyond stucco

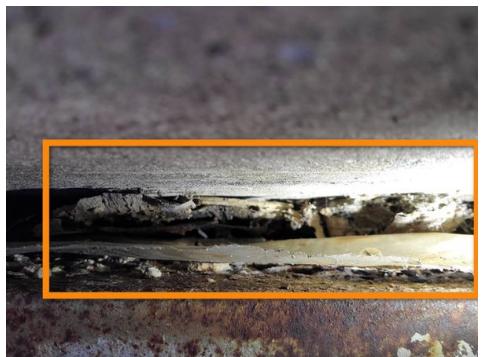
Deteriorated substrate at bottom of wall

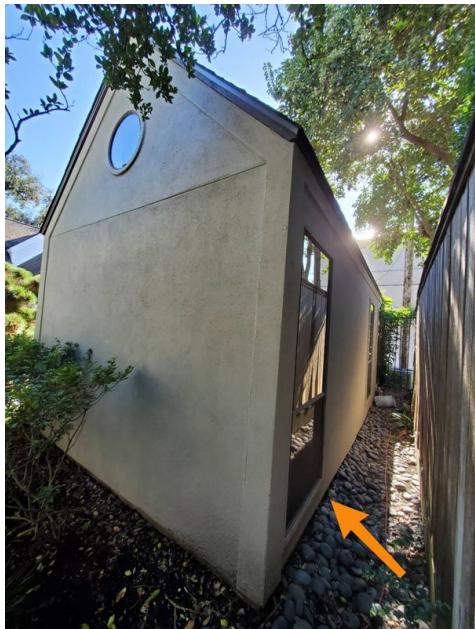
Deteriorated substrate at bottom of wall

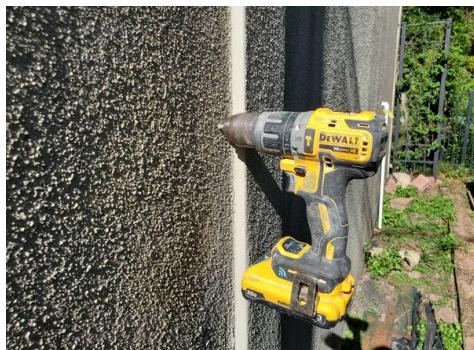
No resistance beyond stucco

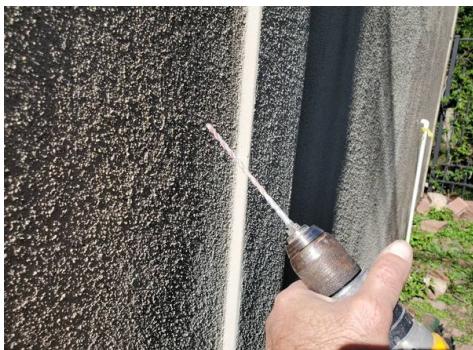
No resistance beyond stucco

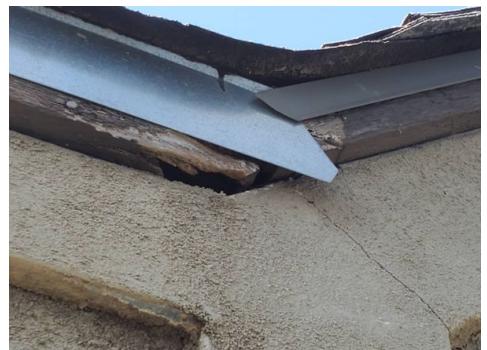
Separations at roof/stucco above damaged area and rotted fascia

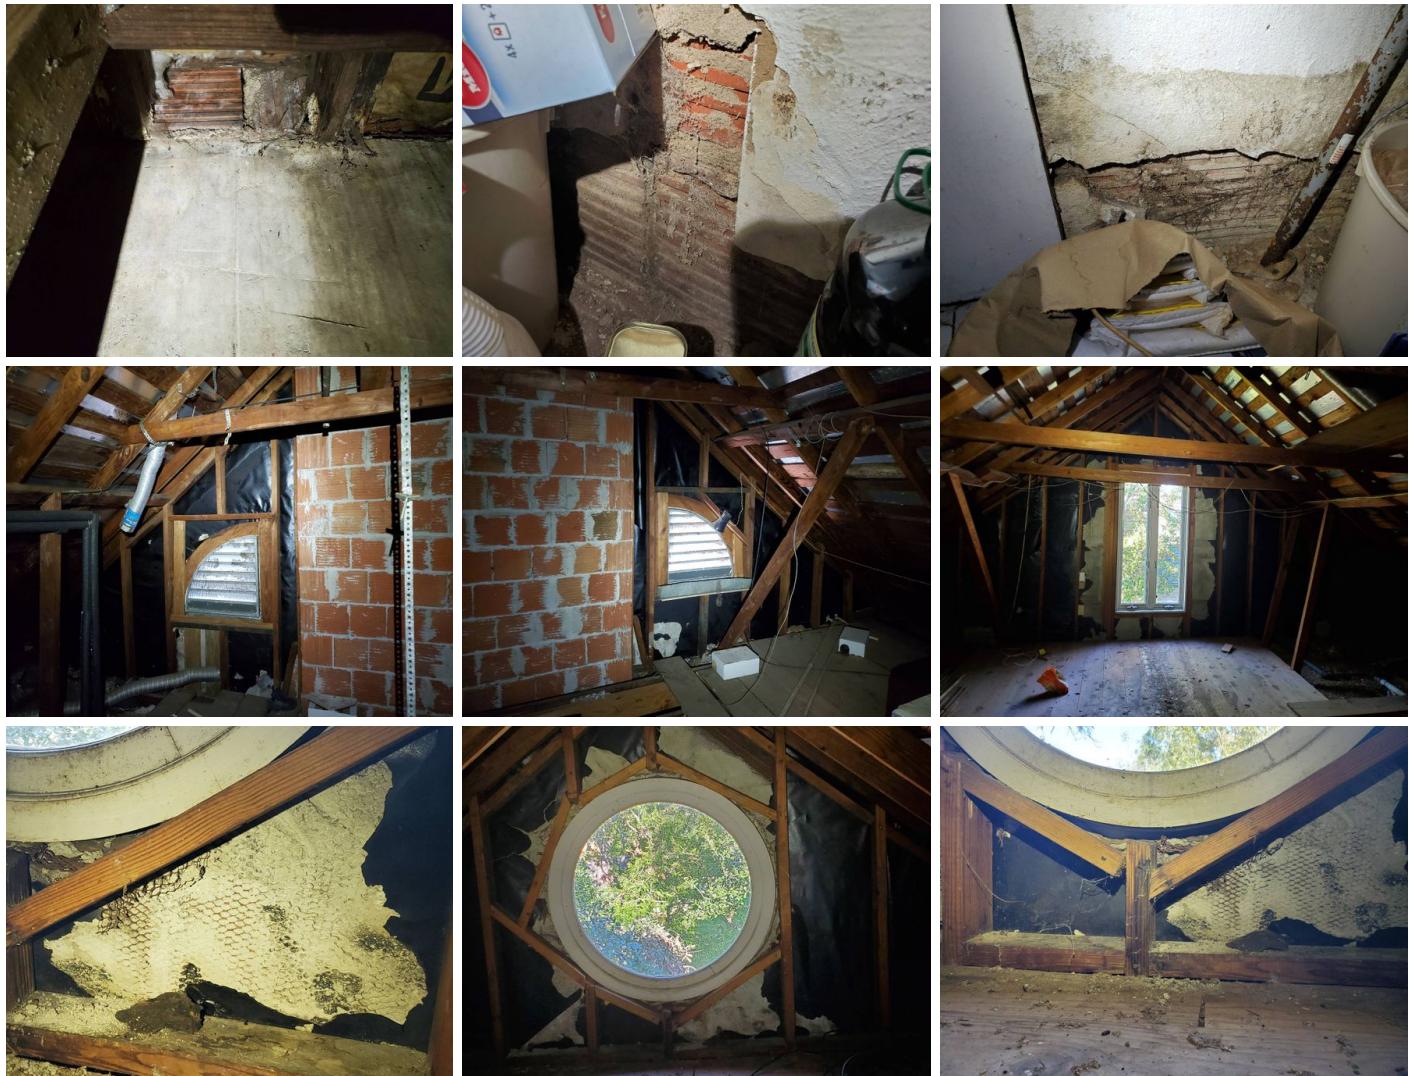
10.1.1 Substrate Integrity

The stucco siding for the house was installed over clay tiles. The stucco over the clay tile material was not probed as there is no wood or gypsum materials to be probed under the layer of stucco finish. Additionally, expansion joints and flashing details typically recommended to be installed for traditional stucco over wood or gypsum applications are not often used in non traditional stucco applications. The clay tiles were visible in the attic and at the crawlspace. It is recommended that you refer to the structural engineering inspection report for observations regarding the house siding.

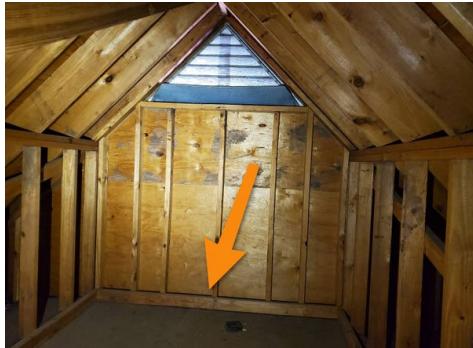
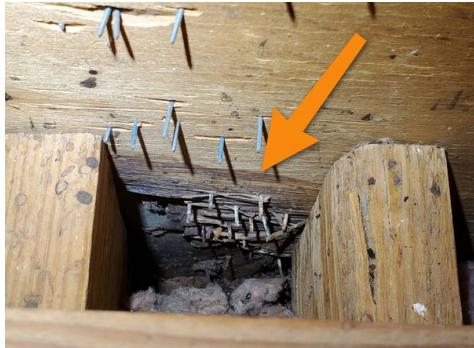
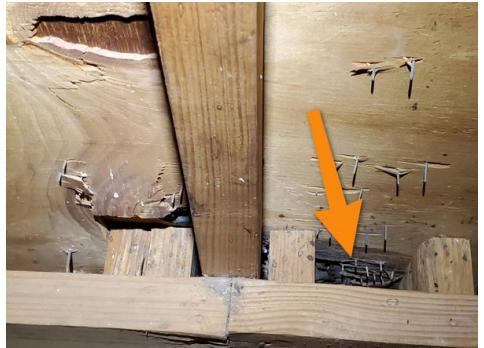
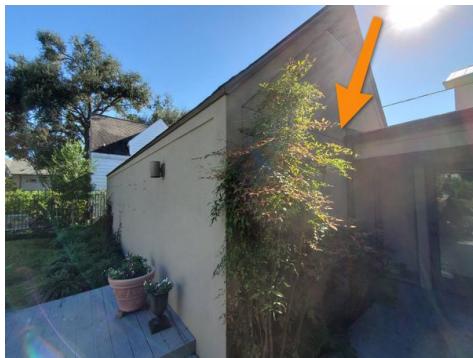
GARAGE WEST WALL

SUBSTRATE VISIBLE FROM ATTIC - WATER INTRUSION OBSERVED

Some of the substrate was visible from the attic for inspection. The substrate was observed to be water stained/damaged apparently due to water intrusion. It is recommended that a stucco contractor be contacted for further investigation and to provide cost estimates to make all of the needed repairs.

Obtain cost estimate

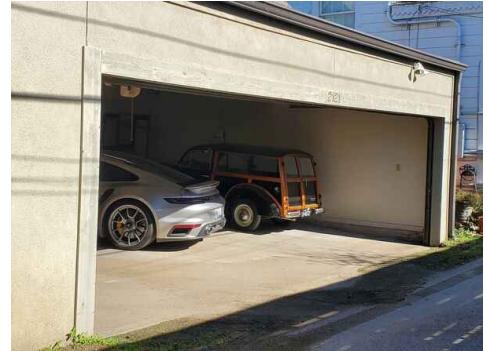
Above garage door

HEAD FLASHING MISSING - REPAIR RECOMMENDED

Head flashing was not installed. Head flashing is intended to prevent water that runs down the wall from entering into wall cavity through the joint between the stucco and the top of the windows and doors. It is recommended that the flashing be installed.

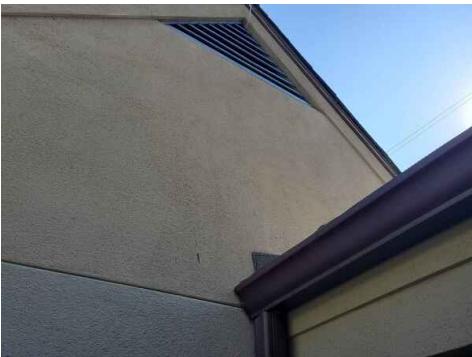
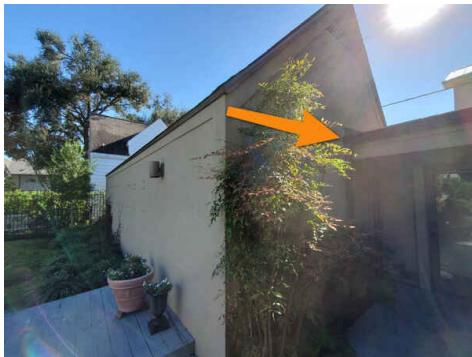
KICKOUT FLASHING MISSING - ROOF TO WALL

Kickout flashing was not present at the roof to wall intersection. A lack of kickout flashing can possibly allow water run off from the roof to be routed into the wall cavity. This condition is known to lead to wood rot, mold, and other moisture related problems. We recommend that a stucco contractor be contacted to install the kickout flashing at all roof/wall intersections to prevent water intrusion.

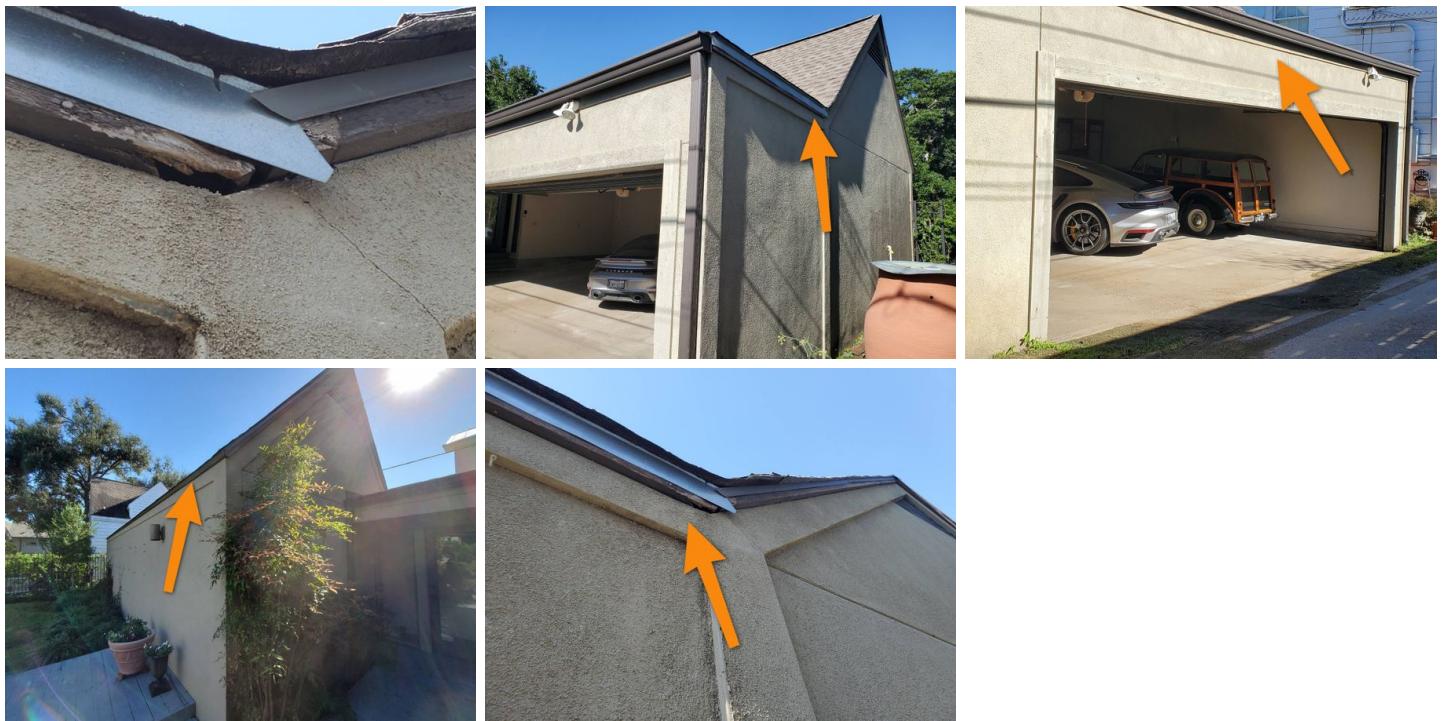
ROOF TO STUCCO TRANSITION

The garage/quarters was not equipped with overhanging soffits and the roof terminated directly over the outer wall. Gaps and separations were observed between the roof and stucco intersections which create avenues for water intrusion. It is recommended that a stucco contractor be contacted to assess the condition and to provide a cost estimate for any needed repairs.

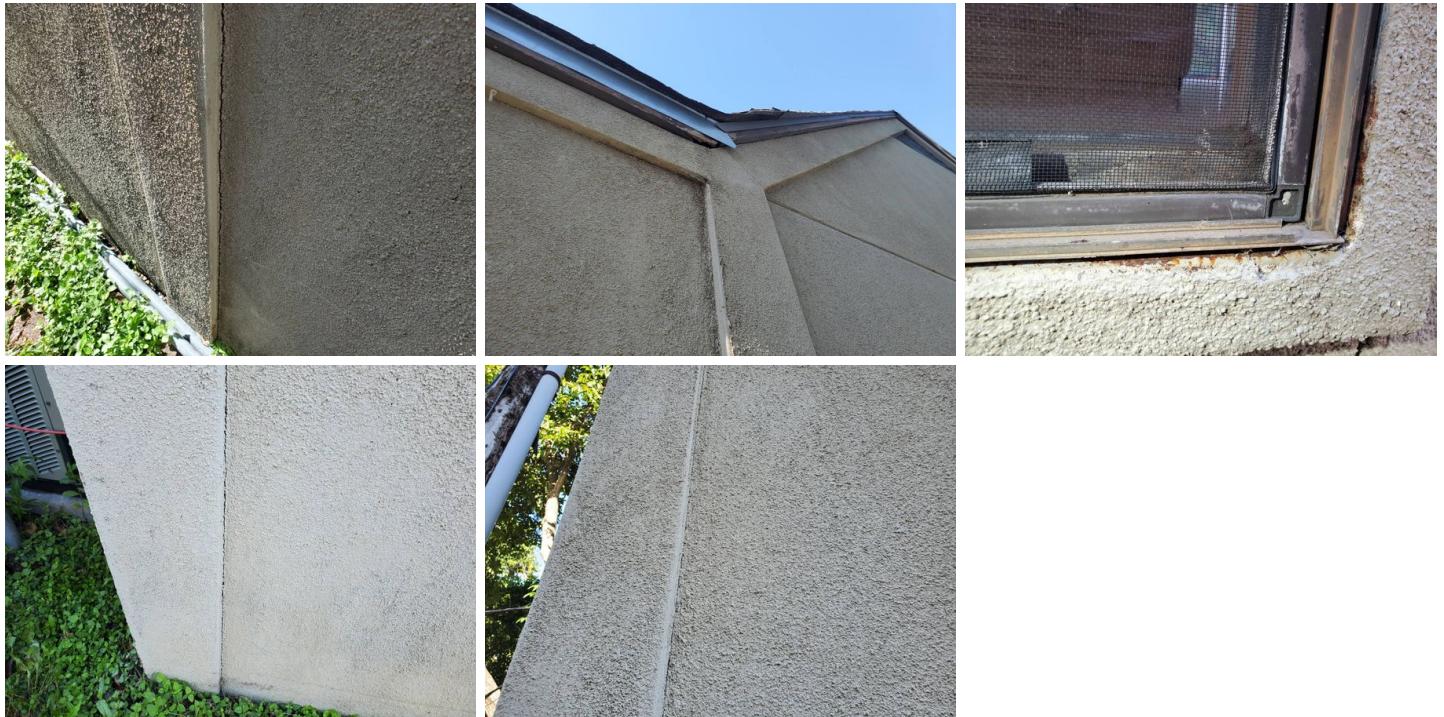
SEAL ACCENT BANDS

The sealant was cracked at the accent bands. It is recommended that all of the accent bands be resealed with a high quality exterior sealant by a qualified stucco waterproofing contractor to prevent moisture intrusion.

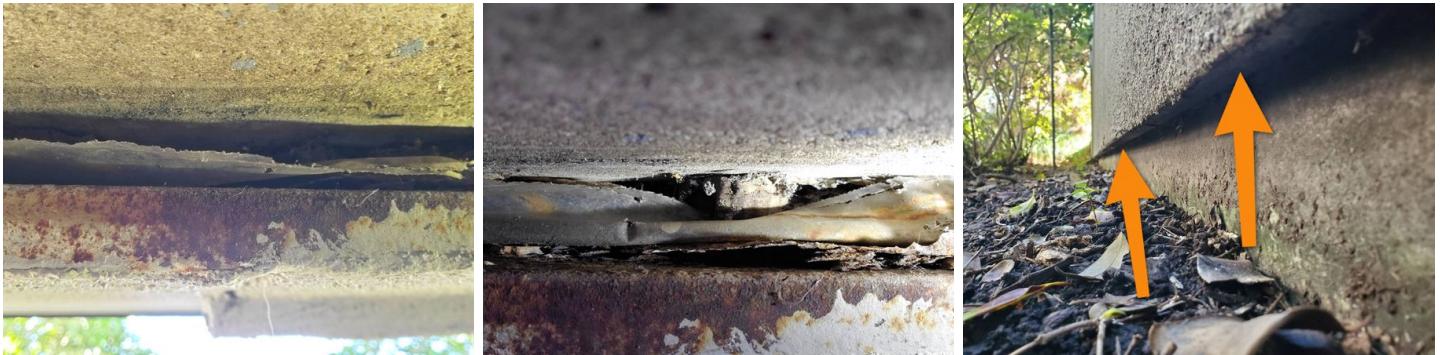
J-Flashing

METAL ACCESSORIES RUSTED - POSSIBLE WATER INTRUSION

Rust was observed on the metal stucco components. Stucco is constructed with metal accessories, and rust can be evidence of excessive moisture concentrating at the rusted area in the stucco veneer, with possibly secondary damages to the wood framing behind the stucco. It is recommended that a stucco contractor be contacted to repair the rusted accessories and any other secondary damages that may be present.

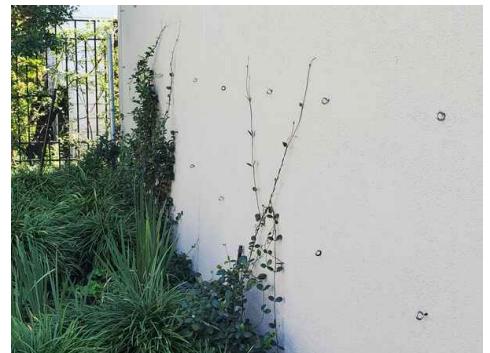
FOLIAGE GROWTH ON STUCCO

Foliage was observed to be growing on the stucco surface. This condition creates a conducive condition to excessive moisture and can cause significant damage to the stucco finish. It is recommended that the foliage be removed.
