MAGNOLIA HOME INSPECTION SERVICES

PROPERTY INSPECTION REPORT FORM

Araceli Gonzales <i>Name of Client</i>	12/21/2023 8:00 am <i>Date of Inspection</i>
1934 Pepperwood Ln, Houston, TX 77084 <i>Address of Inspected Property</i>	TREC# 22294 <i>TREC License #</i>
Steve Vincent <i>Name of Inspector</i>	
Name of Sponsor (if applicable)	<i>TREC License #</i>

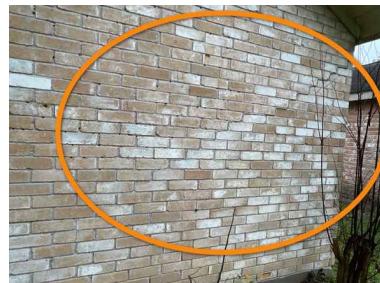
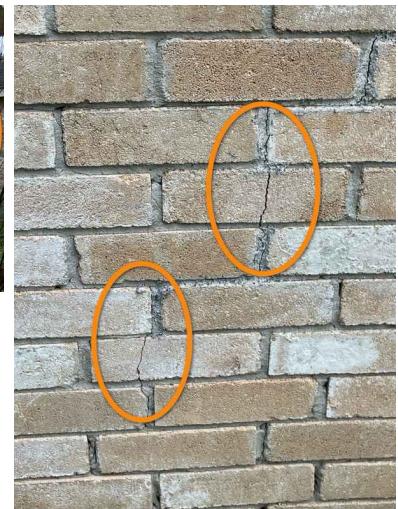
**2: Foundation has settled.****Repair/Replace**

Cracks in the exterior walls, flooring, interior walls and ceiling can be indications that the foundation has settled. Due to issues noted at time of the inspection it is recommended to have further evaluated.

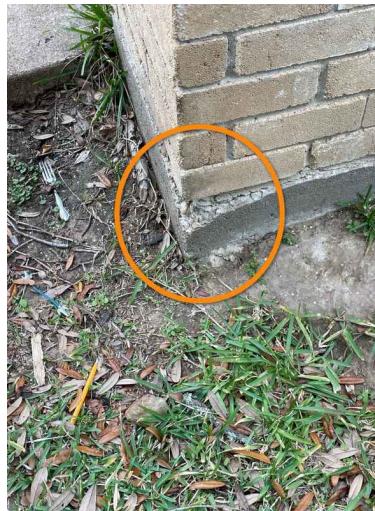
**3: Corner pops****Repair/Replace**

The corner of the foundation has broken apart. This has or can lead to the foundation no longer providing the proper support for the brick cladding. Recommend to repair.

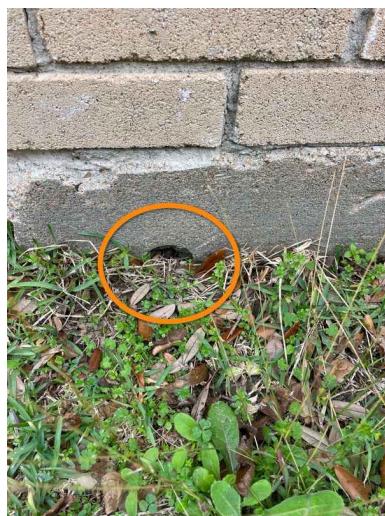
**4: Post Tension Cable Ends Exposed****Repair/Replace**

Post tension cable ends were observed on the exterior of the foundation. This should be repaired to prevent corrosion.

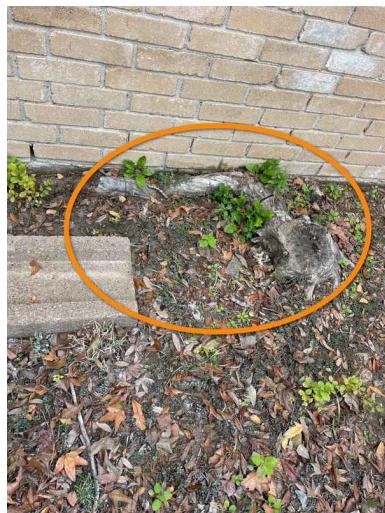
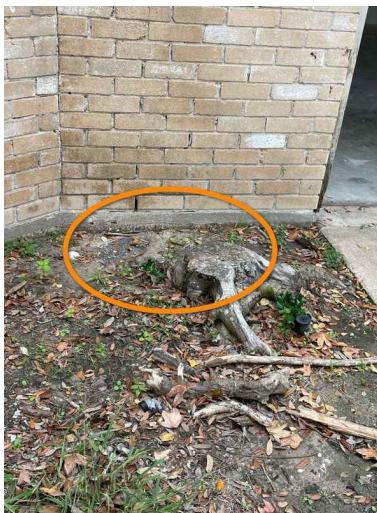
Example Front

5: Roots next to foundation**Repair/Replace**

Roots next to foundation. Roots can damage plumbing drains and foundations, recommend to repair.

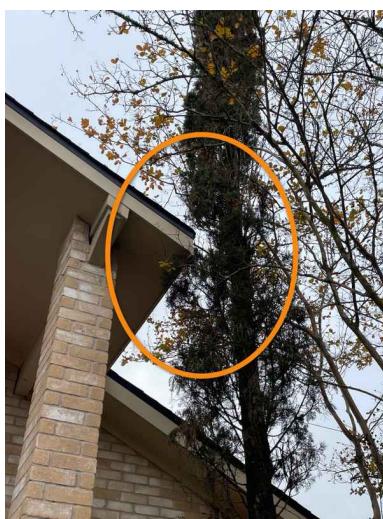
**1: Vegetation next to building or roof line.****Repair/Replace**

Vegetation needs to be trimmed back at least one foot away from exterior walls and roof line. The foliage was noted close to the structure, we recommend trimming all bushes away from the structure. Bushes and trees too close to the structure can prevent the wall from drying properly, their roots can affect the foundation and their branches can damage the structure.

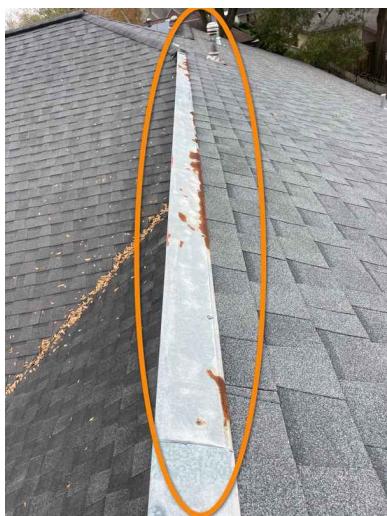
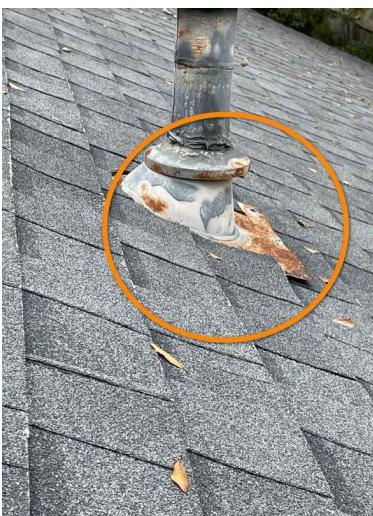
1: Flashing General Damage / Lifted

All Repairs Listed should be performed by a professional roof company. If repairs are made, we recommend that the professional roof company evaluate the entire roof system.

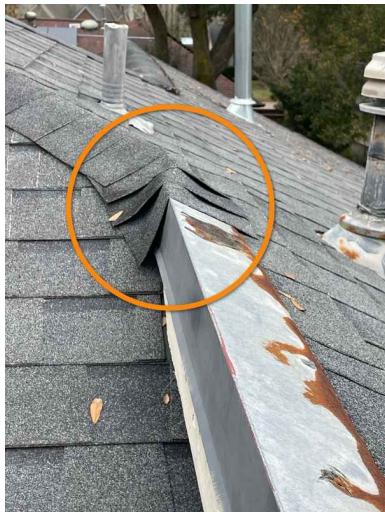
2: Roof - Lifted shingles

Lifted shingle noted. Recommend to repair as needed by a professional roofer.

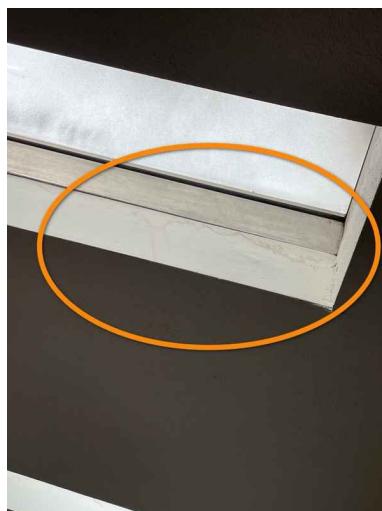
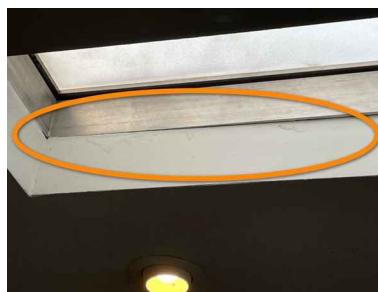
3: Skylight leak

Stains noted around the skylight. Skylight appears to be leaking. Recommend to have further evaluated and repaired by a qualified roofer.

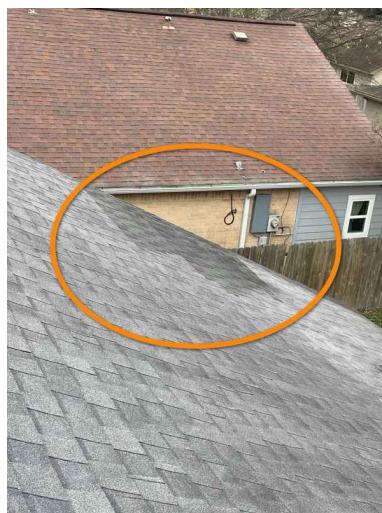
4: Roof - Prior Repairs**Repair/Replace**

Prior repairs to the roofing are evident. This would suggest that problems have been experienced in the past. This area should be monitored. (repairs may be required if leaks noted)

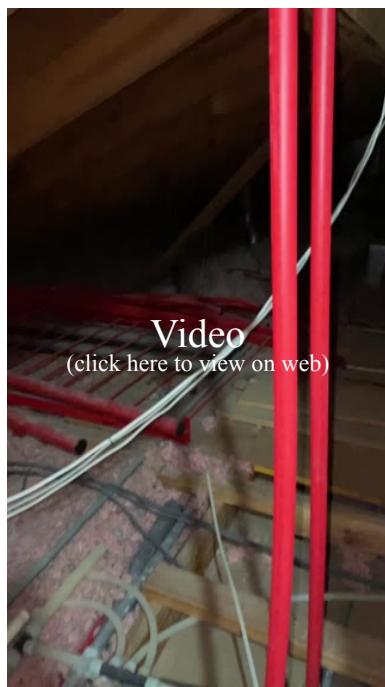
Not Accessible:

Some of the attic spaces were not safely accessible at the time of inspection. Only areas of the attic determined accessible by the inspector are inspected.

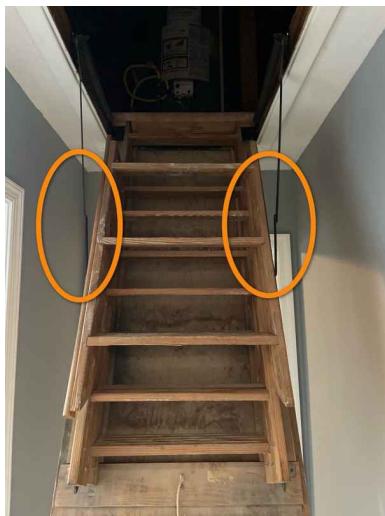
1: Attic Hatch Door Not Closing Properly

The attic hatch door is not closing shut properly. Repair and adjust as needed.

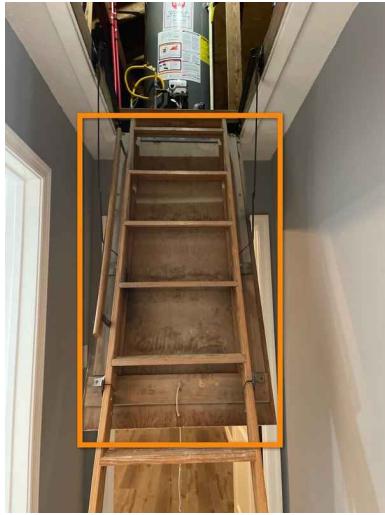
2: Attic Hatch Door Not Insulated**Repair/Replace**

To improve air conditioning efficiency and to prevent loss of conditioned air to the attic, the attic hatch door should be insulated.

R402.2.4, which says Access doors from conditioned spaces to unconditioned spaces (e.g., attics and crawl spaces) shall be weatherstripped and insulated to a level equivalent to the insulation on the surrounding surfaces. This code went into effect in 2016, previously built homes are grandfathered in, but are still recommended to improve the efficiency of the home.

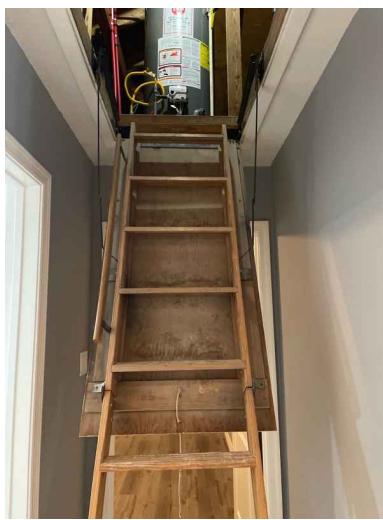
3: Attic hatch weather stripping is missing or damaged.**Repair/Replace**

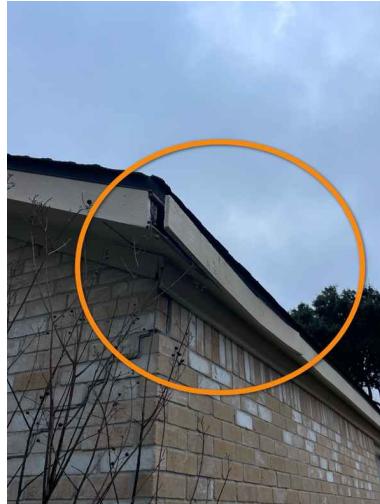
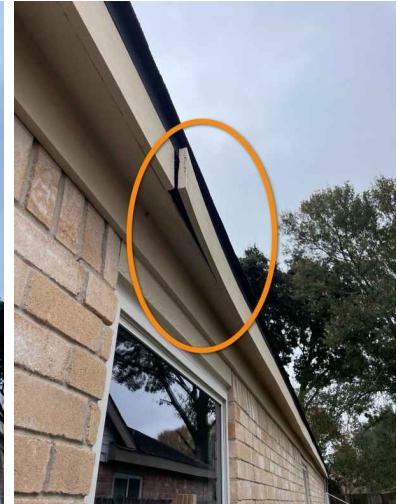
4: General Damage found to soffits / facia

Damaged soffit / facia noted. Recommend to replace damaged soffit as needed.

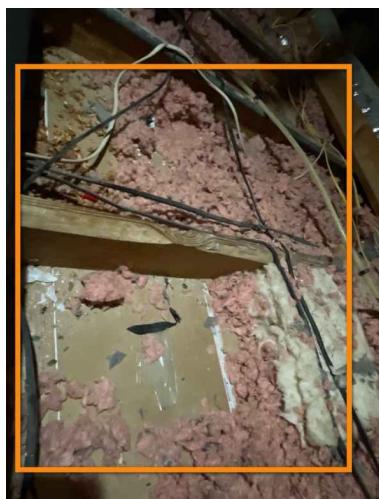
Example

6: Light Visible Through Sheathing / Siding**Repair/Replace**

While investigating the attic structure, outside light was visible. This condition suggests that openings exist in the sheathing and siding. Repairs should be made, as necessary.

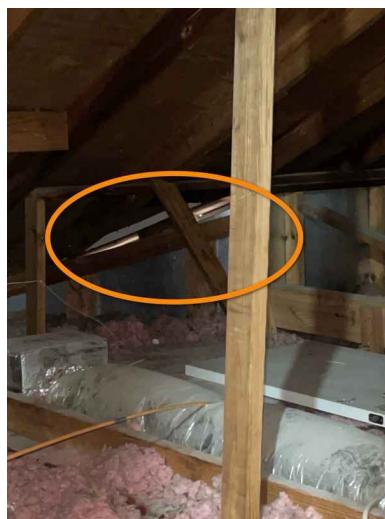
Example Front

7: Roof Deck H Clips Missing**Repair/Replace**

Roof decking spacing H clips missing. The 1/8 inch gap is not present between sheets of roof decking. This can cause damage to the roofing system during climate change. Recommend to repair.

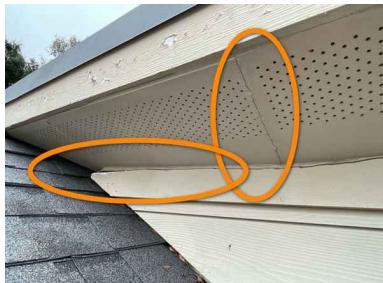
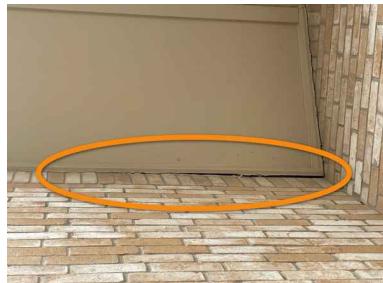
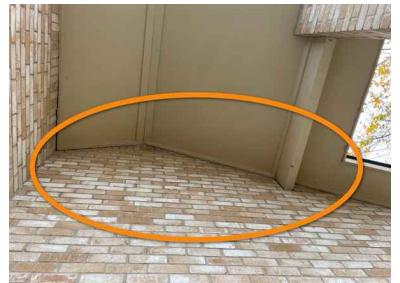
8: Soffit/Facia Caulking repairs

Caulking repairs to soffit/facia.

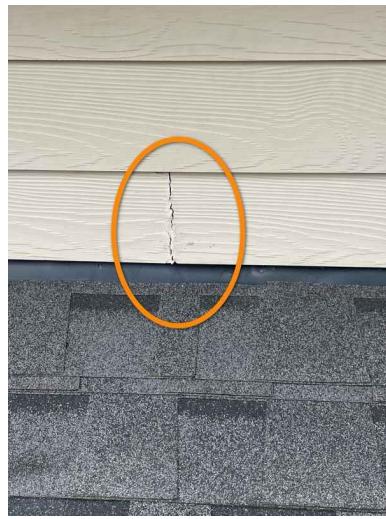
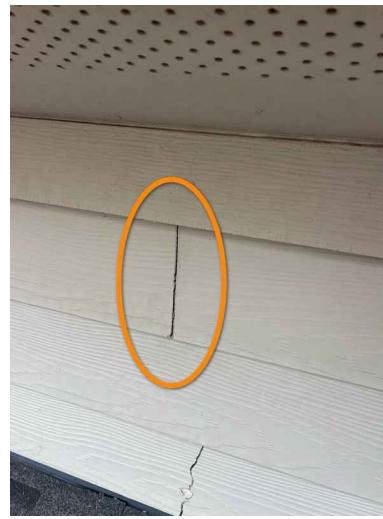
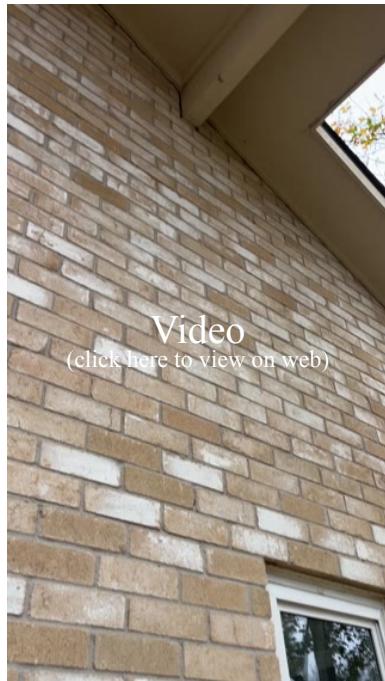
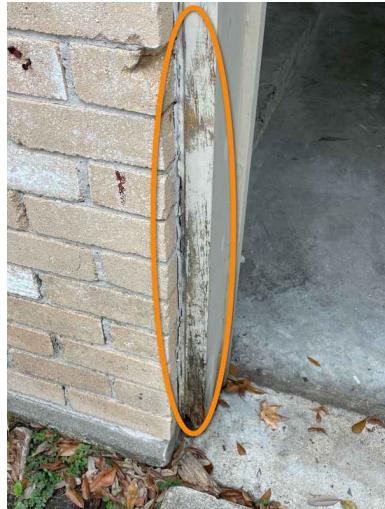
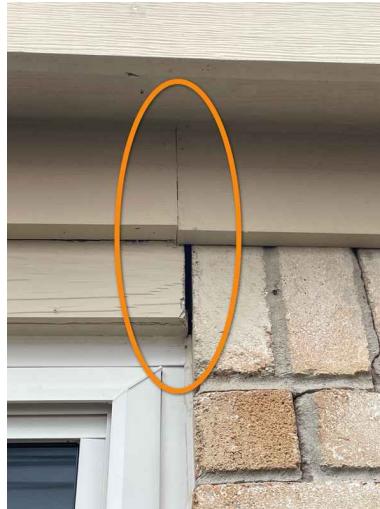
1: Caulking repairs needed**Repair/Replace**

Caulking repairs needed around exterior siding and trim. Repairs are not limited to the photos provided.

International Residential Code IRC R703.10.2 requires lap siding to have:

1. A minimum vertical overlap of 1 ¼ inch (31.75 mm), and
2. One of the following butt joint treatments:
 - a) Joint Flashing,
 - b). Caulking, or
 - c). “H” jointer covers

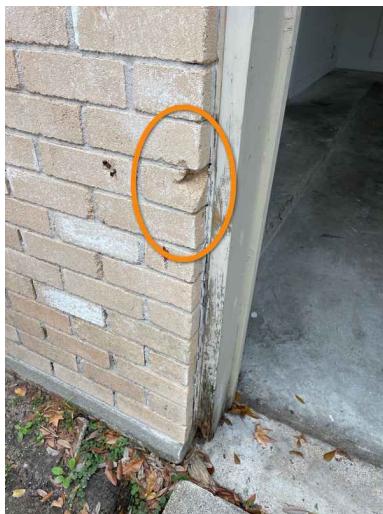
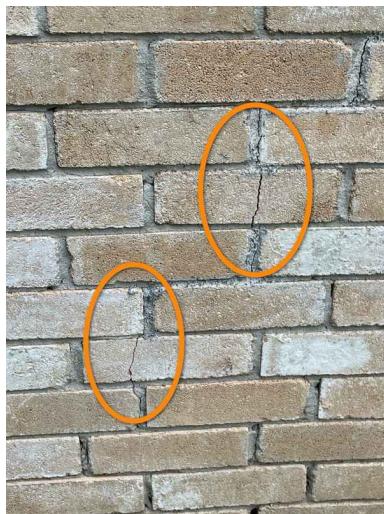
2: Cracks in brick\stone

Cracks found in bricks\ stone. Recommend to repair as needed.

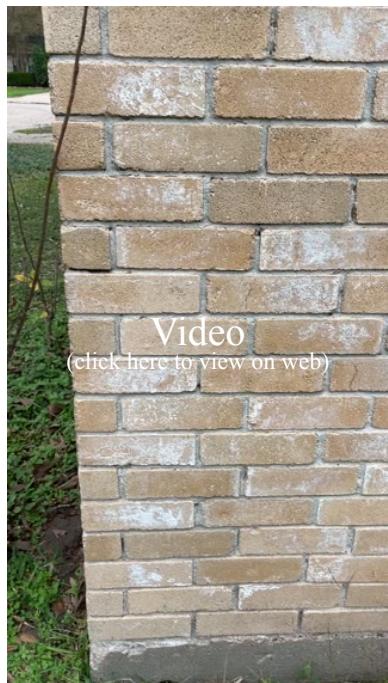
Recommend to repair cracks in mortar.

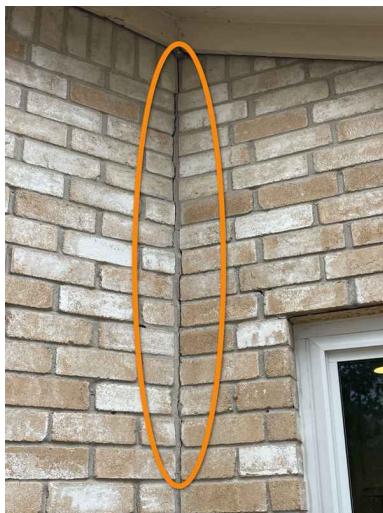
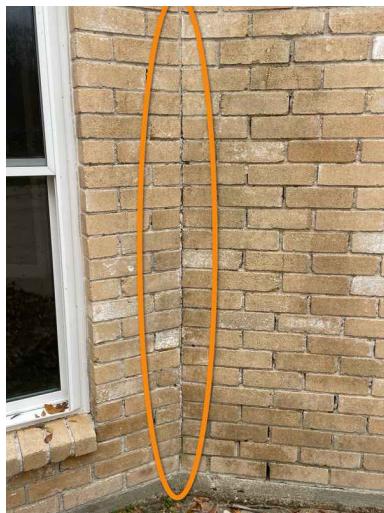
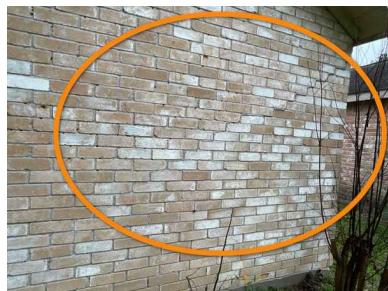
**Video**
(click here to view on web)**3: Cracks in mortar.****Repair/Replace**

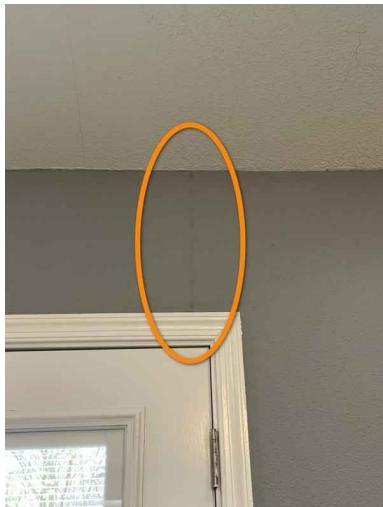
Example Living Room

4: Cracks

Cracking was observed in wall structure. Recommend to seal cracks and monitor.

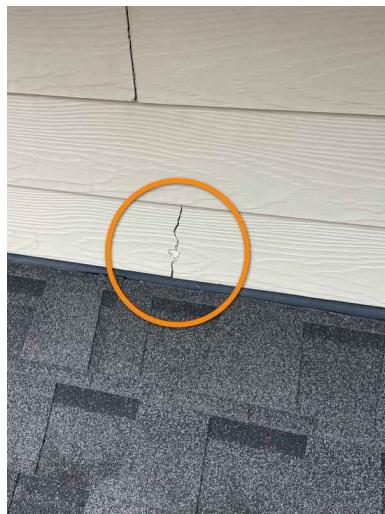
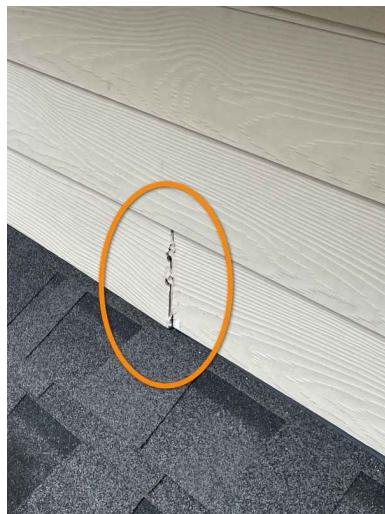
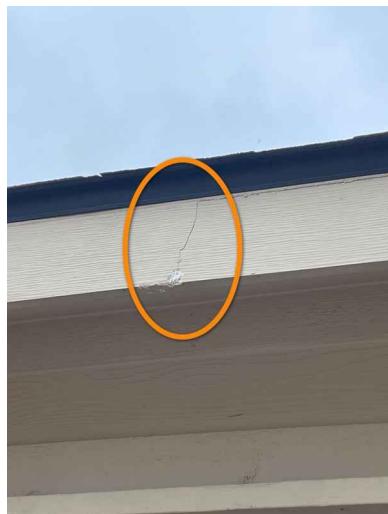
5: General Damage found to Siding and Trim

General damage was found to siding and trim. Recommend to repair as needed.

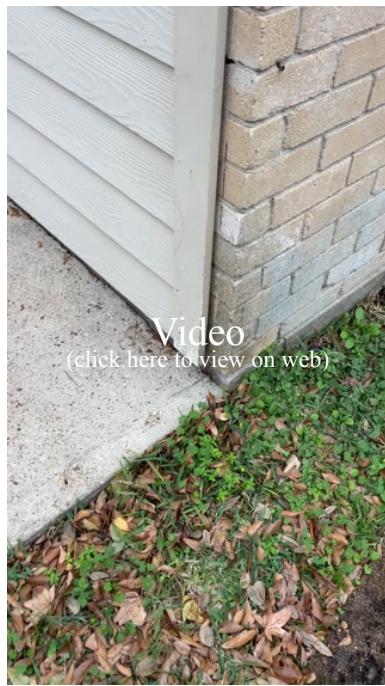
**6: Exterior paint\stain****Repair/Replace**

The exterior/interior of the house is due to be painted\stained.

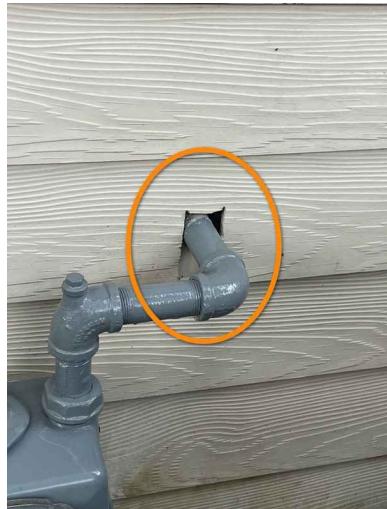
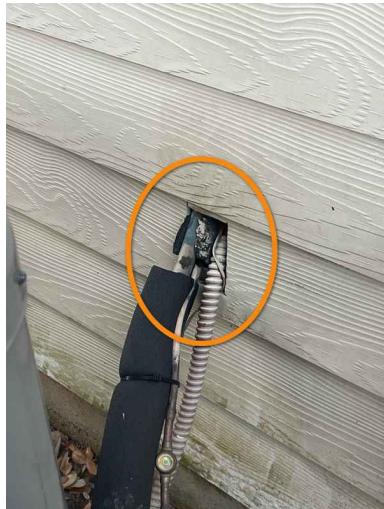
7: Penetration points**Repair/Replace**

Recommend to seal all penetration points.

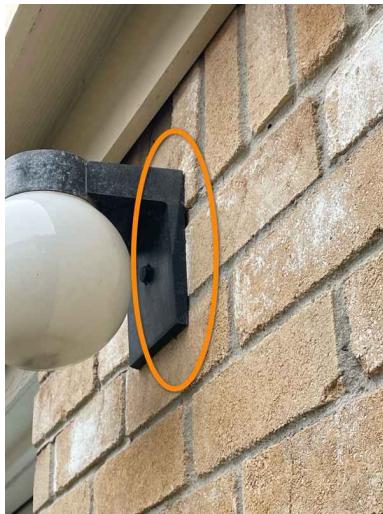
Example

8: Seal Wall/Ceiling Fixtures**Repair/Replace**

Note: Modern building practices recommend sealing around components that are mounted on or pass through the exterior walls/ceilings to limit moisture and insect intrusion.

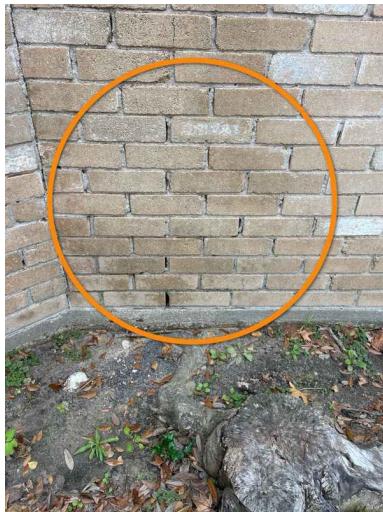
Example Front Exterior Wall

9: Gaps in mortar

Recommend to repair gaps in mortar.

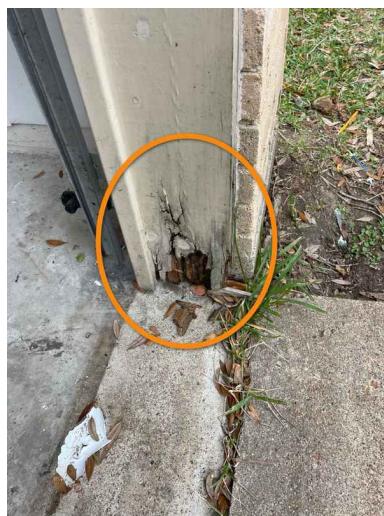
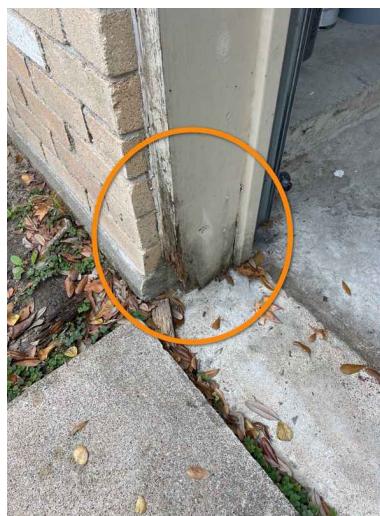
10: Siding/trim-rot/moisture damage

Siding and/or Trim had signs of rot/deterioration and moisture damage. Recommend further evaluation by qualified, siding, professional.

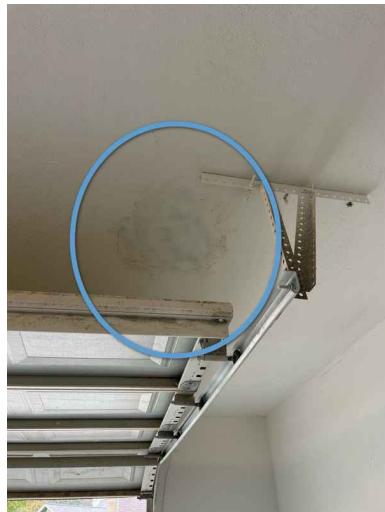
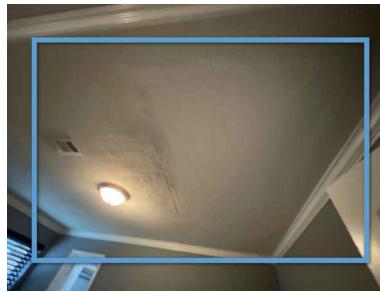
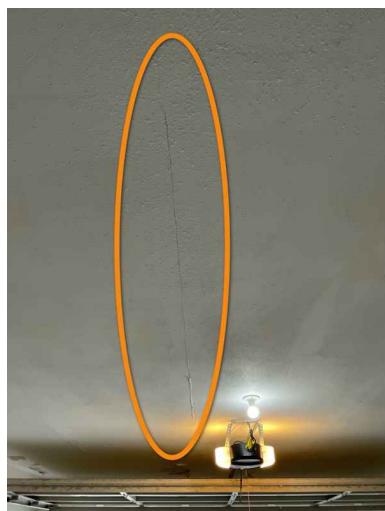
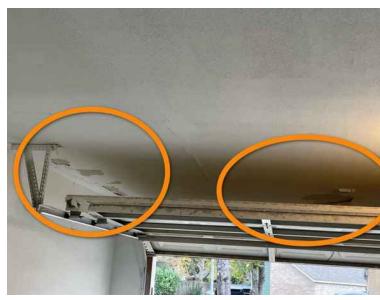
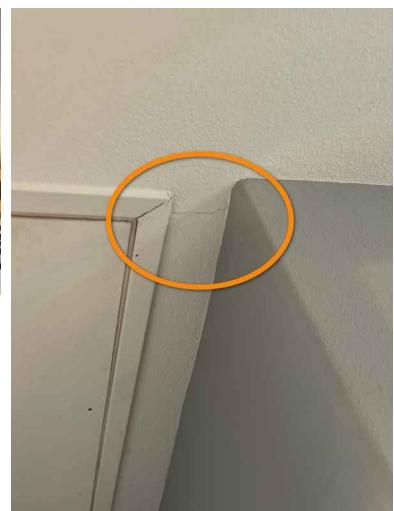
1: Ceiling Previous repairs **Maintenance Required**

Previous repairs to ceiling, possibly due to moisture damage. No signs of moisture damage at time of inspection. Recommend to monitor.

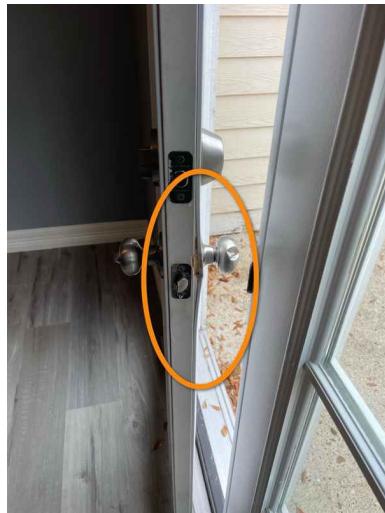
Example Flex Room Exterior Door

2: General Damaged Door(s)

General damaged or non-functioning doors should be repaired.

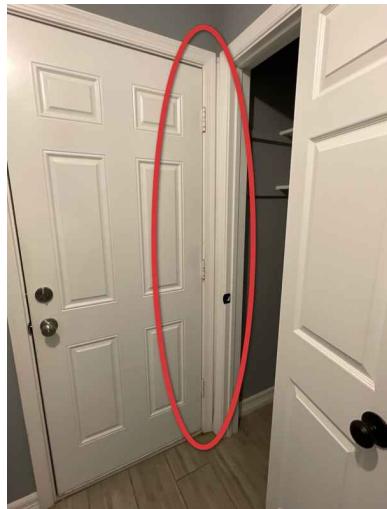
Example

6: Garage door self closing hinges

The garage door needs to have self closing hinges installed to meet national fire code.

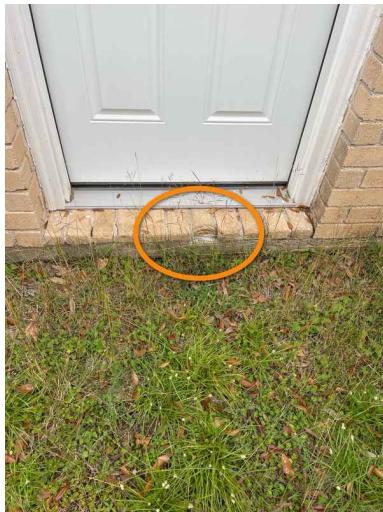
Example Right Exterior Door

8: Missing or damaged Threshold

Missing or damaged threshold. Recommend to repair.

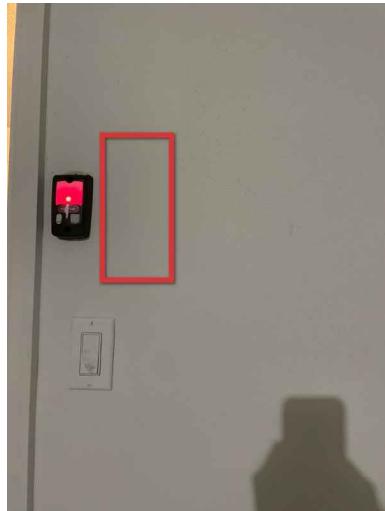
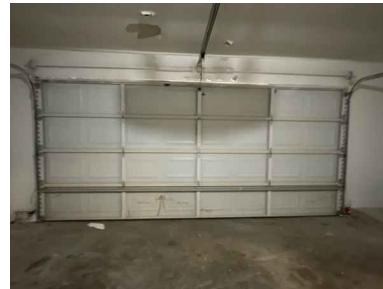
Example

9: Garage Door Warning Labels

- warning labels. The following four warning labels should be present on or around garage door assemblies:
 1. a spring warning label, attached to the spring assembly;
 2. a general warning label, attached to the back of the door panel;
 3. a warning label attached to the wall in the vicinity of the wall control button, and;
 4. a tension warning label, attached to the garage door's bottom bracket.

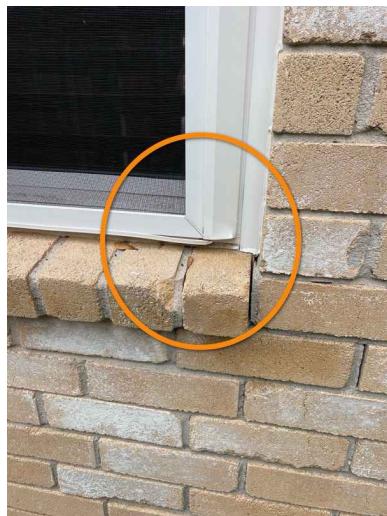
Example Rear Guest Bedroom

1: Damaged Windows

One or more windows appears to have general damage, but are operational. Recommend a window professional clean, lubricate & adjust as necessary.

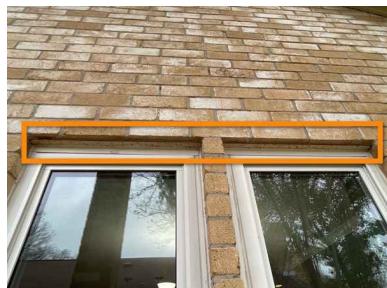
Example

2: Rusted lintels**Repair/Replace**

Rust window lintels need to be sanded and treated for rust and the repainted.

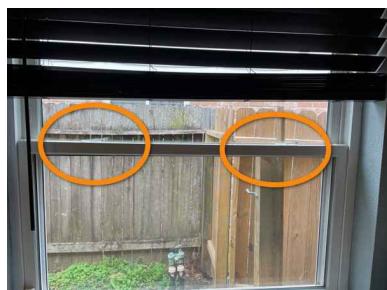
Example Front Guest Bedroom

3: Windows would not latch**Repair/Replace**

One or more windows would not latch when testing. Recommend to repair as needed.

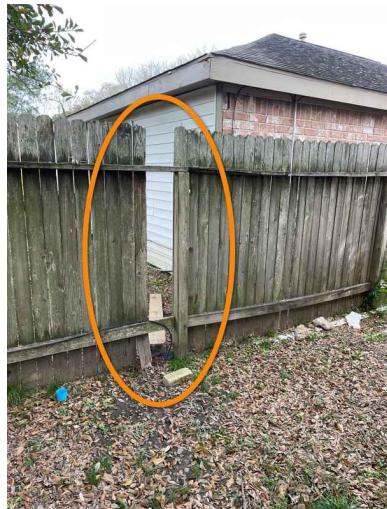
Example

1: Damaged fence (post,pickets, framing,gates)

General damaged was found to the fence or the operation of the gate. Recommend to have repaired.

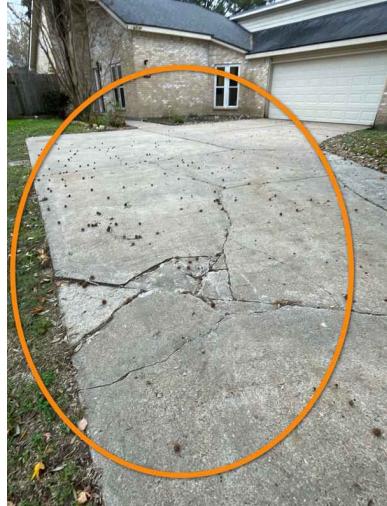
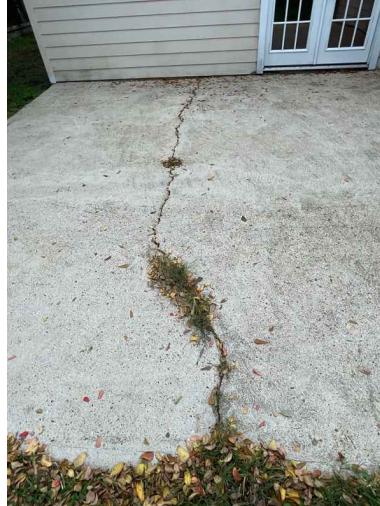
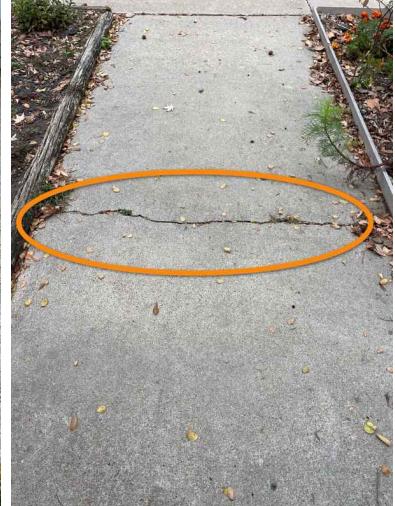
O. Driveway, Sidewalks**1: Driveway/sidewalk/porch/garage cracks**

Cracks noted in driveway/sidewalk/porch/garage recommend to seal cracks and monitor.

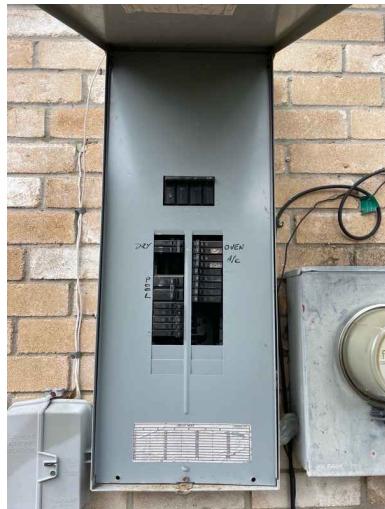
Example

4: Panel Missing Labels**Repair/Replace**

Electrical panel does not have labels. Recommend a qualified electrician test and properly label all switches.

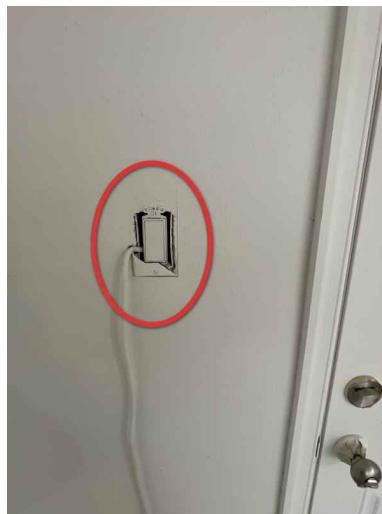
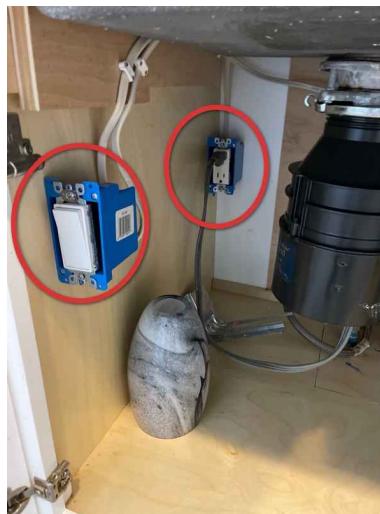
1: Cover Plates Missing

One or more receptacles are missing a cover plate. This causes short and shock risk. Recommend installation of plates.

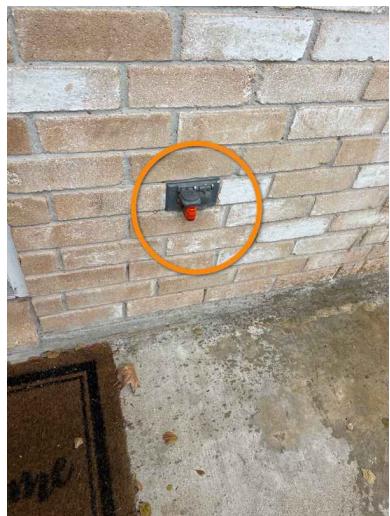
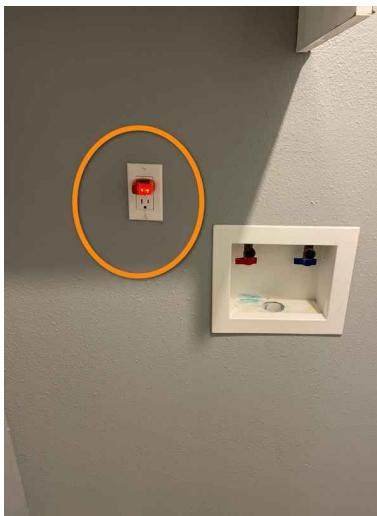
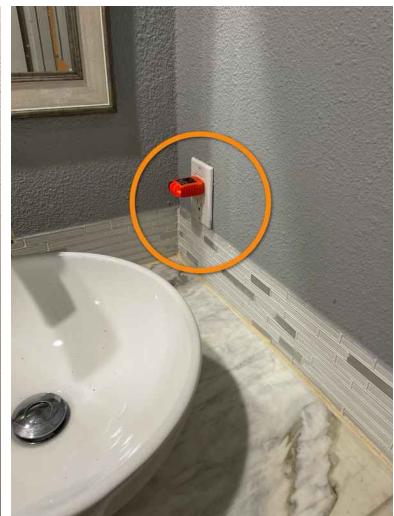
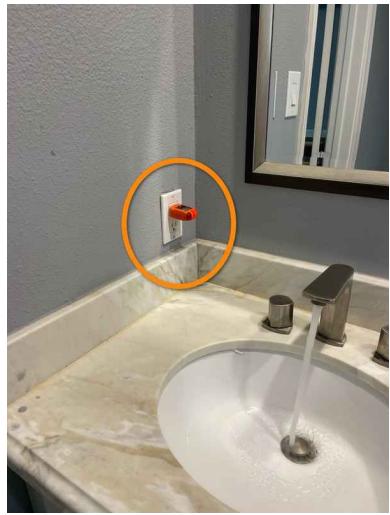
3: Not GFCI Protected**Repair/Replace**

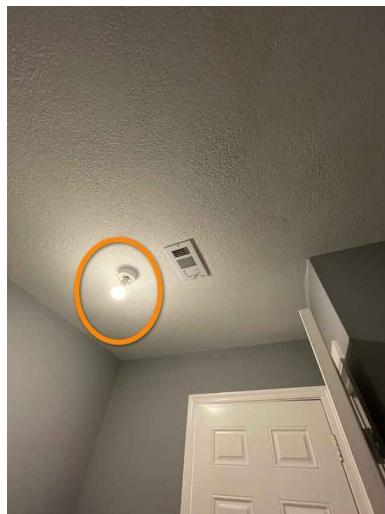
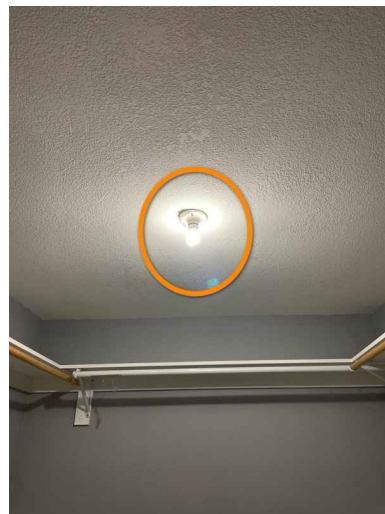
4: Glass Globes Missing**Repair/Replace**

The glass globes is missing. Recommend to repair.

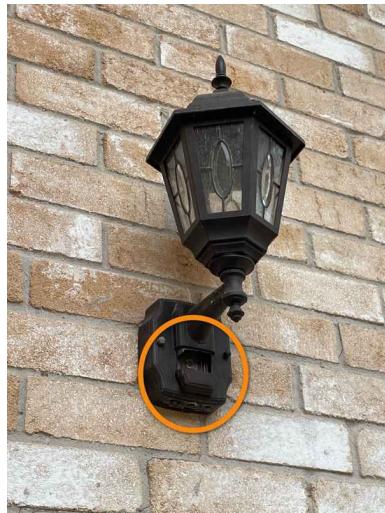
Example Front Exterior

5: Light fixture Damaged

The damaged light fixture should be repaired or replaced.

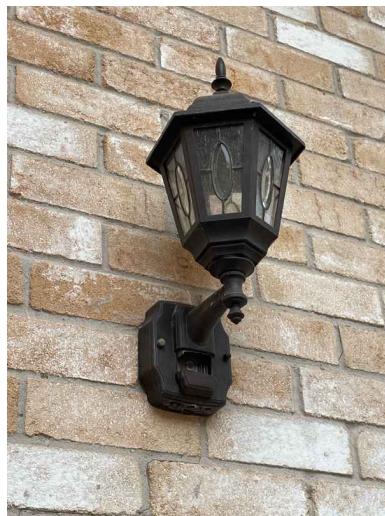
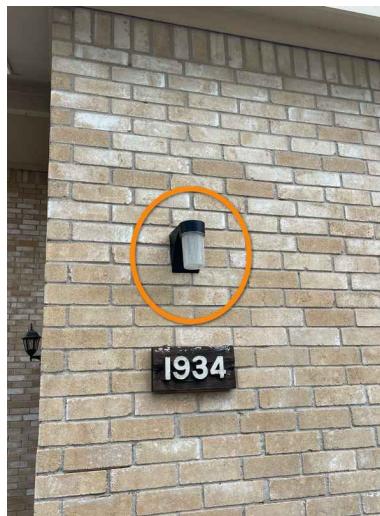
6: Light Inoperable

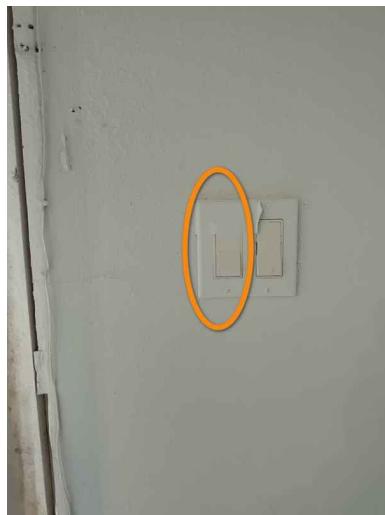
Example Garage

7: Light / Outlet inoperative due to tape or note

A light switch / outlet was not operated due to tape or note attached to switch. Recommend to inquire about function of switch and why the switch is tapped or has a note to not operate.

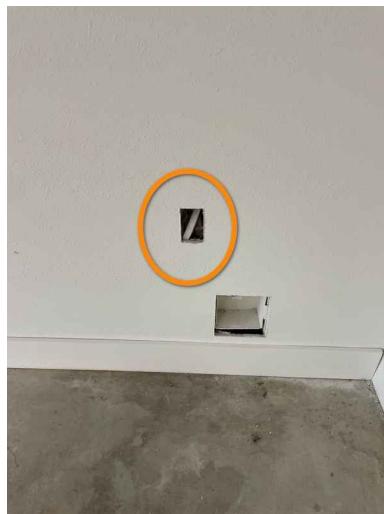
8: Missing junction box

Electrical wires are required to terminate inside a enclosed electrical box. Recommend to repair.

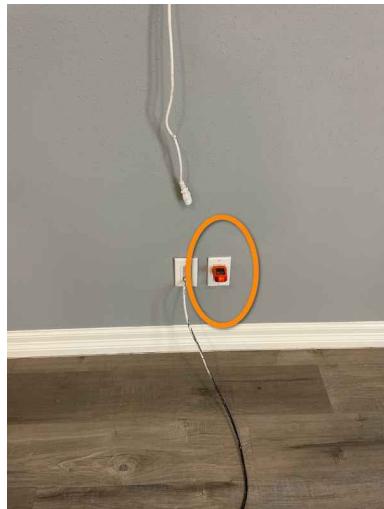
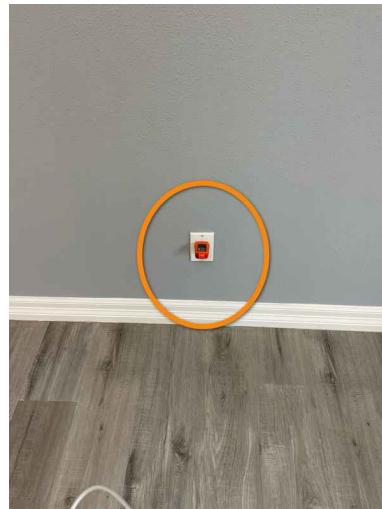
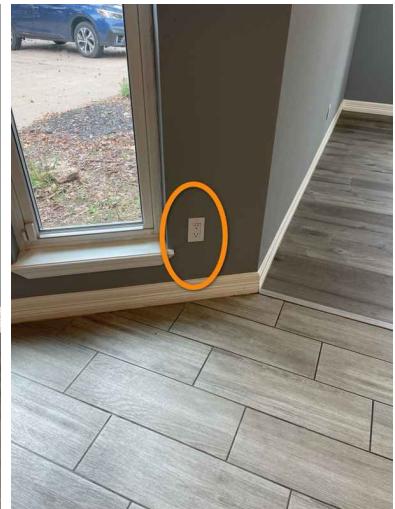
9: Outlet has Open Ground**Repair/Replace**

Outlet has open ground. Open grounds can prevent GFCI receptacles from tripping when tested. Repair by electrician and then retest any related GFCI receptacles as needed.

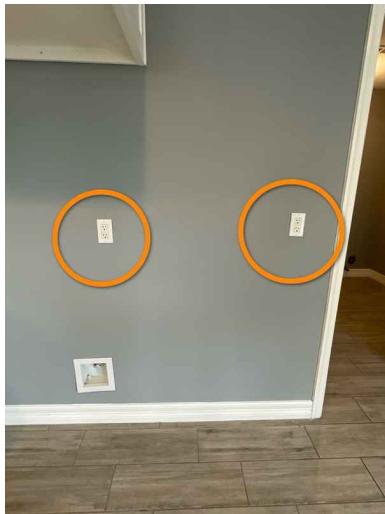
Example Kitchen

10: Outlet Loose

An outlet is loose and should be resecured.

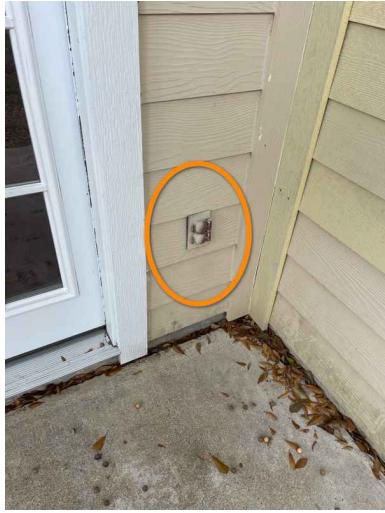
Example Rear Exterior Wall

11: Outlet missing

No electrical outlet present. Recommend installation by licensed professional.

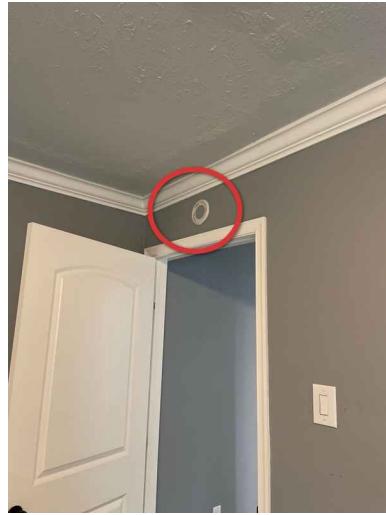
1: Smoke/Carbon Monoxide Detector Missing

Smoke/Carbon monoxide detector is not present at time of inspection. Recommend installation before closing.

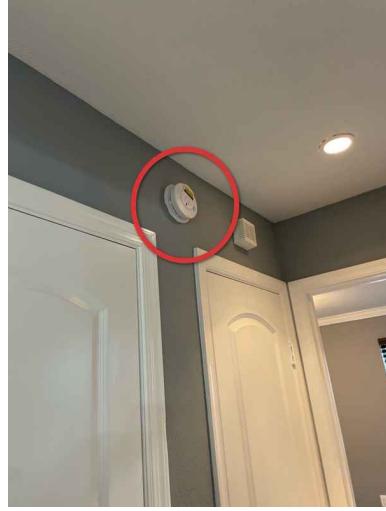
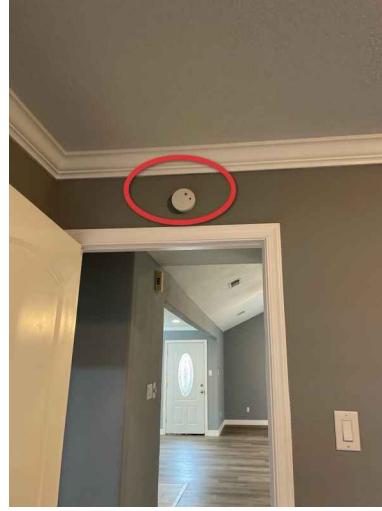
2: Smoke Detector Failed Test**⚠Safety Hazard**

Smoke detectors failed to sound when tested. Recommend to replace batteries and retest.. further repairs may be required.

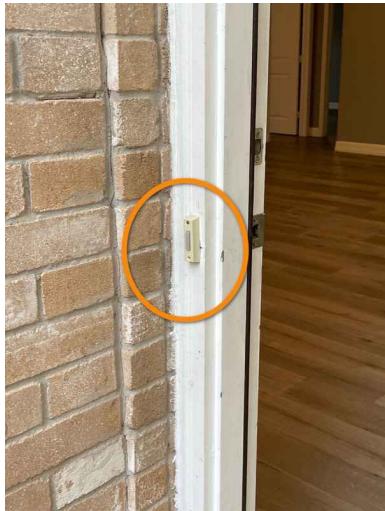
Example

The doorbell chime does not appear to be functioning properly. recommend to repair

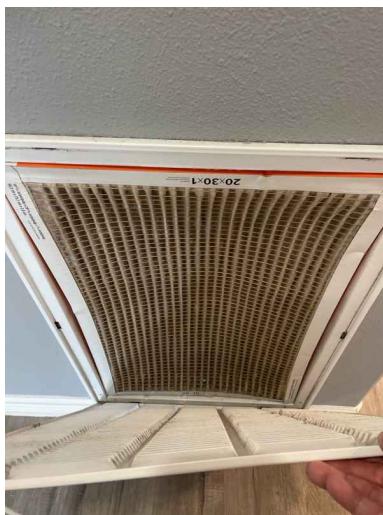
Example

1: Filter requires replacement

The furnace filter appears to be beyond its expected lifespan. Recommend replacement.

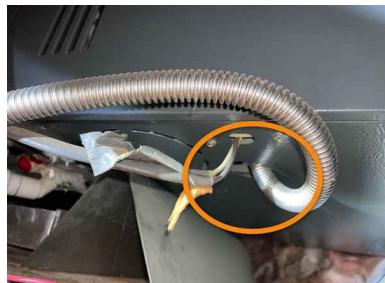
Example

2: Flex Line Penetrates Cabinet**Repair/Replace**

Flexible tubing should not penetrate the furnace cabinet. Recommend installing a proper fixture.

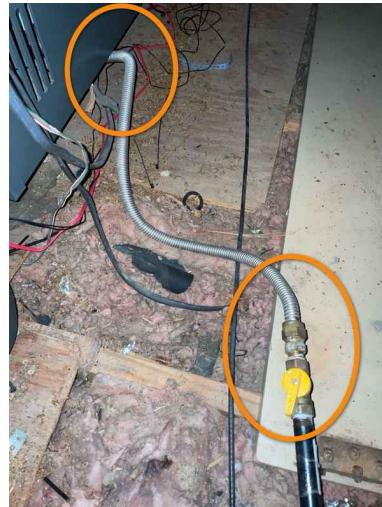
Example

3: Missing Sediment trap**Repair/Replace**

Recommend to install a sediment trap on the gas line.

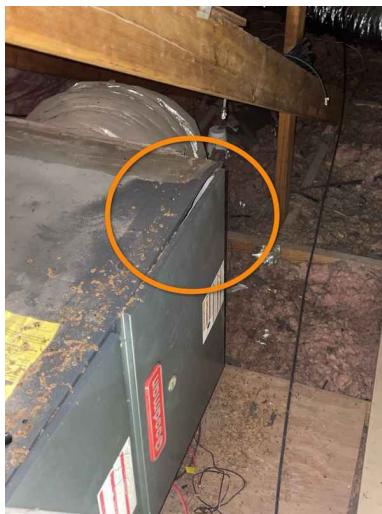
Example

4: Furnace Housing Damaged**Repair/Replace**

Damage to furnace housing.

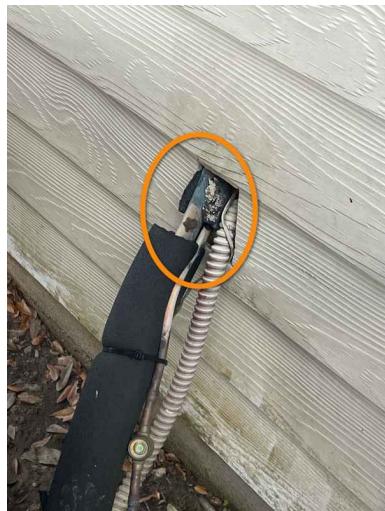
Example

3: Damaged insulation on lines

Insulation on condensing unit lines and evaporative unit drain lines break down over time. We recommend that the home owner replace any damaged, missing or degrading insulation on the HVAC lines prior to move in.

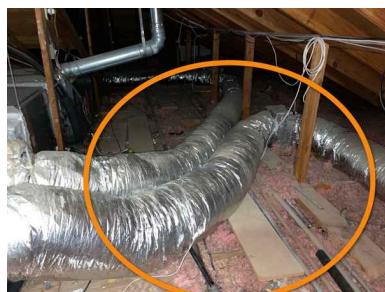
Example

4: Duct work not supported**Repair/Replace**

The ducts are not supported. The ducts should be suspended from the rafters/trusses. Recommend to repair.

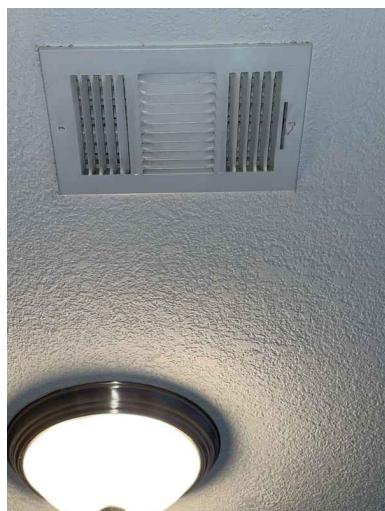
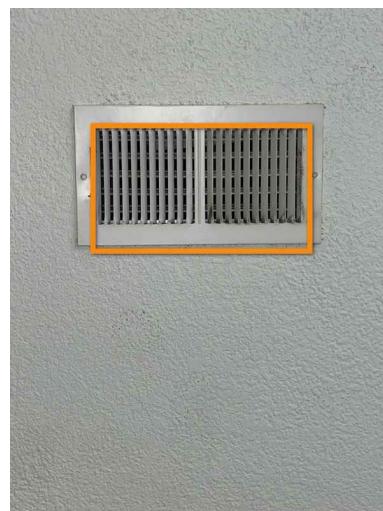
5: Mildew/mold like substance at register**Repair/Replace**

Mildew/mold like substance at register. Recommended to have duct work professionally cleaned

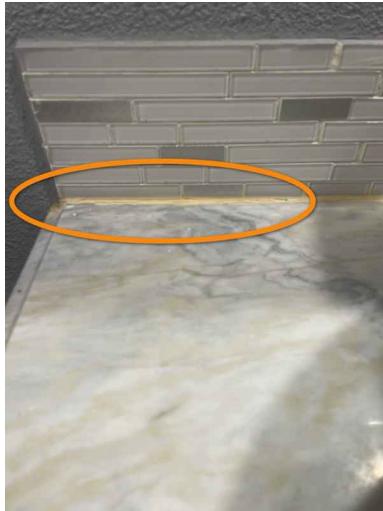
Example Guest Bathroom

1: Back splash needs caulking/grout repairs**Repair/Replace**

Caulking/grout repairs needed at back splash.

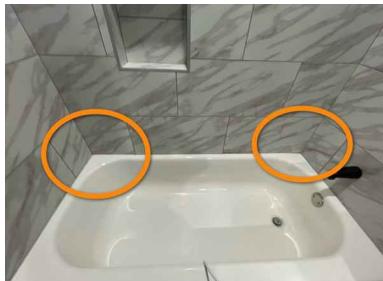
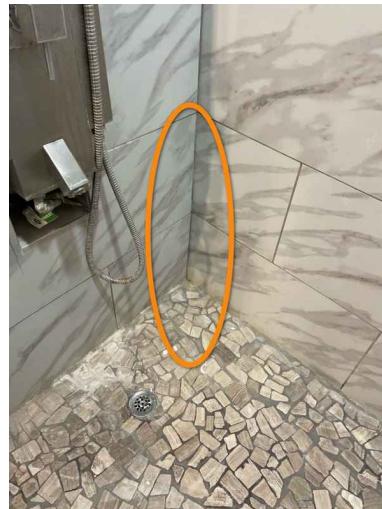
2: Bathtub or shower Caulk/Grout**Repair/Replace**

Cracked, deteriorated and/or missing grout and caulk should be replaced.

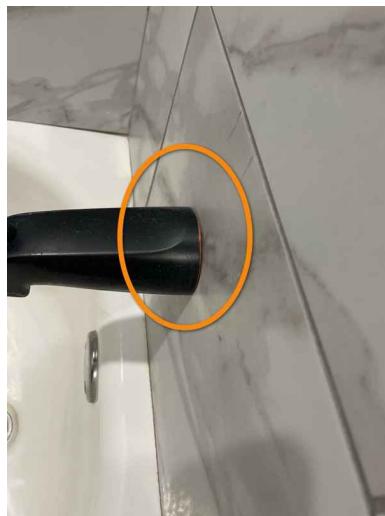
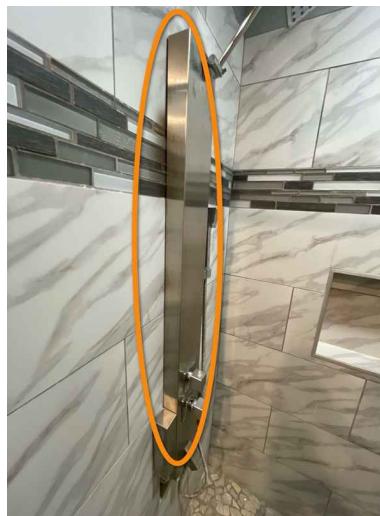
3: Caulking repairs around fixture**Repair/Replace**

Caulking repairs around a fixture is needed.

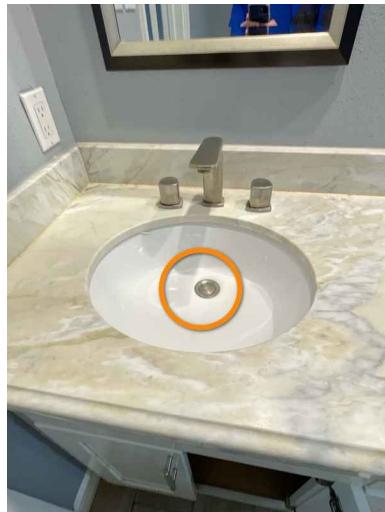
Example Primary Bathroom Left Sink

4: Drain stopper not working / not working properly

Drain stopper found to be not working / not working properly. Recommend to repair.

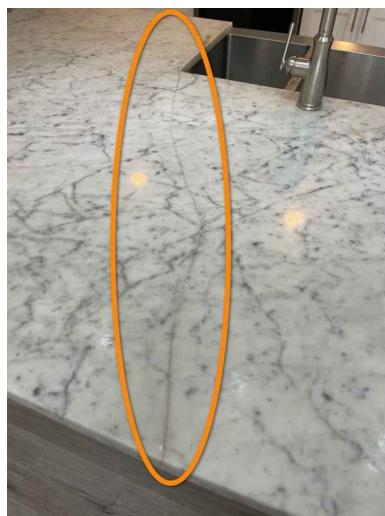
Example Kitchen

5: General damage to counter tops

Damage noted to counter tops. Recommended to repair.

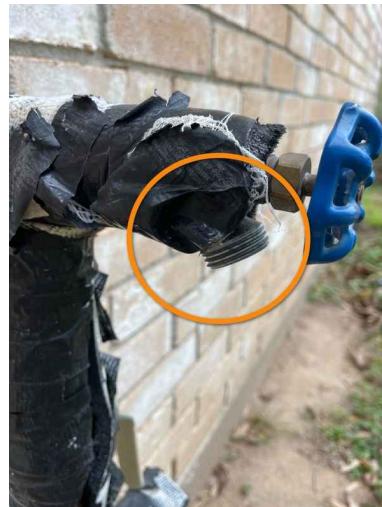
6: Hose Bib Missing Anti-Siphon Device

It is recommended that an anti-siphon device be added to the hose bib(s).

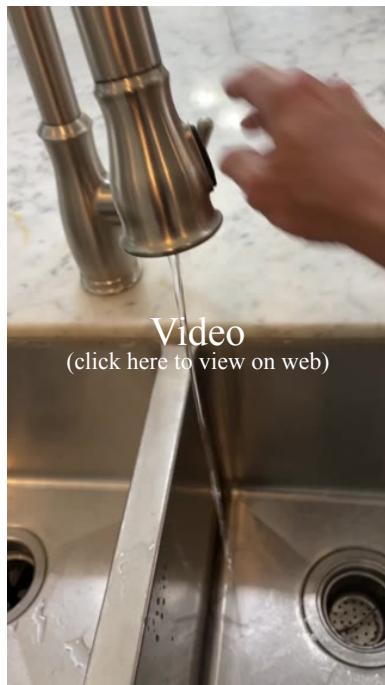
**8: Plumber Recommended****Repair/Replace**

Due to the extent of issues with the plumbing a licence plumber is recommended to evaluate the entire house plumbing systems and make repairs as needed.

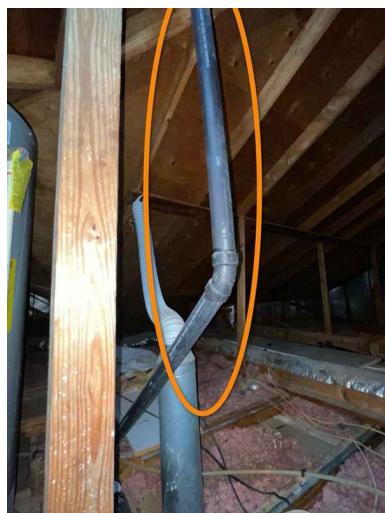
Example

2: ABS Pipe Replace**🔴Repair/Replace**

The ABS black plastic waste piping may be a defective product. Repair or replacement may be necessary.
