MAGNOLIA HOME INSPECTION SERVICES

PROPERTY INSPECTION REPORT FORM

Araceli Gonzales <i>Name of Client</i>	12/21/2023 8:00 am <i>Date of Inspection</i>
1934 Pepperwood Ln, Houston, TX 77084 <i>Address of Inspected Property</i>	TREC# 22294 <i>TREC License #</i>
Steve Vincent <i>Name of Inspector</i>	
Name of Sponsor (if applicable)	<i>TREC License #</i>

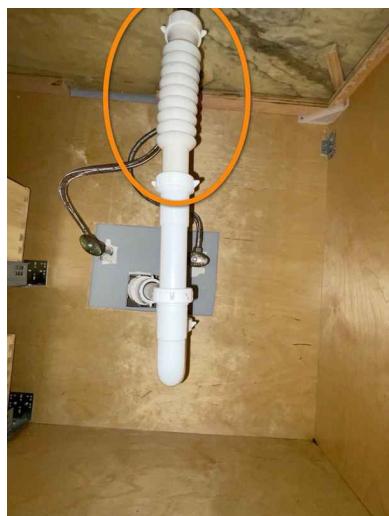
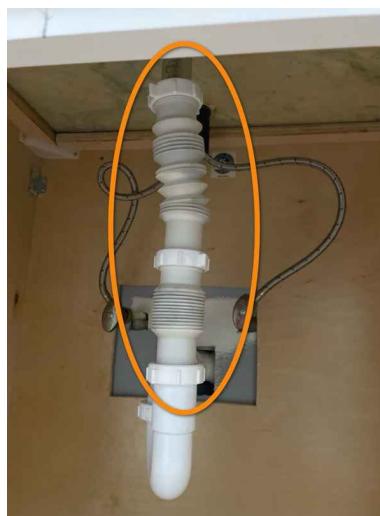
3: Flex Pipe Not Recommended**🔴Repair/Replace**

Flex pipe is not a recommended repair or replacement pipe for drains. Flex pipes have a history of clogging over time and are no longer a coded repair. Recommend to replace flex pipes with smooth wall pvc pipes.

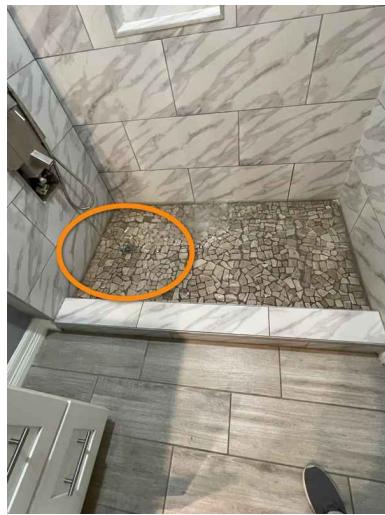
The tub / shower is slow to drain. Recommend to have repaired.

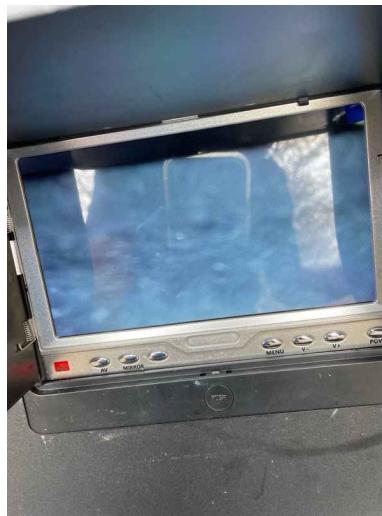
Example

There is a low point in the drain line which will promote clogging. We recommend further review and repair as needed.

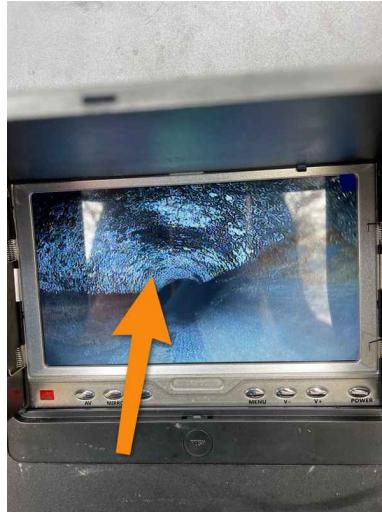
Example

Video
(click here to view on web)**7: Sewer Scope Scale Build Up****Repair/Replace**

There is scale build up inside sewer line which will promote clogging. We recommend repair as needed.

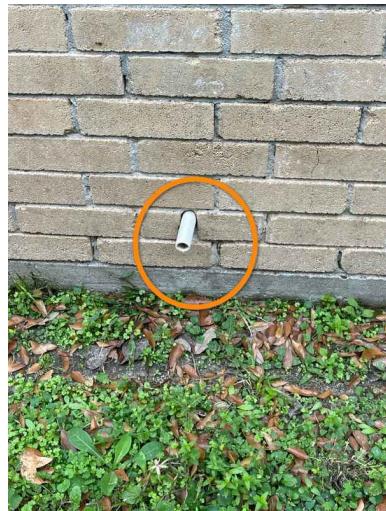
Example

2: Exterior Discharge Missing 90 degree Elbow

The exterior discharge tube is missing the 90 degree elbow

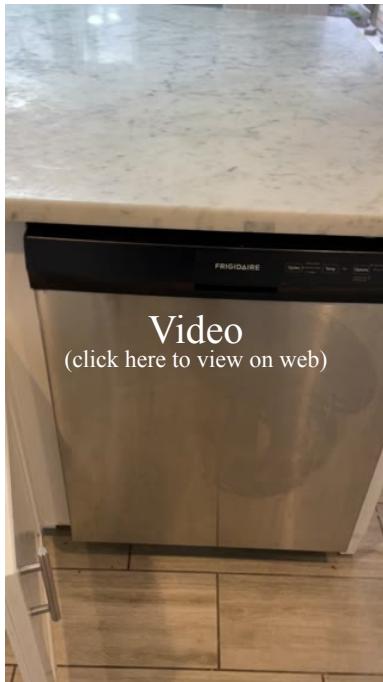
3: Older Dishwasher**Repair/Replace**

The dishwasher is an older unit. While replacement is not needed right away, however, dishwashers don't last forever. The life expectancy of a dishwasher is about 10 years, according to manufacturers surveyed by Consumer Reports. However, issues with the appliances tend to develop within the first five years.

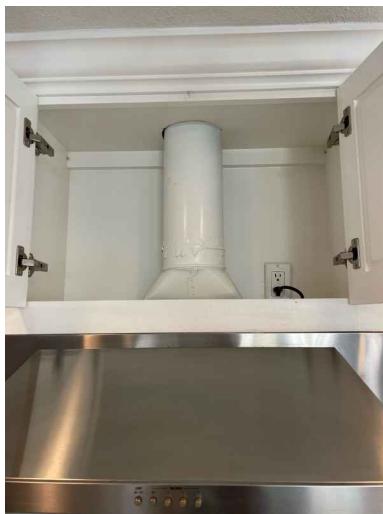
**1: Exhaust Duct Terminates into Attic****Repair/Replace**

The exhaust duct from the range hood terminated in the attic. This condition is improper and may result in moisture damage to attic materials from the formation of condensation. Excessively high moisture levels may also result in the growth of mold colonies which can raise mold spore concentrations in indoor air to unhealthy levels. We recommend that this duct be extended to terminate at the home exterior.

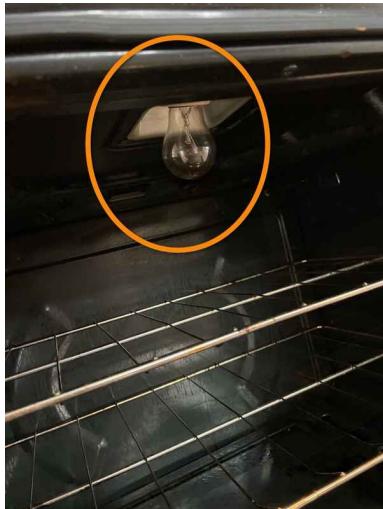
Example

2: Oven Light Not Working**✖Repair/Replace**

Oven light did not operate when testing. Recommend to replace the light bulb and retest.

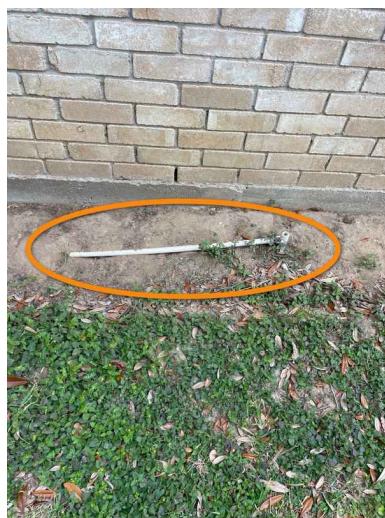
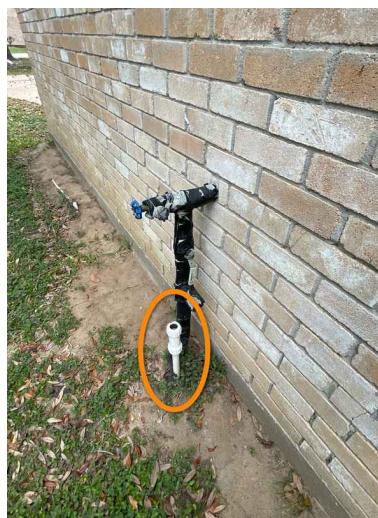
Example Front Exterior

2: Exposed / Damaged plumbing

Exposed plumbing needs to be buried / damaged plumbing repaired.
