MECHANICAL REPORT

2121 Bolsover St
Houston, TX 77005

PROPERTY INSPECTION REPORT FORM

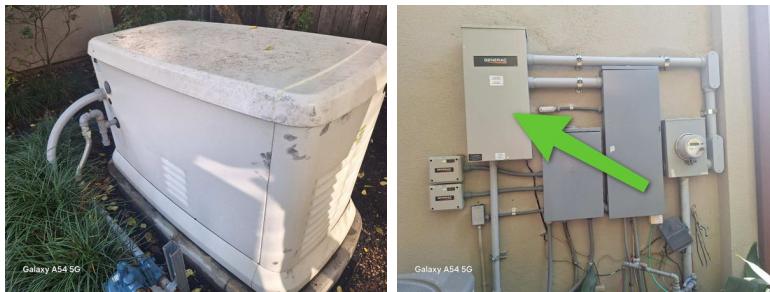
**Automatic Transfer Switch Panel*****Surge Protector - Functional:***

The electrical system was equipped with a gas fired backup generator with an automatic transfer switch. Backup generators are beyond the scope of this inspection, and the generator and transfer panel were not operationally checked. It is recommended that an electrician or generator service company be contacted to operationally check all aspects of the backup generator and transfer panel.

Further investigation is recommended

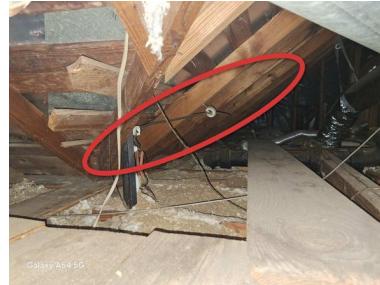
The house was originally equipped with observed knob-and-tube wiring. The house appears to have been rewired with modern non metallic sheathed wire, however inactive remnants of knob and tube wiring were visible in the attic. It is pointed out that the inspector has no way of determining if all of the knob and tube wiring was replaced. Knob-and-tube wiring is an antiquated, ungrounded, and unbonded system, and many insurance companies will require the wiring to be replaced with non-metallic sheathed wiring that is properly grounded and bonded. It is noted, visible knob and tube wiring that we observed was tested and appeared to be inactive at the time of the inspection. It is recommended that you contact an electrician for further investigation to determine the entire scope of the knob-and-tube wiring present throughout the house, and to determine if any of the knob-and-tube is still active. The service company should provide a cost estimate for any needed repairs and/or upgrading the electrical wiring to meet current code requirements.

Further Investigation Recommended

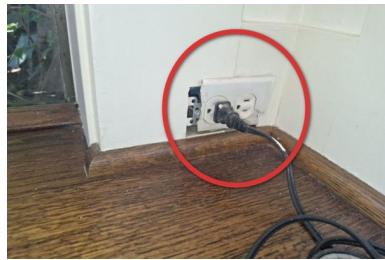
Piano room east baseboard

**3: Cover Plate - Damaged/Missing**

A missing or damaged cover plate was observed.

Obtain Cost Estimate

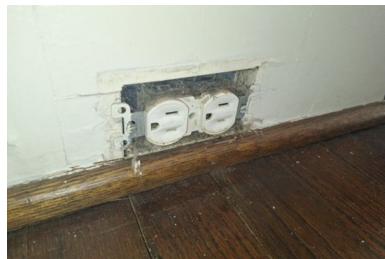
**4: Outlets - Box extenders missing at baseboard**

We observed outlets located in baseboard trim that were not protected by junction box extenders. This is considered to be a fire hazard, and it is recommended that the extenders be installed.

Obtain Cost Estimate

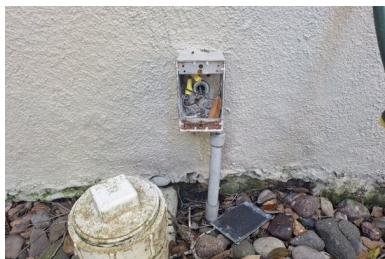
An open junction box that was missing a cover was observed.

Obtain Cost Estimate

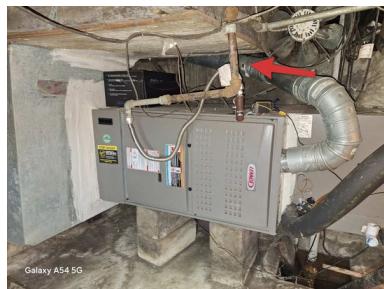
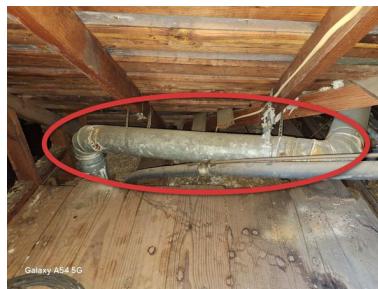
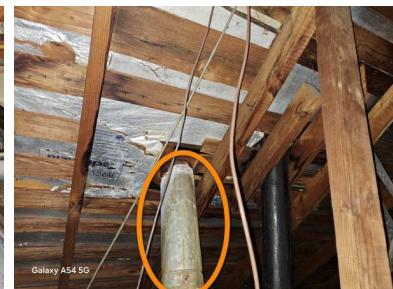
Evidence of water dripping down the pipe

Obtain cost estimate

Recommendation: Contact a qualified professional.

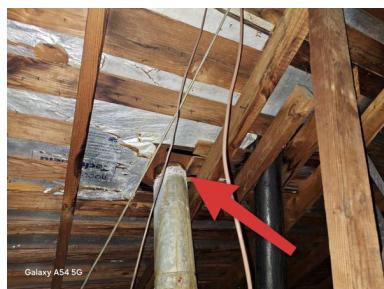
4: Vent Pipe - Not Terminated properly through roof

The vent pipe did not extend through the roof to the outside in a currently approved manner. The vent pipe terminates inside a metal vent cover in the attic, rather than the vent pipe extending completely through a type-B roof jack system to the outside. This can allow the hazardous combustion gases to be routed back to

Obtain Cost Estimate

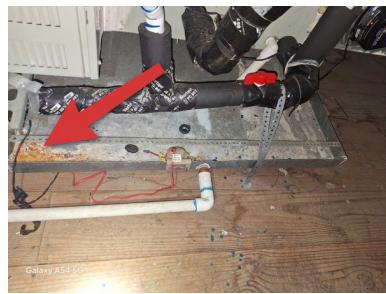
Rust was observed in the overflow pan under the coil, apparently due to water backing up at the primary drain line and overflowing into the pan. No water was observed in the overflow pan at the time of the inspection. However, since the equipment was only operated for a short time during the inspection, it is recommended that the primary drain line and the coil be checked by an air conditioning service company.

Obtain Cost Estimate

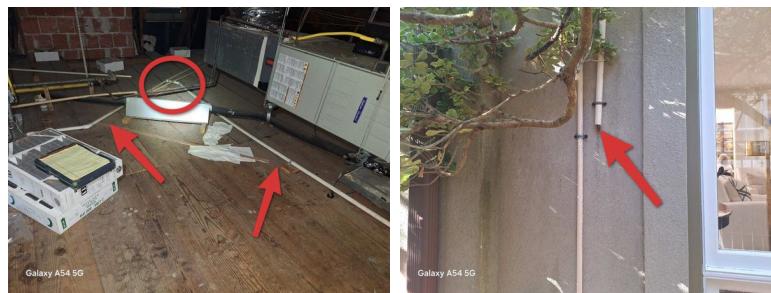
AC and Water Heater overflow pan drains connected and terminated at East side of house

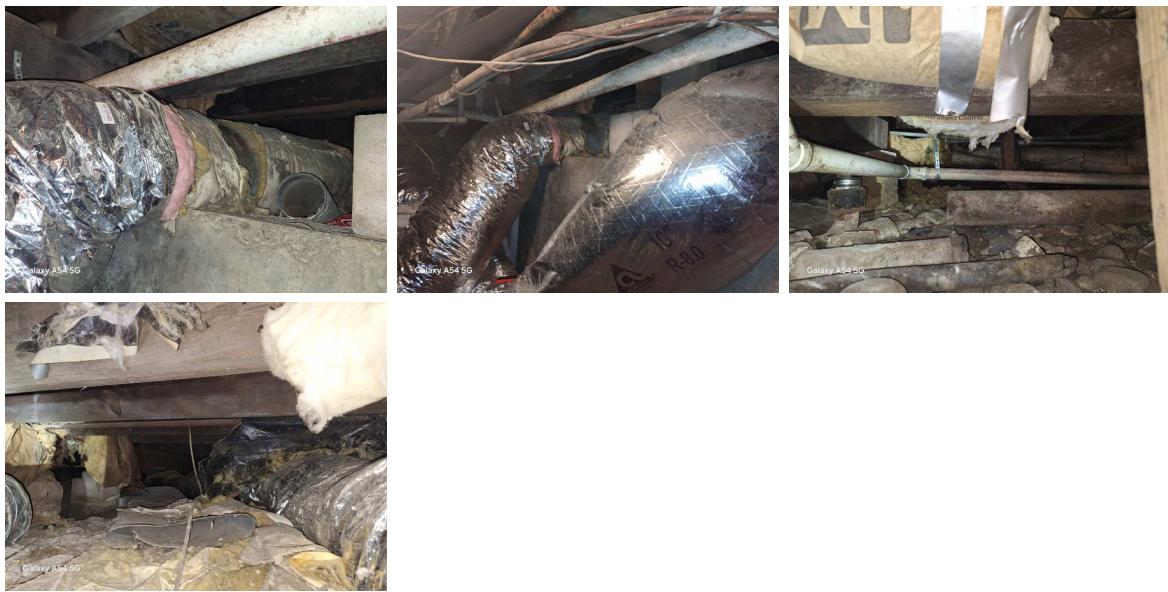
1: Return Air - Not sealed
Apartment

The chase was not sealed properly and was drawing unconditioned air from the floor and/or wall cavities into the system. Have the chase sealed against air leaks.

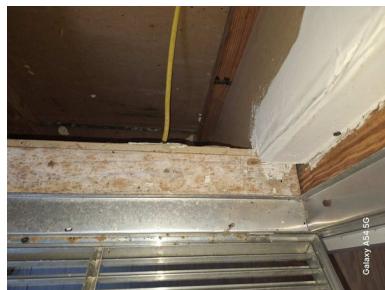
2: Return Air - Wires inside chase
Apartment

Wiring was observed to have been run in the return air chase. It is pointed out that wiring can give off poisonous gases when it is burned, and these wires could be hazardous, should they be affected by excess heat. The wiring needs to be encased in conduit, rerouted, or encapsulated into the wall cavity. It is recommended that an electrician be contacted to make the needed repairs.

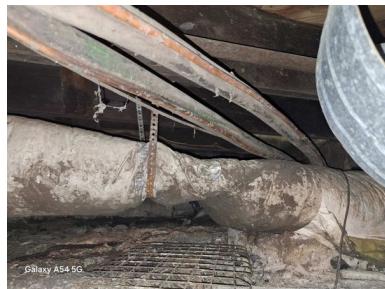
Crawlspace

**3: Metal Air Ducts - Crushed/Pinched**

[**Obtain Cost Estimate**](#)

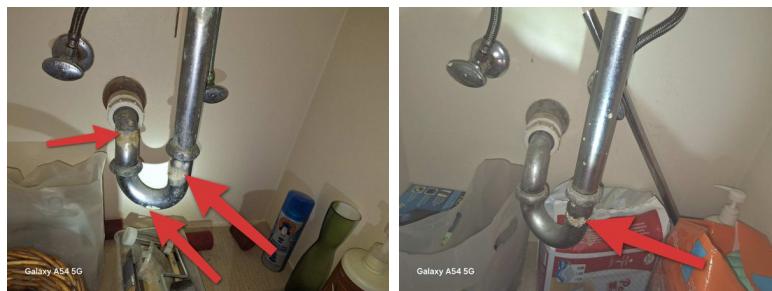
The drain piping was corroded under a sink at the P-trap or drain line. The piping was not leaking at the time of the inspection, but it can be anticipated that it will need replacement in the near future.

Obtain Cost Estimate

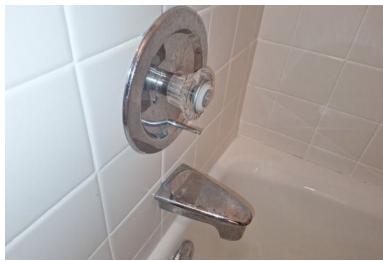
All Bathrooms

**8: Shower/Tub - Caulk valves**

Obtain Cost Estimate

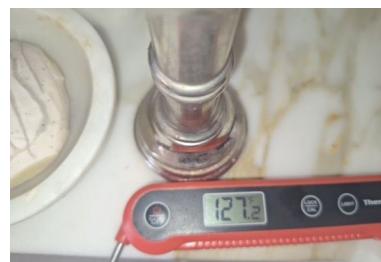
The generally recommended maximum temperature setting for a hot water heater, to prevent accidental scalding, is 120-125 degrees. It is recommended that the water heater thermostat be adjusted to and maintained in this temperature range.

The temperature of the hot water was measured at the kitchen sink and observed to be 127.2 degrees at the time of the inspection.

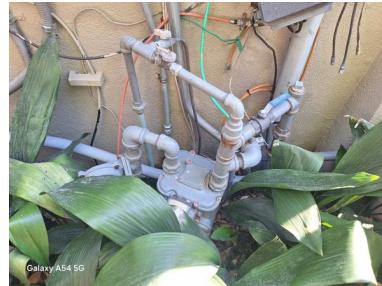
A cursory visual inspection was performed on the gas supply piping. The inspection was limited to the gas pipes that were visible and accessible at the time of the inspection, without digging to uncover gas lines. The underground gas line is typically galvanized steel, which can and does rust. However, viewing the underground gas line(s) would require digging, and HEI does not do any digging around the gas lines to determine their condition or the degree of rusting at the underground piping. Also, the use of specialized equipment to detect leaks is not included in the scope of this inspection, nor is determining the gas supply pressure or adequacy. If further investigation is desired to know the condition of the underground gas line(s), it is recommended that a plumber be contacted.

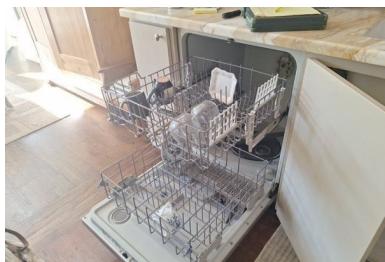
1: No Anti-Siphon

The drain line under the sink was not equipped with an anti-siphon device, nor was it looped up so that the top of the loop is at least six inches above the entrance of the drain line into the disposal. It is recommended at least that the drain line be looped to prevent the water from the garbage disposal from siphoning back into the dishwasher, or an anti-siphon device installed.

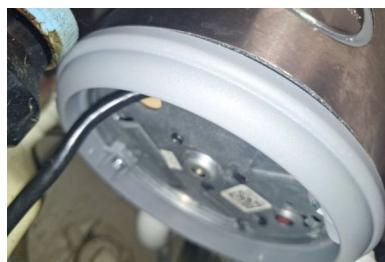
1: Vent Pipe - leaking air

The vent pipe was leaking air into the kitchen cabinet and needs to be sealed.

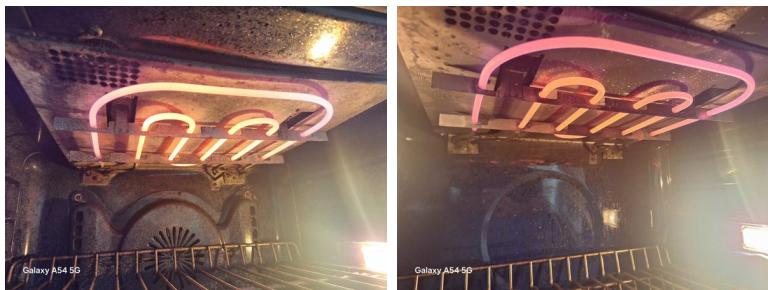
Both oven thermostats were checked and were properly calibrated. The thermostats were set at 350 degrees, and the ovens heated to within the allowable ± 25 degrees. The ovens were checked with an oven thermometer and found to heat to 330 degrees for the upper oven, and 370 degrees for the lower oven.

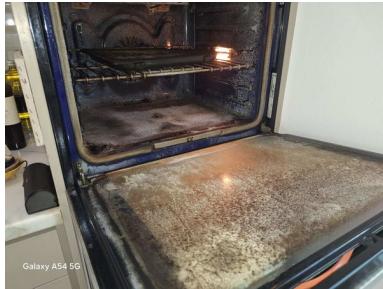
2: Oven Interior - Surface Damaged

The interior of the oven appeared to be distressed from possible over heating or corrosion from an oven cleaner.

Have an appliance technician evaluate the condition and provide a cost estimate for any necessary repairs.

Further investigation is recommended.**Obtain Cost Estimate**

Recommendation: Contact a qualified professional.

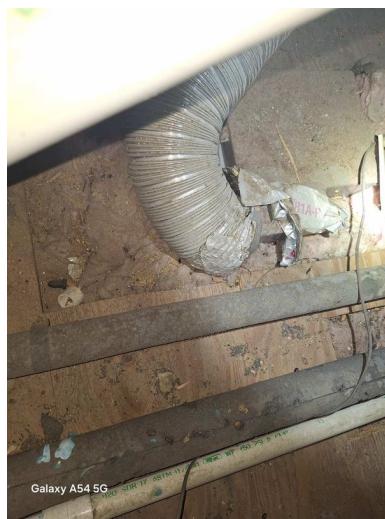
The vent duct for the exhaust fan was disconnected in the attic and needs to be repaired.

Obtain Cost Estimate

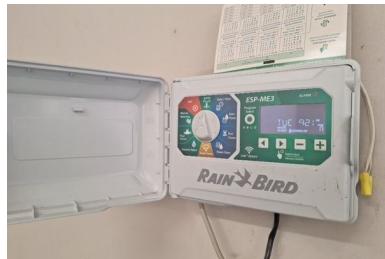
Sprinkler System: Rainbird, Located inside garage, 5 zones -

An automatic sprinkler system was installed. The system included a control panel, one or more solenoid valves, underground water lines and with sprinkler heads.

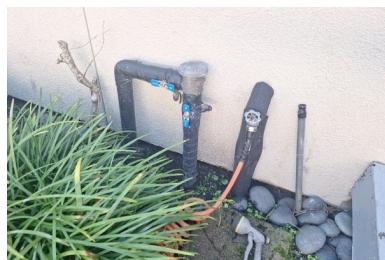
North Side of Garage

Backflow Prevention Device - present:

A backflow prevention device was present and was equipped with the two water shut off valves on the water supply line to the sprinkler system.

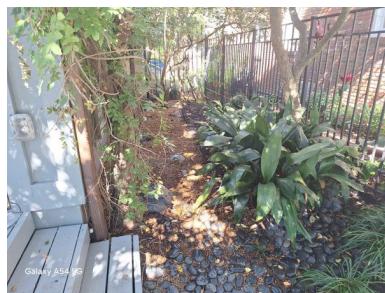
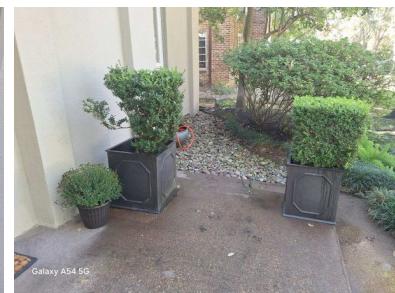
The sprinkler head spray was in need of adjustment/repair.

Obtain cost estimate

Recommendation: Contact a qualified professional.
