**INSPECTION REPORT**

Report No.: PP-2026-WH-001

**RODENT INSPECTION REPORT | INITIAL ASSESSMENT & TREATMENT**

Windsor Hills Resort · 7809 Basnett Circle, Kissimmee, FL

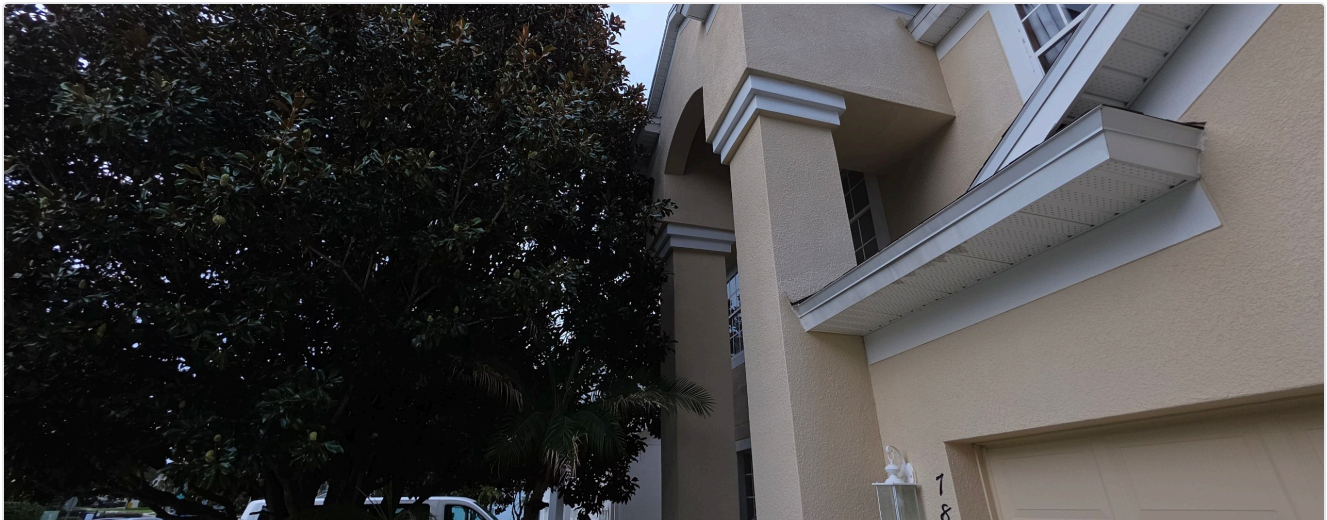
### 1. Tree Branches in Contact with the Roofline (Exterior, Front of Structure)

A large tree at the front of the property has branches growing directly into contact with the roofline and soffit. This is one of the most common ways rodents and other pests gain access to a structure. Branches that touch or overhang a roofline act as a natural bridge, allowing rodents to move from the tree canopy directly onto and into the building. Trimming these branches back so they no longer make contact with the structure is something we would recommend coordinating with a landscaper or tree service.

**Fig. 1:** Tree branches in contact with the roofline at the front of the property. A common rodent bridge point onto the structure.

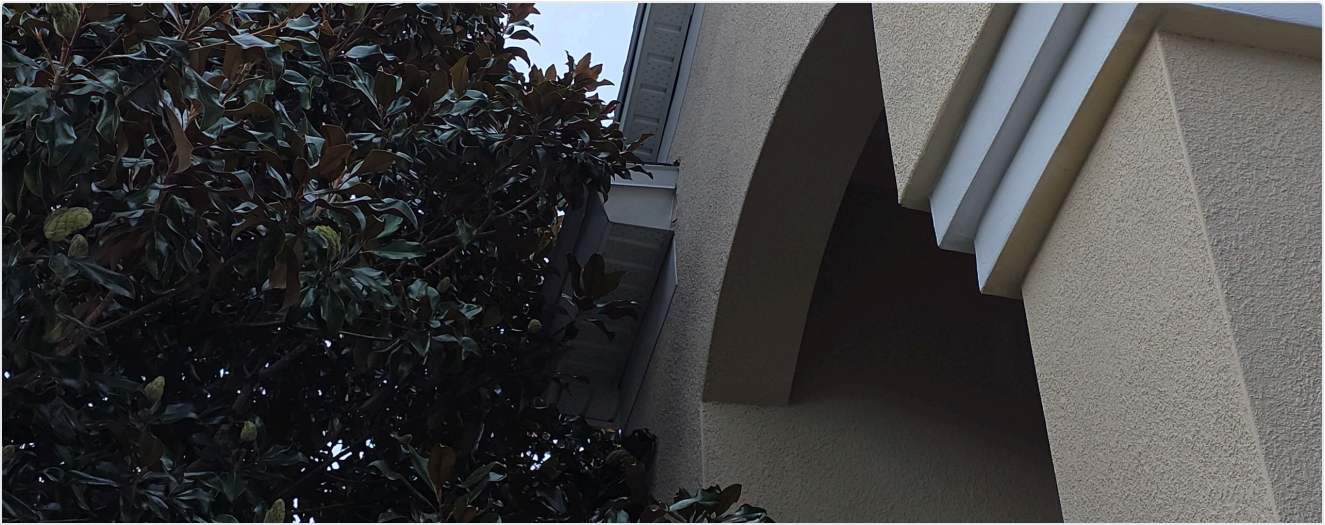
**Fig. 2:** Close-up of branch contact at the soffit and gutter line. Branches are pressing directly against the structure.

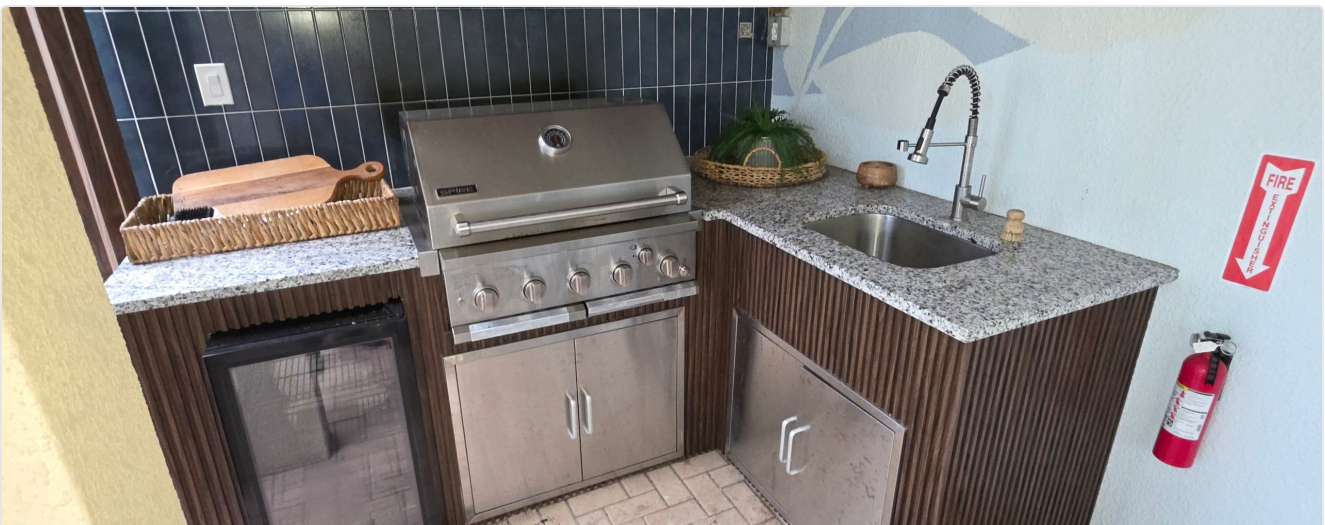
**Fig. 3:** The outdoor kitchen and BBQ area where the rodent was first observed by the guest. Primary area of activity.

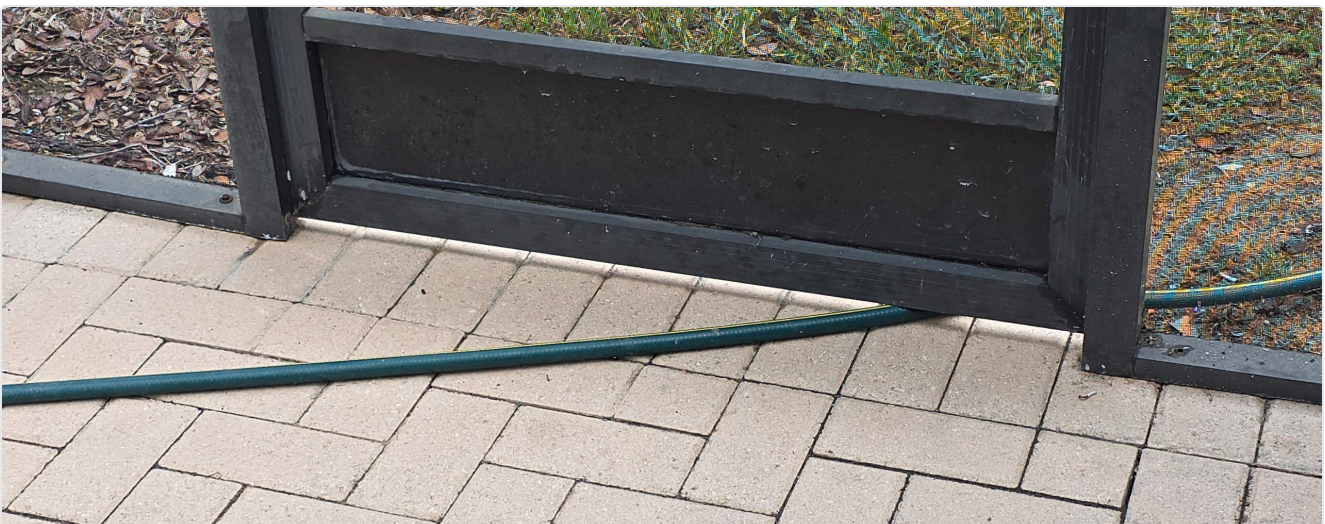
### 2. Screen Door Gap (Patio Screen Enclosure)

There is a visible gap along the bottom of the patio screen door sweep that is large enough to allow pests and small rodents to pass through. Normally this would be an easy fix with a new weather strip or door sweep. However, this particular door has a garden hose running through the gap, which is used to fill the pool, so a full seal is not practical without relocating the hose access point. We are noting this as a known limitation and flagging it as something to address when the hose routing can be changed.

**Fig. 4:** Gap at the base of the patio screen door sweep. Garden hose runs through the opening to fill the pool, preventing a full seal.

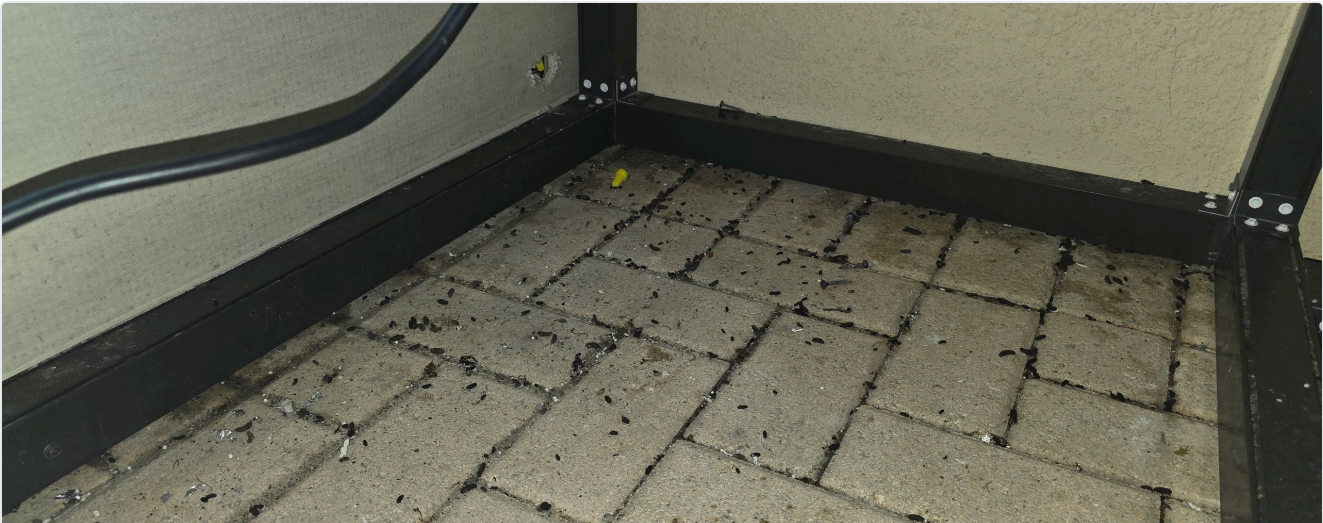
### 3. Rodent Feces Isolated to the Grill Cabinetry Area

Rodent droppings were found isolated specifically to the area beneath the outdoor grill cabinetry. No droppings were observed elsewhere in the screen enclosure. The volume and distribution concentrated in that one location are consistent with ongoing, regular activity in and around the grill structure, not a rodent simply passing through. Based on the size and shape of the droppings observed, the activity is more consistent with rat rather than mouse. This is where the guest's initial sighting occurred, and the evidence supports that rodents have been actively using this space for some time.

**Fig. 5:** Rodent droppings scattered across the paver floor beneath the grill cabinetry. Volume and distribution indicate ongoing, regular activity.

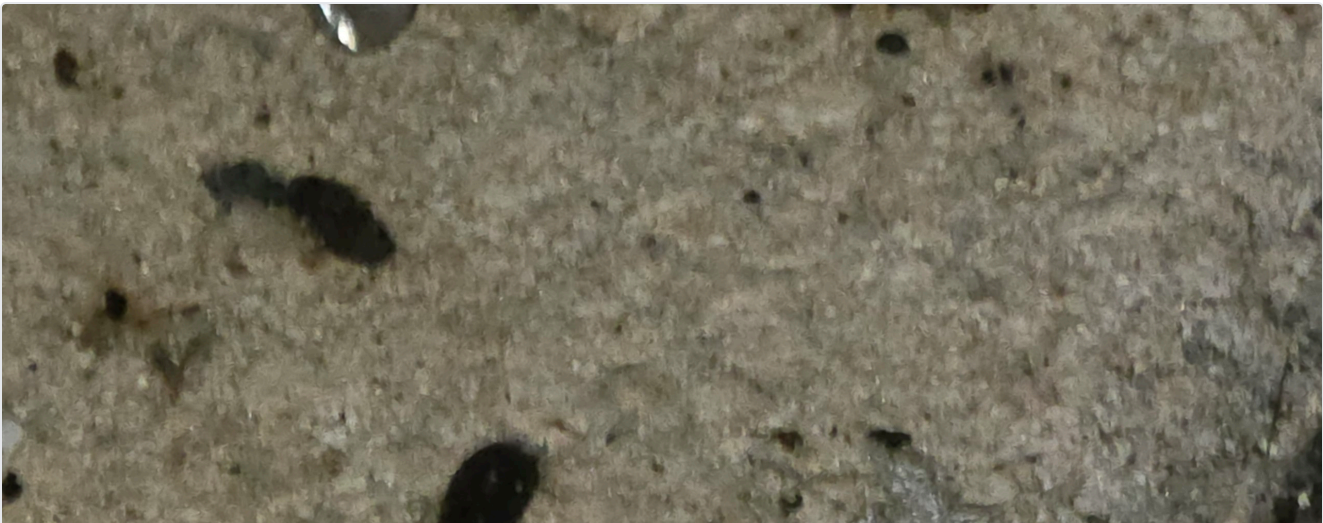
**Fig. 6:** Close-up of rodent feces collected from beneath the BBQ cabinetry. Size and shape are consistent with rat activity.

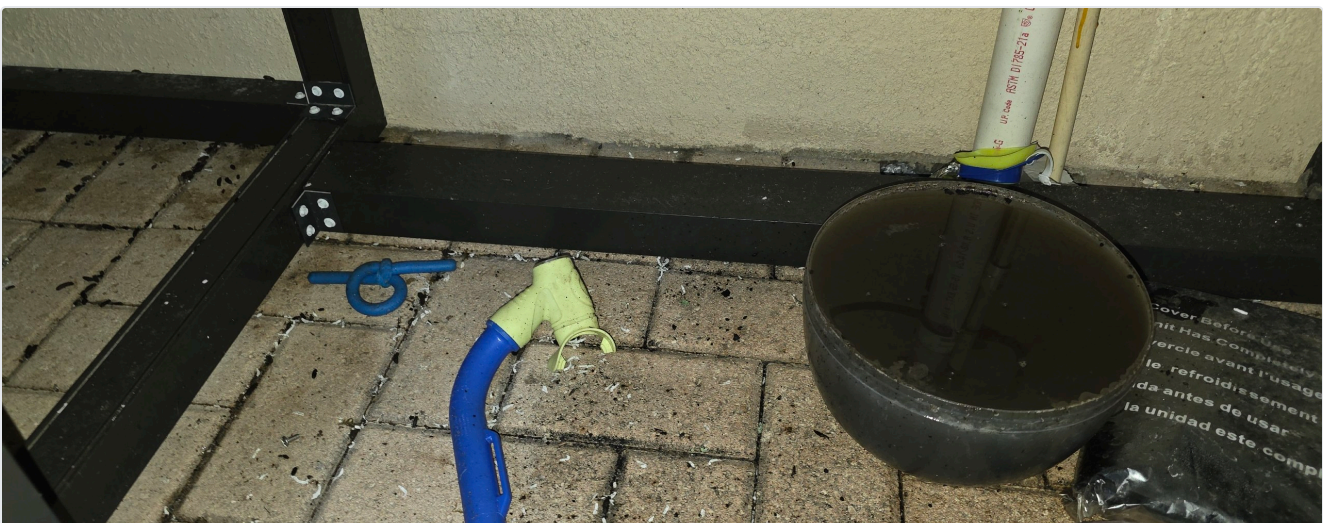
### 4. Standing Water Beneath the Grill Cabinetry

A container of standing water was found underneath the BBQ cabinetry. Standing water is a reliable attractant for rodents and other pests. Removing this and ensuring no water is allowed to accumulate in this area will help reduce the conditions that make the space attractive to wildlife.

**Fig. 7:** Under the grill cabinetry showing standing water, utility pipe penetrations, and the concentration of feces throughout the area.

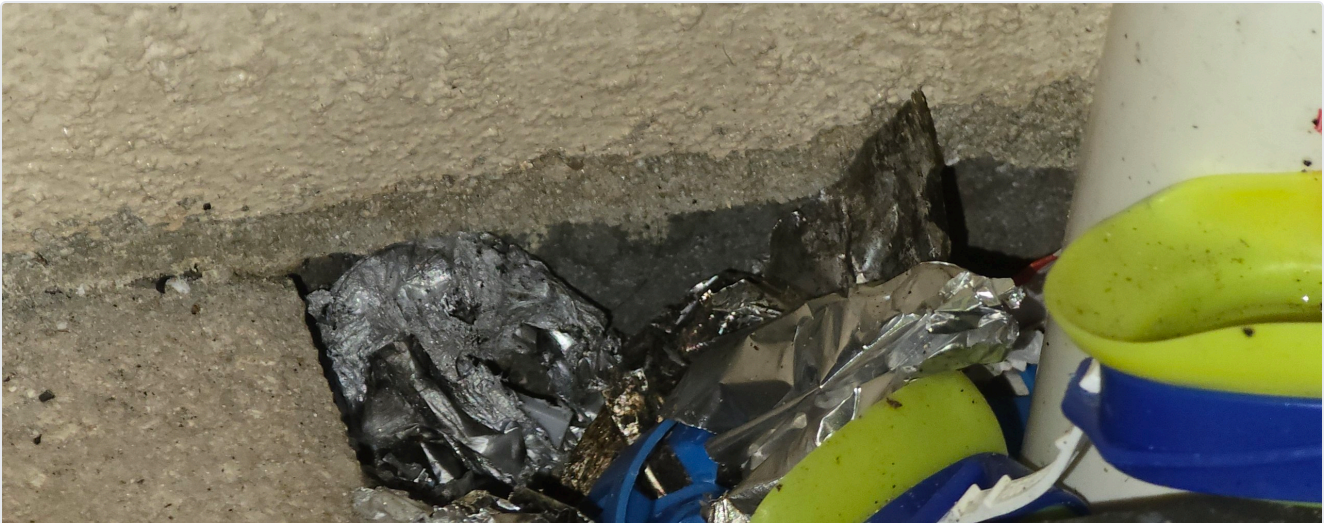
## 5. Floor and Wall Penetration with Nesting Material (Primary Entry Point)

A gap was found at the base of the exterior wall where the paver floor and utility pipes meet. This opening appears to connect to the structural wall cavity or extend beneath the foundation. Nesting material was found at and around this penetration, which tells us this is not just a travel corridor but an active harborage site. This is the most significant finding from this inspection and will need to be properly sealed by a contractor using appropriate rodent-exclusion materials.

**Fig. 8:** Penetration at the wall and floor junction where pavers meet utility pipes. Nesting material present. Opens into the wall cavity or beneath the foundation.

### 1. Seal the Penetration Points

The two open penetrations beneath the grill cabinetry are the most important thing to address. Until those openings are properly sealed with rodent-exclusion materials, new rodents can continue to enter from outside. We recommend coordinating with a licensed contractor to close both gaps. We are also flagging the second penetration for an electrician to evaluate, given the exposed wiring found there. Additionally, we would suggest looking into a new door sweep or weather stripping for the patio screen door when the hose routing situation allows for it.

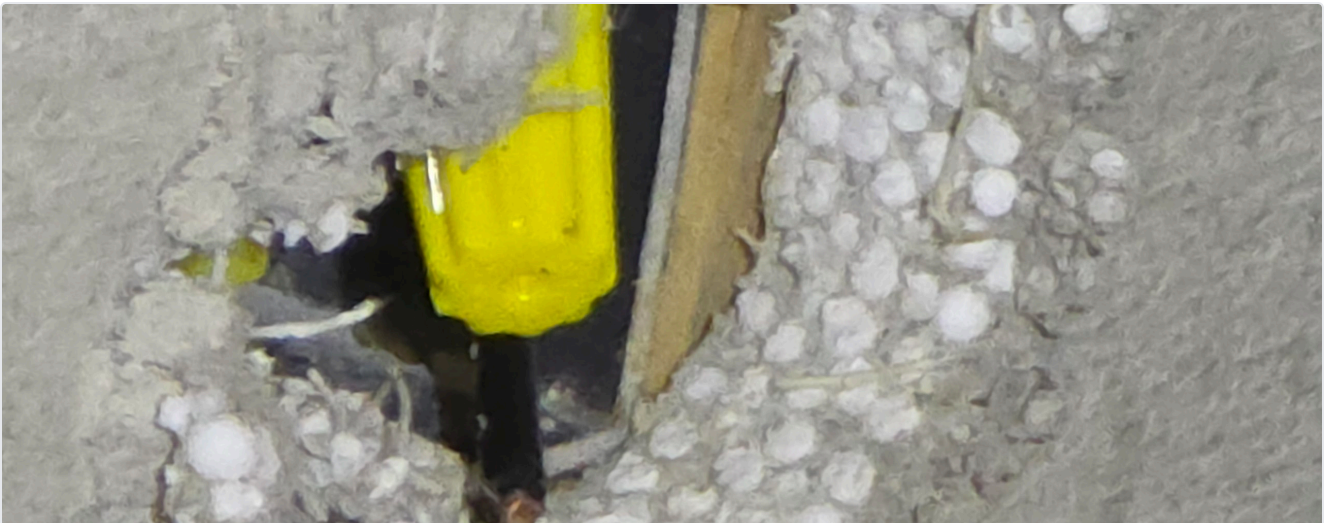
## 6. Second Wall Penetration with Exposed Wiring (Safety Concern)

A second opening was found in the exterior stucco wall nearby. This penetration has exposed electrical wiring passing through it, and a wire nut that appears to have come loose was found on the ground below the opening. Beyond being a rodent entry point, this is an electrical safety concern that should be evaluated by a licensed electrician. We are flagging it here so it can be addressed alongside the pest-proofing work.

**Fig. 9:** Second wall penetration with exposed wiring and a disconnected wire nut found on the ground. Glue board placed directly in the active rodent travel path along the wall.

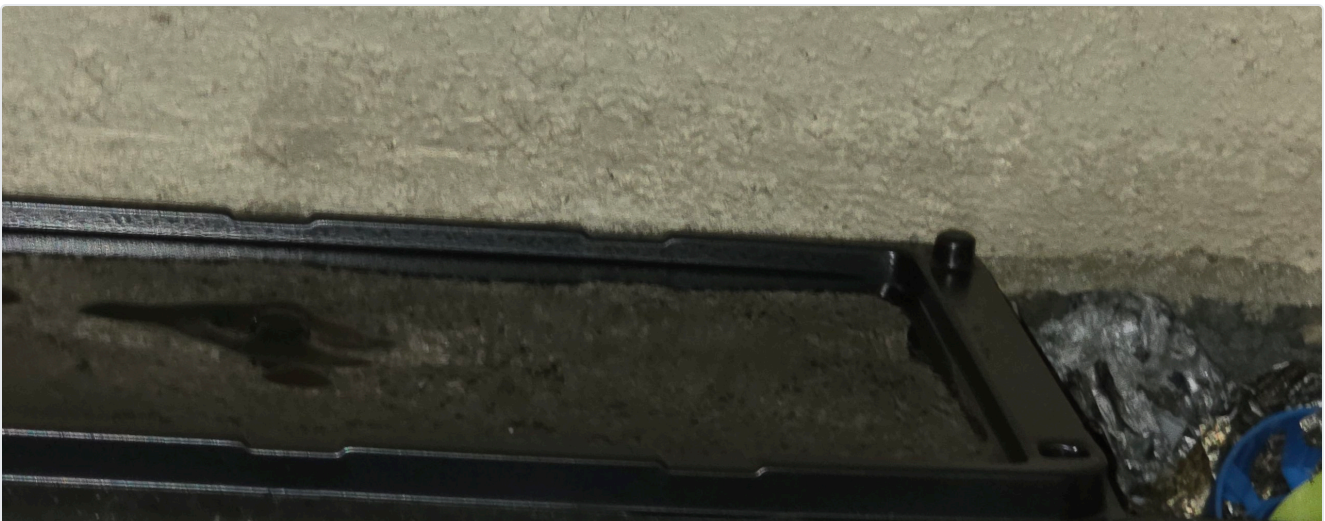
**Fig. 10:** Additional glue board monitor placed along the wall in the secondary rodent runway. All monitors are positioned flush to the wall per proper rodent control placement protocol.
