# New support for Vasa

Navigating technical requirements and ethical dilemmas in a large-scale, ongoing interdisciplinary preservation project

Malin Sahlstedt and Håkan Thorén

Collections Unit, The Vasa Museum, Swedish National Maritime Transport and Military Museums, Stockholm, Sweden

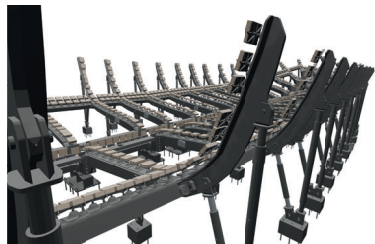
Detail of the new outer support. Illustration Vasamuseet/SMHMF. CC-BY

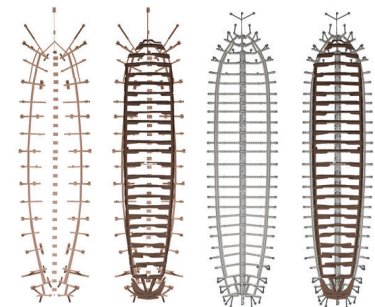
Old support Old support with the ship's rider timbers New support New support with the ship's rider timbers  
Illustrations Vasamuseet/SMHMF. CC-BY

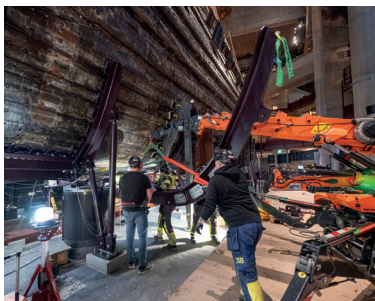
Assembly of the new support structure. Photo Annell Karlsson, Vasamuseet/SMHMF. CC-BY

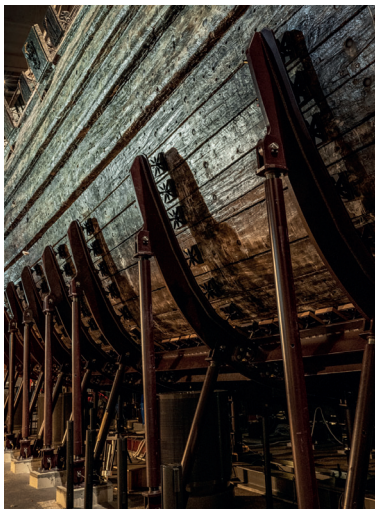
The adjustability of all major components will allow the ship – currently tilting about 1.5° to port – to be gradually shifted into a more upright, stable position.

The port side of Vasa with the new support cradles in place. Photo Annell Karlsson, Vasamuseet/SMHMF. CC-BY
