## Navigating technical requirements and ethical dilemmas in a large-scale, ongoing interdisciplinary preservation project

Collections Unit, The Vasa Museum, Swedish National Maritime Transport and Military Museums, Stockholm, Sweden

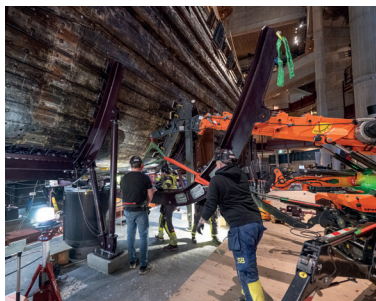
Assembly of the new support structure. Photo Anneli Karlsson, Vasamuseet/SMMTE. CC-BY
