# HSX Roofing Field Report

| <b>JOB NAME</b><br>570 Alden Road | <b>CUSTOMER / PROPERTY MANAGER</b><br>Milestone Property Management Limited |

## Leak Source

Skylight

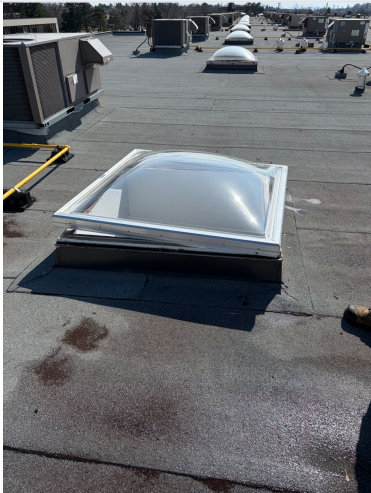
IMG\_0734.jpeg

The staff working at the desks below the skylight were experiencing excessive heat and strong sun glare. We implemented measures to help reduce these issues and improve their comfort.

Following the same approach, we proceeded with the removal of the skylight dome and installed a premium-grade plywood cover with a white finish to improve both aesthetics and light control. The skylight dome was then properly reinstalled, as illustrated in the attached
