| TPDS | | TEST REPORT | | | | |
| SIMULATED HILL DECENT TEST FOR BRAKE SYSTEM ON VP PHASE UP78 VEHICLE IN GVW CONDITION | | | | | | |
| To : NAGRIKAR RAVI/MISHRA KRISHNA | | Report No: TPDS/VT/RDP201/VP/2024/28051 | | | | |
| Project No: RDP201-UPP Goods-G2-Domestic | | Report Date: 31-May-2024 | | | | |

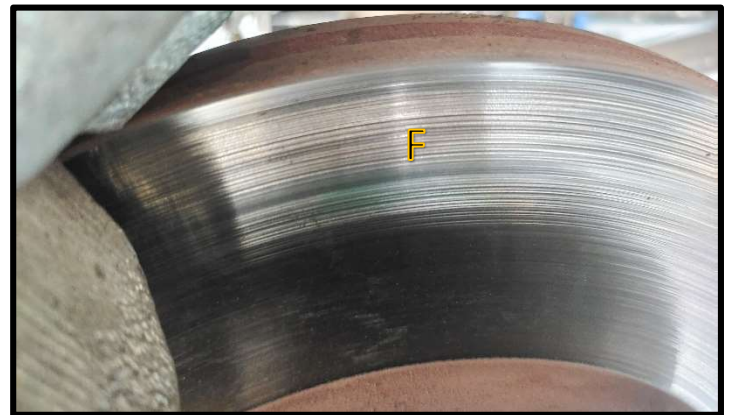
A - Inner Pad: Glazing, Decolorization and bluish color observed.

B - Outer Pad: Glazing, Decolorization observed.

C- Inner pad Sim: Piston marks observed.

D - Outer pad Sim: Caliper marks observed.

E - Ash formation found on front brake Pad.

F - Disc: Scoring marks, Glazing, decolorization observed.

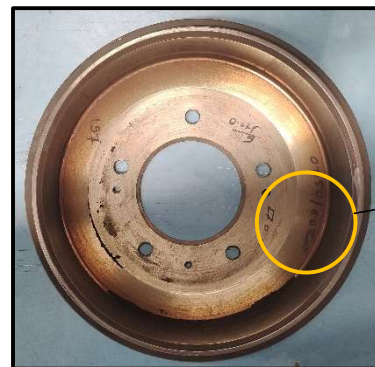
Bluish on drum
