HEALTH & SAFETY RISK ASSESSMENT

Address of Property: Scheme number 796

**Northfields
Colchester
CO4 5NF**

Date of Risk Assessment: **21st August 2020**

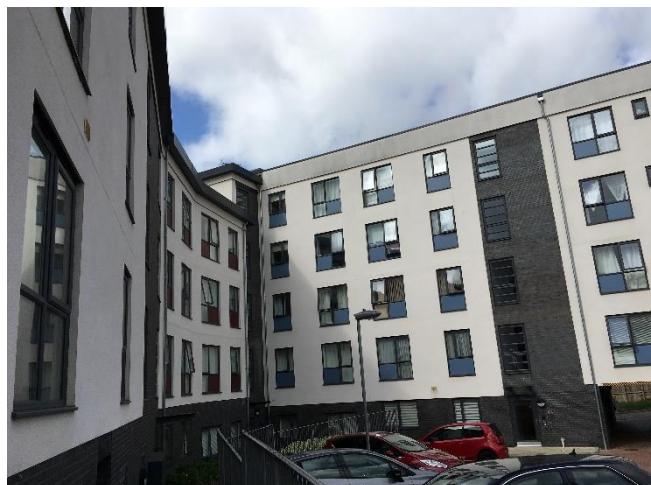
Block overview

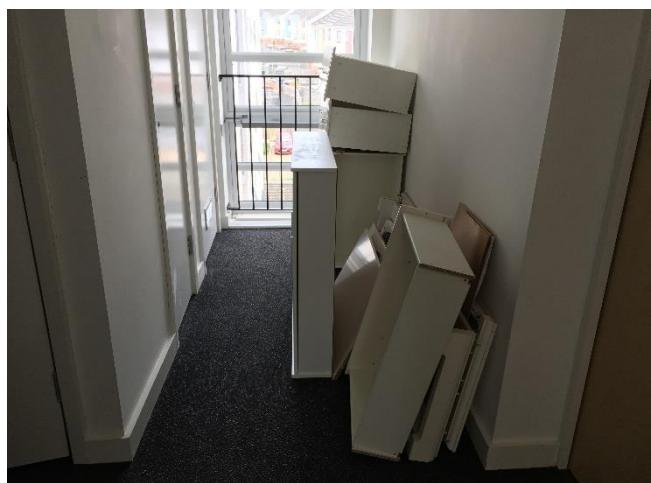
Unauthorised storage

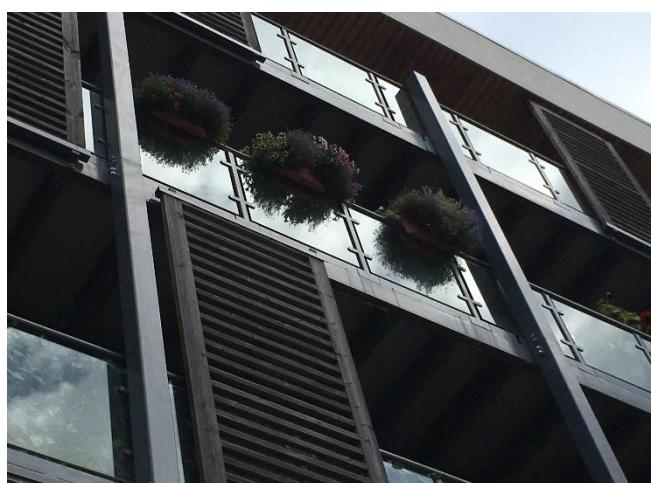
Planters on railings
