MacLean Power Systems Frozen Process Plan 3.5" Extruded Line Posts May 3, 2013

Root Cause Analysis:

"TESTS ON INTERFACES AND CONNECTION OF END FITTINGS" TEST REPORT ON 3.5" DIAMETER COMPOSITE LINE POST INSULATOR

CORE TIME-LOAD TEST REPORT ON 3.5" DIAMETER COMPOSITE LINE POST INSULATOR

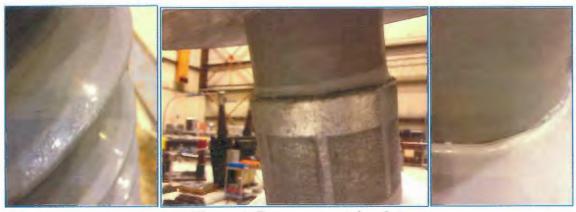
Figure 4: Extra paste on insulators

The alcohol steps were removed from the cleaning process for the samples that passed the electrical testing therefore; the MI has been updated to reflect this change in process. Due to this change, there may be some excess paste left on the insulators. This paste is purely cosmetic and does not affect the performance of the insulators. Figure 4 shows several pictures of the insulators that passed steep front with this cosmetic issue.

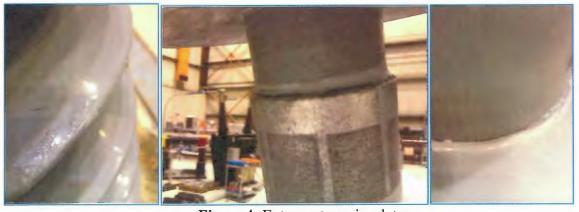
Figure 4: Extra paste on insulators

A: There was cosmetic glue on the units. At the time of the samples being manufactured, MPS did not know if excessive paste had any influence on the results of steep front testing. It was discovered during testing at Powertech that excessive paste does not influence the testing. Therefore, this step, eliminating units with excessive glue, will not be continued for production. Figure 1 shows excessive paste on insulators that passed testing.

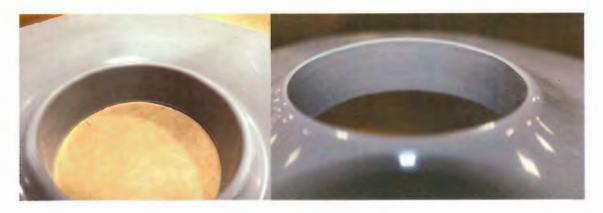
Figure 1: Sheds where sanding has not occurred.

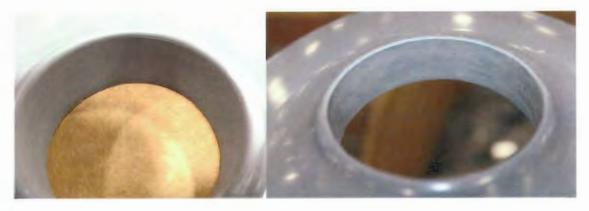
Figure 2: Sanded Sheds
