A STUDY ON THE RADIOLOGICAL SAFETY OF DUAL ENERGY X-RAY ABSORPTIOMETRY BONE MINERAL DENSITOMETRY EQUIPMENT

July 23, 2001

Ministry of Health Services

Radiation Protection Branch

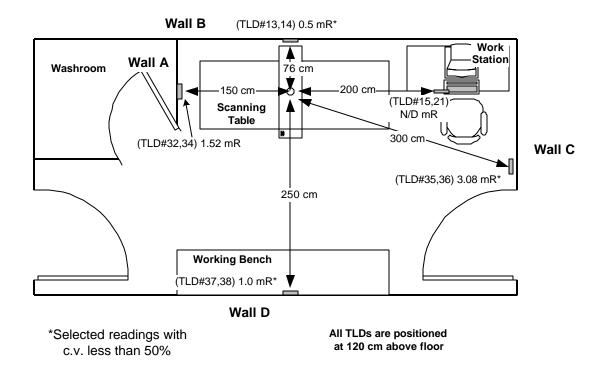
SITE # 3				
Location	Average Exposure on TLDs (mR)	Standard Deviation	Coefficient of Variation (%)	Net Exposure (less background) (mR)
Background	11.7	± 5.96	51	0
Wall A	13.2	± 6.72	51	1.52
Wall B	12.2	± 4.02	33	0.50
Wall C	14.8	± 4.84	33	3.08
Wall D	12.7	± 6.34	50	1.00
Workstation	5.4	± 3.98	74	Non- detectable
