## DESIGNER EXTRUDER HEAD.

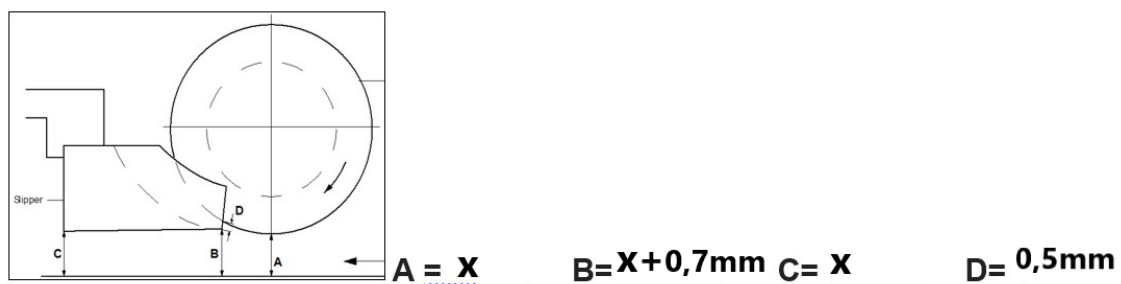
**Adjustment of (A) roller heights, end slipper(C) and inclination (B-C). Setting 020223**

**\*Adjust the upper side guide in underlap wáter course overlap, to be 0.5 mm, to avoid leverage.**

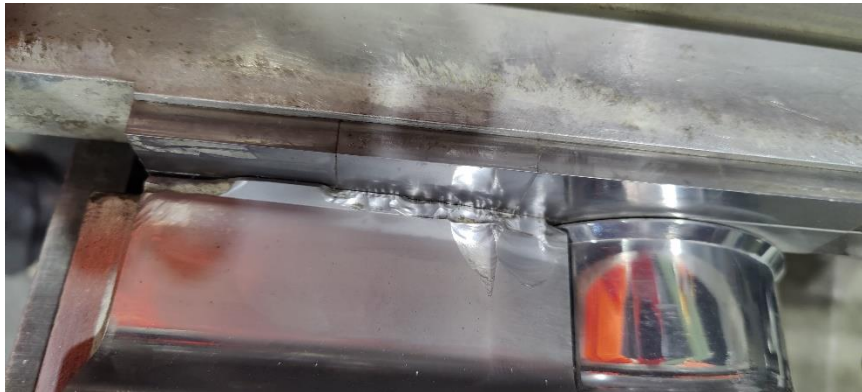
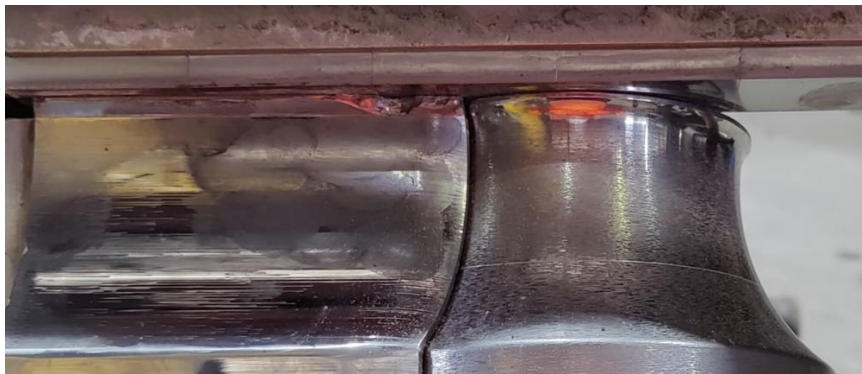
**\*One of the possible causes of these breakages on the overlap side of the slipper and roller big is the excess slack in the side locking guide, which allows the guide to be pressed laterally at the bottom, putting excess pressure on the critical areas of the roller and slipper.**

**\*I believe that this excess clearance and pressure should be identified and, if necessary, the guide should be pressed on a higher line, outside the critical areas of breakage of roller and slipper big.**

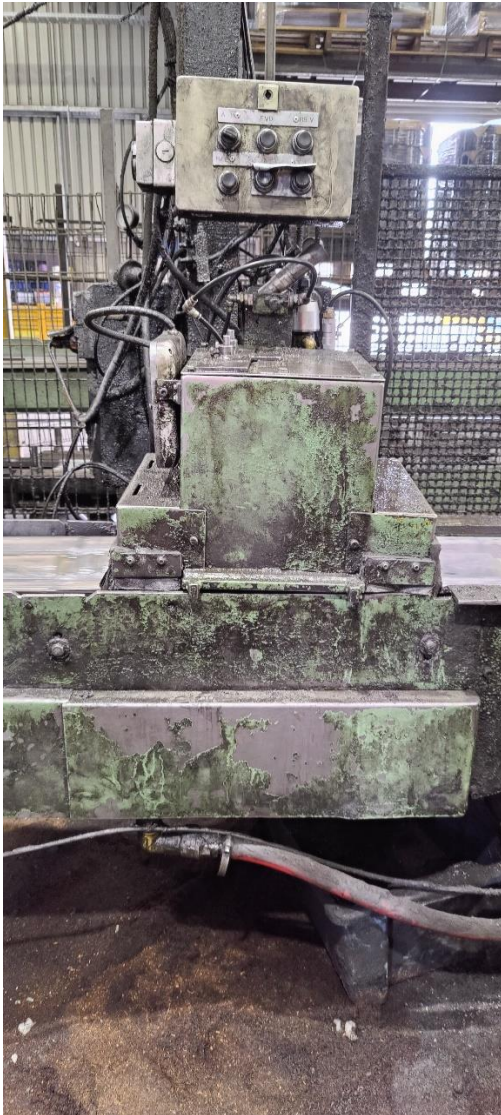
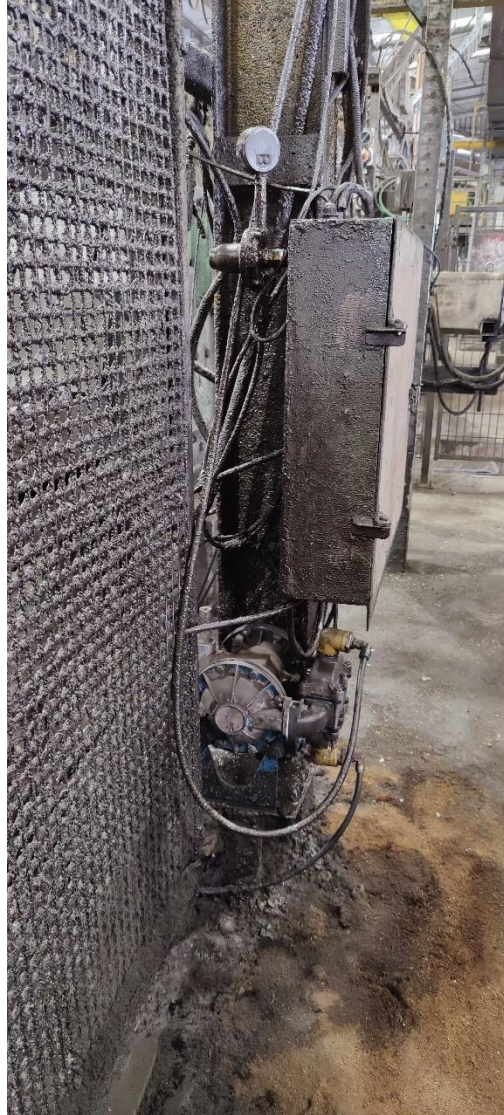
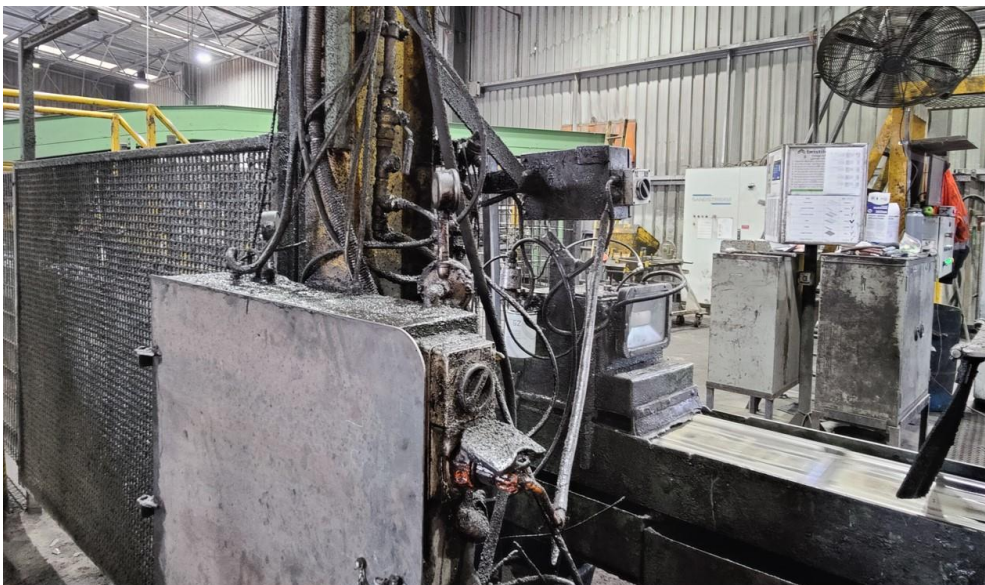
**\*The current system pollutes a “lot”, by the pneumatic pump and nozzles in its application.**

**\*Better “to change the oil application system” to the New oil curtain application system.**

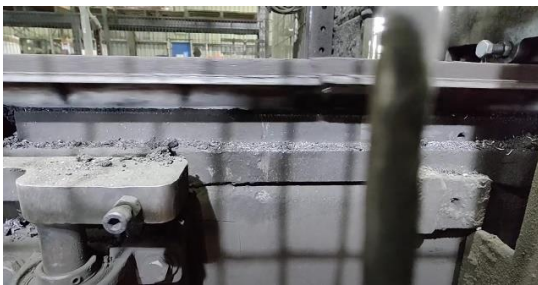
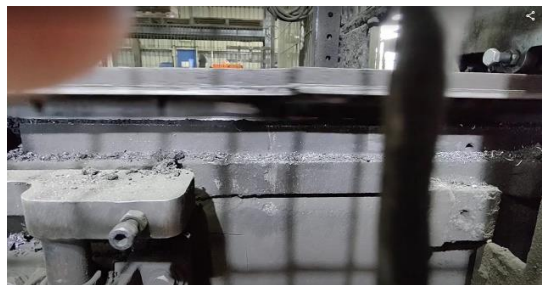
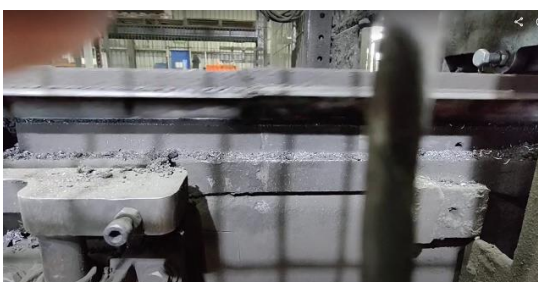
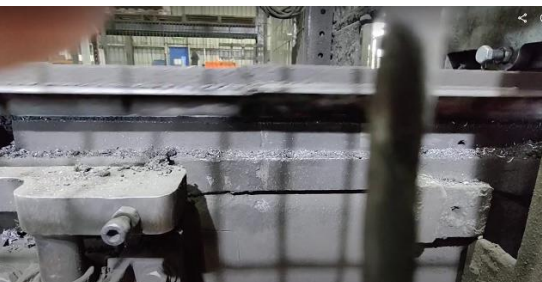
**\*Point where the pallet is raised and lowered at the extruder outlet.**

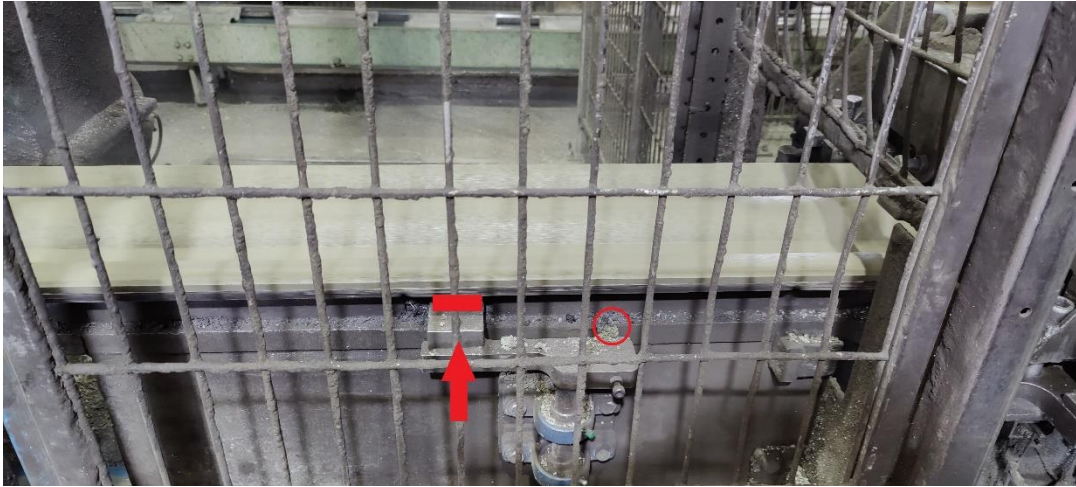
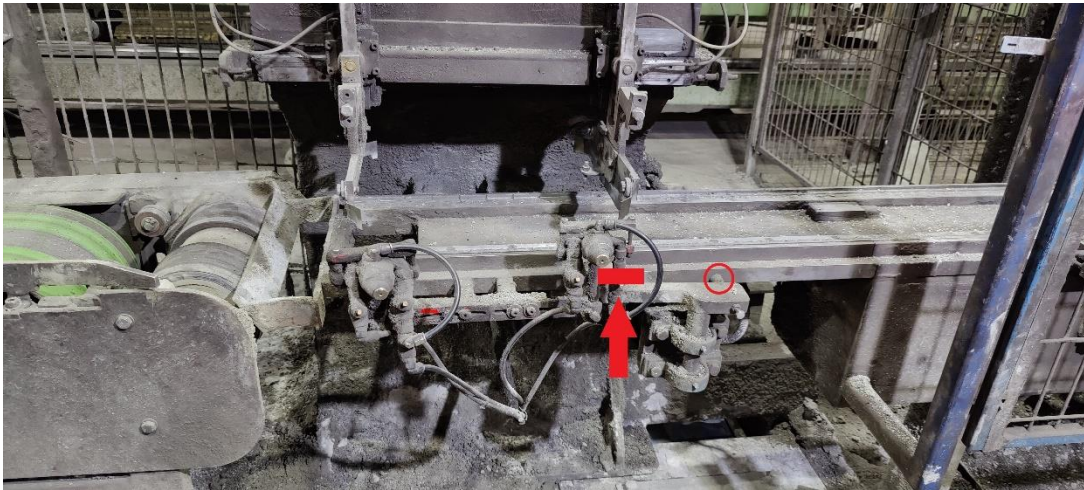
**\*The pallet retention system at the bottom lateral does not work, the pallet has excessive wear and deformation on the pallet sides, which makes it impossible to clamp the pallet.**

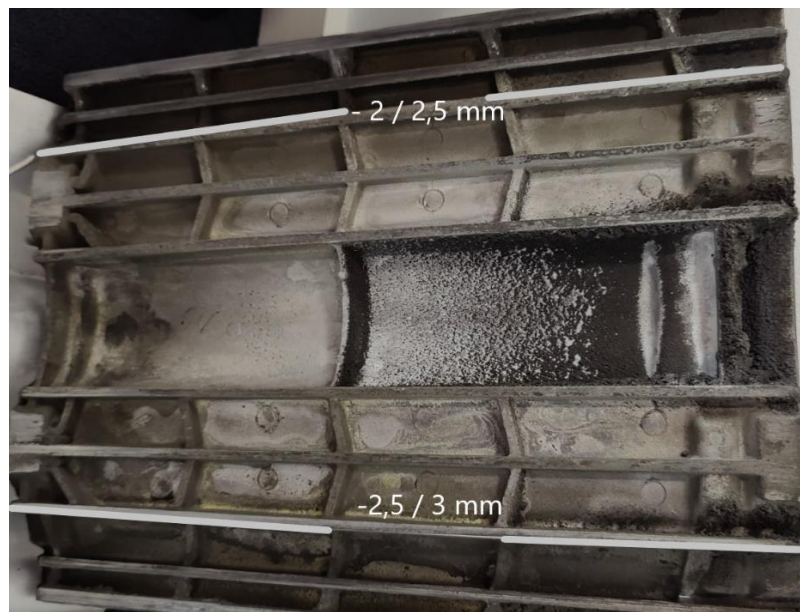
**\*Lack of pressure or excess wear on the side of the pallet (-2 / 3 mm) or wear on the base (0,5 / 0,7 mm), the free pallet and the pressure exerted by the big slipper between two pallets causes the pallet to rise. (The pallets are a lot wear)**

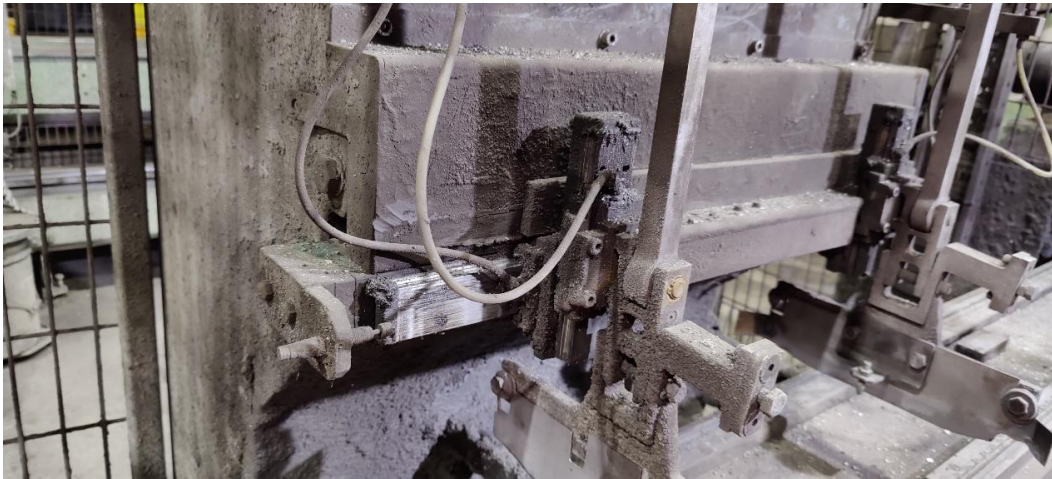
**\*Current contamination of the cutter must be avoided in order to keep the cutter in good working order and to reduce maintenance costs.**

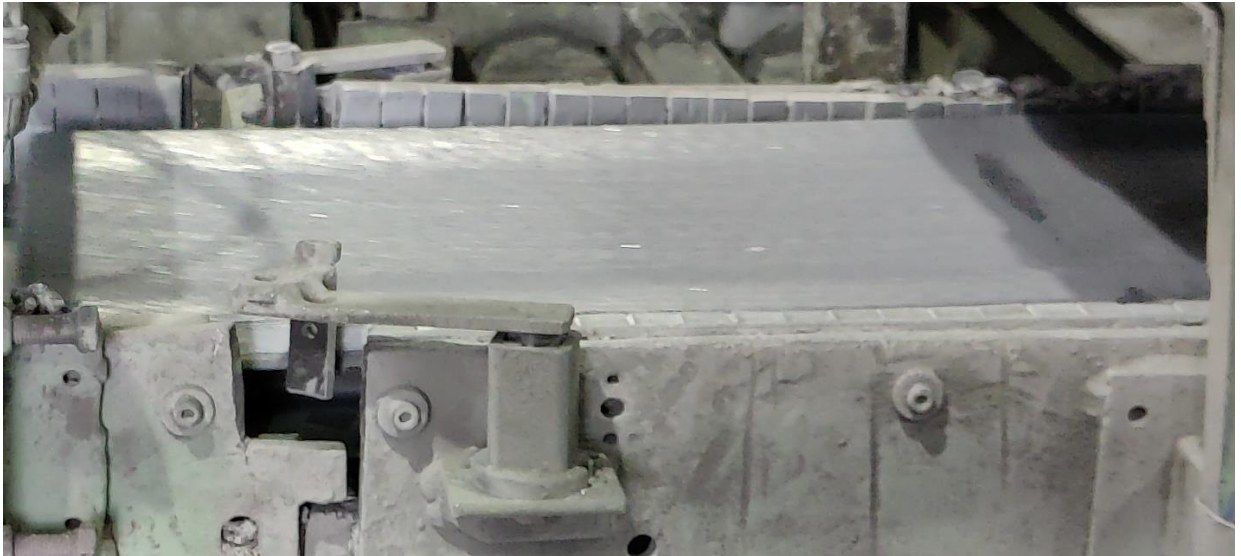
**\*There is dirt on the sides of the pallets, currently in the scraper area, there is a “non-contact área”.**

**\*Consider placing pallet side scrapers at conveyor feeding pallets to the pusher chain or the exit of the cutting system.( A check and evaluatio of the pallets is necessary)**

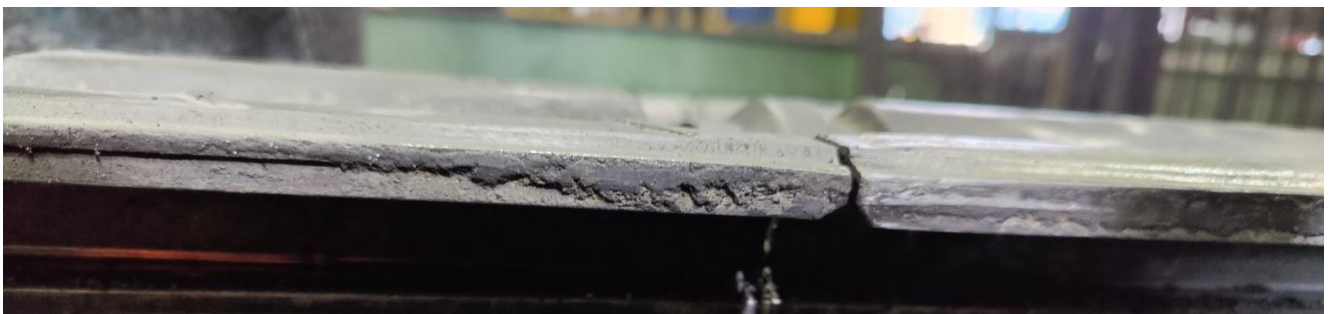
**\*The pallets with the most lateral dirt are the DESIGNER and the ARTISAN.**

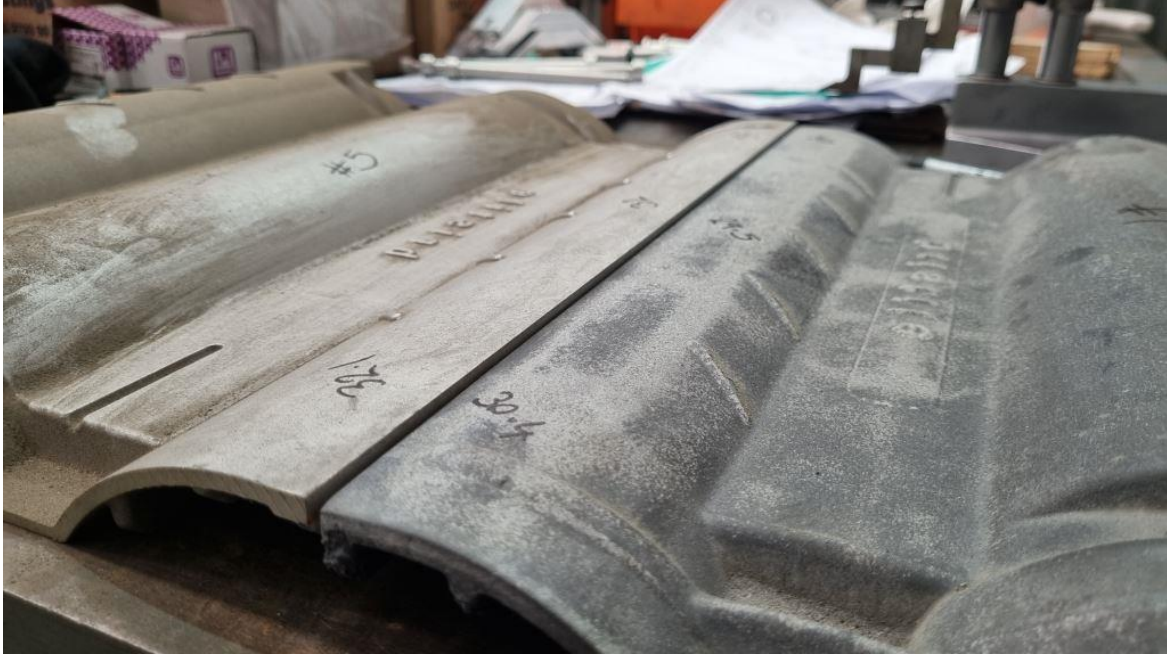
**\*In addition to the lower wear of the DESIGNER pallet, on the side of the underlap water course, there is a wear of 2.5 / 3 mm on the support guide, which has led to a deformation of the pallet on that side.**

**\*In addition to the lower wear of the DESIGNER mould, on the side of the underlap water course. .( A check the dimensions of the pallets on a monthly basis, in order to identify possible wear, as early as possible.)**
