# REPORT NORTHSTONE 160323

From my visit to the NORTHSTONE (Antrim) factory from 14 to 16 March 2023, I give my assessment and recommendations on the different equipment and processes that I have been able to review.

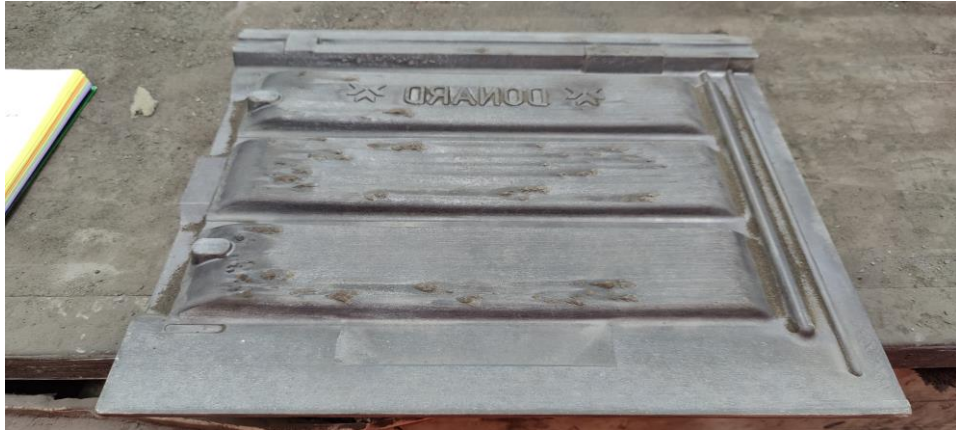
On the top of the DONARD mould some small concrete adherence, no problema.

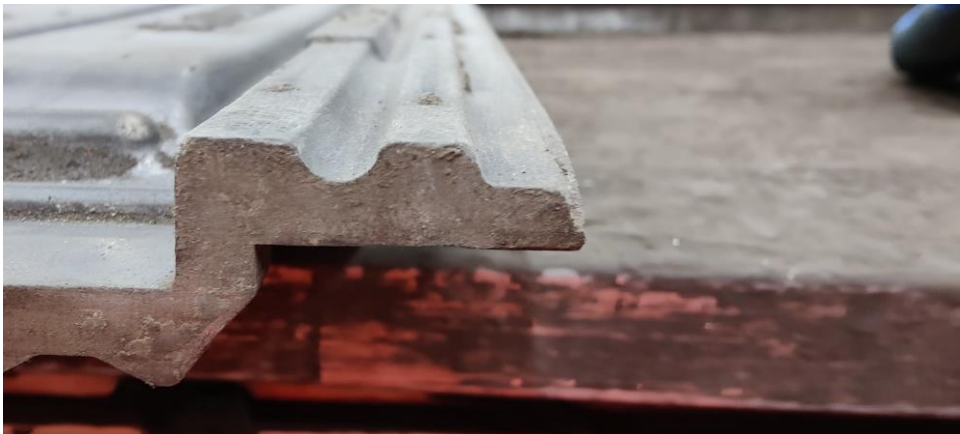
It also has wear on the corner due to contact with the mould release pallete blades.

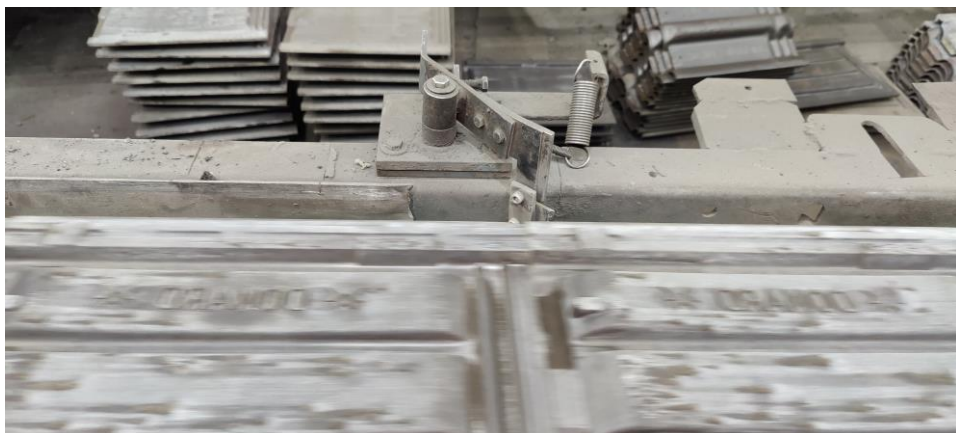
No pallet side scrapers act, if there are no concrete adherence they are not necessary.

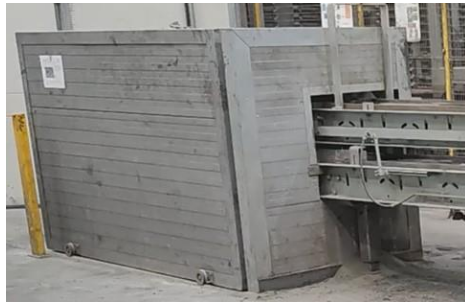
The polycords of the lower outlet conveyor are quite damaged, so it would be necessary to consider the replacement

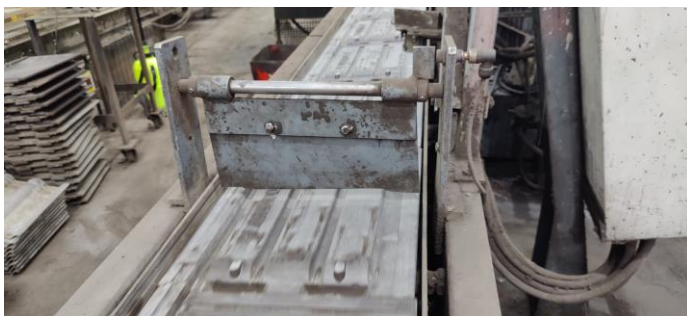
Based on comments in profile changes on the accommodation or adjustment of the flap, I recommend, possible change of the screen system for each model to a fixed non-adjustable one.

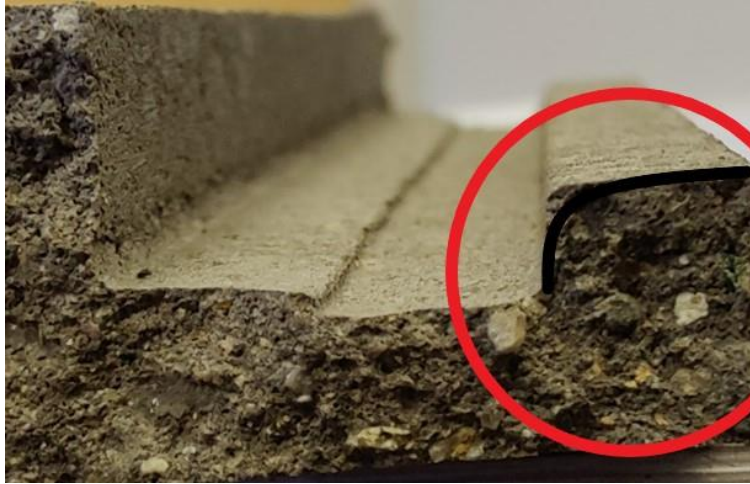
The adjustment values of the DONARD / CAUSEWAY models with tungsten (TC) rollers and slippers have been identified with the factory operators, as well as with the DERRIE model which uses steel rollers and slippers.

I recommend the study and evaluation of modifying one area of the CAUSEWAY tile interlocking from straight to curved.

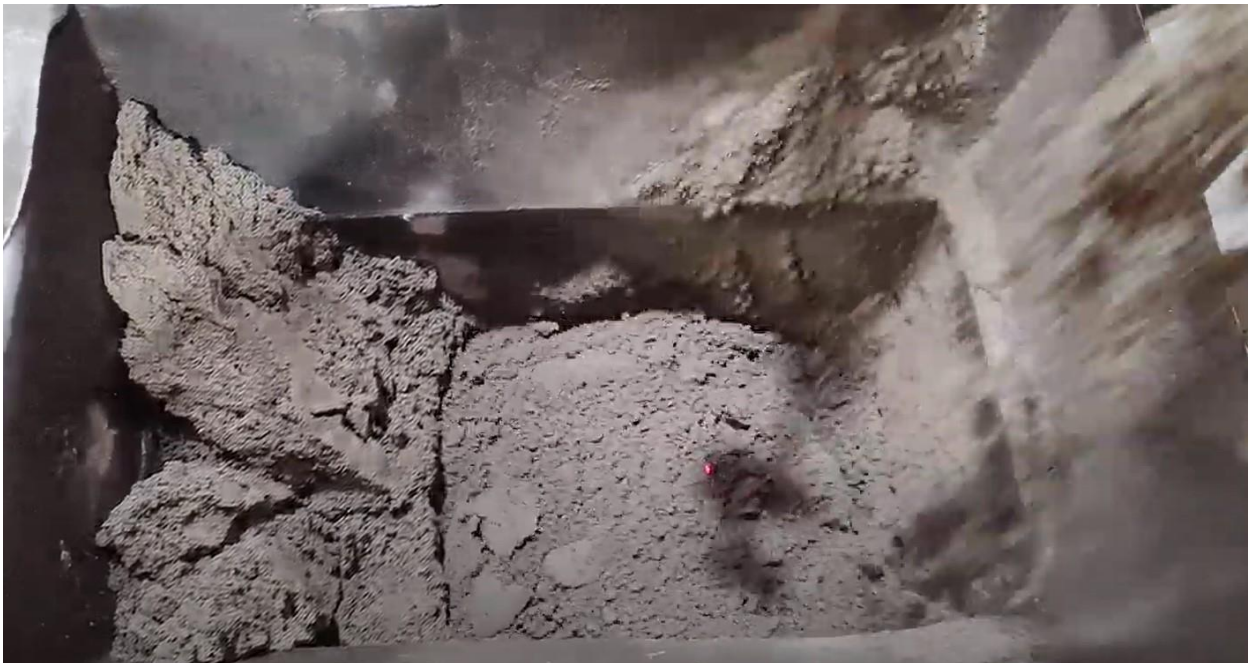
I recommend increasing the concrete column in the extruder, to guarantee the feeding of concrete to the roller and slipper.

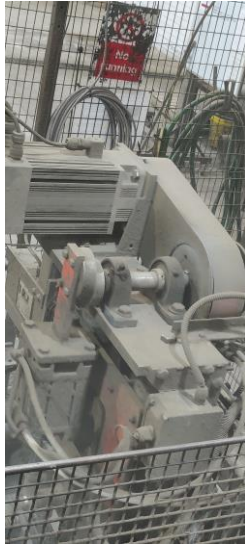
Study and evaluate the possible application of a frontal knife water and air nozzle (currently only lateral) in the production of CAUSEWAY tiles on the rounded cut area.

Check the protections of the belt that drives the cutting blades, as it vibrates a lot and causes excessive noise.

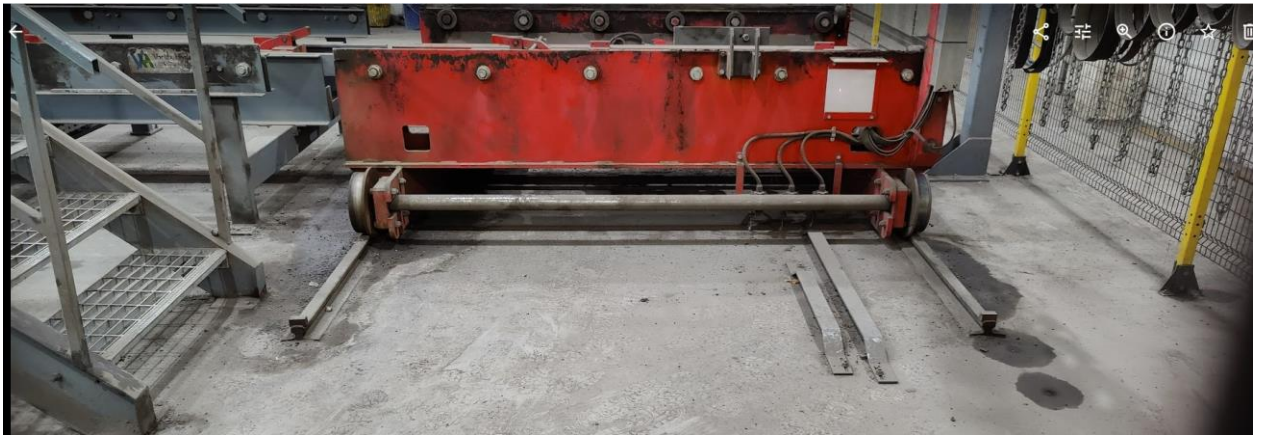
In my opinion, the fresh tile transfer has some shaft / bearing problems in some of the wheels, it makes a noise out of the ordinary compared to the cured tile transfer.

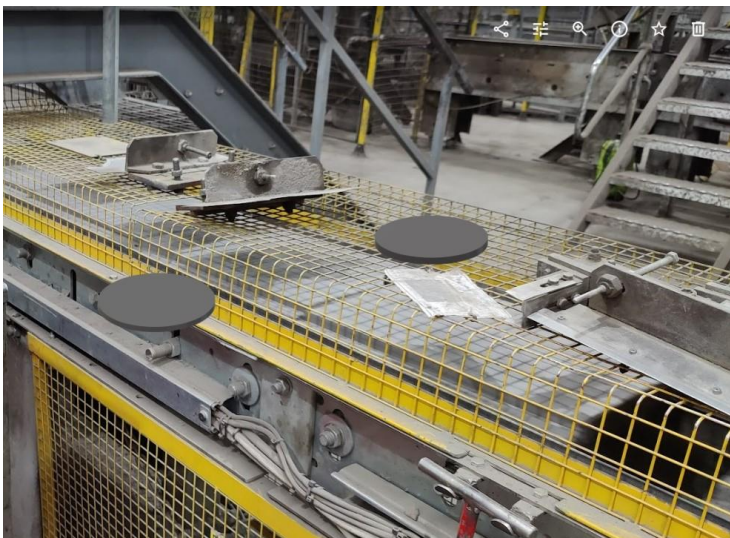
Regarding the adjustments of the depalletter machine for the 3 tile profiles, depending on the current pallet conveyor, the only thing I would consider is a study and evaluation of the accommodation of a pre-depalletter unit at the entrance of the current conveyor, with guides and adjustable for each model.

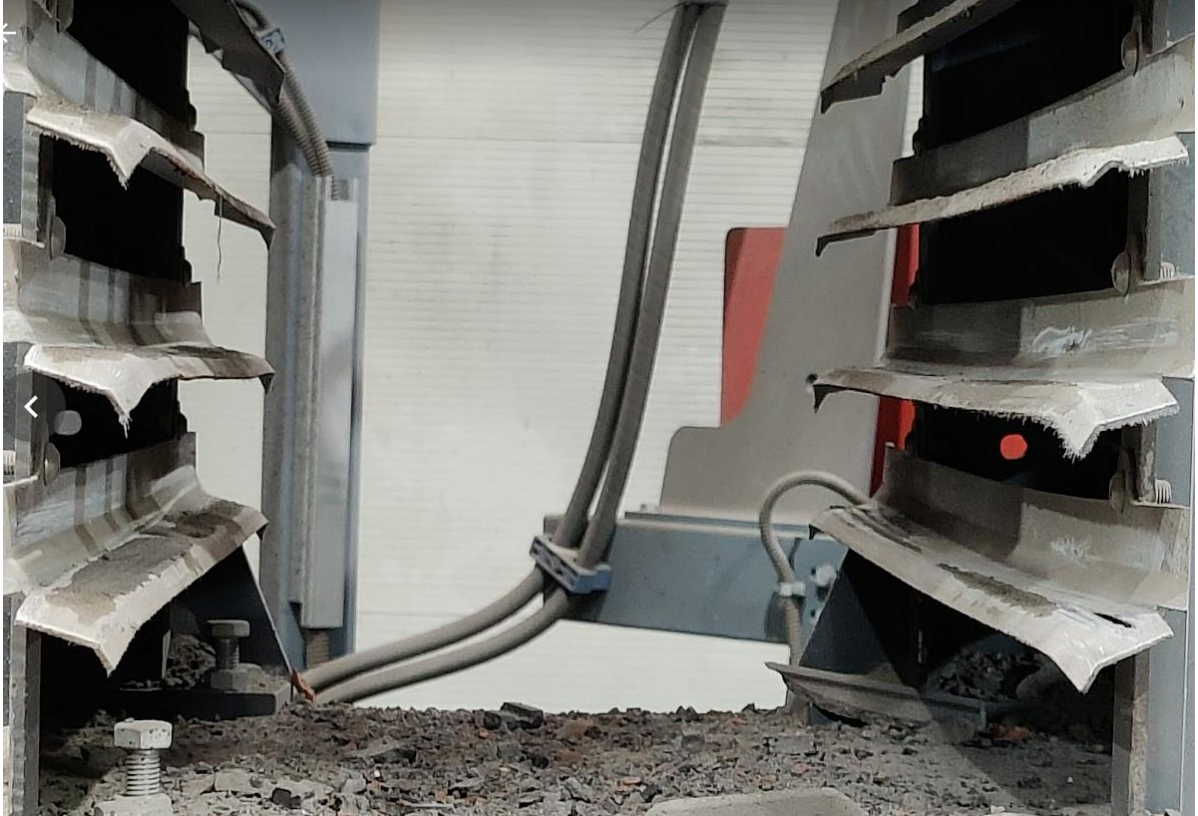
Heavy wear on all the guides, they need to be replaced.
