## **1. MODIFICATION OF THE FRONT ENCLOSURE IN THE LOADING/UNLOADING ZONE (RACKER AND DERACKER)**

## **2. AMBIENT HUMIDITY CONTROL SYSTEM FOR CURING**

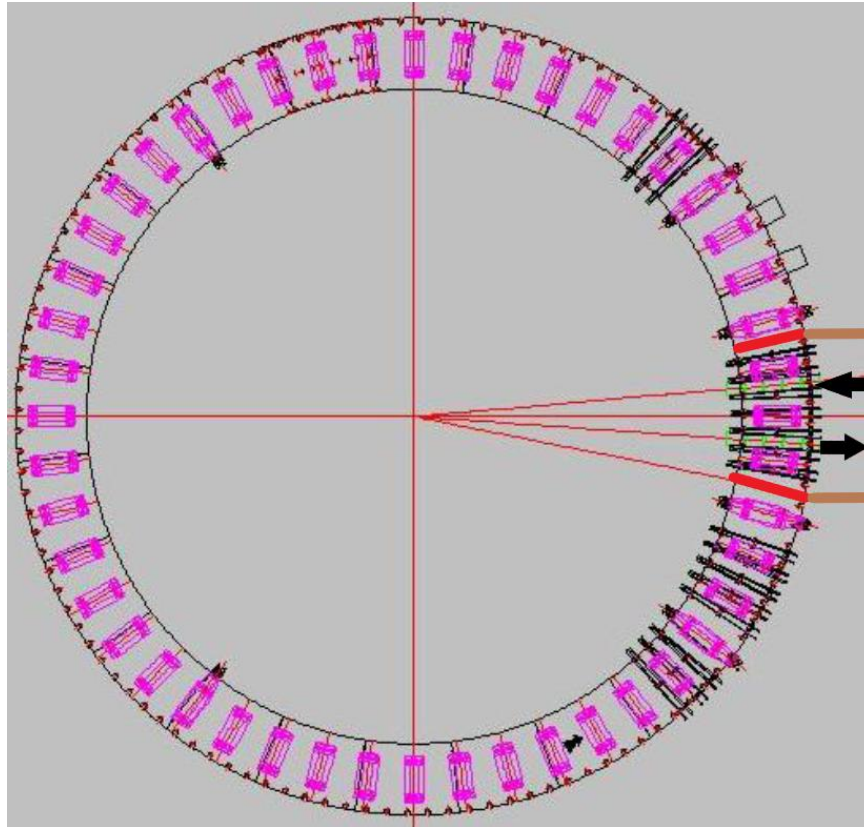
- The Racker and Deracker areas are located within the ROTARY's internal enclosure, sharing the same ambient air as the curing chamber.

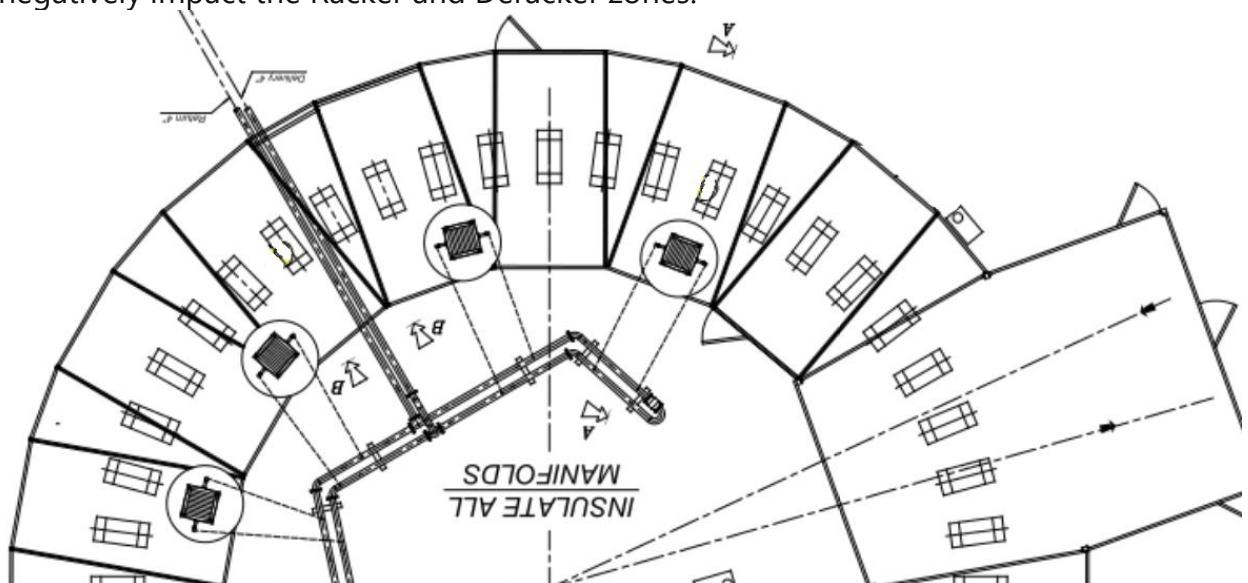
- As a result, temperature and humidity spikes during tile loading directly and negatively impact the Racker and Deracker zones.

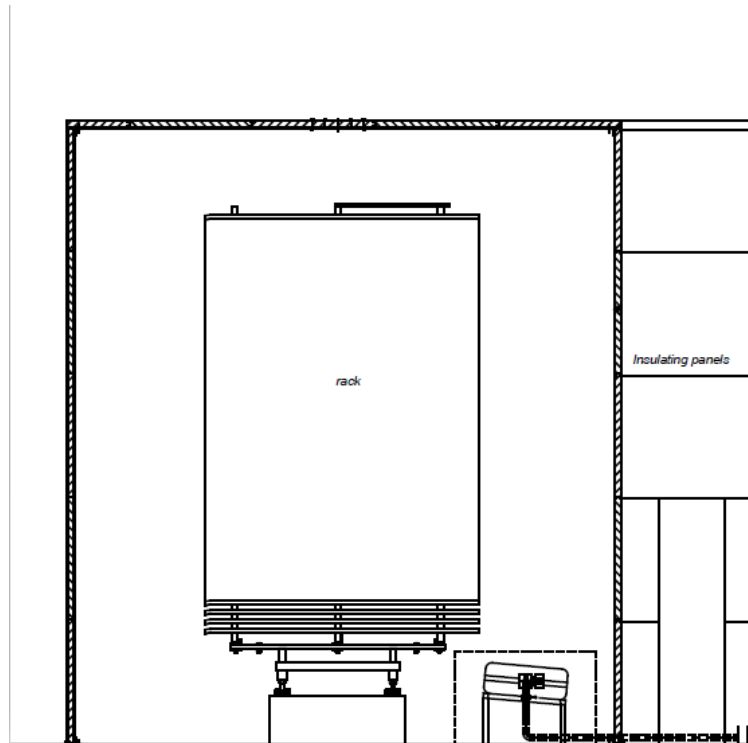
- The current setup allows visibility into the ROTARY's interior from the lateral access points of the Racker and Deracker.

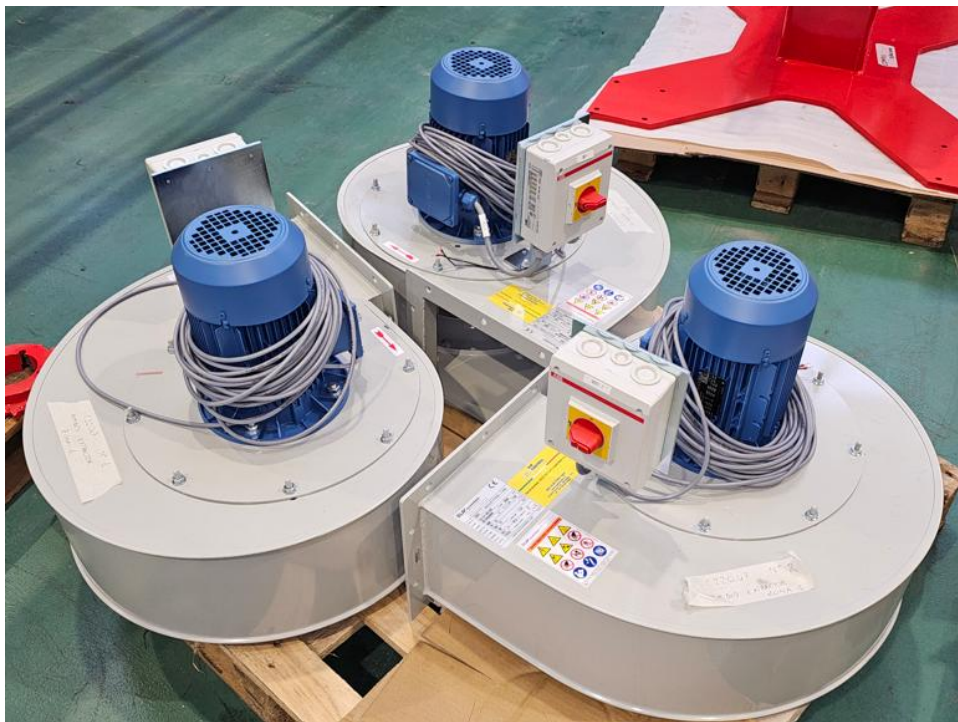
- 100% relative humidity inside the ROTARY.
- Condensation leading to water dripping from the ceiling onto the tiles.
- Tile surface damage and excessive moisture in the connection boxes.

A conventional system involving the placement of specialized fans at the top of the chamber.

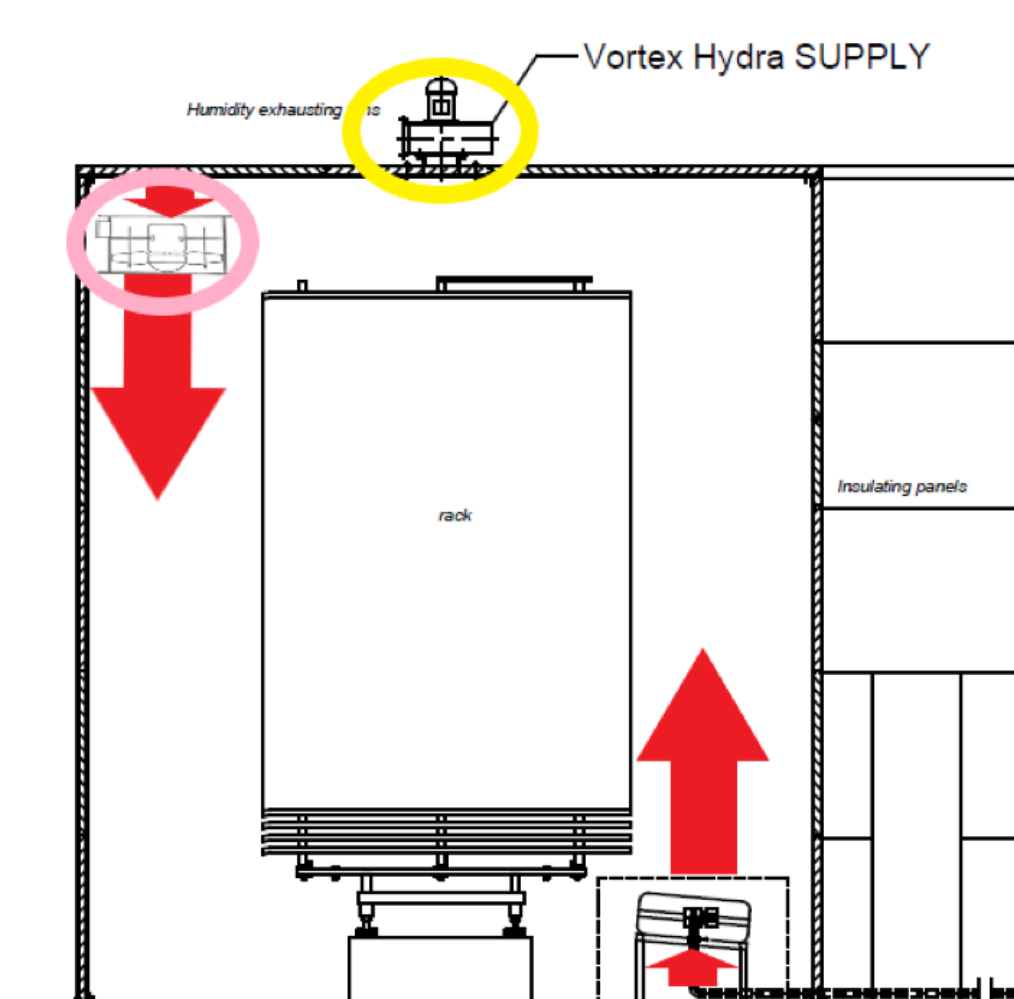
A temperature difference of approximately 15°C has been identified between the upper and lower zones of the ROTARY curing system. This variation causes significant discrepancies in tile finish, with higher gloss on the upper tiles and darker shades on the lower ones.

The proposed solution includes the installation of two recirculation fans strategically placed in front of the existing heat exchangers. This design will:

- Force the descent of accumulated hot air from the upper section.
- Ensure constant and uniform air circulation throughout the chamber.
- Maintain even thermal distribution during the curing process.
