## **AFRYSTAR / ASSESSMENT OF DOUBLE ROMAN TILE BREAKAGE**

**(291121)**

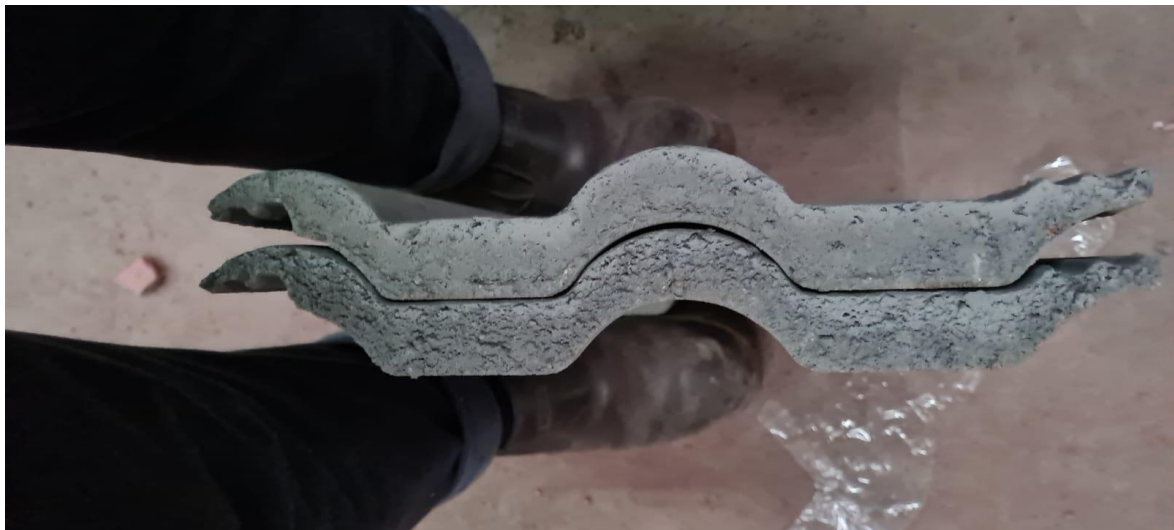
Although there is some breakage of the tile in the corners, according to the photos provided, most of them are longitudinal breaks in the centre of the tile.

As a reference I take the photo you sent me of the 2 roof tiles

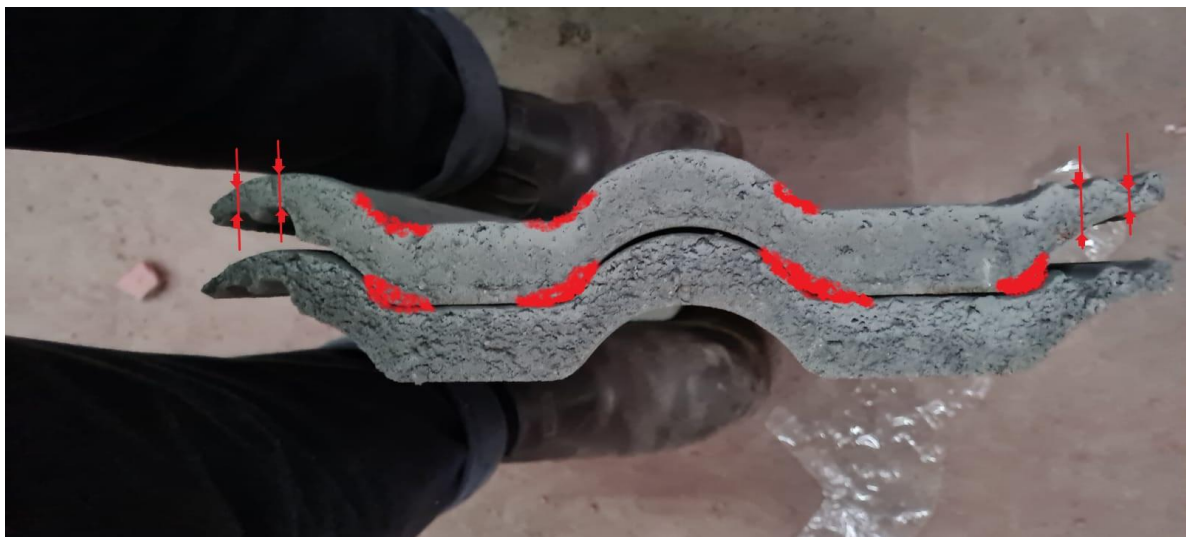
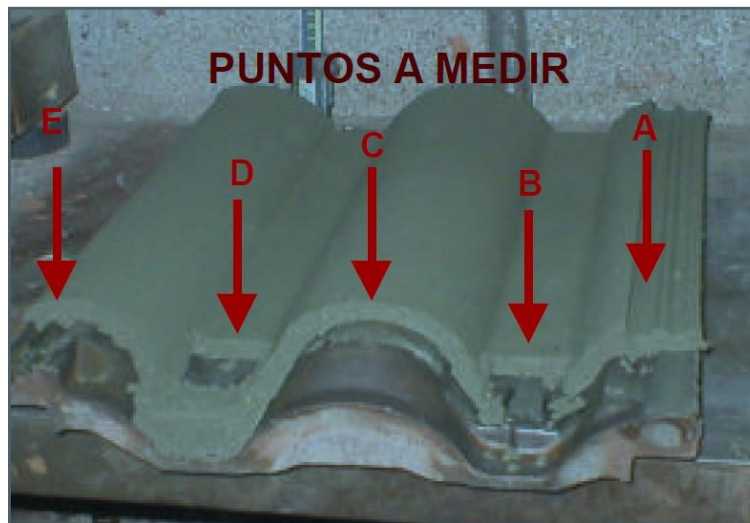
During the manufacturing of the concrete tiles, there is a wear of the Small Slipper, Small Rollers, Big Slippers and Big Rollers, which gradually change the upper profile of the tile, causing an increase in the thickness and weight of the concrete tile.

As is normal, there is first a rapid wear of the interlock with the Roller and the Small Slipper, and then in the body of the tile by the Big Slipper and Big Roller.

I believe that the measurements of the entire body of the tile must be very strictly controlled.

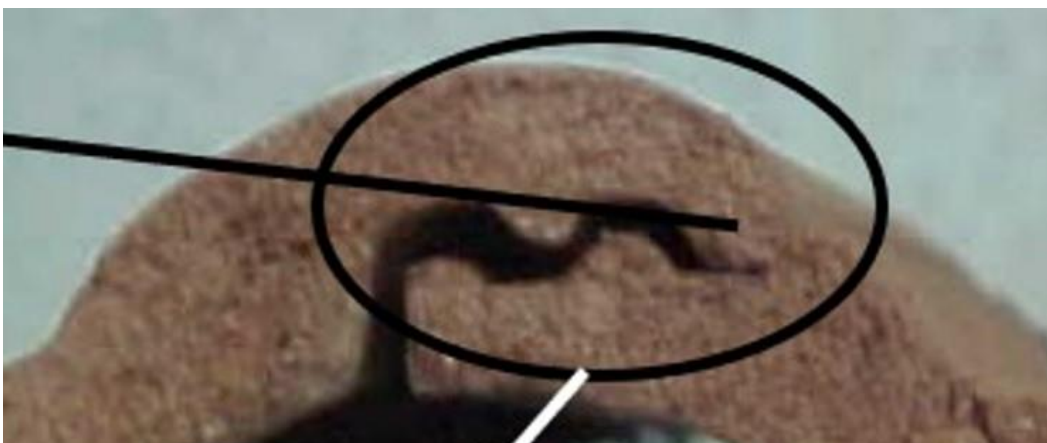
A) A) When the thicknesses of the interlock areas are greater than the permitted tolerance, we can have a problem of coupling between tiles.

Causing a bad coupling

Try to get a good coupling, and there should always be a certain amount of play in the interlock, such as when the Roller and Small Slipper are new.

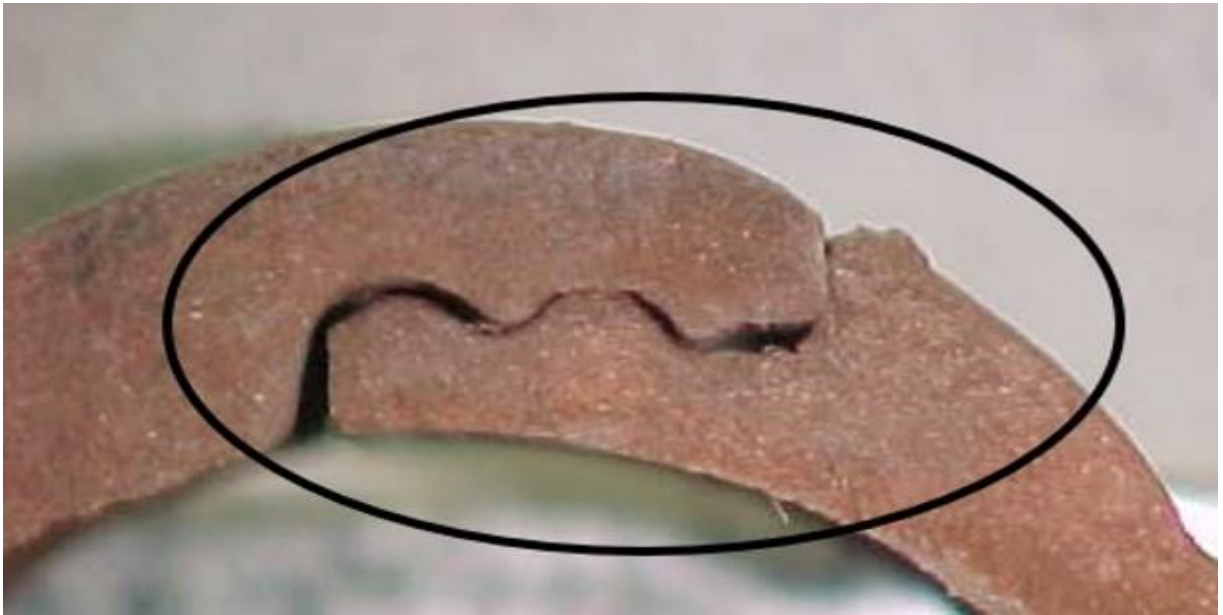
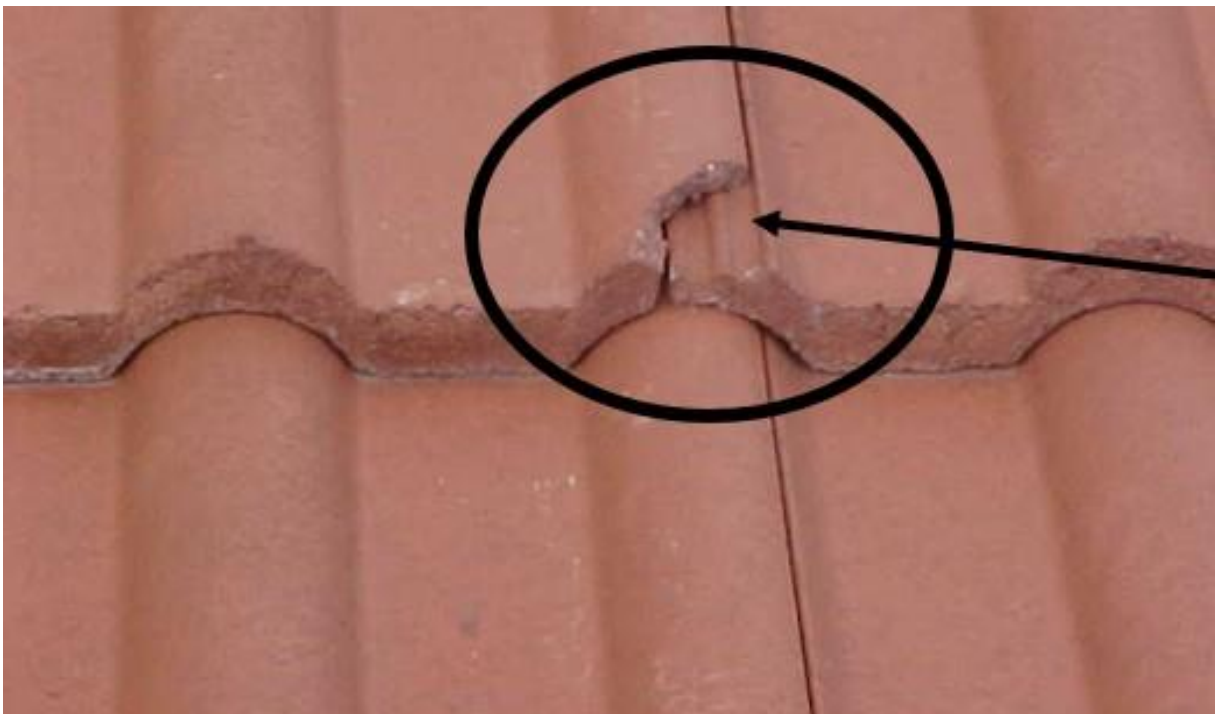
The problem with this bad coupling between the tiles, is that they can lift the tile on one side of the tile (the tile is suspended in the air), not being able to support the tile on the "4" Front / Rear ribs and with the transit of people on the roof tiles, when stepping on the tiles, the corners or the tile break longitudinally.

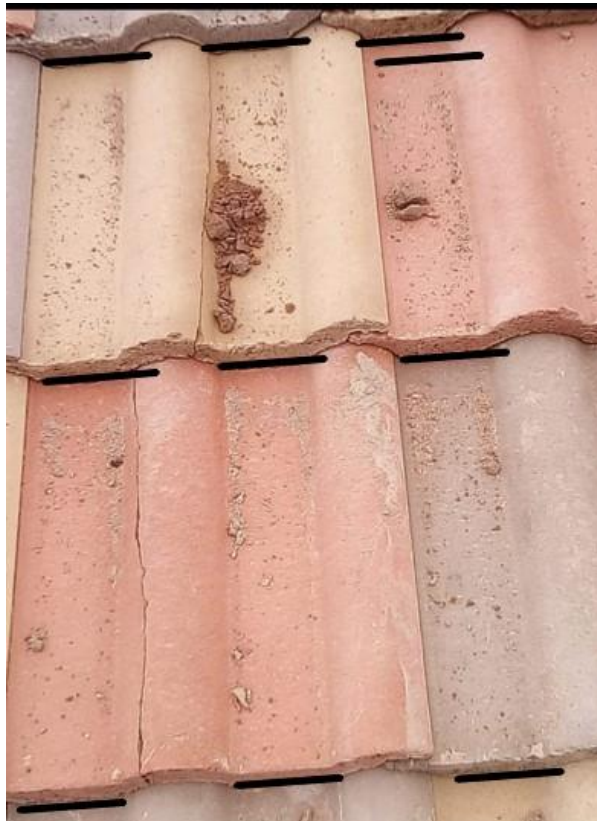
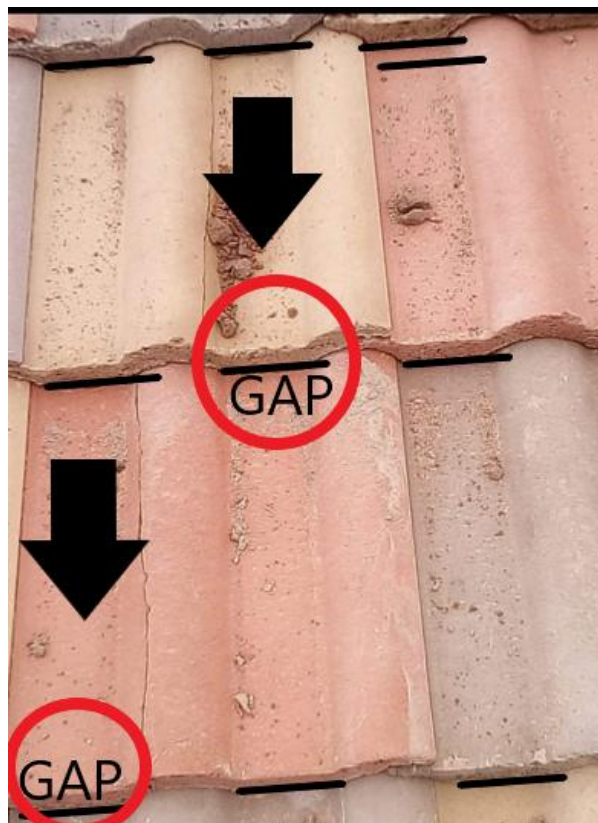
In the case of the photos of the roof tiles, I consider that the tiles mounted on the roof are not supporting the "4" Front / Rear ribs of the tile.

As there is an unsupported gap, the tile does not rest on the "4" Front / Rear ribs, and when the tile is stepped on, it breaks longitudinally.

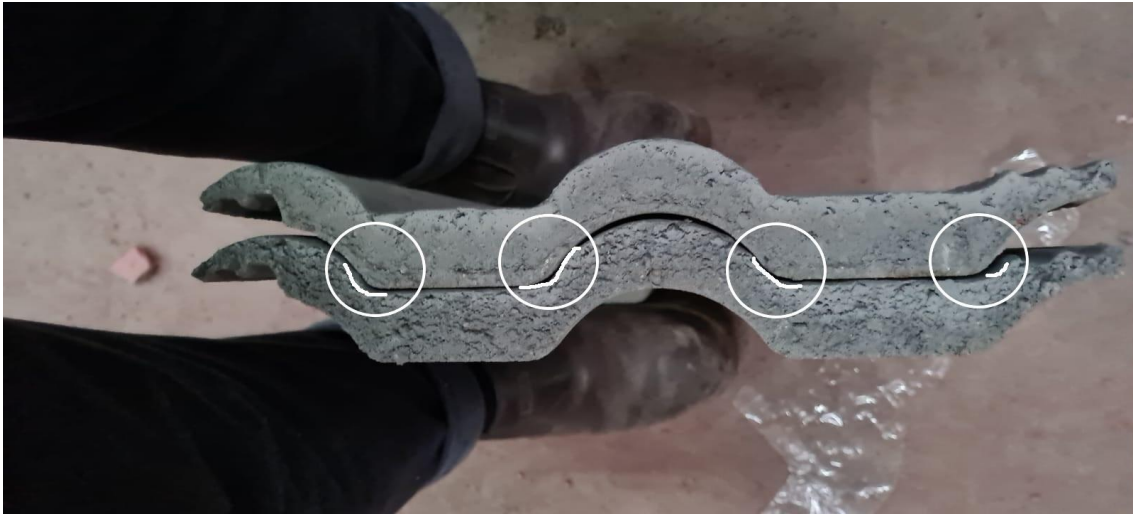
- B) The upper part of the roof tile can also suffer from excessive wear in the Big Slipper, such as curved areas, these areas can cause bad support between the roof tiles and cause longitudinal breakage.

In these curved areas there must always be sufficient clearance, so that there is always support for "4" Front / Rear ribs of the tile and does not allow one tile to swing over the other.
