### **CORNER TILES BREAKAGE ON THE ROOF:**

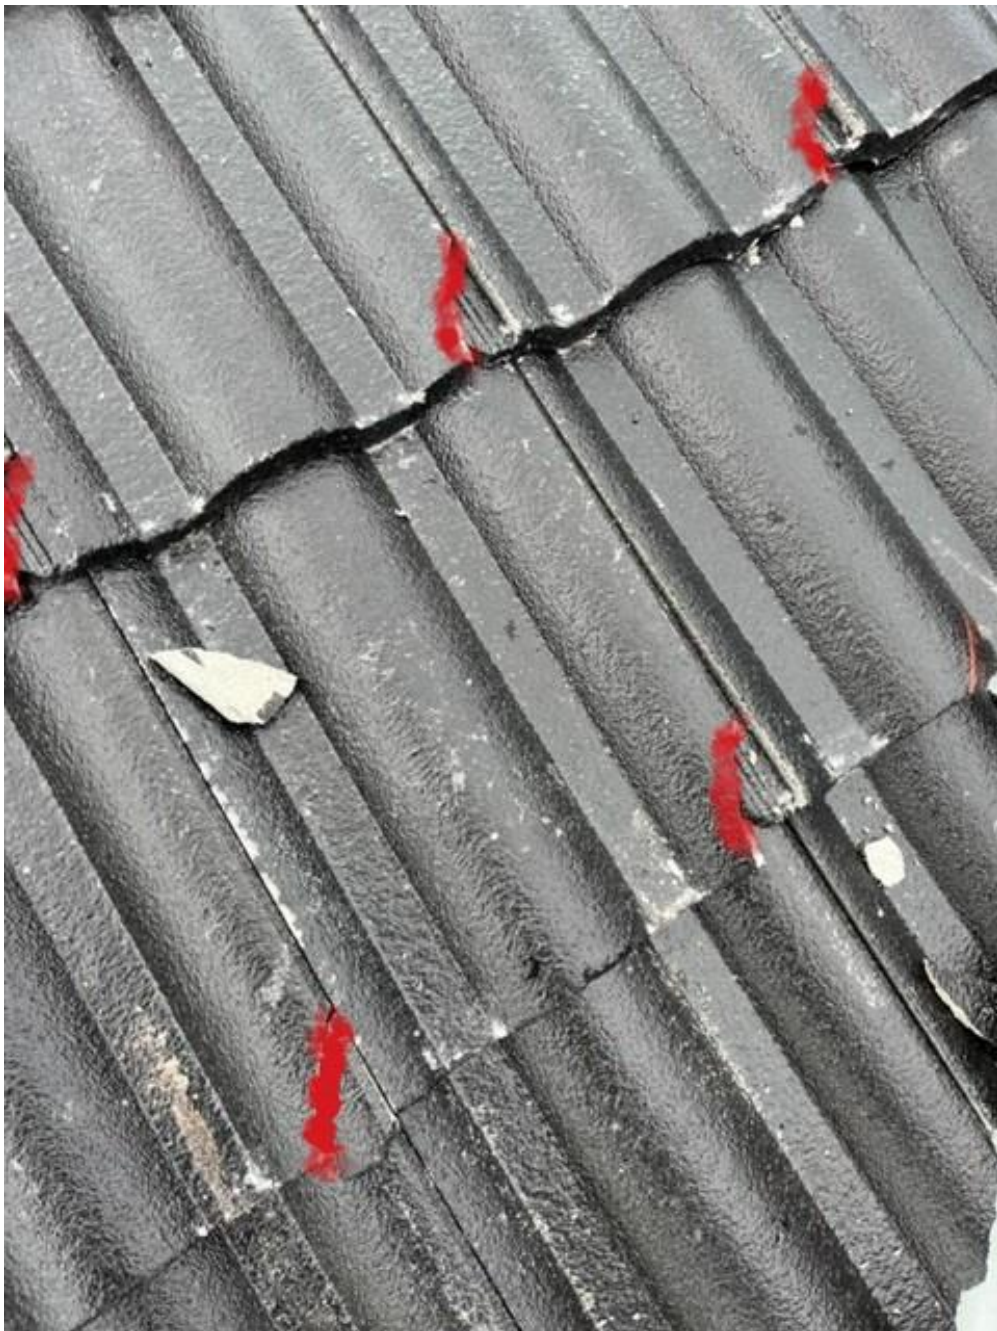
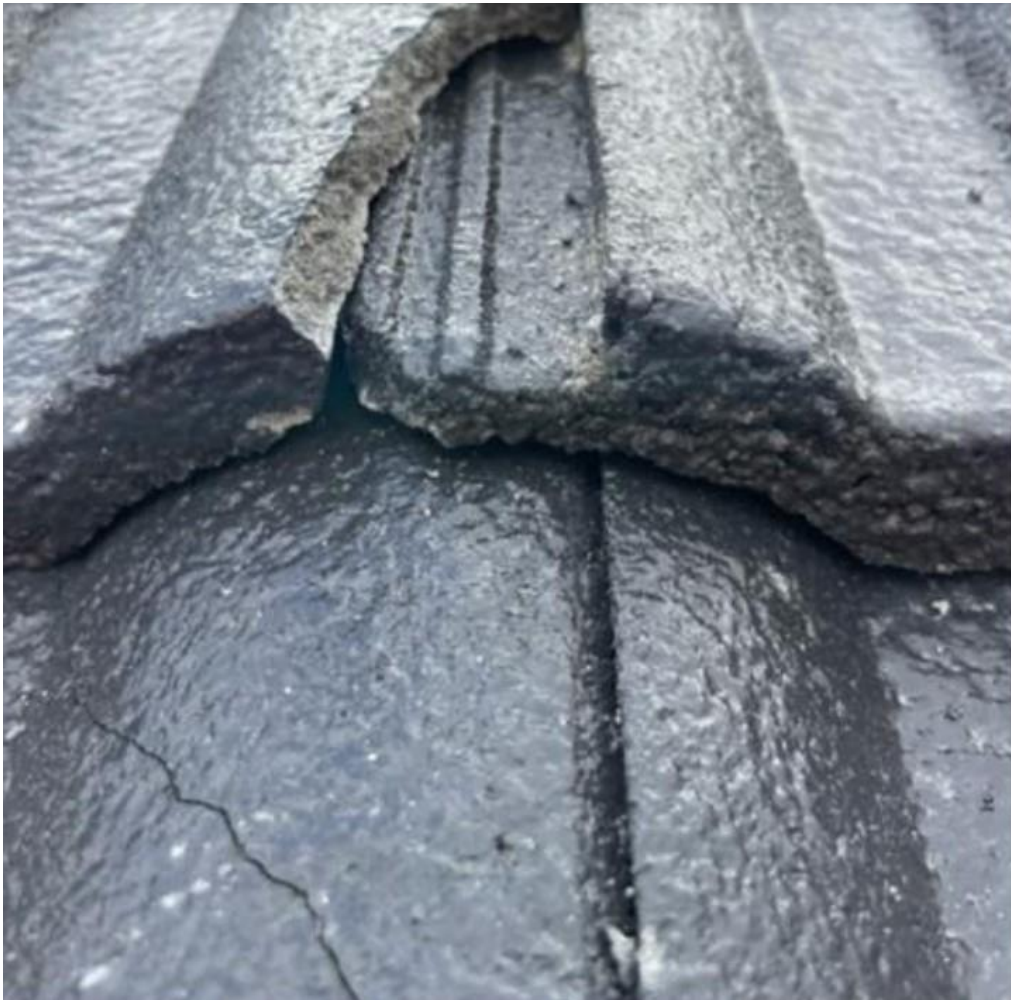
In the photos provided of the “corner breakage” tiles on the roof, it is not possible to identify how the tiles are supported by each other and how much slack they have in the assembly.

If you can identify **a very clearly defined break in the tile**, possibly the same length, always the same break line and in the form of an arch (these measurements would have to be checked).

Once checked the differences between the values given for the thicknesses of the manufactured tiles, it will be possible to make an initial assessment of possible causes of this breakage in the roof:

- a) If the tile breaks on the roof when walking, I consider that the tile does not support the effort downwards, when stepping on the tile in the centre with the support of the side (possible bad support in the area of assembly in the 2 tiles or lateral contact) and that facilitates making an **over lever effort that the tile cannot resist**, that area is too critical (fragile) before any value of resistance to bending of the standardised tile.

- b) If the tile breaks when it is placed on the roof, without additional external stress, it may be because there is already a crack in the tile that facilitates the breakage (when **fresh** by lifting that area of **the tile when cutting the tile** or in the **curing process** due to a shrinkage of the tile in the mould). There is less possibility of tile breakage due to **no good support** between tiles due to deformations in the aluminium moulds or **deformation in the profile** in the support area.
