## **COMMENTS ARAL KIREMIT (TURKEY) 240123.**

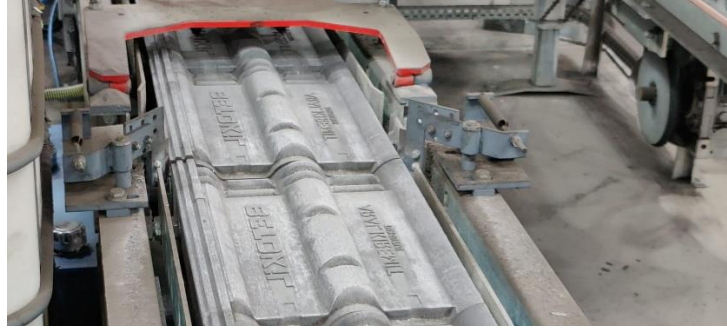
### **DIRT ON THE BOTH SIDES OF THE PALLETS:**

We continue with the lateral dirt of the PALLETS, I confirm that there are cleanings by the lateral scrapers in the conveyor of entrance to the extruder, it is not enough.

On these 2 scrapers it cleans more residues in the interlocking area than in the overlocking area, I suggest to clean the sides of the pallet at the extruder outlet

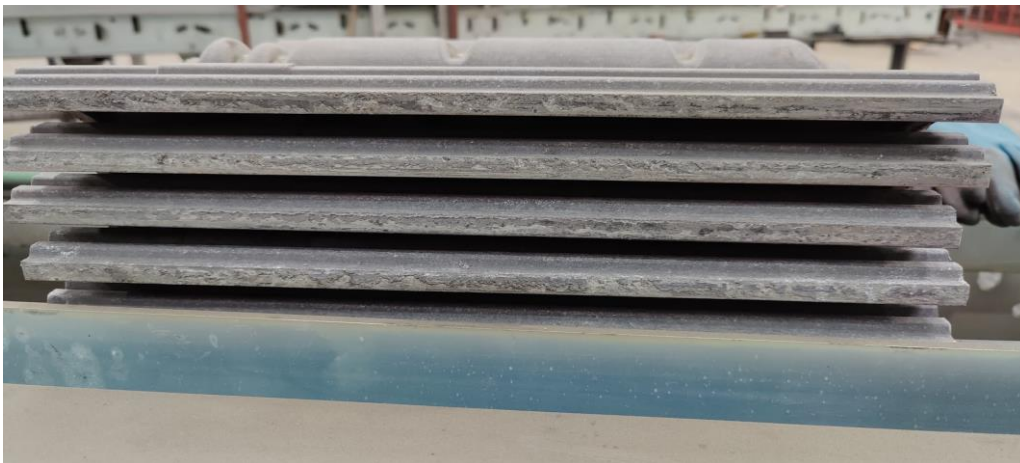
The lateral guide at the extruder outlet on the overlocking side was replaced because it was broken, in this position in my opinion, although insufficient, it is cleaning the side of the mould with its friction.

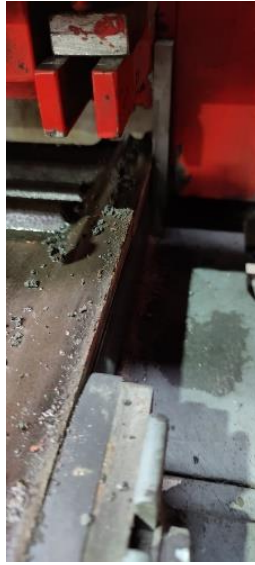
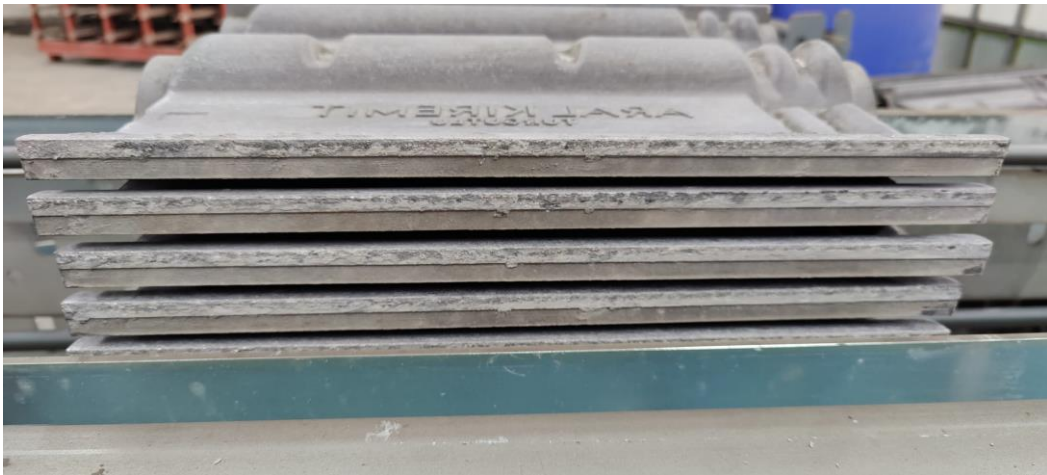
On the other hand, the other guide in interlocking I think that the level of dirt is the same or worse because of the entrance of the guide.

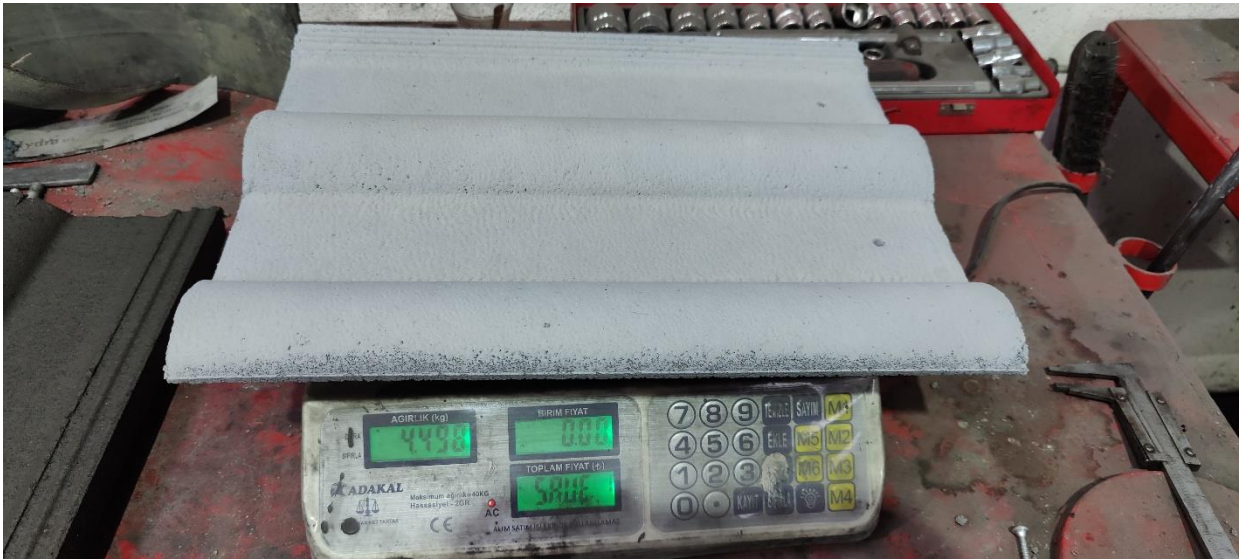
The heights of the Big Roller and the inclination of the pads have been checked again with Ibrahim's brother, and after 70,000 tiles have lost (-0.1 to -0.2 mm).

We consider that the pallet has a weight difference of **2,420 g / 2,368 gr**, and that the loss in curing can vary from **150 gr / 200 gr**. ( untested)

Therefore, the dry weight of the tile can vary from **4.5 kg to 4.4 kg**, provided that the conditions of the sand mixtures and the humidity of the mixture are maintained.

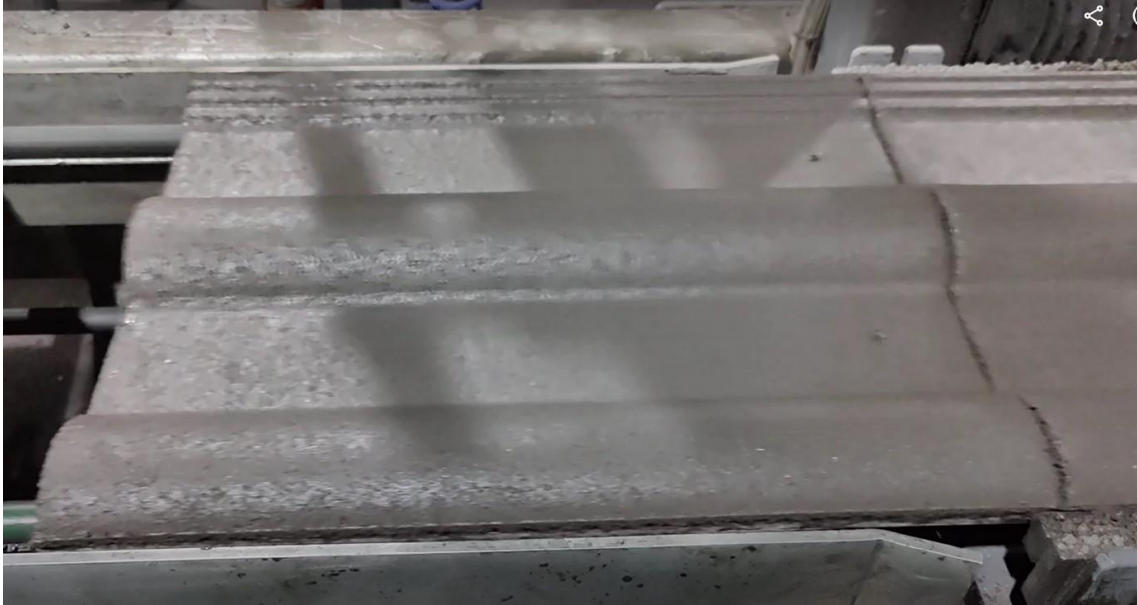
On the subject of the cutting of the tiles, once the mixture of sands was changed and the water in the mixture was increased, it improved and stabilised, what I don't know is the real proportions, the data I have are **900 kg** of sand, **295 kg** of cement and **6 kg** of pigment.

The production on the 17th, 18th and 19th of January was very stable, with the consumption of the pallet advancement and the roller remaining stable, with **16.5 A / 16.2 A** on the pallet advancement and **11.3 A / 11.4 A** on the roller.

On the 16th of January until the adjustment of the sand or sand and water mixtures the consumption was **29 A / 23 A** at the pallet advancement and **25 A / 17 A** at the roller.

On the 19th of January when I left, the production at 20:00 was 19.910 tiles and the consumption was **16,5 A** for the pallet advancement and **11,5 A** for the roller.

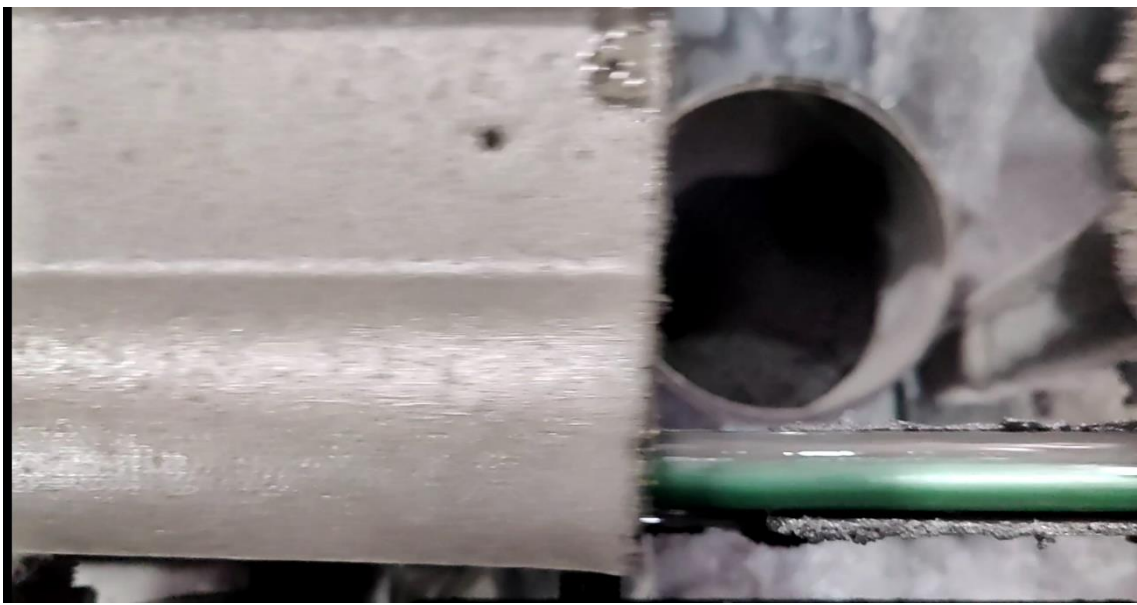
#### **DISPLACEMENT OF THE TILE MOULD AT THE OUTLET OF THE FIXED BED AT THE OUTLET CONVEYOR.**

In addition to a possible height adjustment of the polycord, the polycord on the overlocking side is impregnated with water and paint which is transferred to it by the polycord of the paint conveyor, which means that it has no traction on this polycord.

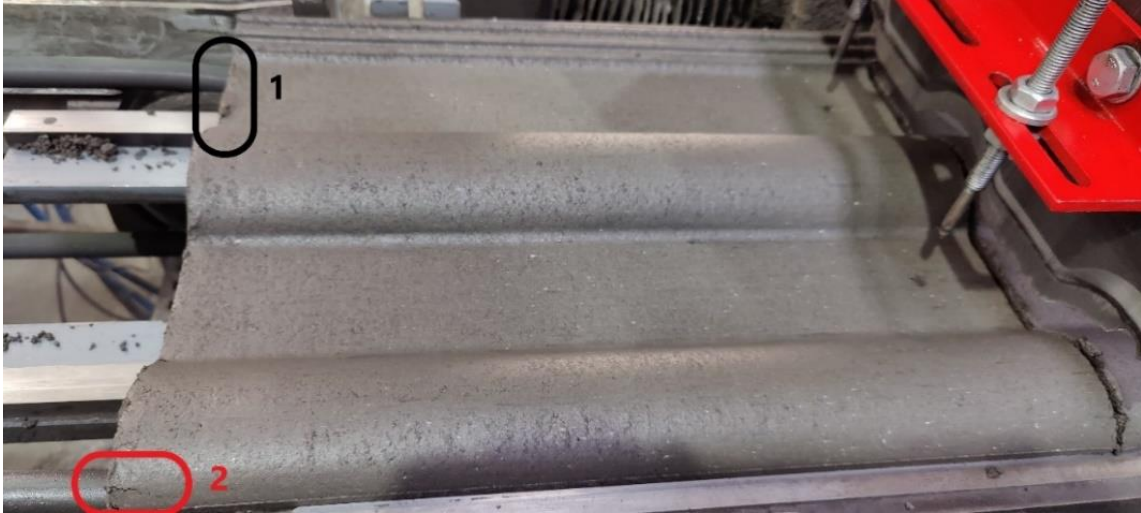
This issue has improved, for the 2 reasons I mentioned yesterday, the mixture with more fine sand and more water in the mix:

- 1) Lifting of the central part and the rest of the tile.
- 2) Deterioration of the peak of the overlocking in the cut.

- 1) Lifting of the central part and the rest of the tile.

There is hardly any lifting of the front part of the tile, as the penetration of the blade is softer. I still don't know when the cutting blades will arrive.

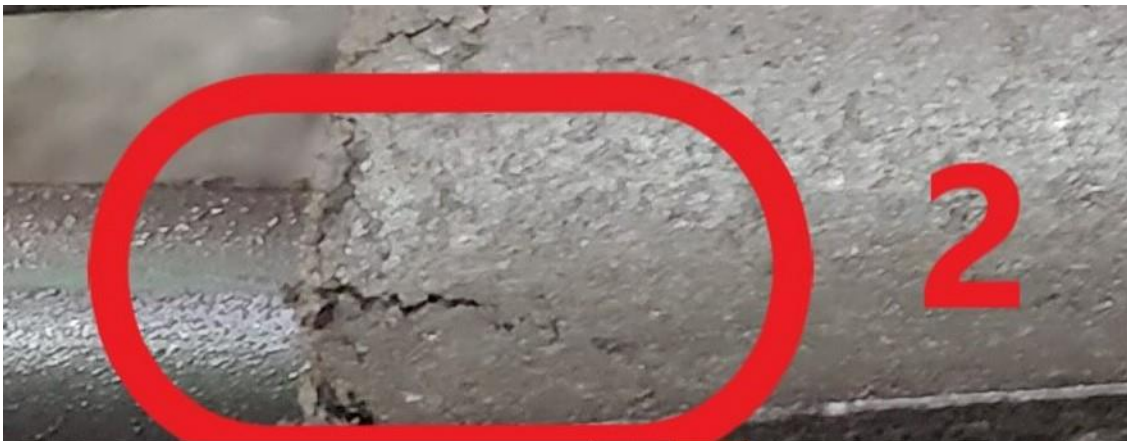
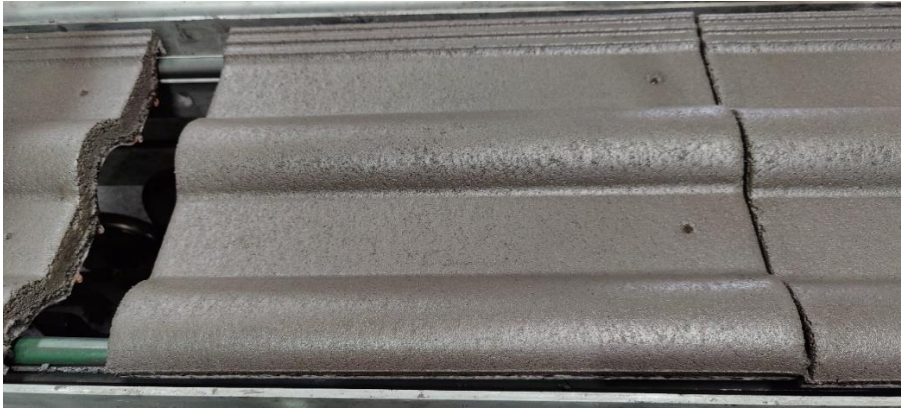
- 2) Deterioration of the overlocking peak in the cut.

It has also improved partly because of the previous section and also because the blade no longer cuts the final area of the overlocking tile, separating this final part when the pallets are separated.

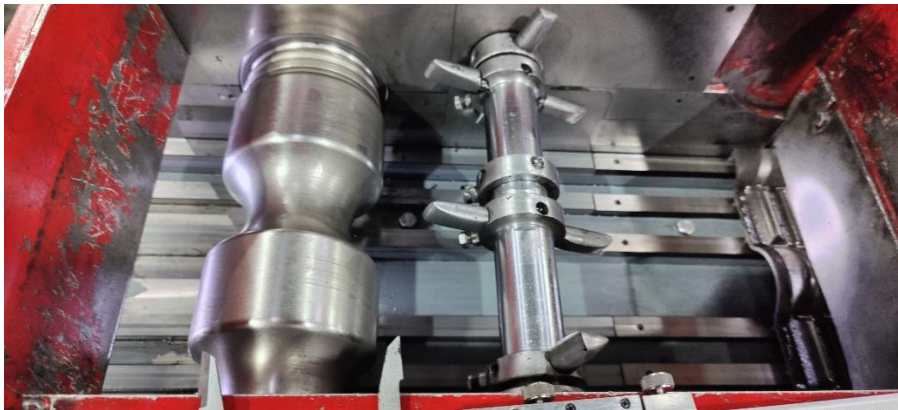
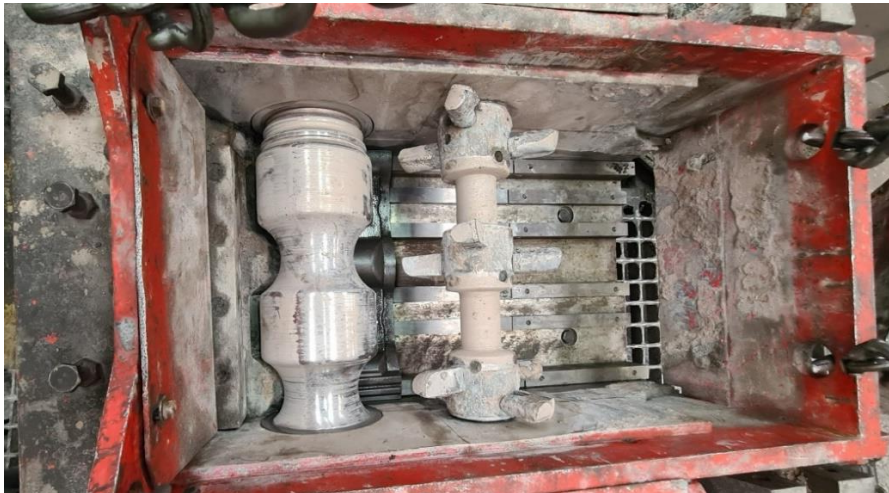
### INTERLOCKING STIRRERS

Follow the weld of the stirrers well
