# ACKERSTEIN 09/02/22

Due to the breakage of **SEA WAVE** tiles on the roofs, a video call was made on the 9th of February in which a request was made to ACKERSTEIN to check the thickness of the tiles and to send 12 tiles to Spain and Italy.

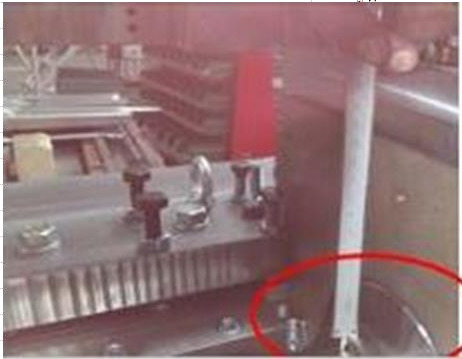
| SETTING OF SLIPPER WITH THE SLIPPER AND GAP WITH SMALL ROLLER | | |
|---|---|---|
| <p>HEIGHT BETWEEN THE ROLLER AND THE SMALL ROLLER.</p> | | <p>7) Another way to start the setting is to measure the height between the roller and the small roller.<br/><b>(See image Red circle).</b><br/>This can be the measure to start the setting of the small slipper height compared to the slipper.</p> <p>8) In any case, verify if the profile of the extruded roof tile is correct or not, and operate consequently</p> |

Diameter Small Roller 119 - Diameter Big Roller 107,65 mm = 11,35 : 2 = 5,7 mm

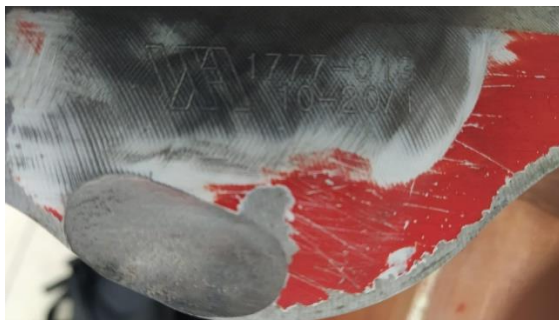
| DENOMINAZIONE | CONTROSAGOMA SEA WAVE 05 | CODICE | 1777-013 |

The steel slipper corresponds to the drawing **1777-013.**

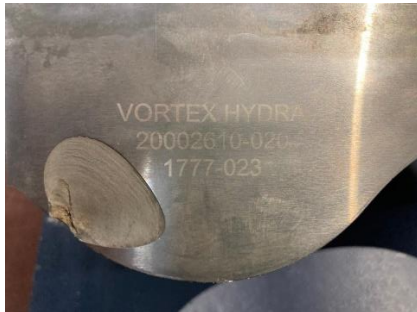
| DENOMINAZIONE | CONTROSAGOMA SEA WAVE 05<br>WIDIA | CODICE | 1777-023 |

The widia/tungsten slipper corresponds to the drawing **1777-023**.

These are the same dimensions “as the steel slipper”.

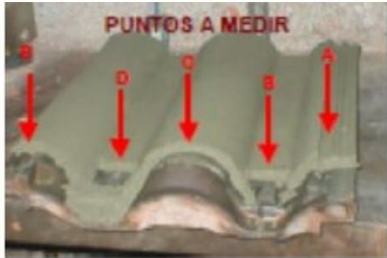
| Prepare the wet tile to measure its thickness according to the image. | | Tools used:<br>-Probe – Digital “caliper”<br>-6 x 20 x 200 mm calibrated bar.<br>-10 mm cylindrical bar 200 mm<br>-Spatula |

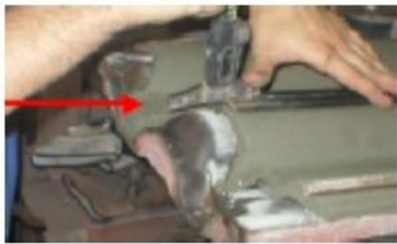
| In order to measure points B, C, D and E we shall use a calibrated bar in order not to deform or vary its measurement. Once measured, we shall deduct the 6mm of the bar. | | Take into account the perfect alignment of the caliper with the calibrated bar and its perpendicularity to the mould. |

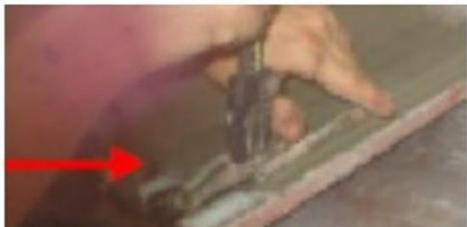
| In order to measure “A” we shall use a cylindrical bar so as not to deform the concrete or vary its measurement. Once measured, we shall deduct the 10 mm | | Take into account the perfect alignment of the caliper with the cylindrical bar and its perpendicularity to the mould. |

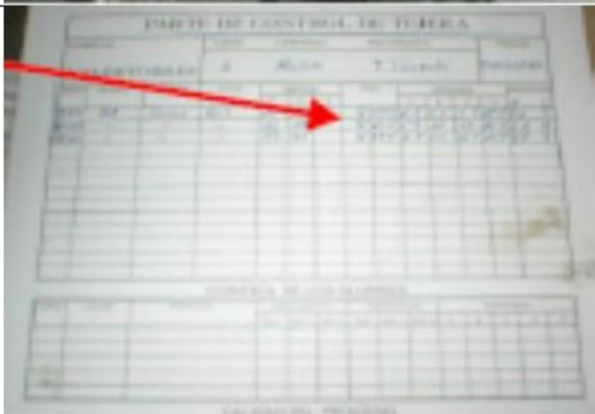
| Note the results in the extruder control sheet | |

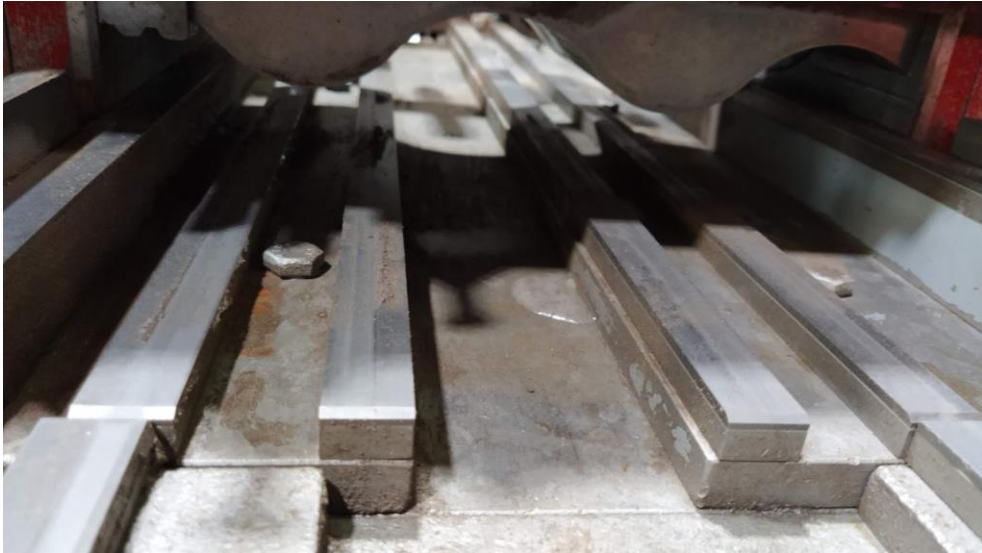
During extruder box set-up, I have identified that for better settings of rollers and slipper a metal bar should be used between the two guides of the bench.

I suggested the use of a metal bar (300 x 100 x 5 mm) to make all the adjustments the extruder needs.

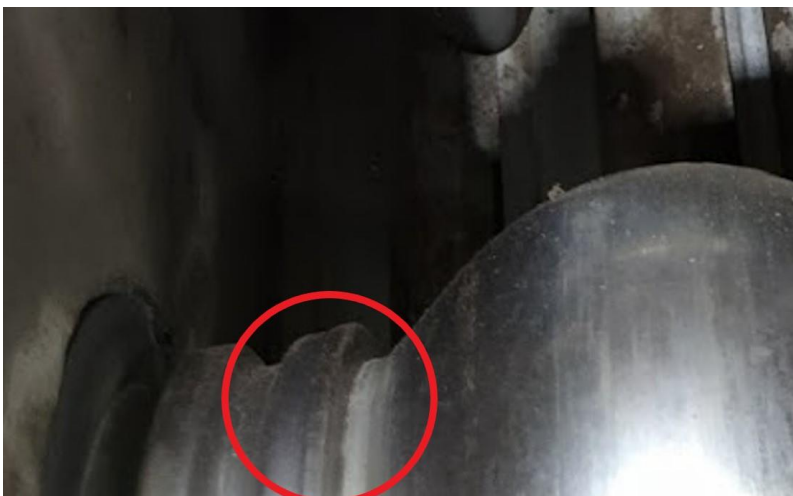
The small roller has excessive wear on the large roller side.

The big roller already has a wear in its diameters of 2 mm and the small roller already has a deformation in the plane between the two rollers.

I suggest a daily CONTROL of the extruder situation (ROLLERS,SLIPPERS, STIRRERS, LIMITERS) that is necessary to improve the tile forming process.

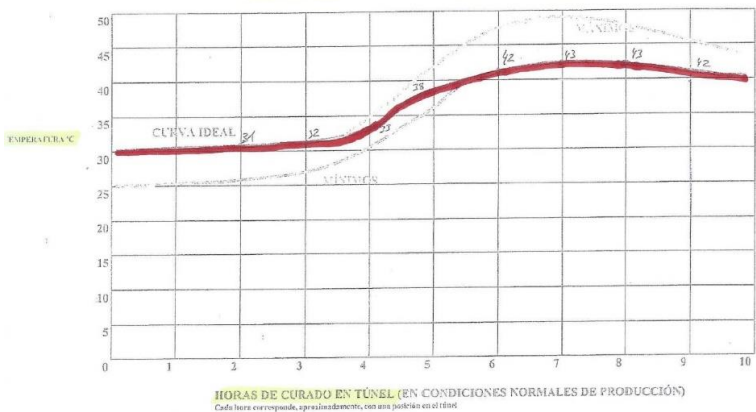
Meeting with Charlie and Adam about the curing chambers, the cycle that is used in Spain and the possibilities for changes that can be made to the current curing chambers.

For the Chamber Curing Process, I suggest :

- a) Placing a system of pipes and extractors on the roof of the chamber to extract excess humidity above 98 %.
- b) Install hot air pipes with diffusers in the lower parts of the chambers to cause an envelope in all the tile racks, so that they try to equalise the chamber temperature at all heights, thereby ensuring better curing.
