AIRCRAFT INSPECTION REPORT

Mission Type
Audit

Aircraft Type: Boeing 737-8

MSN: 42825

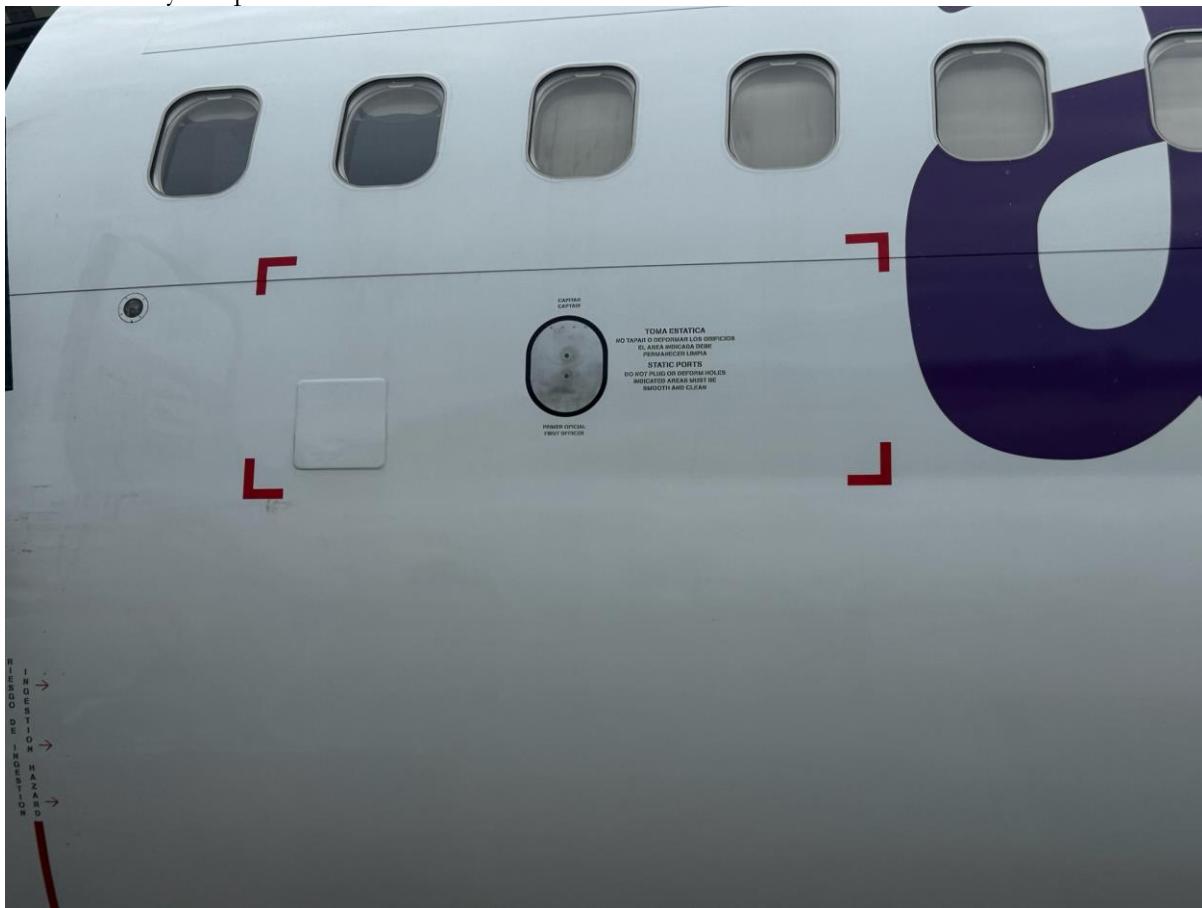
- A **doubler repair** is installed forward of the LH fuselage static port within the RVSM area boundaries. This repair is supported with OEM messages and recorded by the provided Dent & Buckle Chart.

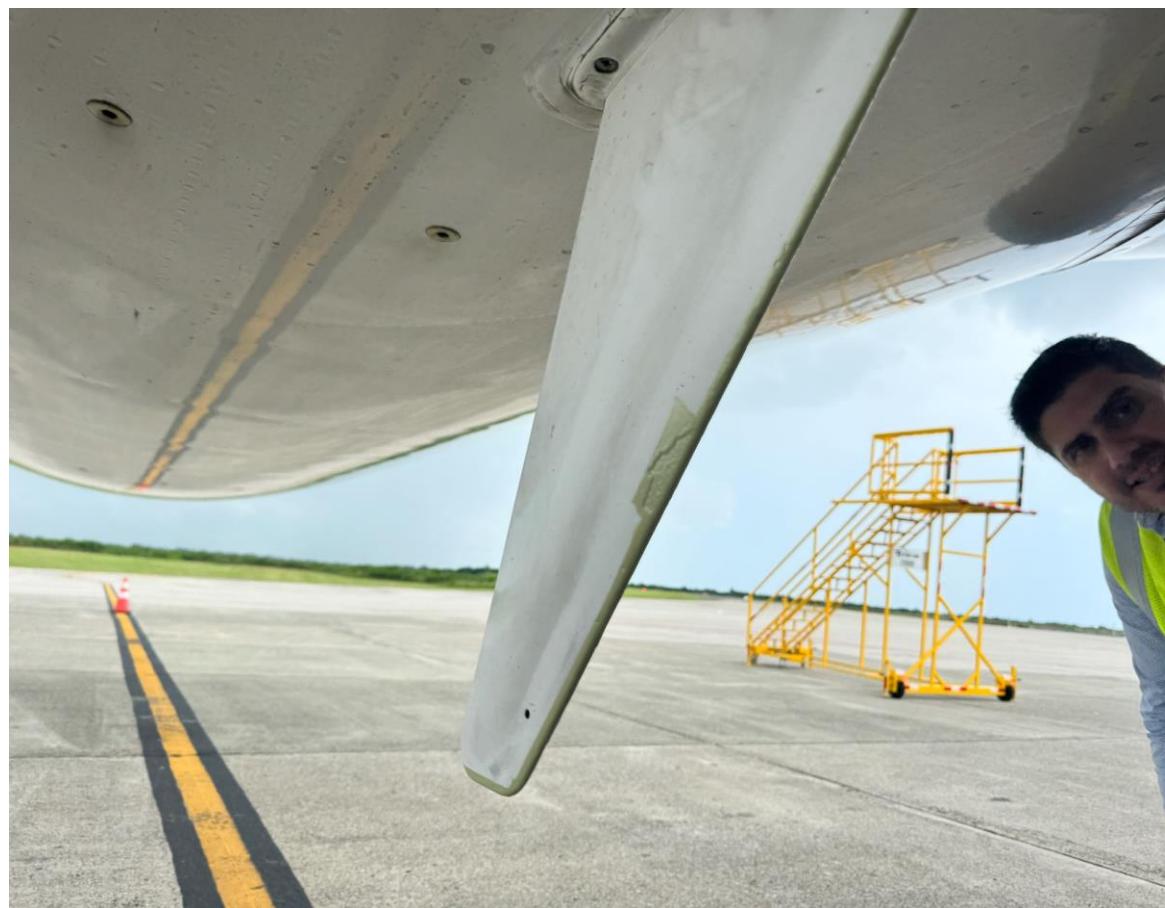
- Erosion on the leading edges of all antennas.
 - VHF antennas show erosion previously **repaired on-wing** with a primer-like coating. For this corrective work have been provided to date.

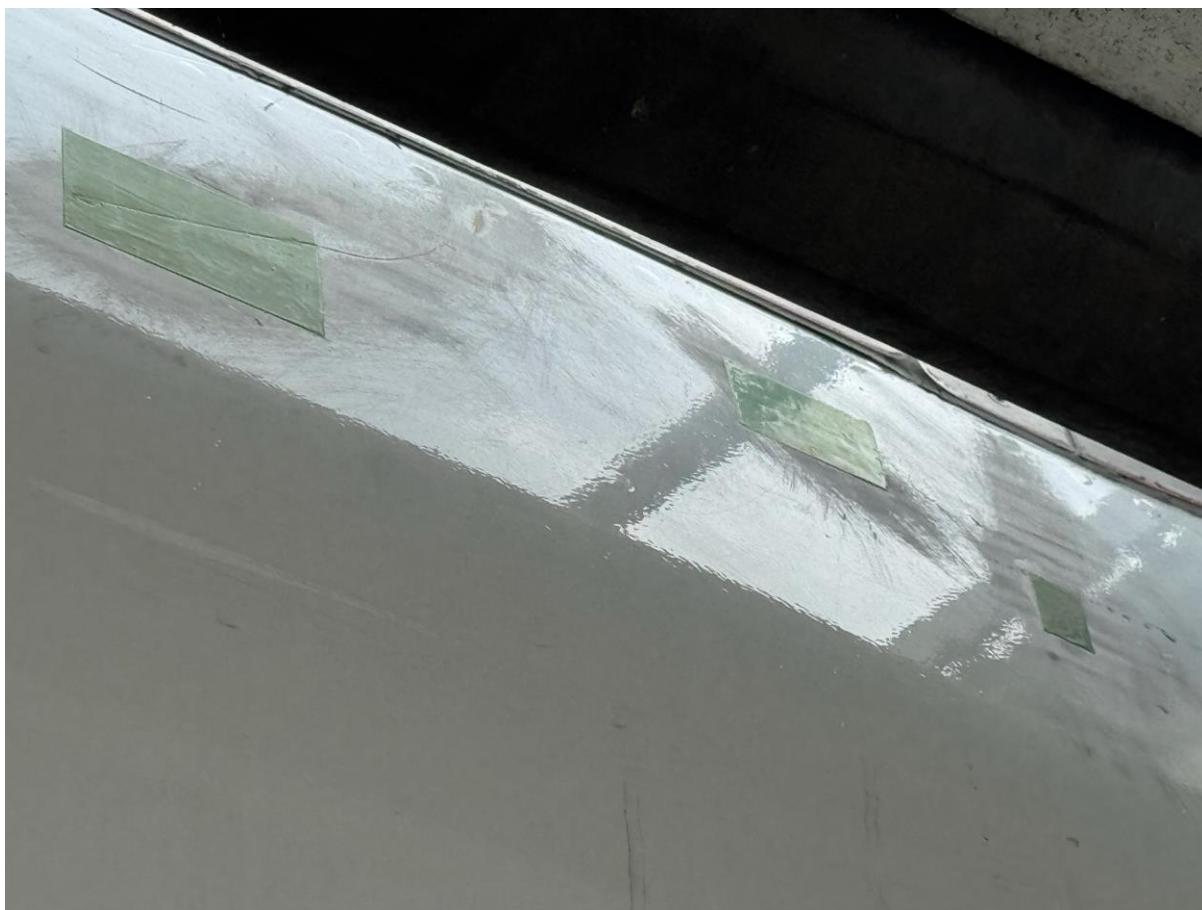
- General paint condition is satisfactory overall, though several areas exhibit **patchy or low-quality touch-ups**. Multiple sections around the **L1 door** were found **stripped and only primed**, with final topcoat not yet applied.

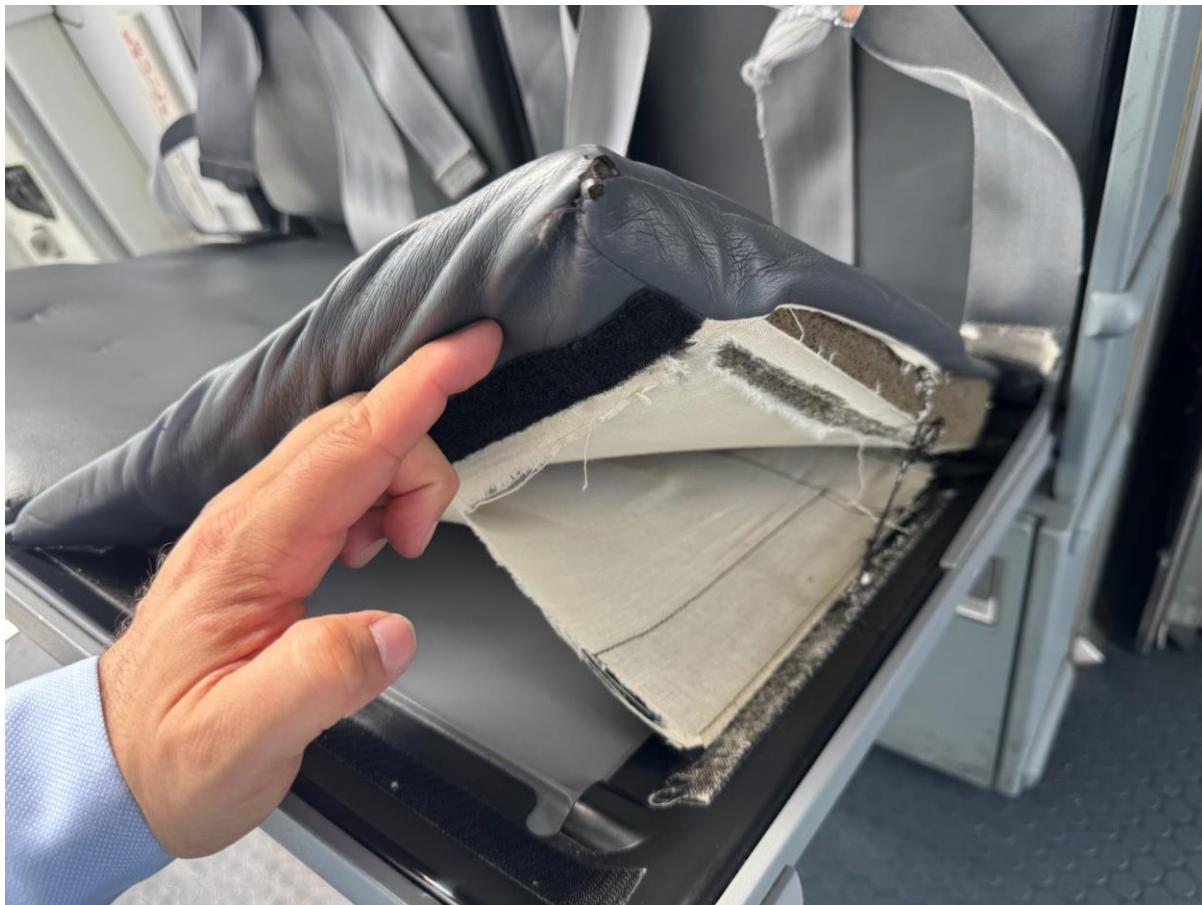
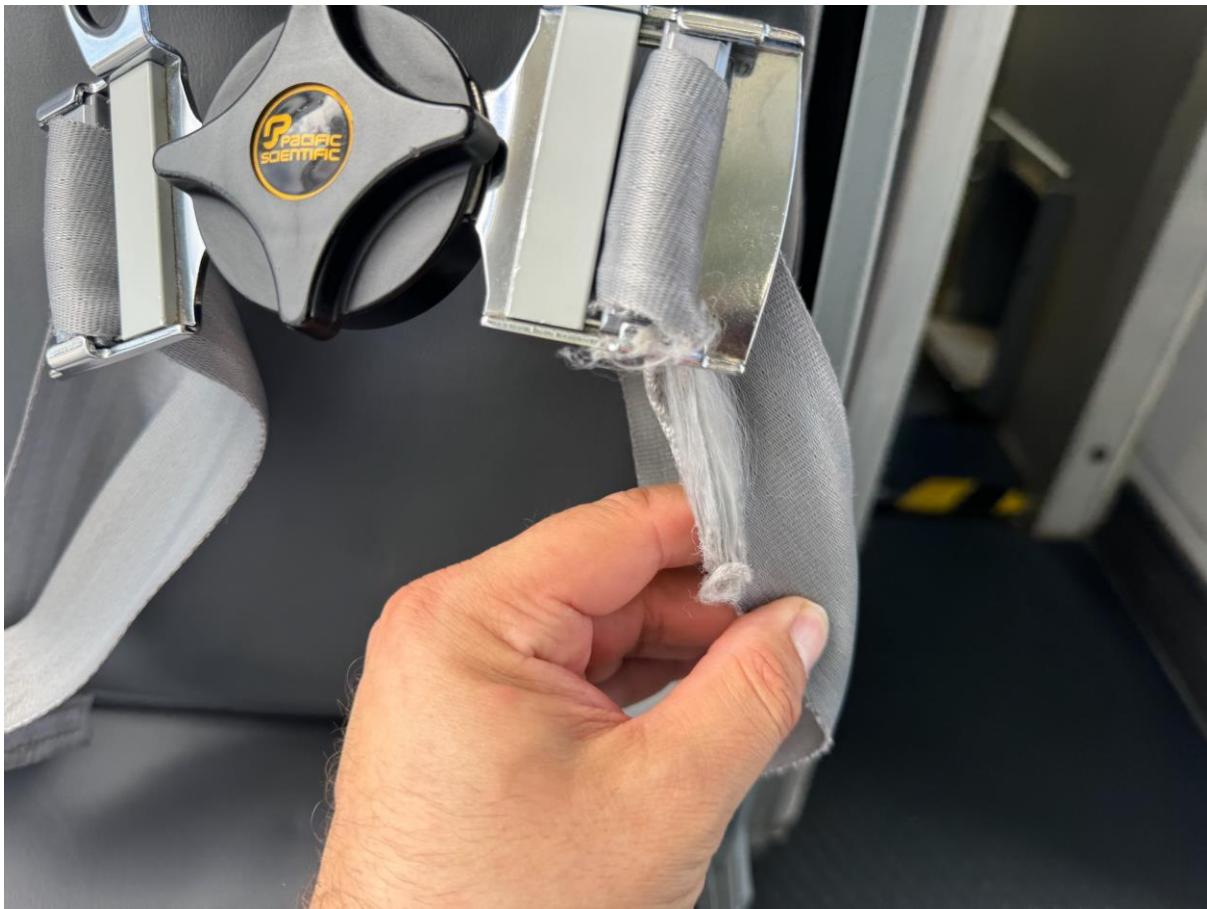
- **Cabin Interior**
 - Several life vest containers under passenger seats were torn, though no life vests were missing.

- **Flight attendant seat covers, cushions, and seatbelts** were found in **average and poor general condition** in certain stations, indicating the need for refurbishment.

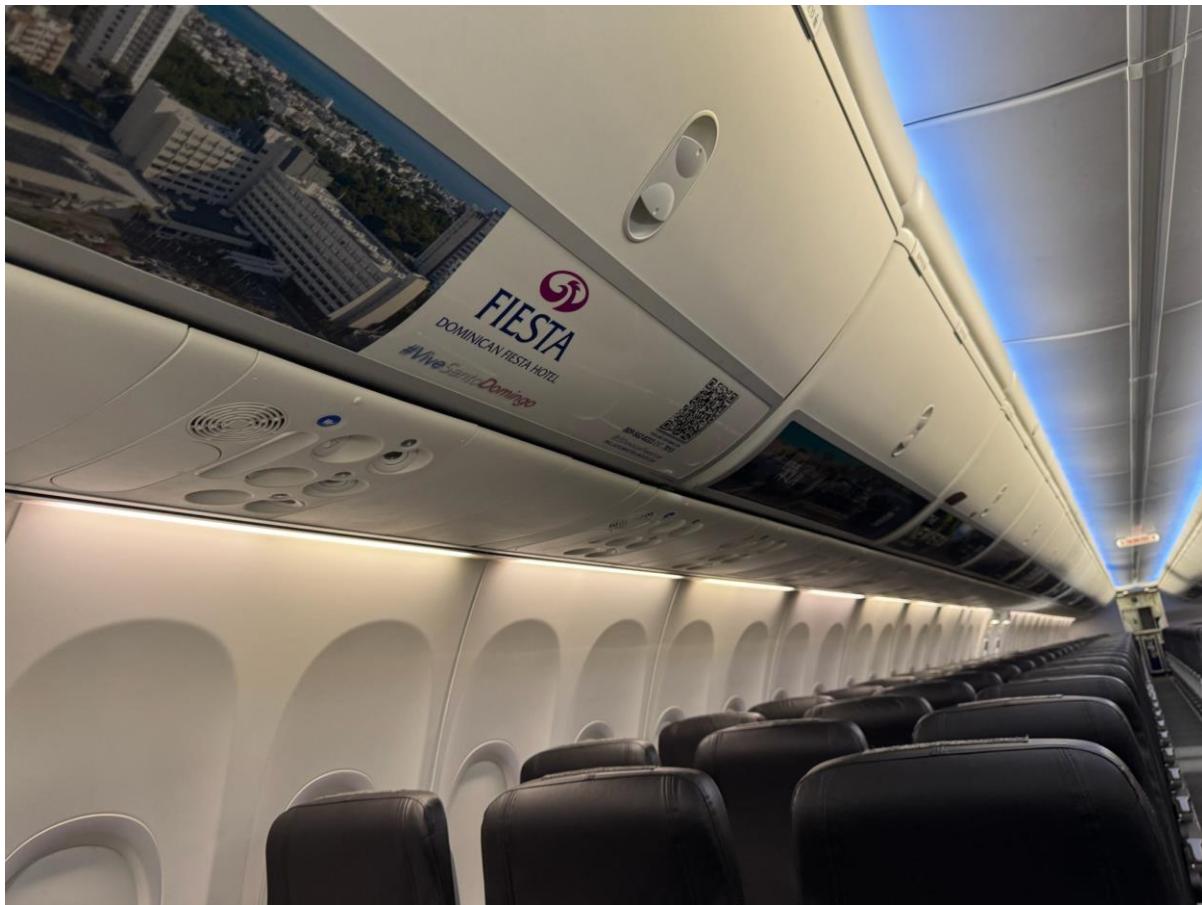
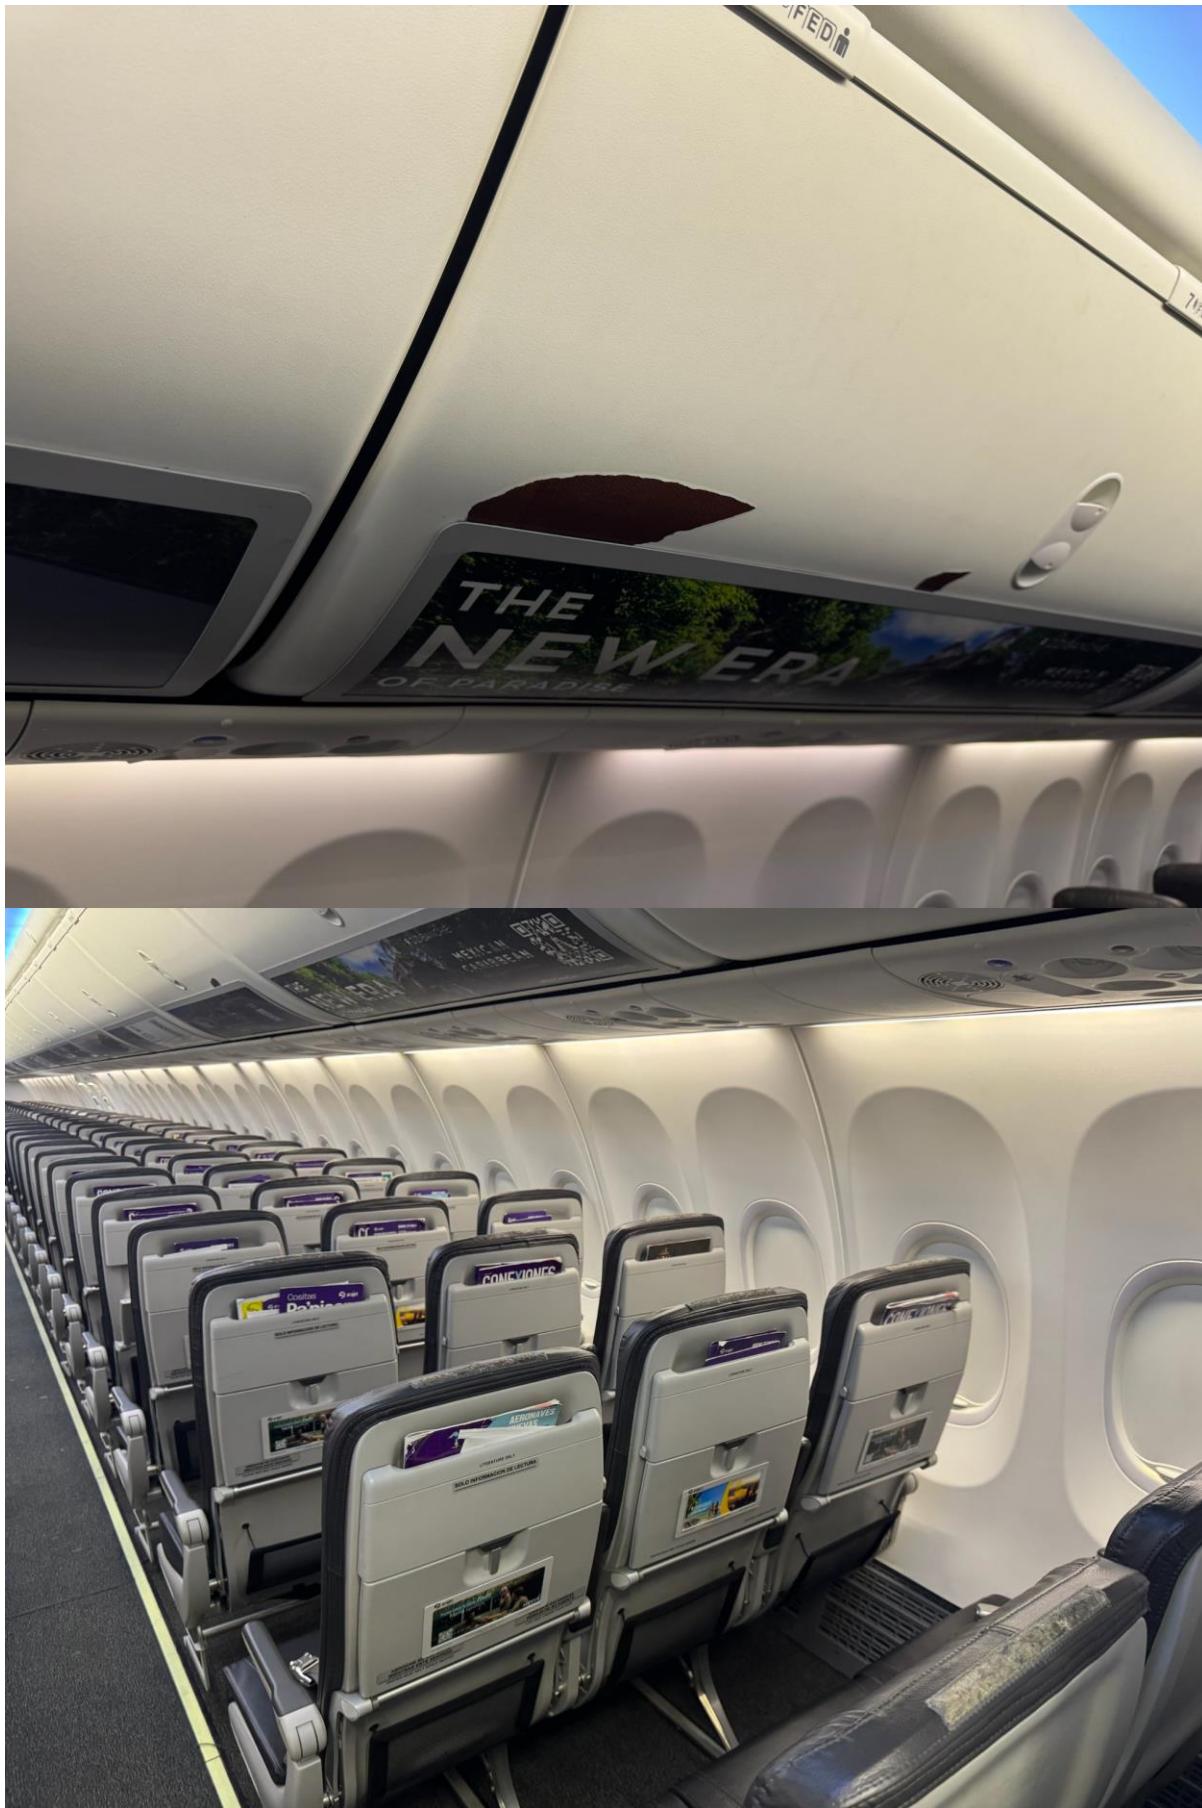
A minor modification has been embodied since delivery involving the installation of large-surface advertisements on the overhead bin doors and on passenger meal trays. These applied surfaces already show signs of coating wear on the bins. Removal of this modification at redelivery may require **re-coating or recovering** the affected areas to meet redelivery standards.

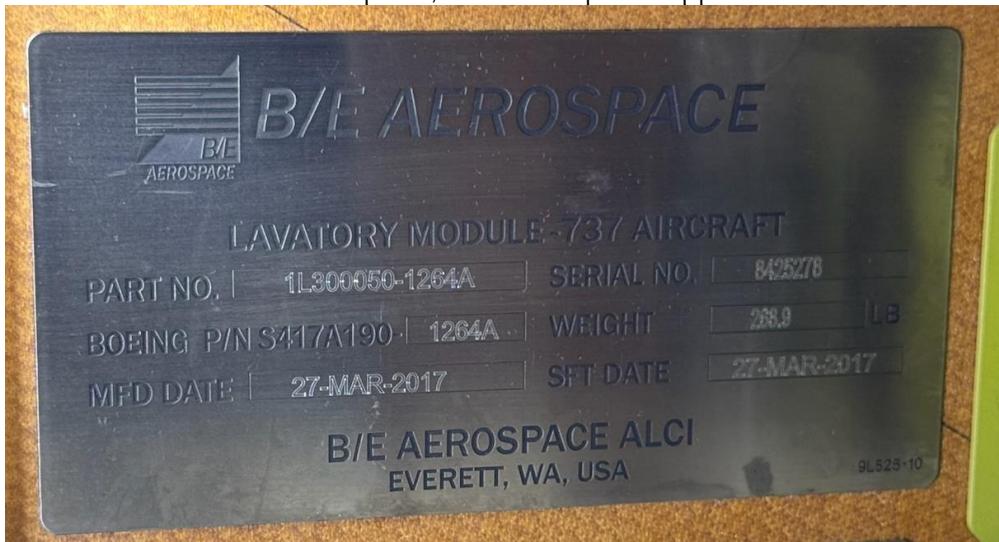
6. All lavatories show B/E Aerospace plates (Formerly AMI industries as shown on spec), but now Rockwell Collins. Update/comment spec as applicable.

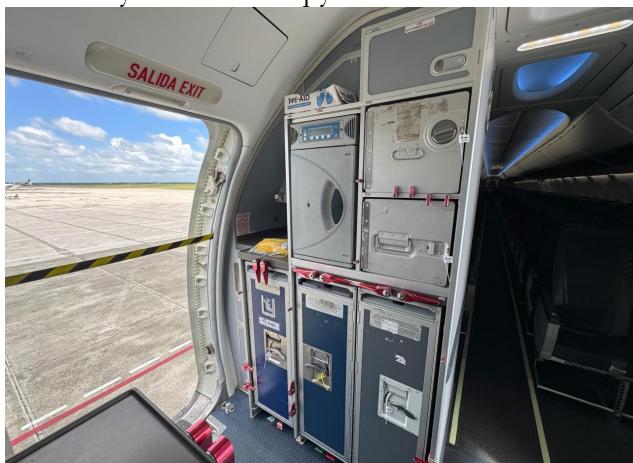
7. G2 Galley : Ice drawer qty should read 0.

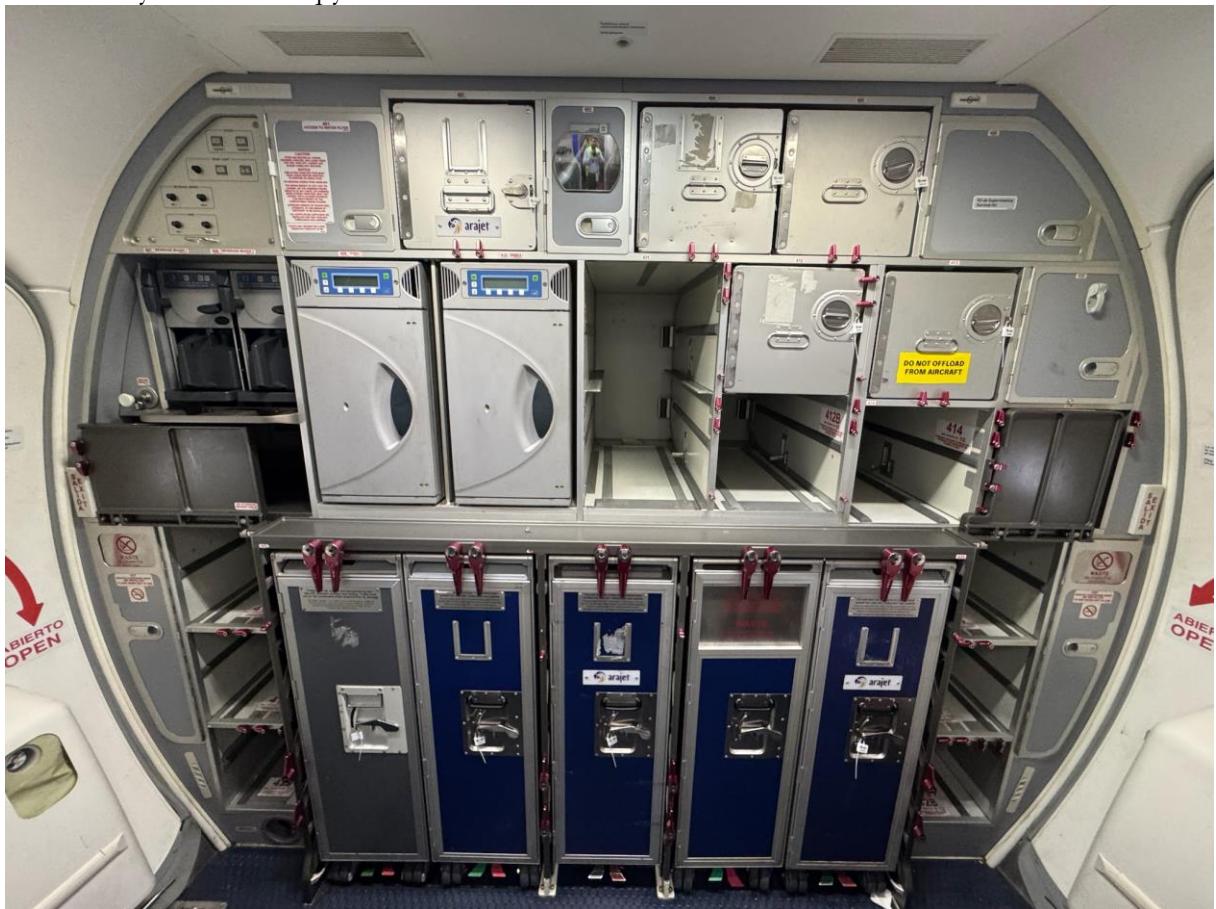
8. G4B Galley ice drawers qty should read 0

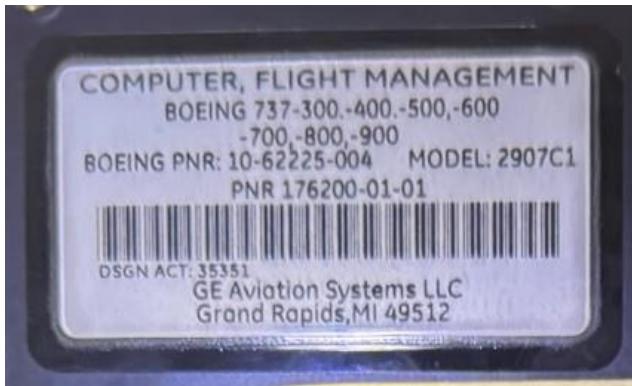
9. FMC OEM should read "GE Aviation"

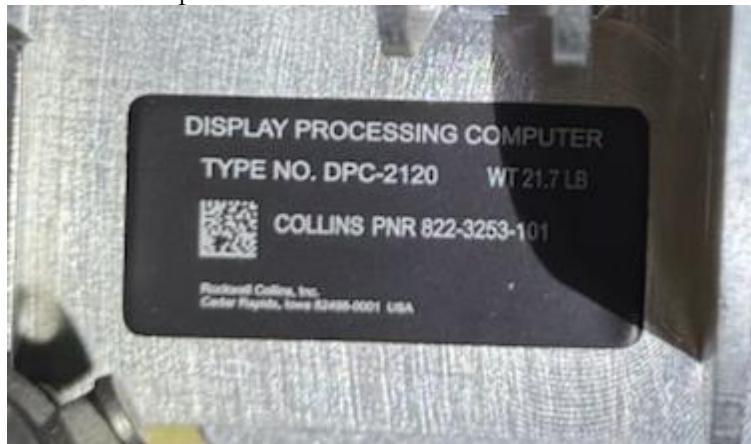
10. EFIS control panel PN should read 822-3253-101
