# UgIFT Asset Verification Report

*Field findings, service gaps and recommended actions*

Ministry of Finance, Planning and Economic Development

27 September 2026

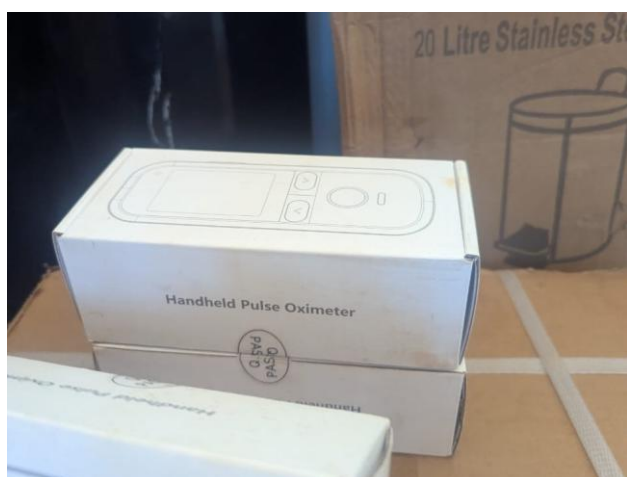
Figure 7: Boxed pulse oximeters at a health centre, Makindye-Ssabagabo Municipal Council (Buganda)

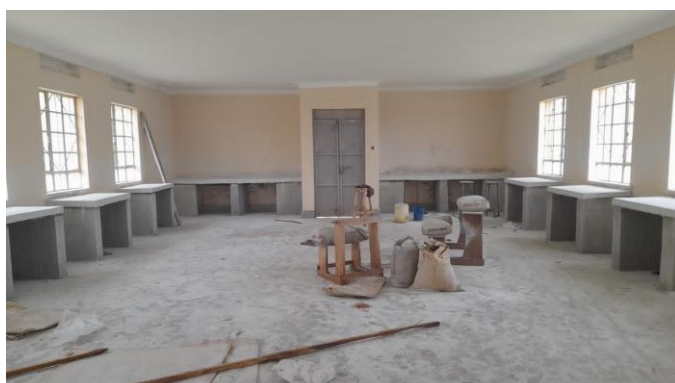
**Figure 27: ICT laboratory interior under construction at Kitawoi Seed Secondary School, Kween District (Sebei)**

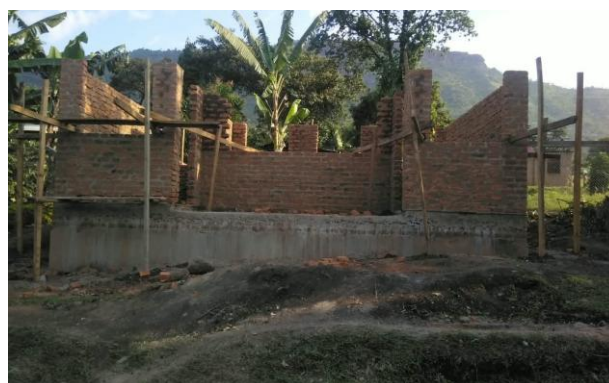
**Figure 28: Unfinished laboratory building at a health centre, Sironko District (Bugisu)**

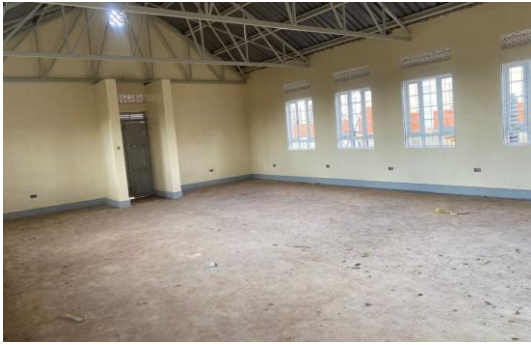
**Figure 29: Empty computer laboratory at a seed secondary school, Kween District (Sebei)**

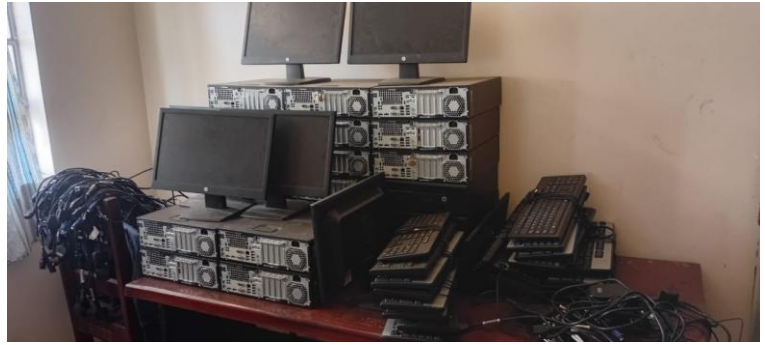
**Figure 30: Computer sets stacked in a store at Bumufuni Seed Secondary School, Bulambuli District (Bugisu)**

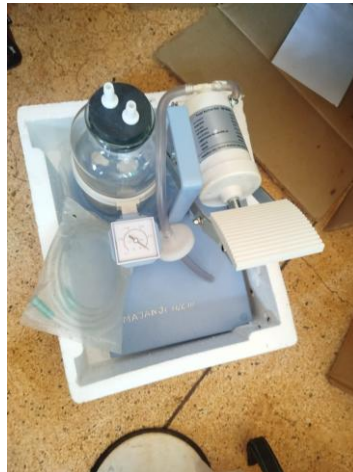
**Figure 31: Pedal suction unit in packaging at Majanji HC III, Busia District (Bukedi)**

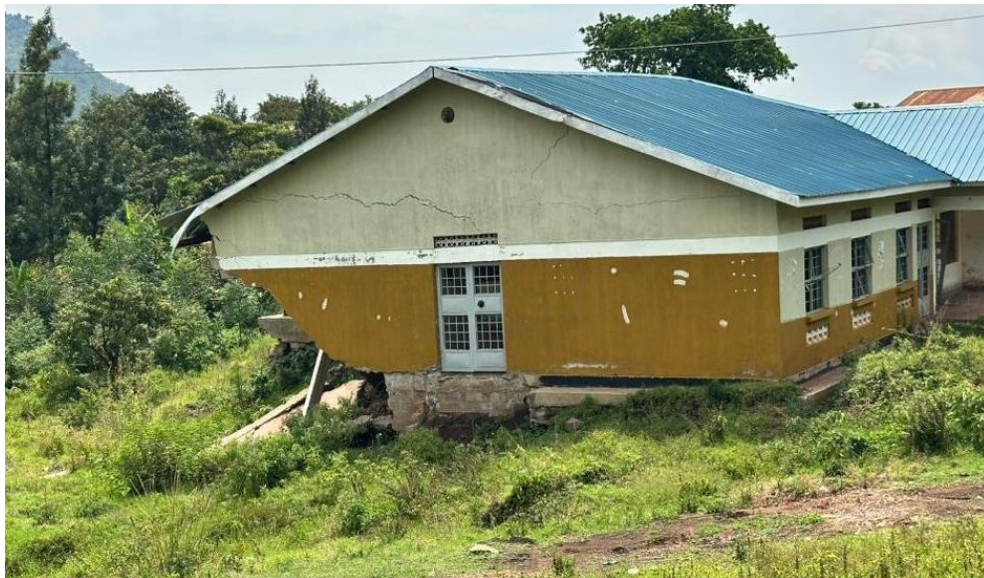
**Figure 32: Cracked health centre block above collapsed ground, Bulambuli District (Bugisu)**

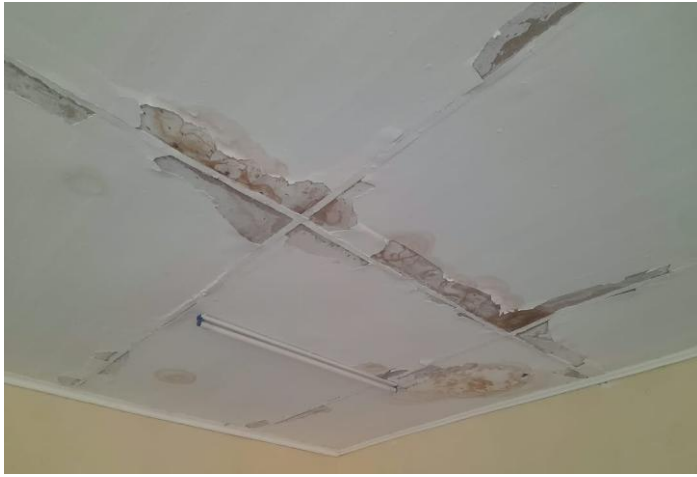
**Figure 33: Stained and peeling ceiling at a health centre, Sironko District (Bugisu)**

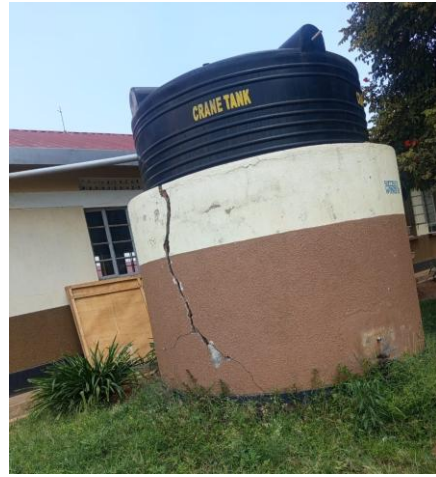
**Figure 34: Water tank on a cracked base at a seed secondary school, Kibuku District (Bukedi)**

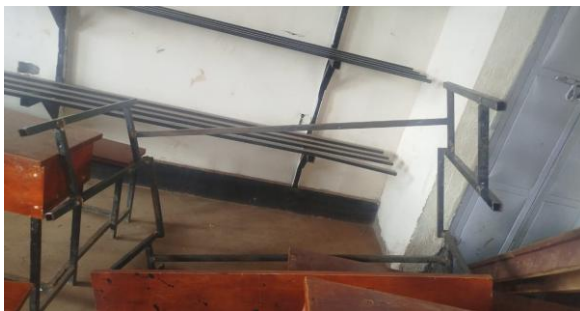
**Figure 35: Broken desk frame at a seed secondary school, Namisindwa District (Bugisu)**

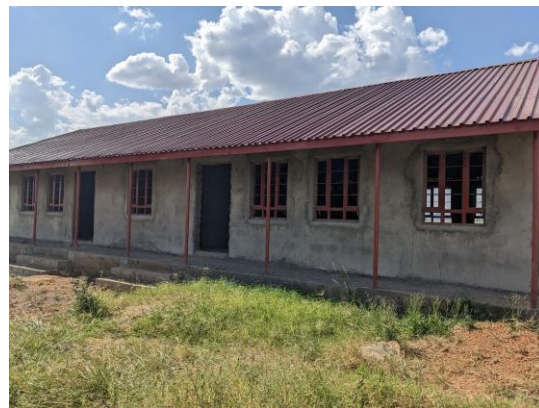
**Figure 57: Unfinished classroom block at Sidok Seed Secondary School, Kaabong District (Karamoja)**

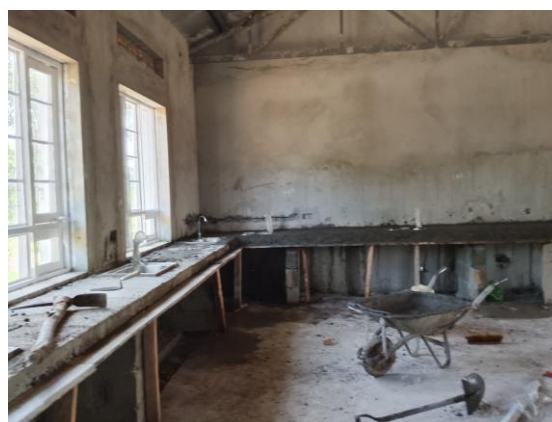
**Figure 87: Biology laboratory under construction at a seed secondary school, Buliisa District (Bunyoro)**

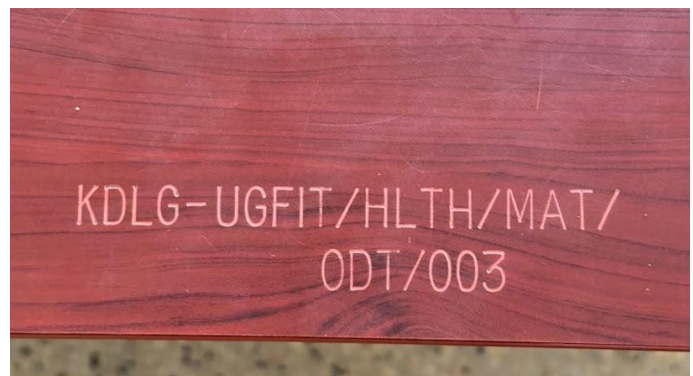
**Figure 97: School engraving on wooden furniture at King Solomon Seed Secondary School, Kagadi District (Bunyoro)**

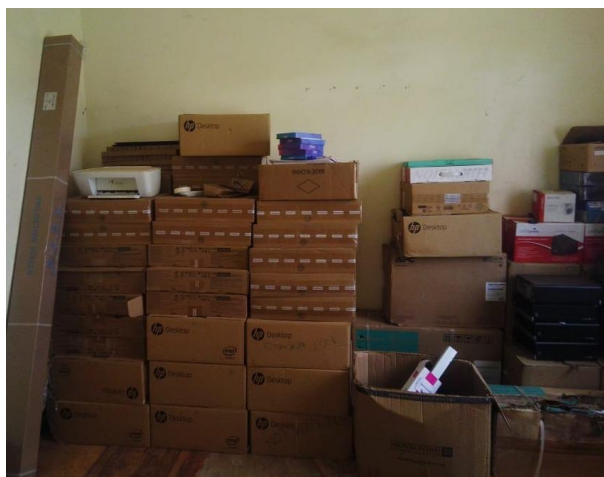
**Figure 114: Boxed computers and related equipment in a seed school store, Nwoya District (Acholi)**

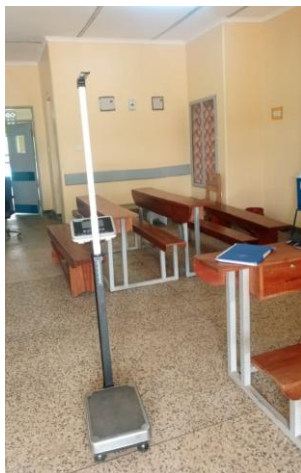
Figure 115: Adult weighing scale with a height meter and waiting benches at Iruhura HC III, Kabarole District (Tooro)

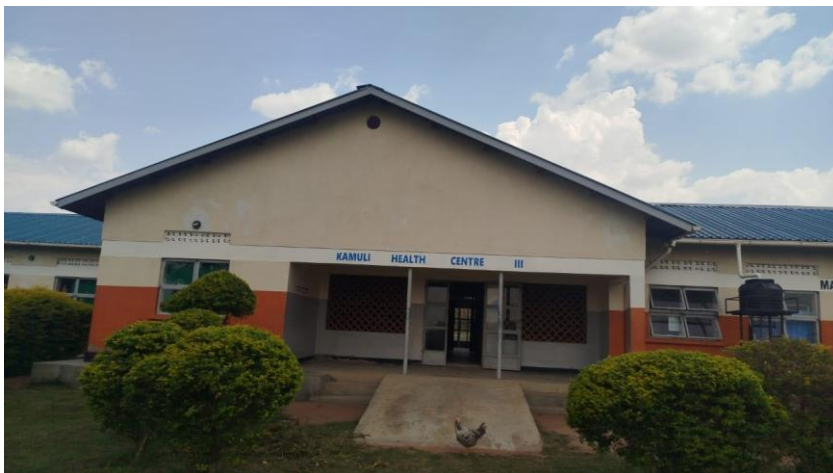
Figure 116: Maternity block entrance and access ramp at Kamuli HC III, Tororo District (Bukedi)

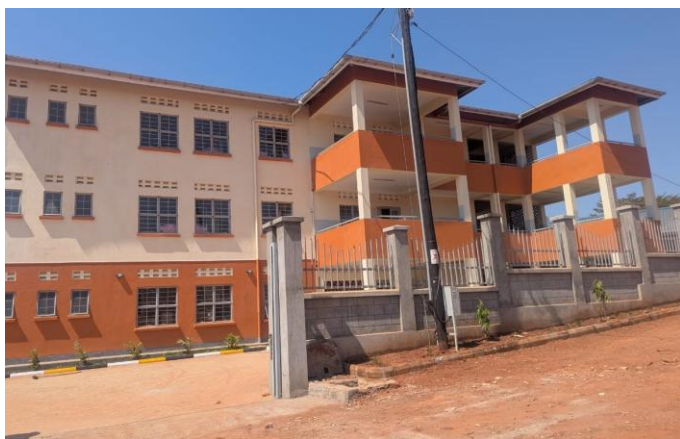
Health centres gave equally practical examples. Kibiri Health Centre III had begun operations by 31 August 2026, while staff were still arranging some equipment. At Kihuukya, the renovated maternity block and walkways were recorded in use and a binocular microscope was seen functioning. Iruhura recorded adult weighing scales and waiting benches in use. Kamuli reported improved service delivery, alongside continuing staffing and accommodation needs.

Figure 117: Health centre building at Kibiri HC III, Makindye-Ssabagabo Municipal Council (Buganda)

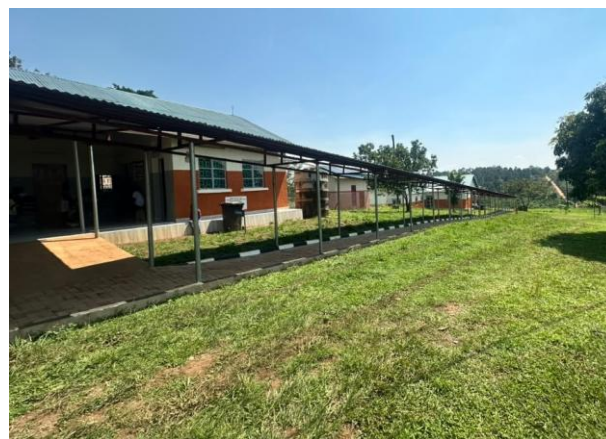
Figure 118: Health centre buildings and covered walkway at Kihuukya HC III, Hoima City (Bunyoro)

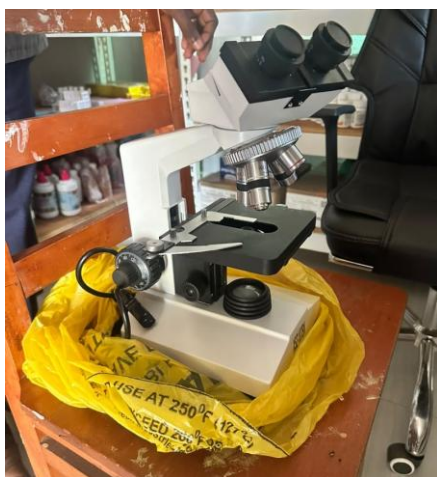
Figure 119: Binocular microscope at Kihuukya HC III, Hoima City (Bunyoro)

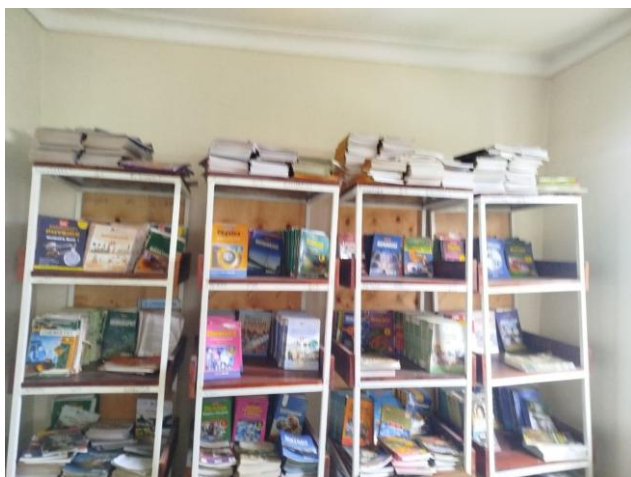
**Figure 121: Books displayed on library shelves at Sibanga Seed School, Manafwa District (Bugisu)**

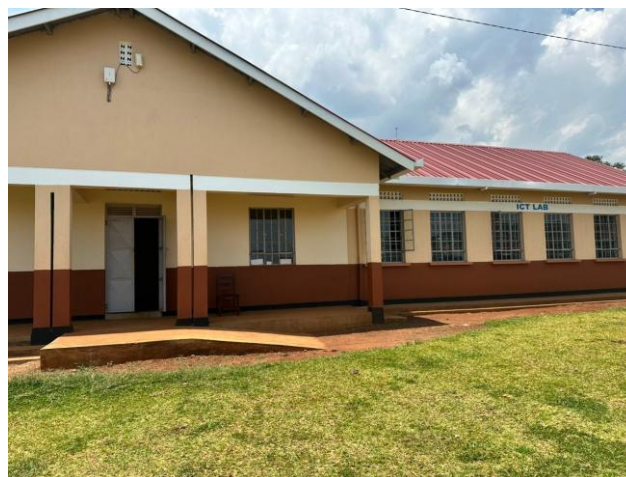
**Figure 122: ICT laboratory block and entrance ramp at Sisiyi Seed Secondary School, Bulambuli District (Bugisu)**
