**CONSULTANCY SERVICES TO VERIFY AND RECORD ASSETS  
UNDER THE UGIFT PROGRAMME**

**REF: MOFPED/UGIFT/CONS/25/26/00015**

**ASSET VERIFICATION REPORT**

**September 2026**

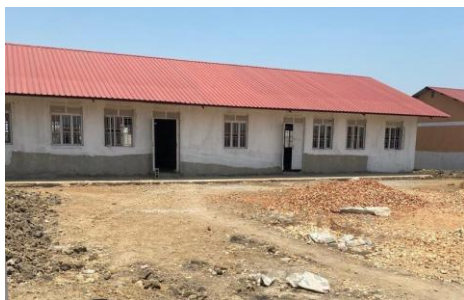
**Figure 6: School block awaiting completion at Butungama Seed Secondary School, Ntoroko District (Tooro)**

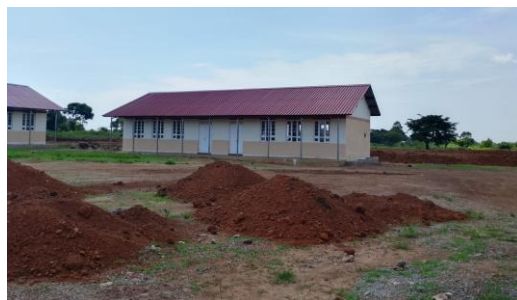
**Figure 8: Classroom block with earthworks in the foreground at Kihungya Seed Secondary School, Buliisa District (Bunyoro)**

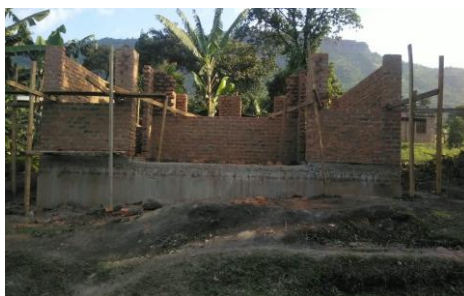
**Figure 9: Unfinished laboratory building at a health centre, Sironko District (Bugisu)**

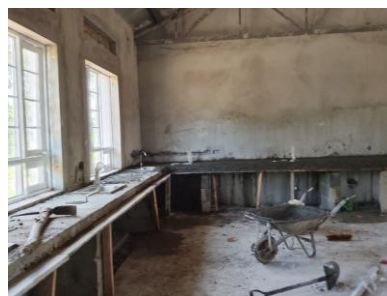
**Figure 10: Biology laboratory under construction at a seed secondary school, Buliisa District (Bunyoro)**

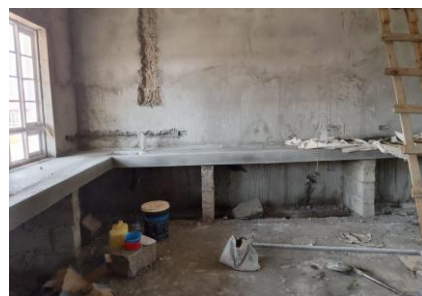
**Figure 11: Unfinished laboratory interior at Kihungya Seed Secondary School, Buliisa District (Bunyoro)**

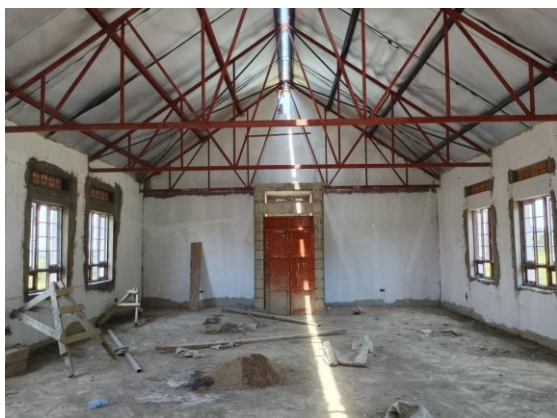
**Figure 12: Library interior under construction at Kihungya Seed Secondary School, Buliisa District (Bunyoro)**

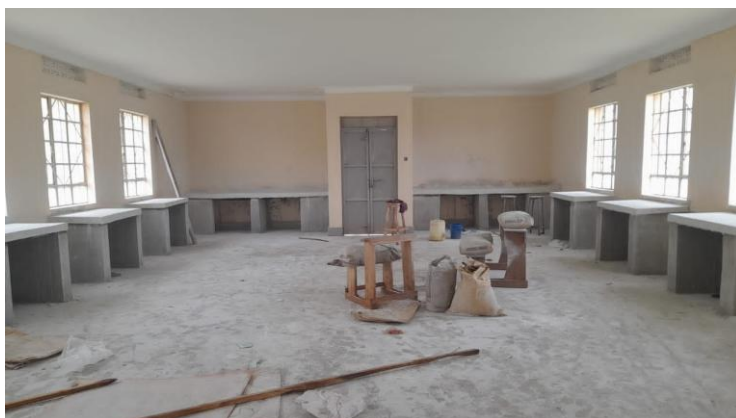
**Figure 13: ICT laboratory interior under construction at Kitawoi Seed Secondary School, Kween District (Sebei)**

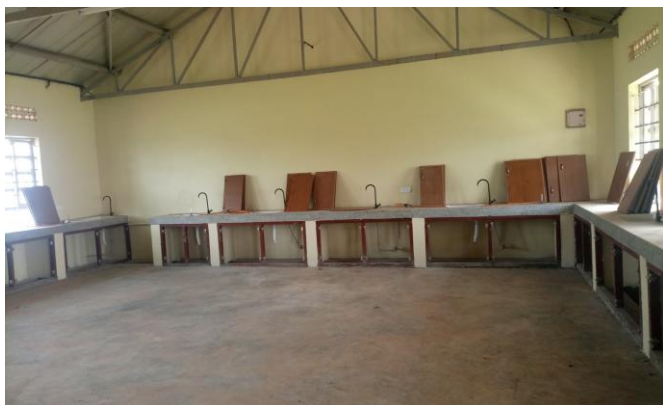
**Figure 14: Laboratory benches with cupboard doors not yet fitted, in a science laboratory block recorded as under construction, at King Solomon Seed Secondary School, Kagadi District (Bunyoro)**

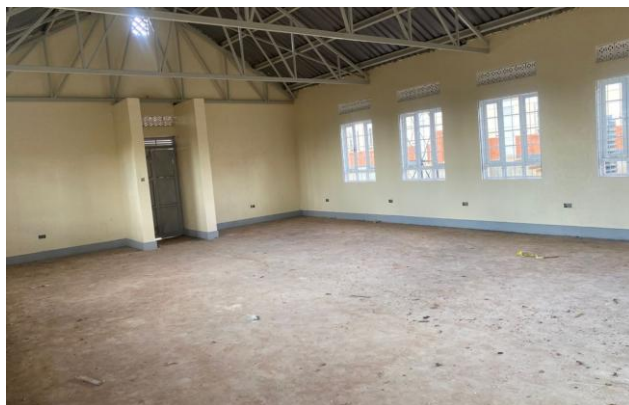
**Figure 15: Empty computer laboratory at Kaptum Seed Secondary School, Kween District (Sebei), where the buildings had not been handed over and no ICT equipment had been received**

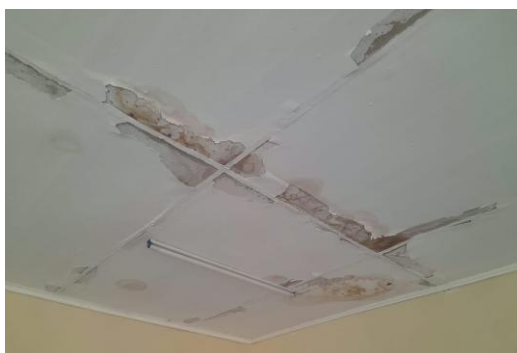
**Figure 24: Stained and peeling ceiling at a health centre, Sironko District (Bugisu)**

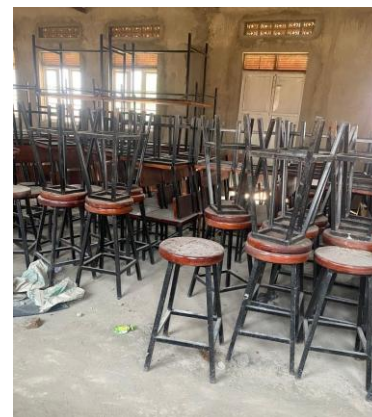
**Figure 46: Laboratory stools and desks stored and not yet in use at Butungama Seed Secondary School, Ntoroko District (Tooro), where the school buildings were still under construction**

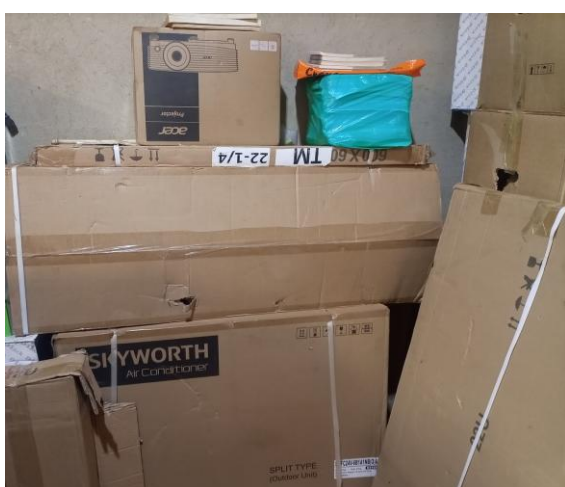
**Figure 47: Boxed projector, air conditioner and other equipment in store at King Solomon Seed Secondary School, Kagadi District (Bunyoro), kept boxed because the school was still under construction**

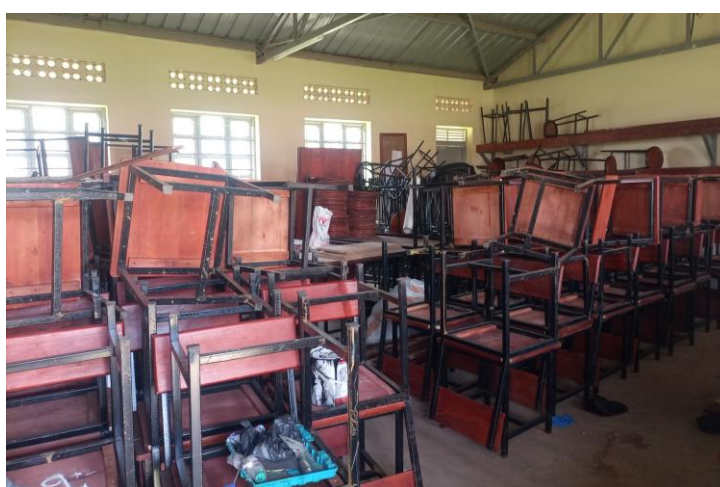
**Figure 48: Chairs, desks and laboratory stools stacked in a hall at King Solomon Seed Secondary School, Kagadi District (Bunyoro), where most assets remained in storage because the school was still under construction**
