# UgIFT Asset Verification Report

*Field findings, service gaps and recommended actions*

Ministry of Finance, Planning and Economic Development

27 September 2026

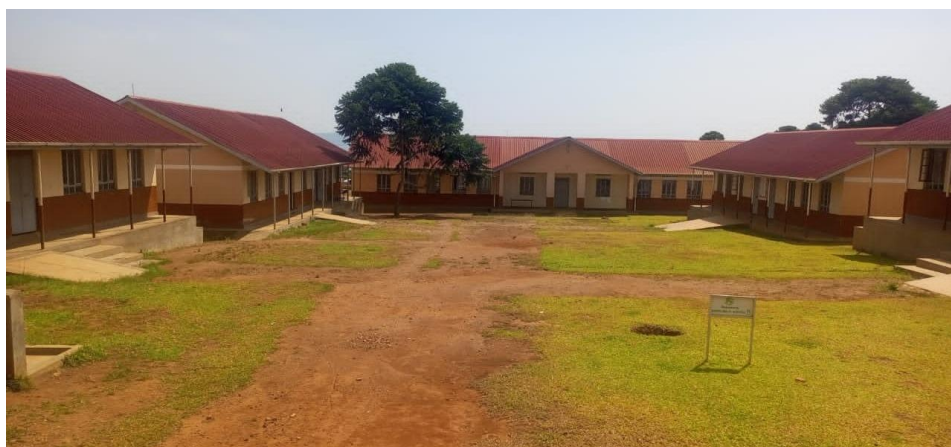
Figure 5: School buildings and courtyard at a seed secondary school, Buvuma District (Buganda)

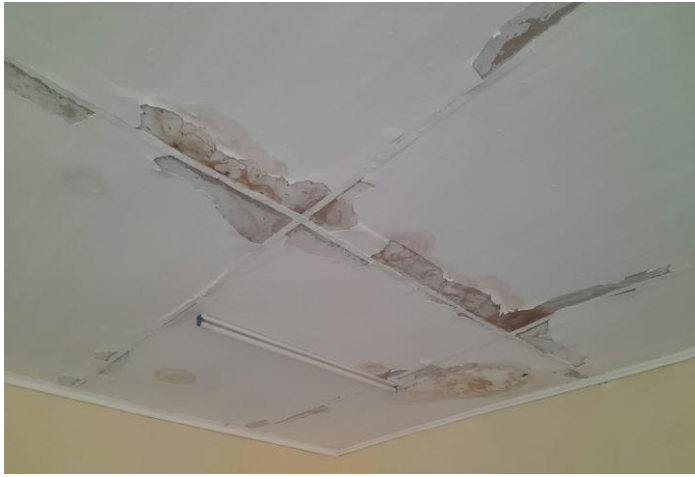
**Figure 33: Stained and peeling ceiling at a health centre, Sironko District (Bugisu)**

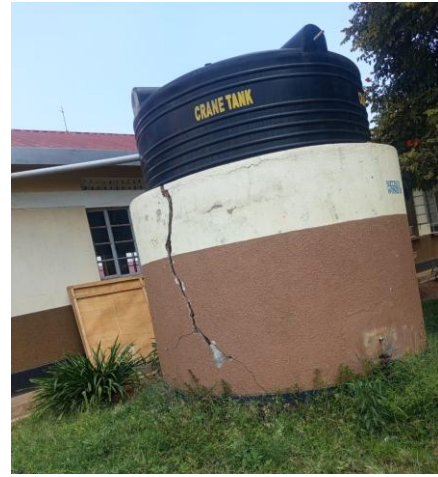
**Figure 34: Water tank on a cracked base at a seed secondary school, Kibuku District (Bukedi)**

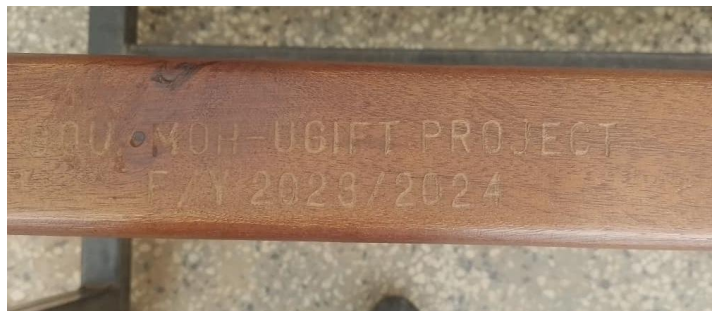
**Figure 36: UglIFT engraving on a health centre bench, Bududa District (Bugisu)**

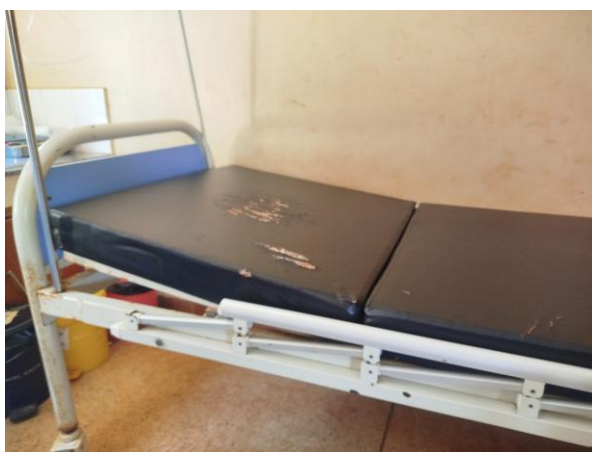
**Figure 50: Delivery bed with a torn mattress cover at a health centre, Busia District (Bukedi)**

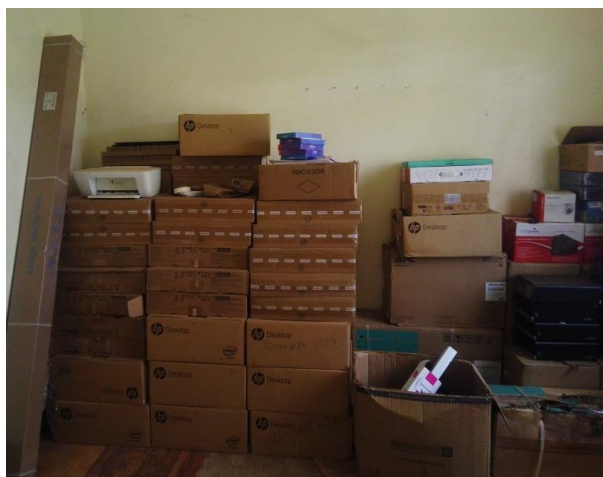
Power and repairs were immediate constraints. Lungulu Seed Secondary School in Nwoya held computers in storage pending a suitable power connection. Pamaka Health Centre III in Nebbi could not use oxygen equipment because of power constraints, and Busaale Health Centre III in Kayunga needed roof, door and solar repairs. Among assets recorded as out of use, 2,569 had damage, fault or repair remarks, while 483 were stored and described as good or new.

**Figure 114: Boxed computers and related equipment in a seed school store, Nwoya District (Acholi)**
