UGANDA INTERGOVERNMENTAL FISCAL TRANSFERS PROGRAMME

# FIELD REPORT ON UgIFT ASSET VERIFICATION

Karamoja, Bukedi, Bugisu / Mount Elgon and Sebei

Fieldwork 24 August to 3 September 2026

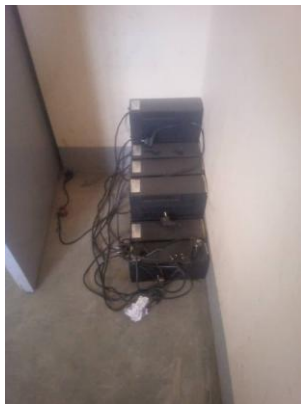
The library and ICT block, twin science laboratory, 2 classroom blocks, multipurpose hall and staff housing are built and standing. The standby power units in the ICT room do not work, nothing on the site is engraved, and no ICT line carries a count.

Figure 6. Standby power units, none working

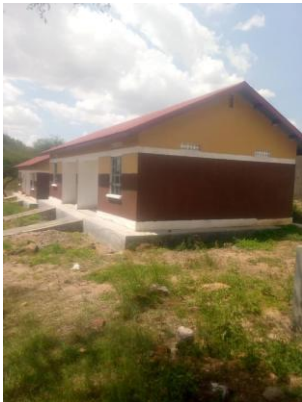
Figure 13. Teachers' houses, still unpainted

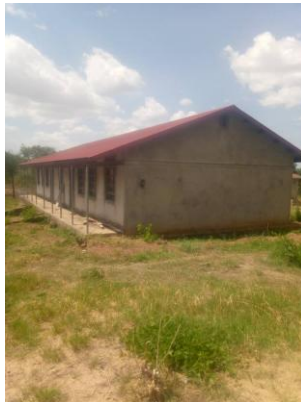
Figure 14. Block left unpainted

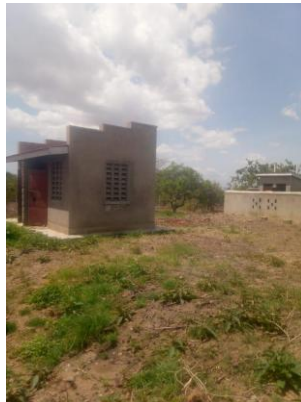
The classroom blocks, teachers' houses and their kitchens are up; the kitchen and toilet blocks and the boys' and girls' latrines are not finished. Nothing here is engraved and no serial number was taken.

Figure 15. Kitchen and toilet block, unfinished

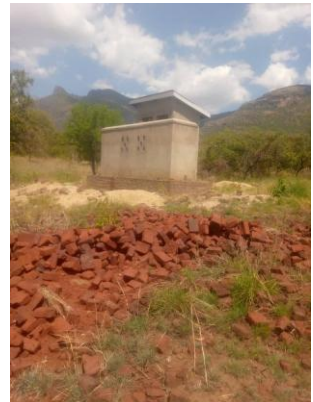
Figure 16. Boys' and girls' latrine block, unfinished

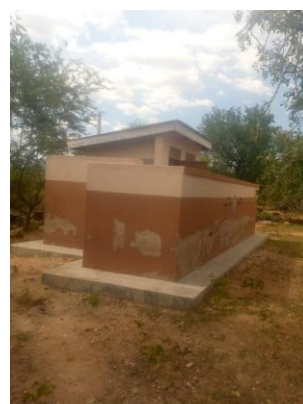
Figure 24. Staff latrine block, render flaking

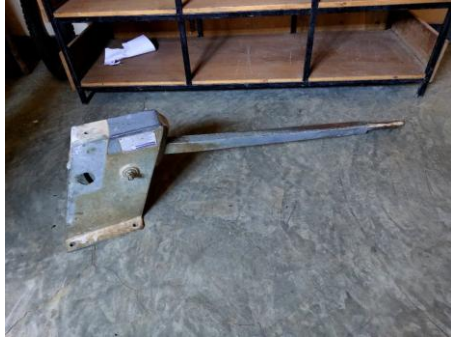
The programme's asset here is one borehole, which is on the school's register as operational and also serves the neighbouring community. It has broken down 4 times, its hand pump has been replaced by a motorised head and the original lies dismantled in a store.

Figure 39. Hand pump head, dismantled and held in the store

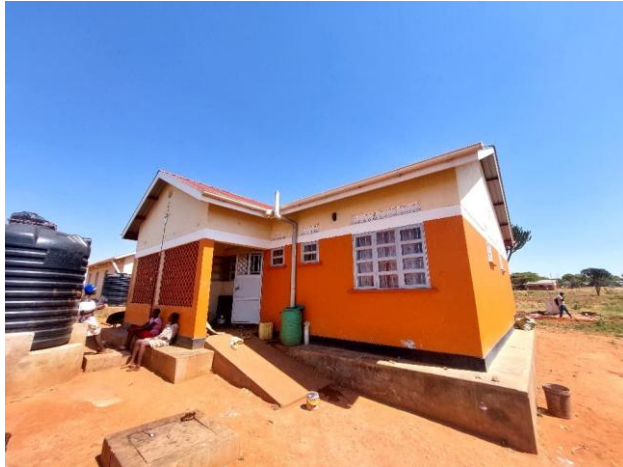
Figure 44. Outpatient block with the water system and tanks

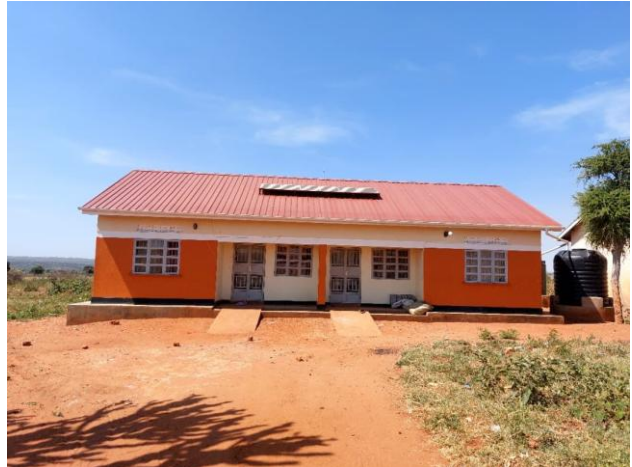
Figure 45. Staff quarters and staff toilet block

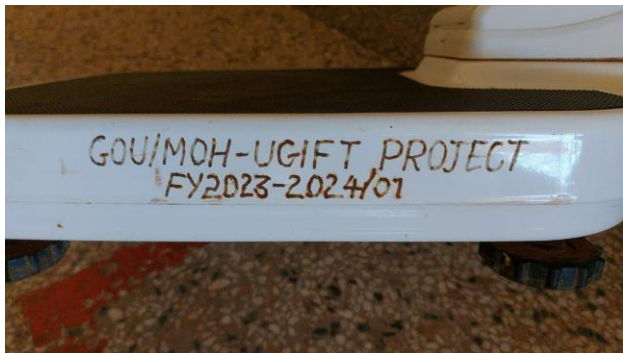
This is the one facility in Karamoja where engraving is the rule: almost every item carries GOU/MOH-UGIFT PROJECT cut into it with the financial year. Against that, a bubble CPAP is still in its unopened carton, trolleys are in the maker's film, a kick bowl leaks, drip stands are broken and 2 of 4 pulse oximeters are missing.

Figure 46. GOU/MOH-UGIFT PROJECT FY2023-2024/01 cut into the weighing scale

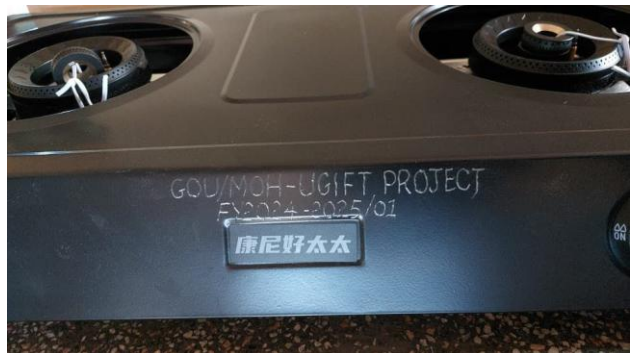
Figure 47. The same mark cut into the gas stove

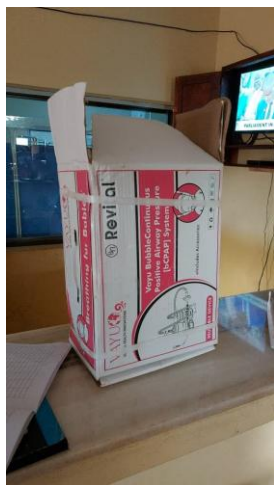
Figure 48. Bubble CPAP still in its unopened carton

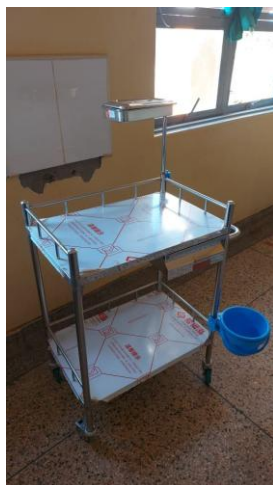
Figure 49. Treatment trolley still in the maker's film

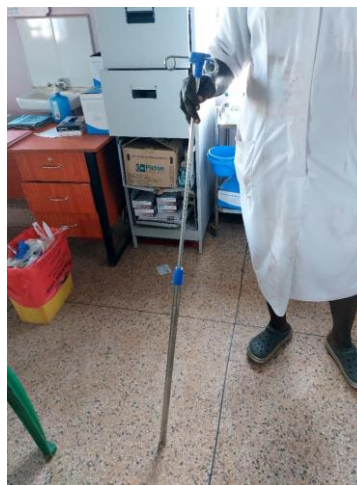
Figure 50. Drip stand, broken

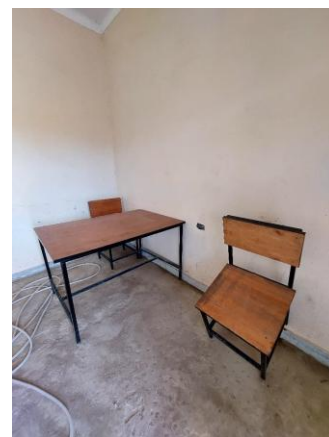
The school is still a building site with the contractor on it, and the furniture was being assembled during the visit. Cracks have already appeared in the staff quarter toilet blocks; nothing is engraved and nothing has been handed over.

Figure 57. Desks being assembled on site during the visit

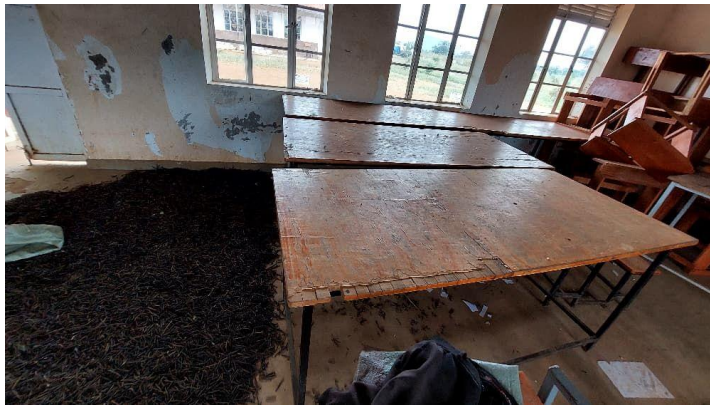
Figure 58. Tables and stacked furniture, none of it engraved

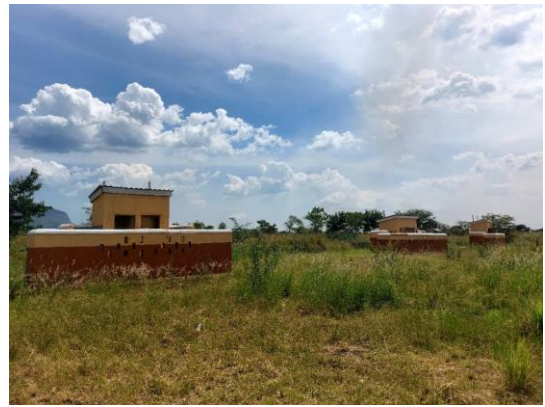
Figure 59. Staff quarter toilet blocks, where the cracks were found

- The contractors' defect liability should be called on while it runs, for the cracked toilet blocks at Iriiri and Napak, the staff house gable at Sisiyi, the cracked staff house at Bumugibole, the water-damaged ceiling at Bundege, the undermined latrine foundation at Namboko and the termite workings at Sidok.
- Bukibologoto HC II needs a decision: the works are destroyed, the catchment is served from the Simu sub-county offices, and the equipment sits unlisted in the district stores.
- The compensation for the land at Mugiti Seed Secondary School should be settled and the title obtained. The site is not secure while the owner is unpaid and threatening litigation.

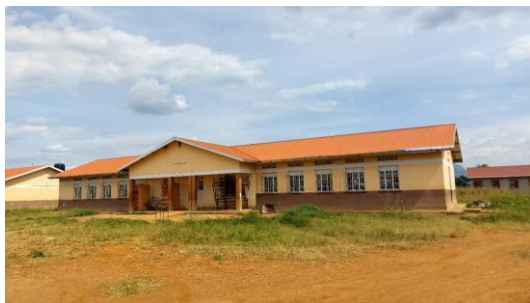
The buildings are complete and 3 of them are in other use: the library and ICT block is a girls' dormitory, the main hall a boys' dormitory, and a classroom block is divided into an A level dormitory and a computer room. Furniture is partly broken, nothing is engraved, and the school's own register mixes other donors with the programme.

Figure 60. Library and ICT block, now a girls' dormitory

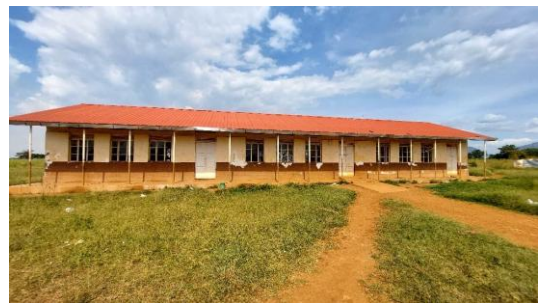
Figure 62. Main hall, now a boys' dormitory

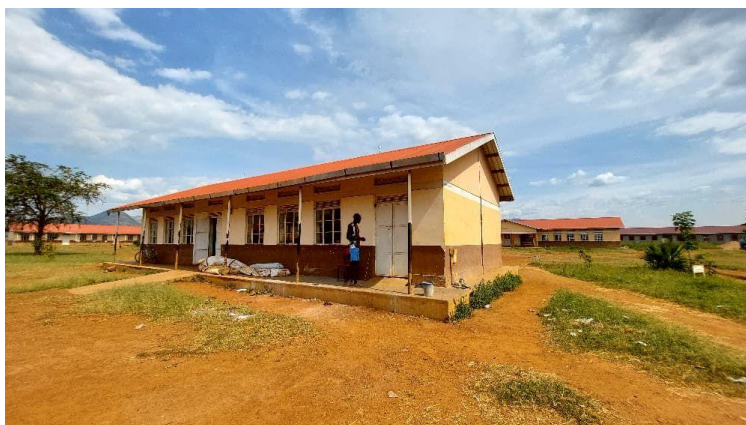
Figure 63. Classroom block divided into an A level dormitory and a computer room

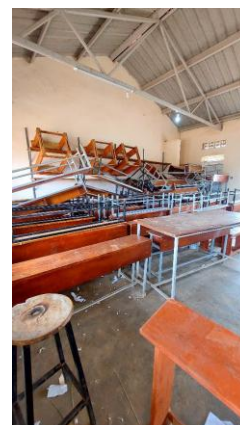
Figure 64. Furniture, some of it broken and none engraved

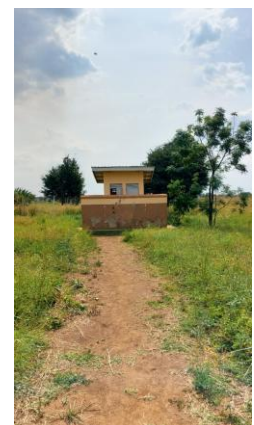
Figure 65. Toilet block, cracked

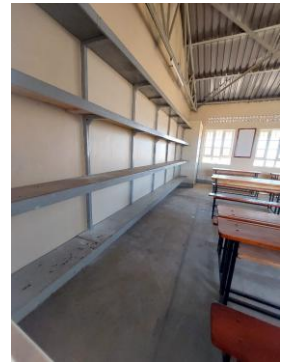
The school is finished and handed over, holding 112 office tables, 242 chairs, 115 stools and its book shelves, and none of it has been used: staff are recruited and the school opens next year. Every line of the filled sheets reads not engraved.

Figure 68. Book shelves and classroom furniture, unused

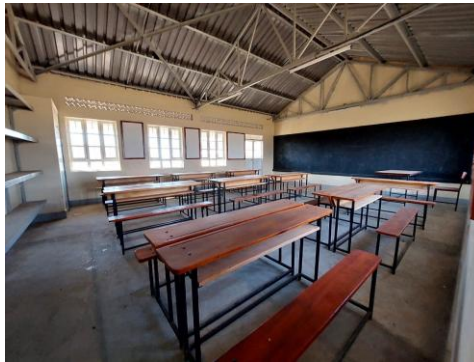
Figure 70. Classroom furniture standing unused

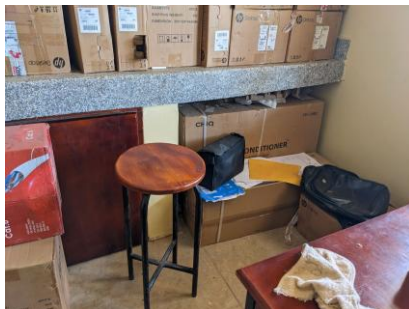
Of the 11 ICT lines, 6 are still in their cartons, the school has no power and its poles were a week away, and 360 laboratory stools with the tables and chairs lie unassembled in the store. The school has never been commissioned and nobody there has seen the bill of quantities.

Figure 75. Air conditioner and paper reams, still boxed

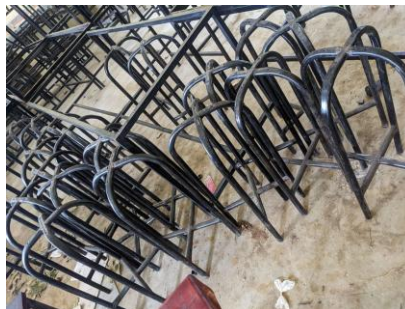
Figure 76. Chair frames, unassembled

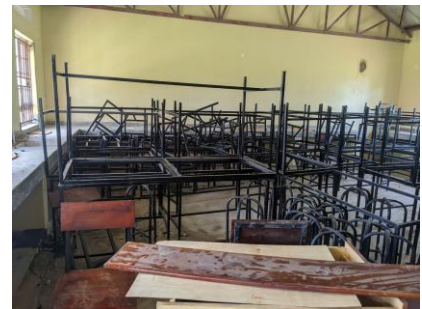
Figure 77. Unassembled furniture filling the store

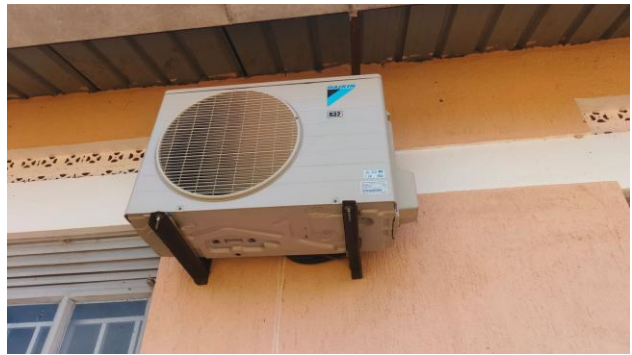
Figure 84. Air conditioner unit on the block; it does not work

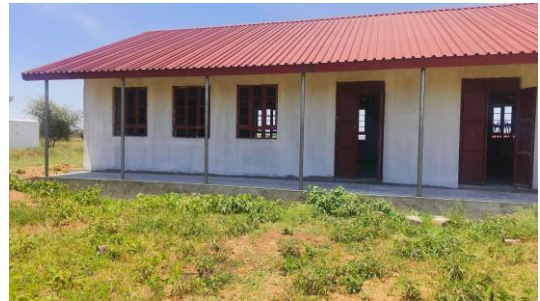
Figure 87. Classroom block, roofed and unfinished

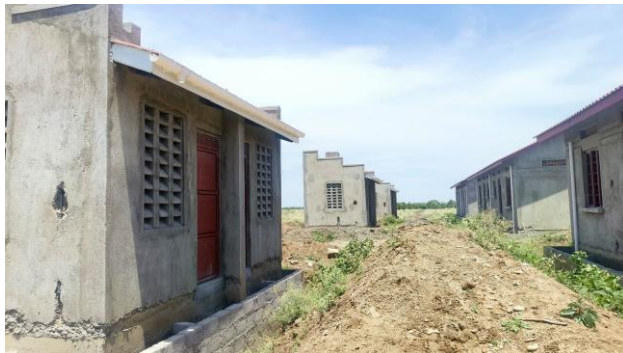
Figure 88. 3 kitchens under construction

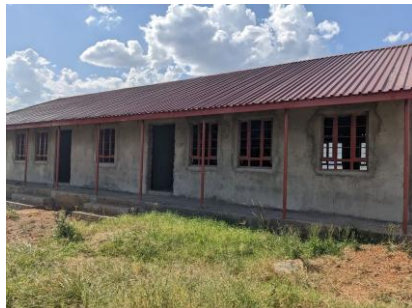
Figure 96. Classroom block under construction

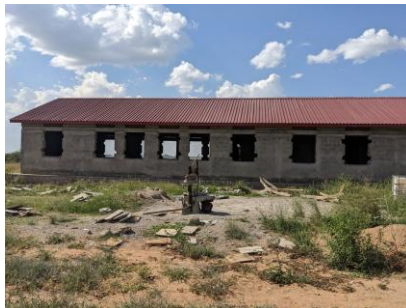
Figure 97. Block shell, windows not yet in

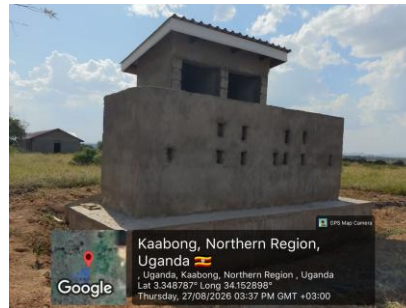
Figure 98. Latrine block under construction

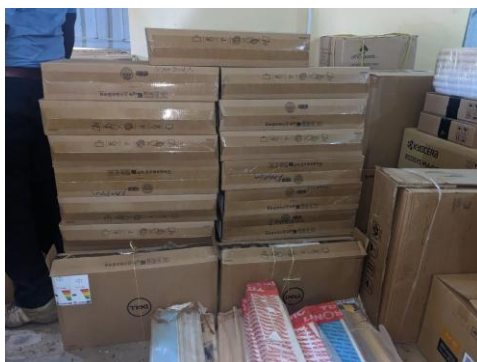
Figure 100. The consignment stacked and unopened

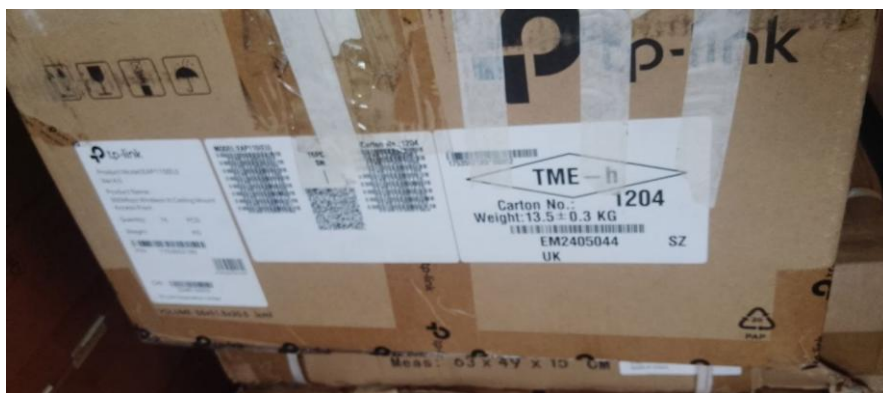
Figure 104. Ceiling-mount access points, carton 1204, sealed

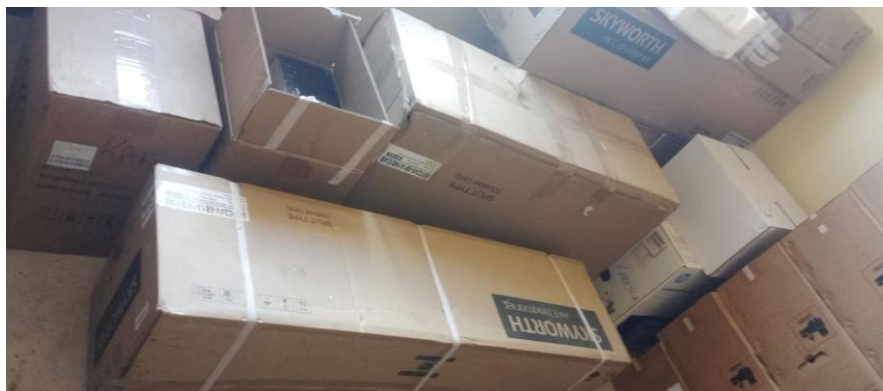
Figure 107. Split air conditioners, indoor and outdoor units still boxed

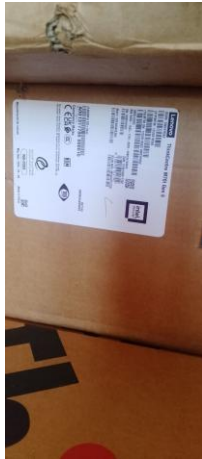
Figure 108. Serial GM0YHS5Z on a desktop carton

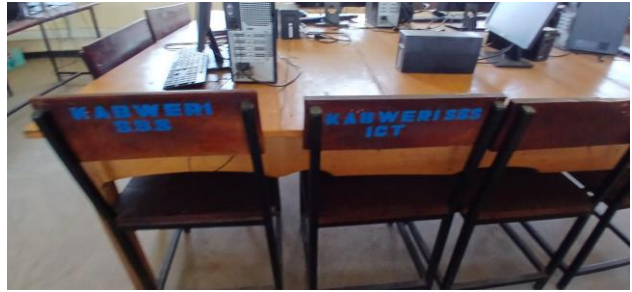
Figure 136. ICT tables painted KABWERI SSS ICT, naming the school and not the item

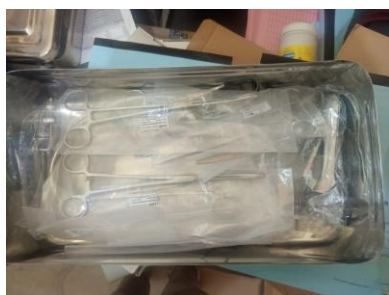
Figure 143. Instrument set, still sealed

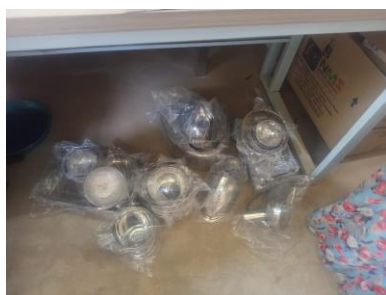
Figure 144. Bowls and galipots packaged on the store floor

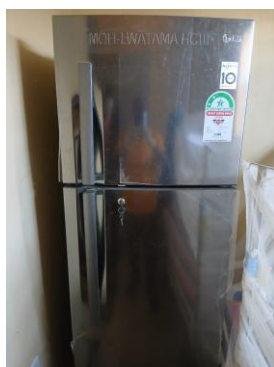
Figure 150. Refrigerator marked MOH-LWATAMA HC III, a different system

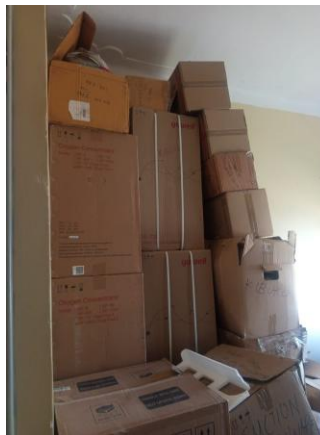
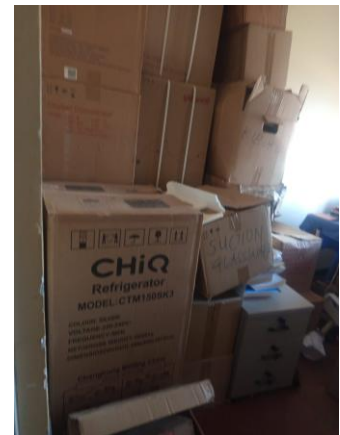
Most of the medical equipment has not been put to use, and the facility gave the reason plainly: it is not engraved. Unopened cartons and stacked bed frames stand in the store, and no item here carries an engraved number, asset number or serial number.

Figure 154. Cartons stacked in the store

Figure 155. Cartons including a refrigerator, unopened

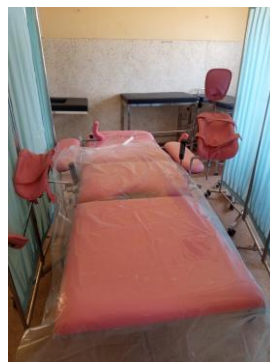
Figure 157. Delivery bed still in its wrapping

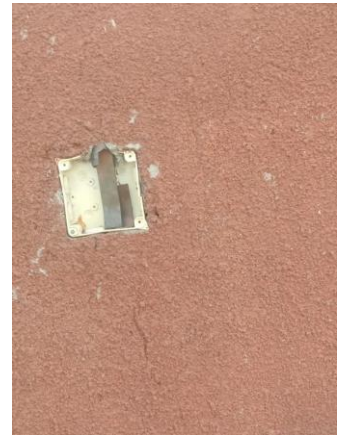
Only the grounds and the outside of the blocks were seen, so no movable asset was recorded. On the outside, 3 socket boxes stand with their covers off and their wiring showing, one window pane is out, and the school holds no title to its ground: the owner was never compensated and is threatening litigation.

Figure 173. Socket box open, wiring exposed

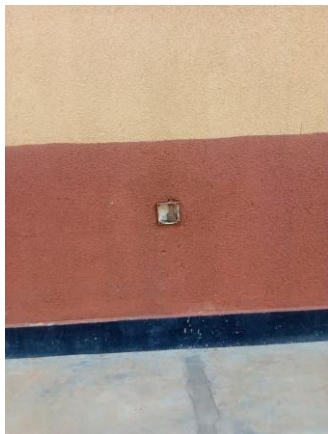
Figure 174. A second socket box with its cover off

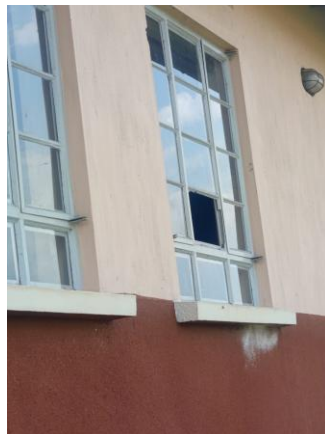
Figure 175. Window with a pane out

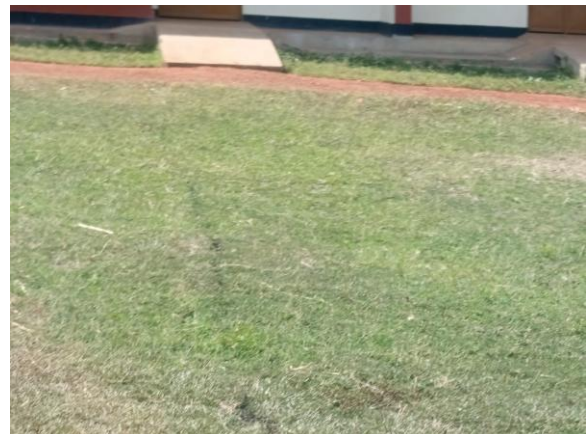
Figure 176. The playing field and block footing, on ground the school holds no title to

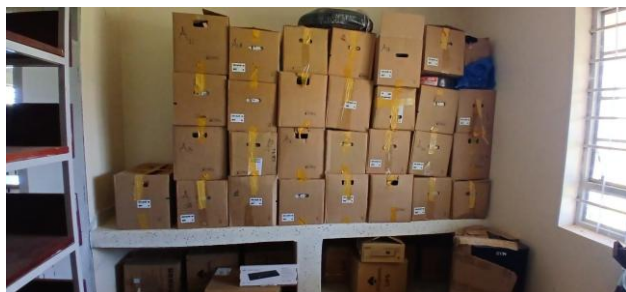
The desks, chairs, stools, library shelving and laboratory benches are out and in use, and the school marks its furniture with a mark that carries a number: N.S.S.S over a three-digit figure. Sealed computer cartons stand in the store, unopened, for want of power.

Figure 181. Store with the computer cartons stacked and sealed

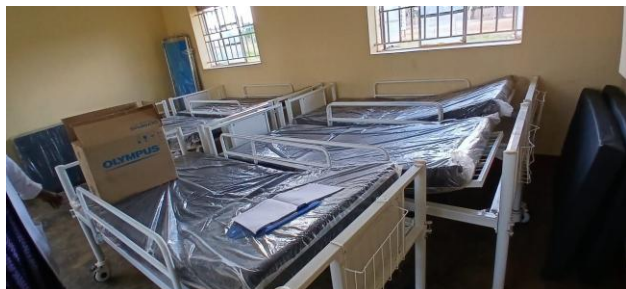
The facility is engraved, and engraved twice over: most of what it holds is cut NAM HCIII/UGIFT/24-25 or NAM HC/UGIFT/24-25. Beds, cots and screens are still wrapped in the wards, and the district's own notes leave a laboratory stool and 2 sets of bed mattresses outstanding a year on.

Figure 183. Ward with the beds still wrapped

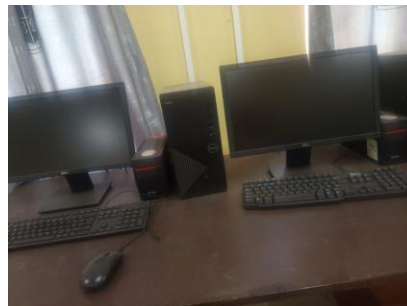
The contractor claims the works complete; the school is not handed over and not in use. The furniture and most ICT stand new and untested, cracks are recorded, laboratory equipment is still at the district, and nothing is engraved.

Figure 193. Computers set out in the ICT room,  
new and untested

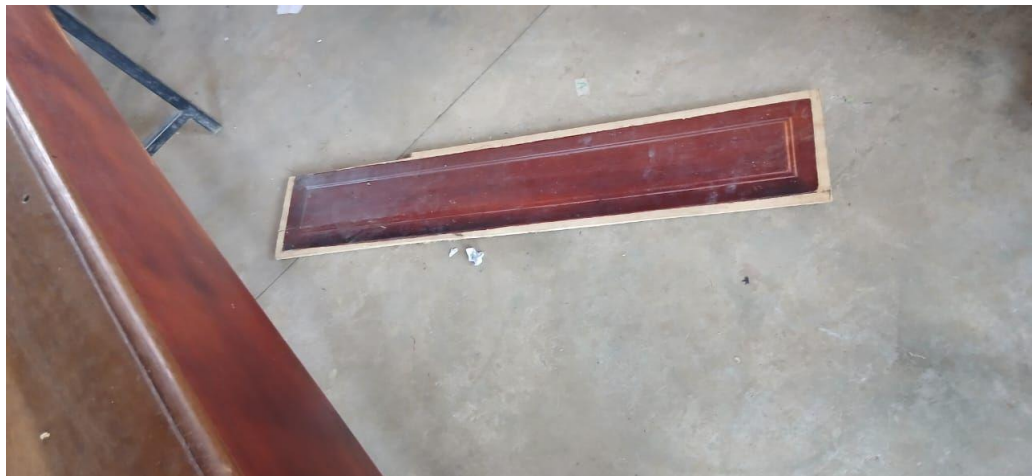
Figure 202. Bench backrest broken off and left on the floor

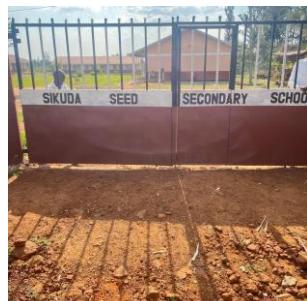
Figure 209. School gate carrying the name

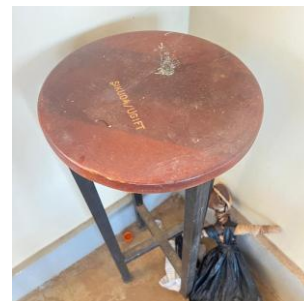
Every block, latrine, kitchen and bathroom is in use though none is commissioned, and one staff kitchen serves as the askari house. The office tables, desks and laboratory stools are engraved SIKUDA/UGIFT, which names the school and not the item; a count found 118 laboratory stools against the 124 on the register.

Figure 212. Laboratory stool engraved SIKUDA/UGIFT, a name and no number

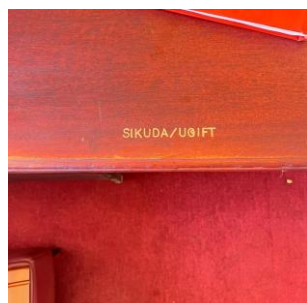
Figure 213. Office table carrying the same mark

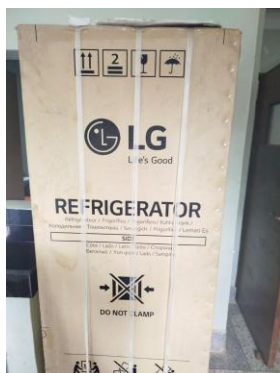
The office, wards, treatment room and cold chain corner hold their furniture and equipment. The facility's own name is cut into 7 assets and none carries a number; a refrigerator, oxygen concentrator, suction apparatus and centrifuge are still strapped in their cartons, and 5 works carrying programme plaques appear on no asset record.

Figure 221. Refrigerator still strapped in its carton

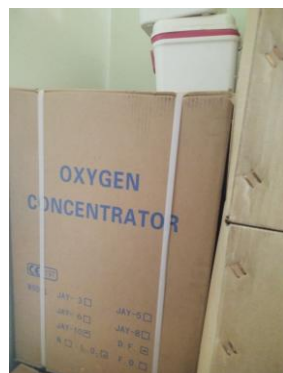
Figure 222. Oxygen concentrator in its carton

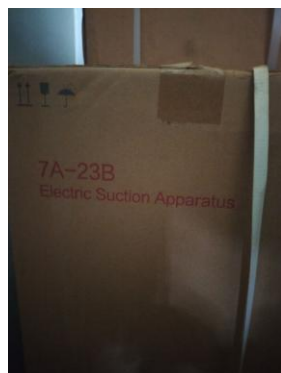
Figure 223. Electric suction apparatus in its carton

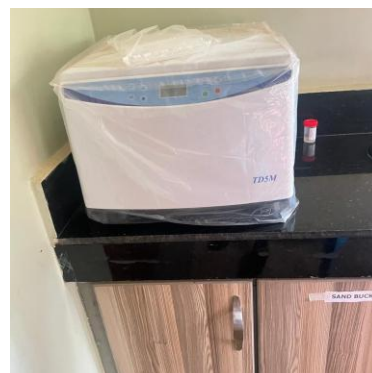
Figure 224. Centrifuge still in its wrapping

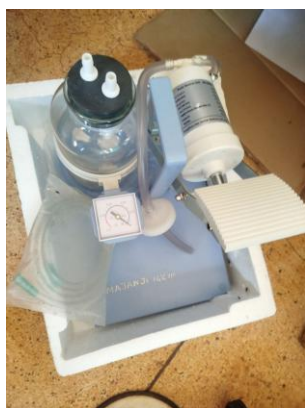
The laboratory, offices and wards hold equipment in use. The supplier recorded NIL against 15 of 17 portable diagnostic lines, 9 of 10 ordinary furniture lines and 3 of 6 medical furniture lines. The facility name is marked in 3 different hands, and no item carries a quantity on the floor.

Figure 229. Suction apparatus marked in a third

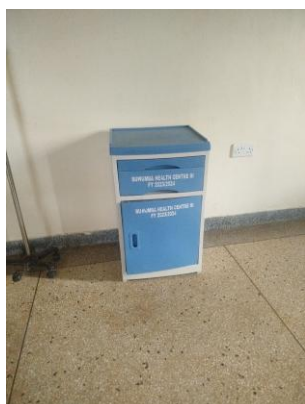
Figure 237. Bedside locker carrying the same mark

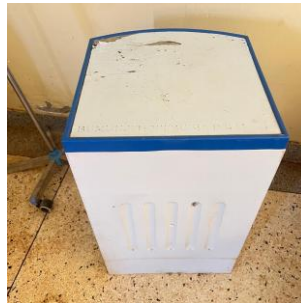
The maternity ward, laboratory and offices hold equipment standing ready, and a haemoglobin meter was photographed in use. The mark cut into the assets reads BUMUNJI/HCIII/BUSIA D.L.G, a name and not a number; an instrument set is unopened, and an autoclave and a ward bed from other donors stand among the programme's own.

Figure 243. Bedside locker cut BUMUNJI/HCIII/BUSIA D.L.G

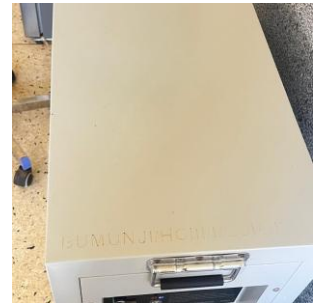
Figure 244. The same mark cut into the oxygen concentrator

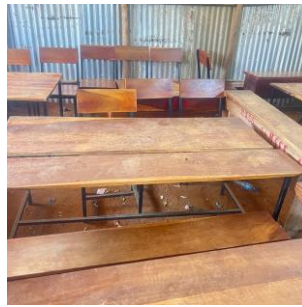
The classrooms, laboratory, library shelving and computers were recorded and photographed. Most furniture and ICT lines read not engraved; the desks carry M.S.S.S markings, and the discussion guide and the register's cover block were never filled.

Figure 255. Desks and chairs marked M.S.S.S

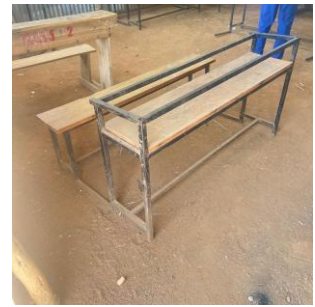
Figure 256. Desk bench carrying the same mark

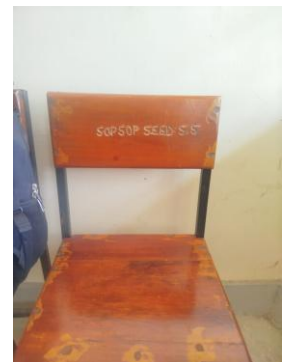
The classroom blocks, ICT room, library, staff housing and latrines are in use, and the desks, chairs and stools are in good condition with one broken stool. The school has no electricity, one camera does not work, and the furniture is engraved but not numbered.

Figure 259. Chair engraved SOPSOP SEED S.S., with no number

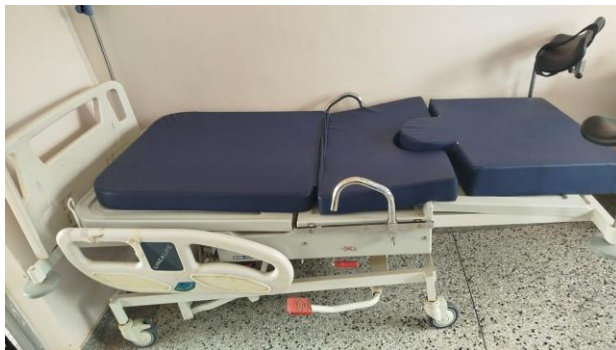
Service delivery and equipment quality are reported good, against low staffing, no fence and short staff accommodation. A refrigerator carries asset number HF0195; 5 adult beds have been moved to Atangi HC III and one delivery bed to Malaba HC IV, and neither transfer is on the district record.

Figure 283. Delivery bed

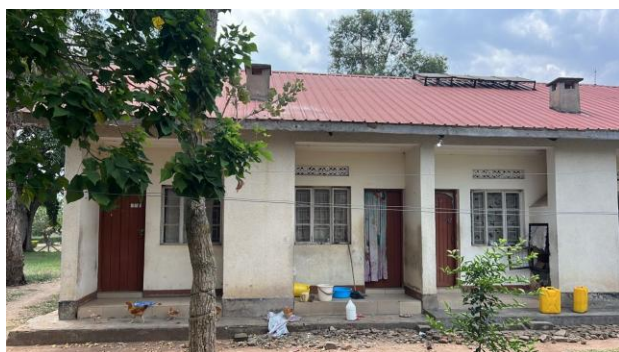
Figure 291. Second block

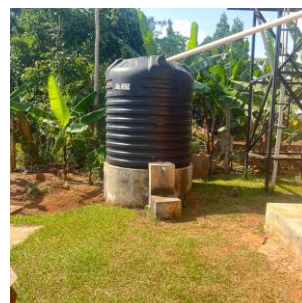
Maternity service has improved. Power is unreliable, the baby warmer's voltage is low and the water pump does not work. Several items carry KYAM- series tags, the first numbered marking seen in this cluster, and nothing here was counted on the day.

Figure 298. Water tank on its plinth; the pump does not work

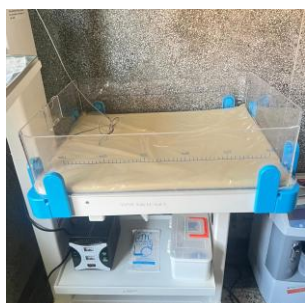
Figure 299. Radiant infant warmer tagged KYAM RIW 01

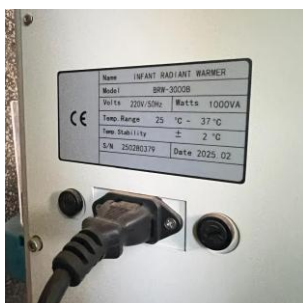
Figure 300. Rating plate on the same warmer

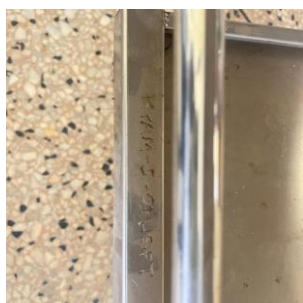
Figure 301. Stainless frame cut KYAM-3-01

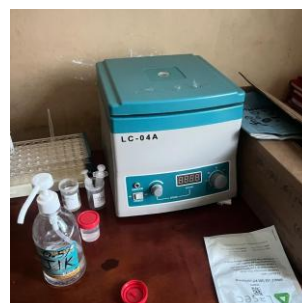
Figure 302. Centrifuge carrying the same series

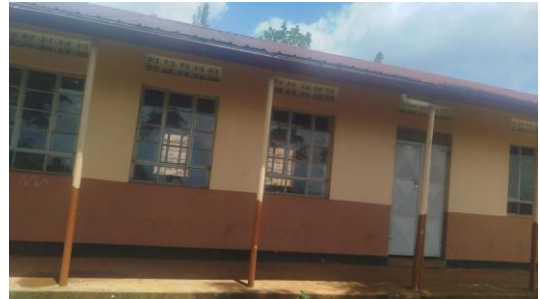
The classroom blocks, ICT room, staff quarters and latrines are up and the school is still in the contractor's hands. Some chairs are engraved but not numbered and most furniture and ICT read not engraved; the terrain is steep, land is encroached on and the site needs fencing.

Figure 311. Classroom block

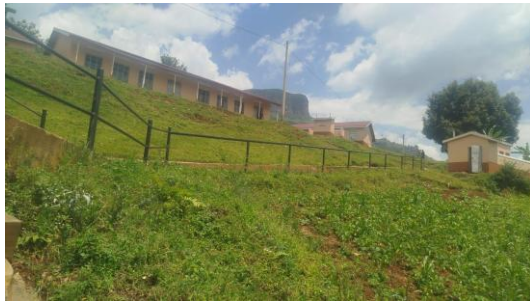
The classroom blocks, laboratory, staff quarters, kitchen, latrines and water tanks stand, and the school is under defect liability. The register marks 17 chairs, 2 laboratory stools and some ICT lines non-functional or stolen; the chairs carry NAMBOKO SEED SEC SCH markings, and the site has no fence.

Figure 315. Classroom block on the slope

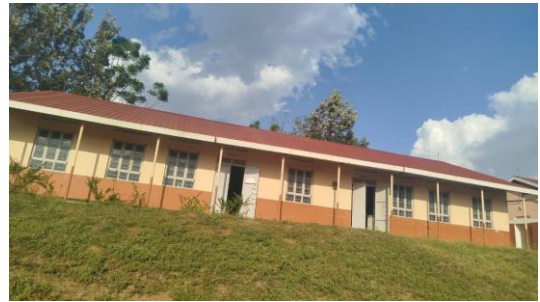
Figure 317. Science laboratory

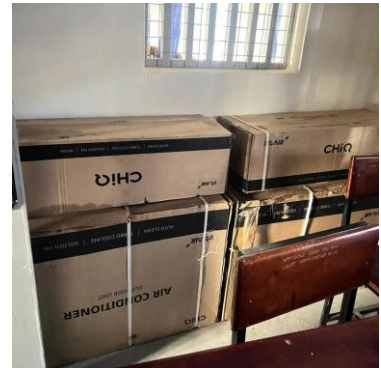
Figure 320. Air conditioners still in their boxes

- Every asset still in its packaging should be opened, counted, taken on charge and put into service, or the reason for holding it recorded in writing. Engraving should not be a reason for withholding equipment from patients, as it is at Nalubembe HC III.
- Power should be connected at the schools that cannot use what they hold - Alerek, Bubentsye, Nansanga, Mugiti and Panyangara - and surge protection fitted where equipment has already been damaged.
- Contractors should assemble the furniture they delivered and it should be counted afterwards, beginning with the 360 laboratory stools at Alerek.
- Buildings in other use should be returned to the purpose they were built for, or the district should record why they are not and what is to be done.

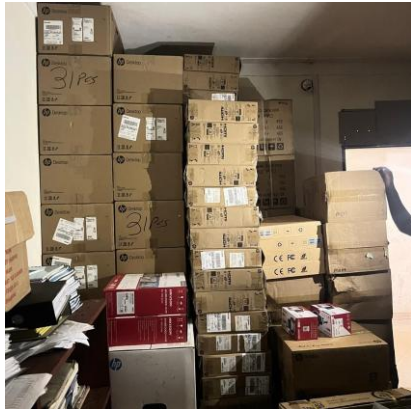
The March 2024 ICT consignment stands boxed to the ceiling of the store, its installation by the contractor still pending. A school letter of 5 February 2025 reports 8 computers stolen from the laboratory, police reference CRB 06/2025; commissioning is delayed and the furniture timber is short.

Figure 321. The ICT consignment stacked to the ceiling of the store

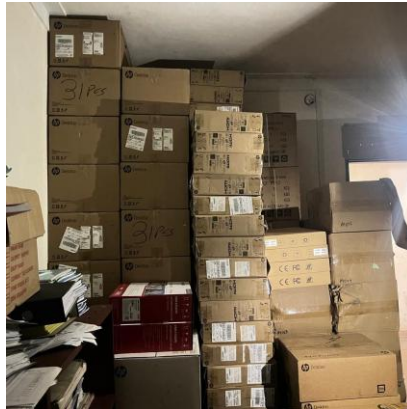
Figure 322. Cartons in the store, still sealed

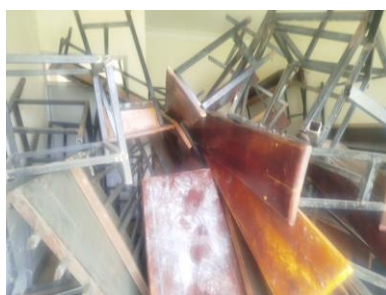
Figure 329. Pile of broken furniture in one of the rooms

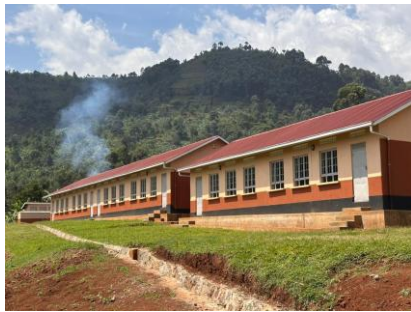
The works are unfinished and the school is not in service. Furniture has been delivered to the site and most of the equipment meant for the school is held at the district; none of it has been counted.

Figure 335. Classroom block, the works still unfinished

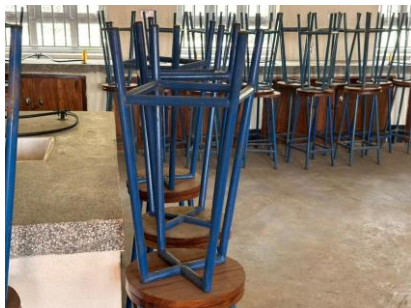
Figure 338. Laboratory stools, stacked and unused

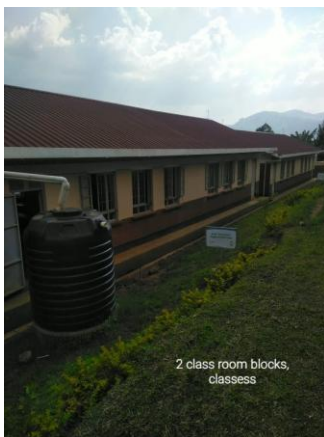
The 6 classroom rooms on 2 blocks were said to be too few, and the 21 computers too few for 100 senior-one learners. A check is done each term and broken furniture set aside for repair; power surges have blown computers, printers, connectors and bulbs, and most lines read not engraved.

Figure 348. The 2 classroom blocks, said to be too few

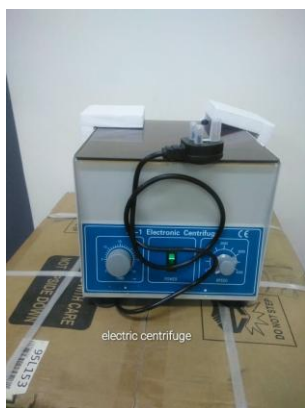
Patient beds, delivery sets, blood pressure machines and oxygen cylinders are in use. Nothing here is engraved or serialised, the centrifuge is unused for want of electricity, and all the unused stock shares one room though space exists elsewhere.

Figure 363. Electric centrifuge, unused for want of power

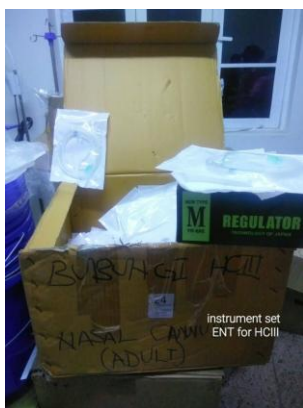
Figure 364. Cartons hand-marked BUBUNGI HC III; nothing here is engraved

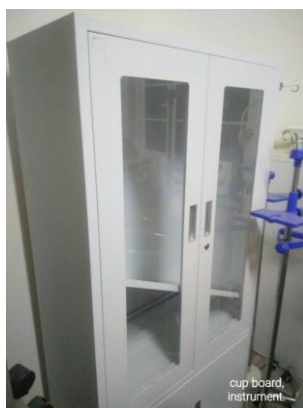
Figure 365. Instrument cupboard and drip stands in the one room the stock shares

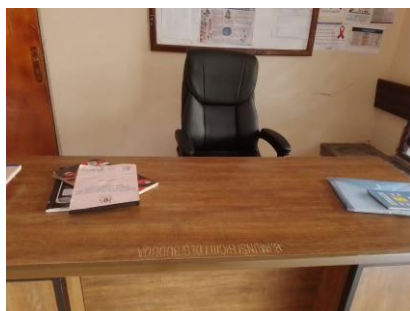
Figure 370. Desk top cut BUMUSI HCIII / DLG BUDUDA, the district's name and not the programme's

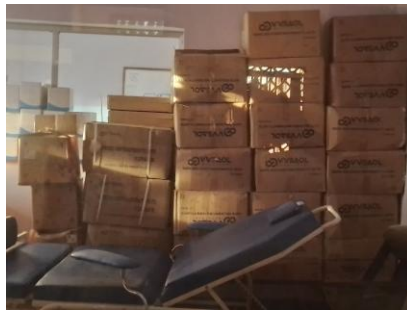
Figure 374. Safe delivery treatment kits, still boxed

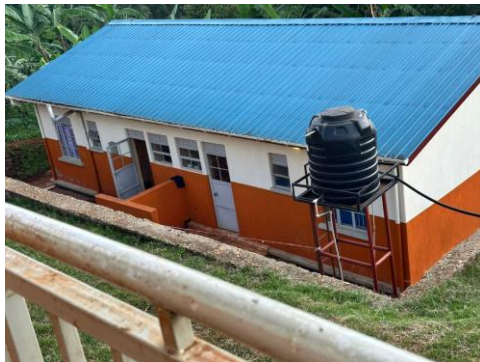
The assets are cut BUD/DLG/BUNAMONO HC 111 with a number, which is the clearest identification in the district, though none carries the programme's initials. The water tank does not work: the solar that should pump it is not connected, so the staff houses have no water.

Figure 376. The block and the water tank the solar does not pump

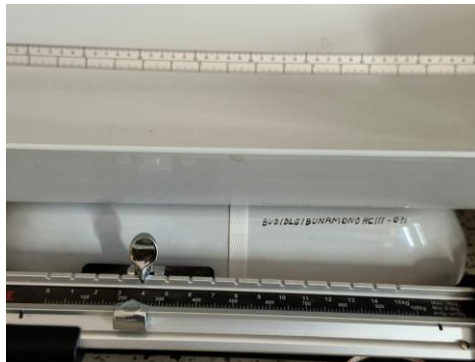
Figure 377. Weighing scale beam marked BUD/DLG/BUNAMONO HCIII with a number

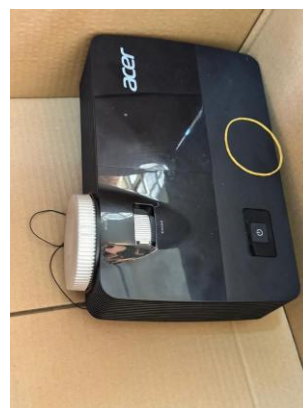
The furniture is engraved throughout: the chairs, lecture benches, laboratory benches and stools are all cut BUGITIMWA S.S.S. The assets were handed over the month before the visit and are in excellent condition; a sound system and a projector stand boxed, and the school needs more staff housing.

Figure 395. Projector still in its carton

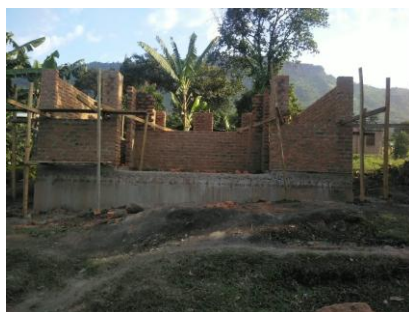
The programme gave the facility a delivery room and a maternal and child health room and supplied the equipment it works with; the medical laboratory building is unfinished and going up slowly. The facility keeps its own inventory register with no cost against any line, and engraving was reported as a challenge but recorded against no item.

Figure 397. Medical laboratory building, unfinished

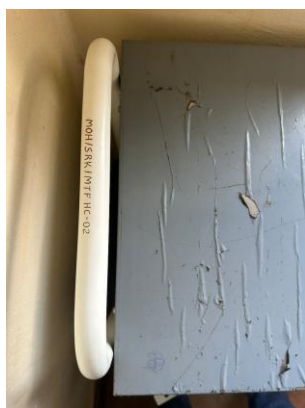
This is the one facility in the district where an individual asset can be identified again, the items carrying numbers in 2 hands: one cot bed reads HC-24 and FURN 023 at once, and which is the number of record is unsettled. The wall plaster is flaking and an oxygen concentrator lies in its carton.

Figure 409. Locker handle engraved MOH/SRK/MTF HC-02

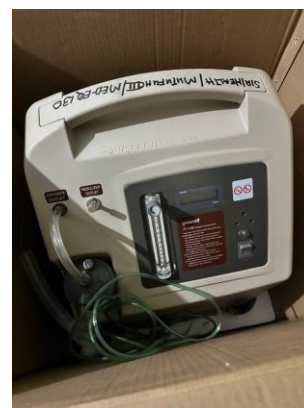
Figure 412. Oxygen concentrator lying in its carton

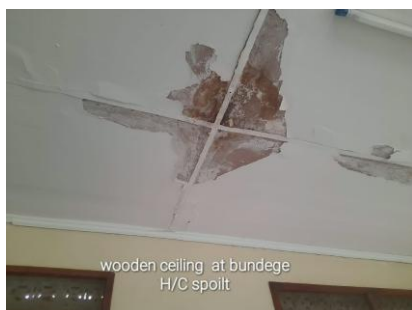
The programme renovated the old outpatient block into laboratory space and supplied a microscope and other equipment. The ceiling is water-damaged, cupboard doors give way when packed, taps at the dispensary fail, and nothing here is engraved or serialised. Beds were taken from the facility under the District Health Officer.

Figure 416. Wooden ceiling spoiled by water

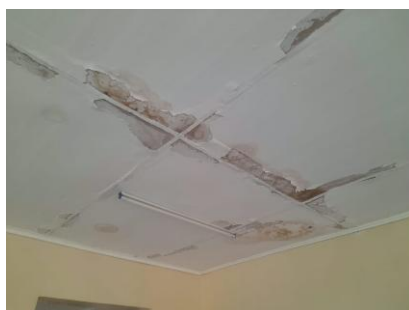
Figure 417. Water damage across a second ceiling

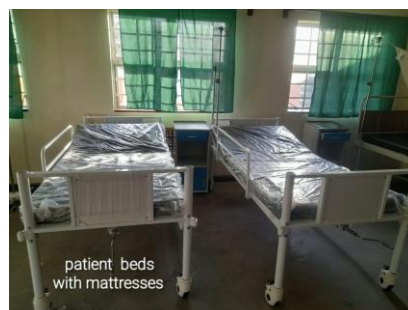
Figure 418. Patient beds with mattresses

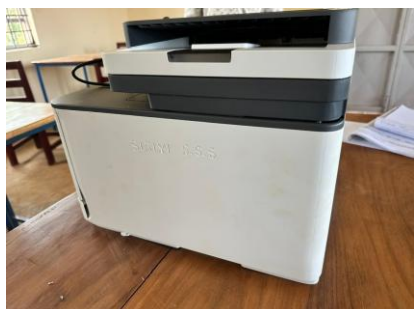
The assets are engraved throughout: SISIYI S.S.S is cut into the chairs, tables, laboratory stools, computer towers and printer, which is the best marking seen in the sub-region. The gable of a staff house is cracked from the eaves to the plinth, and the school reports a shortage against the district's computer schedule.

Figure 426. Multipurpose printer engraved SISIYI S.S.S

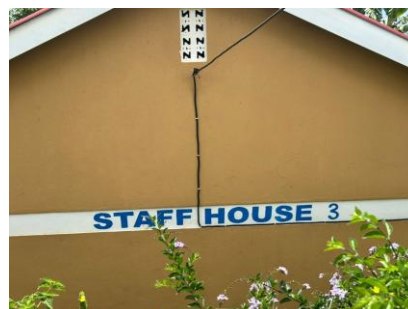
Figure 427. Staff house gable, cracked from the eaves to the plinth

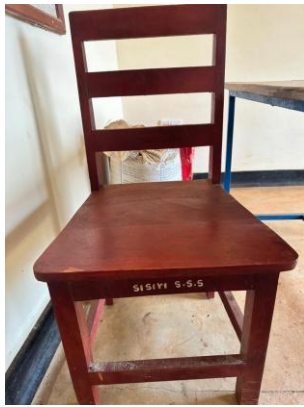
Figure 428. Classroom chair cut  
SISIYI S.S.S

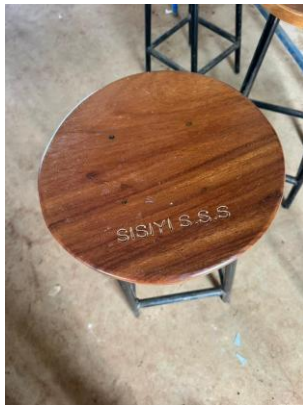
Figure 429. Laboratory stool  
carrying the same mark

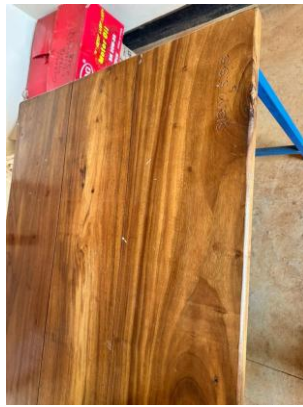
Figure 430. Table top carrying the  
same mark

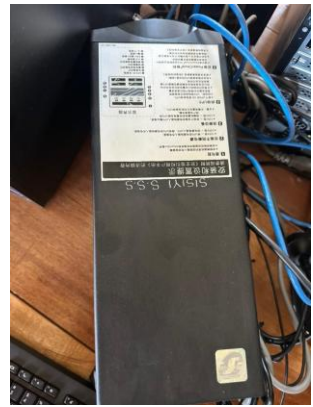
Figure 431. Uninterruptible power  
supply, marked in the same way

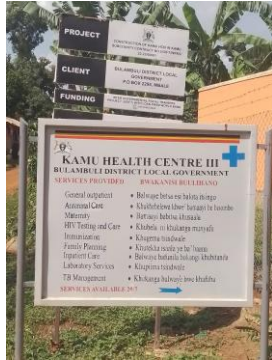
Almost every register line reads working; 2 of the 8 patient screens are faulty. A steel drum lid and 3 buckets carry GOU/MOH - UGIFT PROJECT FY2023/2024 in lettering applied to the surface rather than cut in. The facility is Bukhalu on the programme list and Kamu on its own signboard.

Figure 433. Signboard reads Kamu Health Centre III; the list says Bukhalu

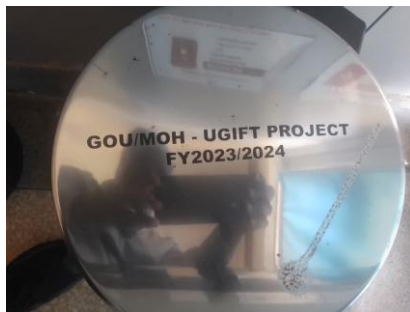
Figure 436. Drum lid lettered GOU/MOH - UGIFT PROJECT FY2023/2024 on the surface, not cut in

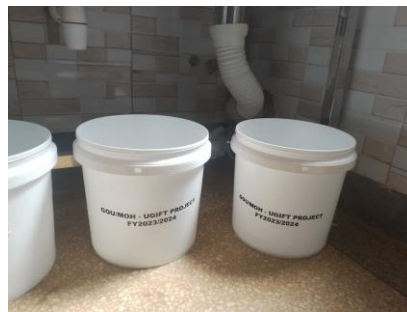
Figure 437. 3 lidded buckets lettered the same way

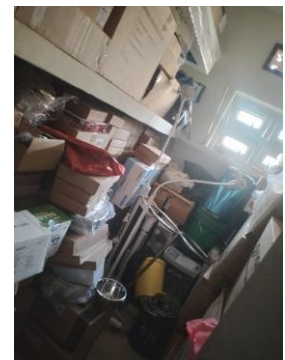
Figure 441. Store stacked with cartons

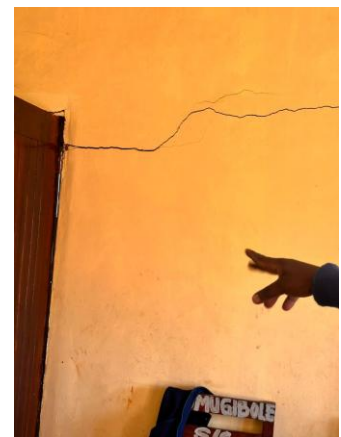
The assets that can take a mark are cut BUMU/2020-2021/UGIFT, which is the programme's own mark with the financial year, though without an asset number. The staff house has deep cracks, the medical staff left it as unsafe and the police now occupy it; one of 3 water tanks still works.

Figure 477. Deep crack running across an interior wall

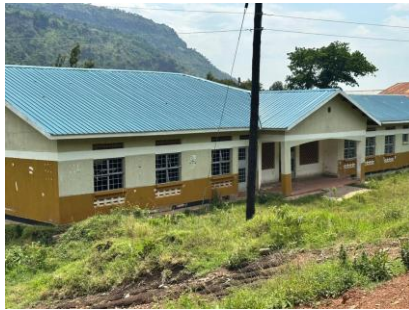
The works were destroyed by mudslides before they were finished: ground has fallen away under one corner of the block and a crack runs across the wall. People from this catchment now get care at the Simu sub-county offices, and the equipment supplied for the facility sits in the district stores, unlisted.

Figure 478. The block as built, seen along the slope

- **New works are failing before or soon after handover.** Bukibologoto HC II was destroyed by mudslides before its works were finished and no longer stands. The staff house at Bumugibole HC III has deep cracks, the medical staff have left it and the police now occupy it. A staff house gable at Sisiyi is cracked from eaves to plinth; toilet blocks at Iriiri and Napak are cracked; the ceiling at Bundege HC III is water-damaged; Namboko's latrine foundation is undermined.

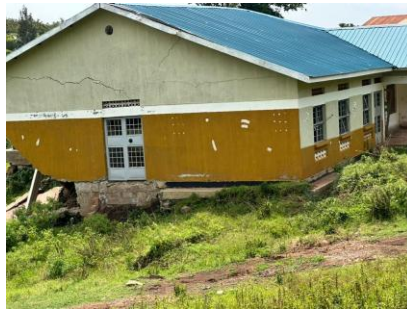
Figure 479. The block standing over ground that has fallen away

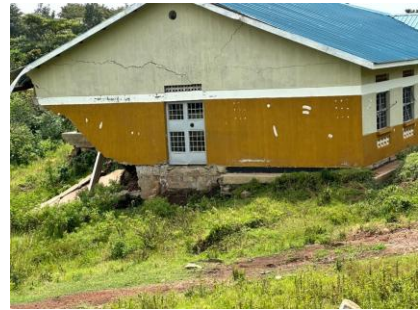
Figure 480. The corner where the ground went from under the foundation

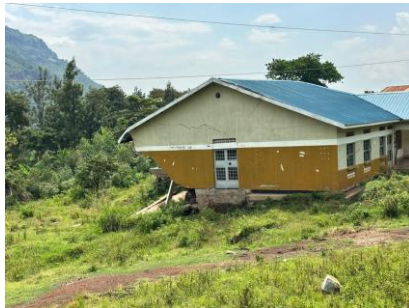
Figure 481. The same corner from the approach

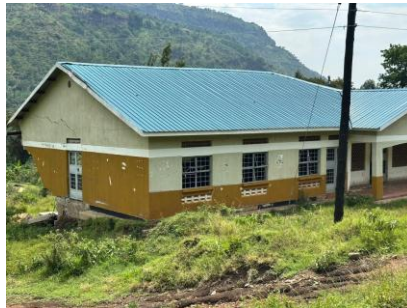
Figure 482. Crack running across the end wall

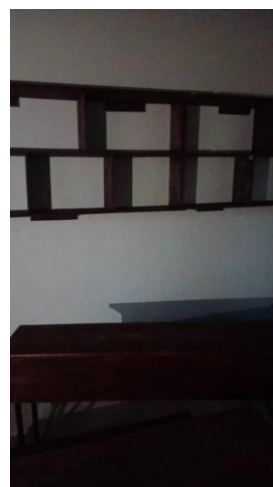
None of the assets here is in use, the school not having been handed over, and none of them is engraved. The desktop computers stand in the store in their cartons.

Figure 494. Chairs, none of them yet in use

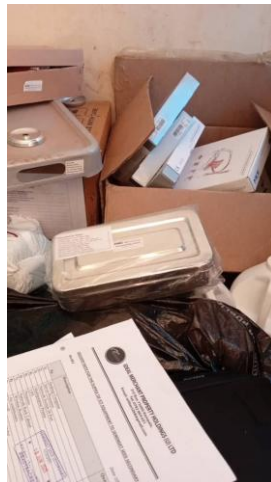
Figure 508. Kidney dishes in their packaging

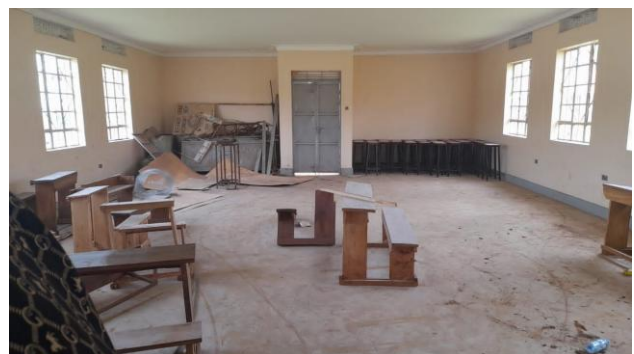
Figure 565. Library, its tables and book shelves missing

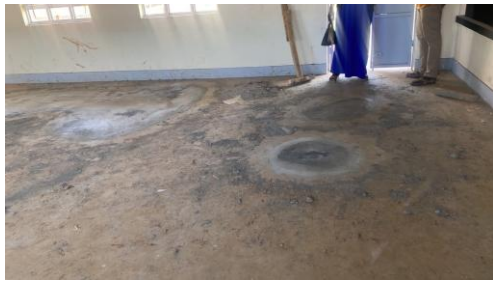
Figure 576. Cracked classroom floor

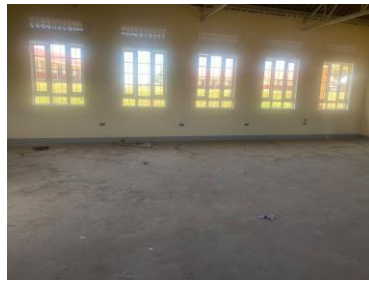
Figure 577. Laboratory, incomplete and with no power supply

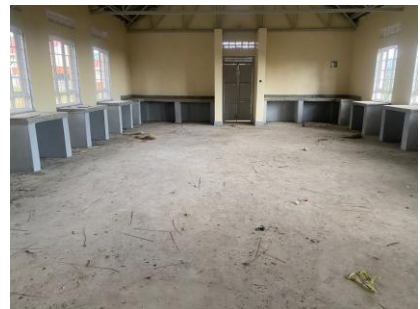
Figure 583. Computer laboratory, with no power supply
