UGANDA INTERGOVERNMENTAL FISCAL TRANSFERS PROGRAMME

# FIELD REPORT ON UgIFT ASSET VERIFICATION

Karamoja, Bukedi, Bugisu / Mount Elgon and Sebei

Fieldwork 24 August to 3 September 2026

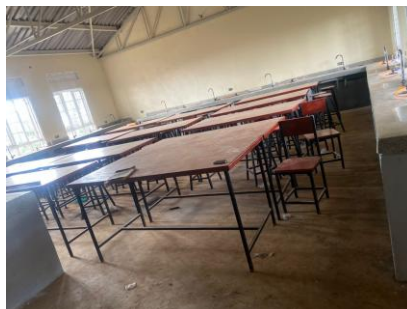
Figure 585. Science laboratory, not complete

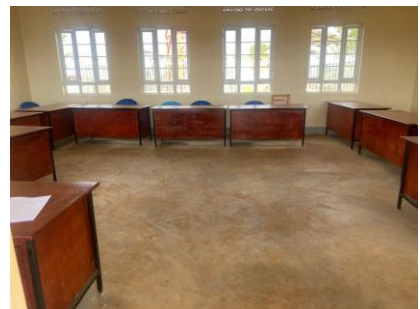
Figure 586. Science laboratory tables, recorded not engraved

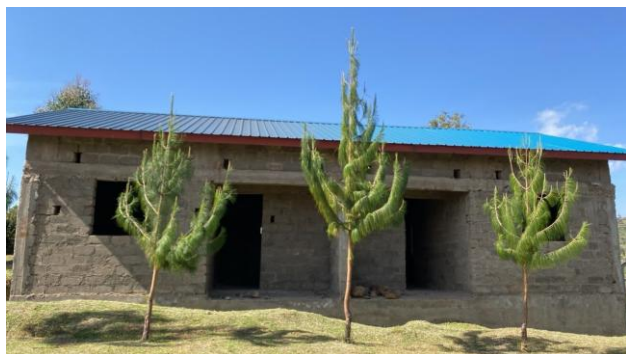
The maternity ward is in use. The staff quarters are unroofed and unfinished, the waiting area has not been handed over, and the equipment is packed in one store of which only part was counted. No engraving status was recorded here.

Figure 588. Staff quarters, unroofed and unfinished

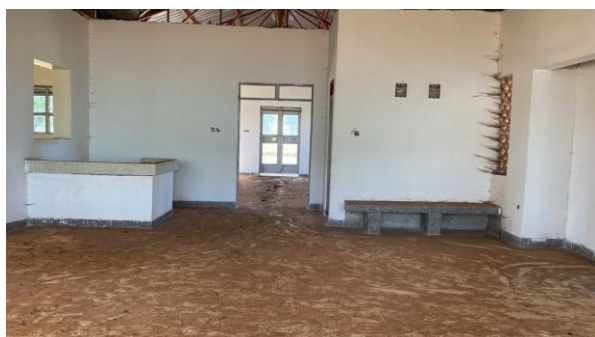
Figure 590. Waiting area, not yet handed over

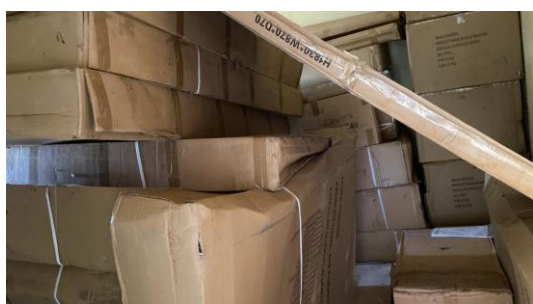
Figure 593. Instruments packed in the one store

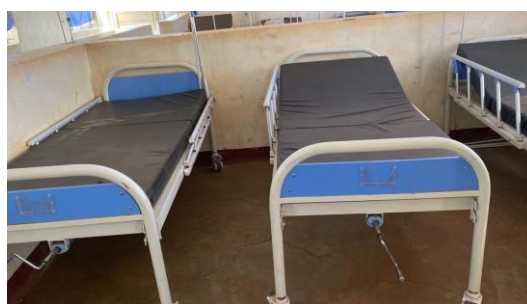
Figure 594. Beds in use; one of the 26 is not functional

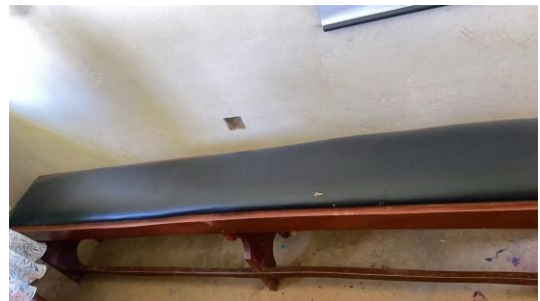
Figure 600. Benches recorded not engraved

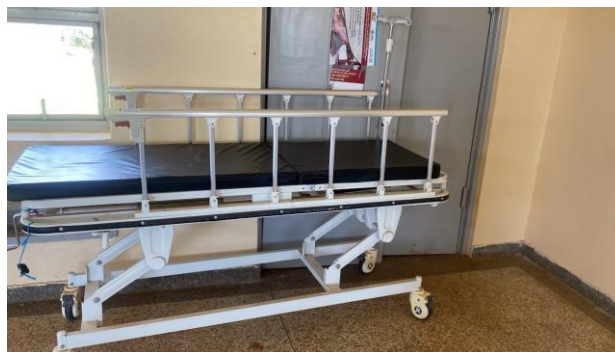
Figure 602. Stretchers, recorded not engraved

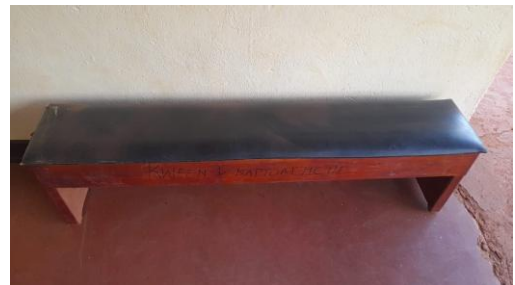
Figure 614. Benches, recorded not engraved

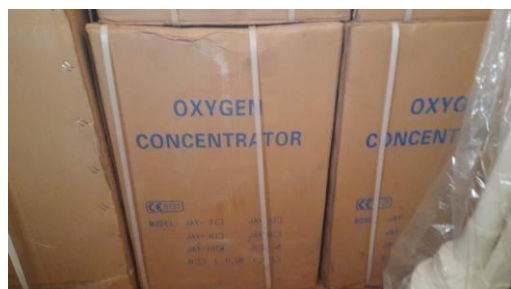
Figure 615. 4 oxygen concentrators, not in use and still in their cartons

- Every asset still in its packaging should be opened, counted, taken on charge and put into service, or the reason for holding it recorded in writing. Engraving should not be a reason for withholding equipment from patients, as it is at Nalubembe HC III.
- Power should be connected at the schools that cannot use what they hold - Alerek, Bubentsye, Nansanga, Mugiti and Panyangara - and surge protection fitted where equipment has already been damaged.
- Contractors should assemble the furniture they delivered and it should be counted afterwards, beginning with the 360 laboratory stools at Alerek.
- Buildings in other use should be returned to the purpose they were built for, or the district should record why they are not and what is to be done.

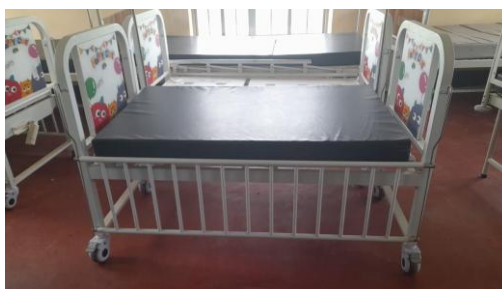
Figure 616. 3 paediatric beds, not in use

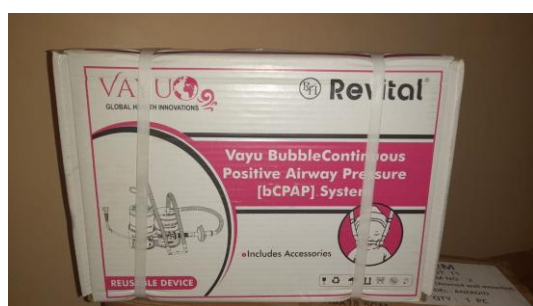
Figure 618. Bubble CPAP units, boxed and not in use

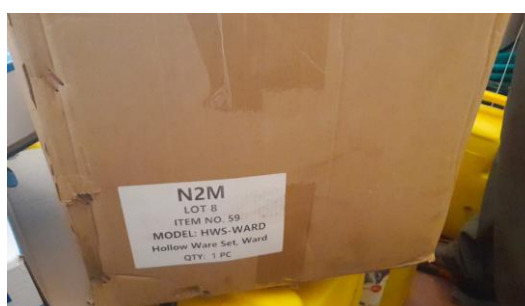
Figure 619. Hollow ware set, still in its carton

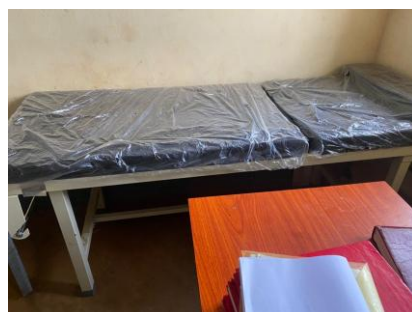
Figure 621. Examination couch, in use

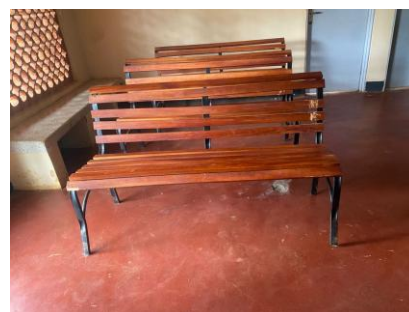
Figure 623. Benches, recorded not engraved

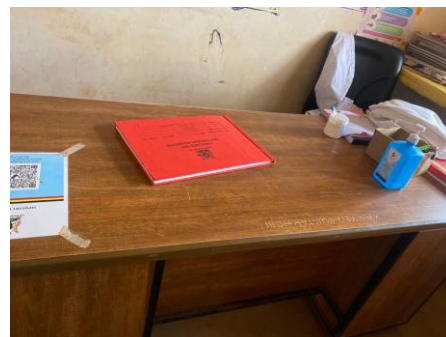
Figure 626. Desks, recorded not engraved

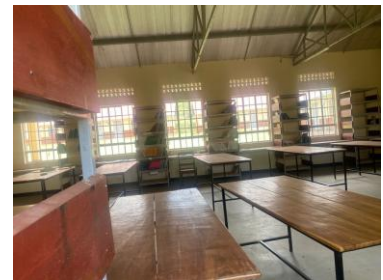
Figure 649. Classroom desks, recorded not engraved

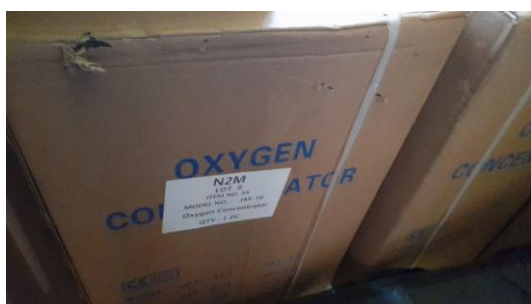
Figure 654. 3 oxygen concentrators, still in their box

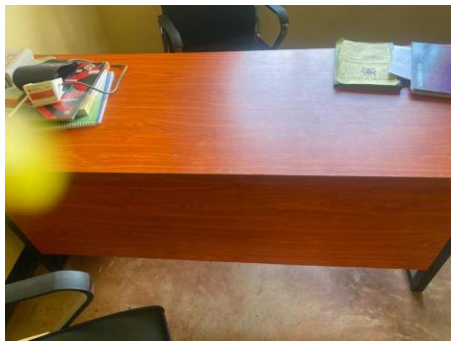
Figure 661. Office desk, recorded not engraved
