# UgIFT Asset Verification Report

*Field findings, service gaps and recommended actions*

Ministry of Finance, Planning and Economic Development

27 September 2026

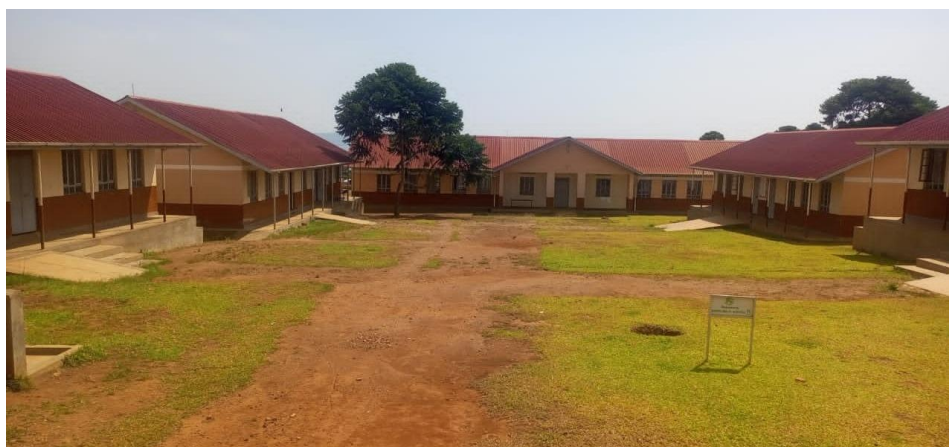
Figure 5: School buildings and courtyard at a seed secondary school, Buvuma District (Buganda)

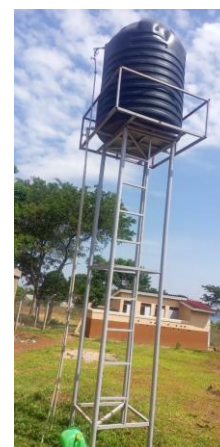
Figure 6: Raised water storage tank at a seed secondary school, Buvuma District (Buganda)

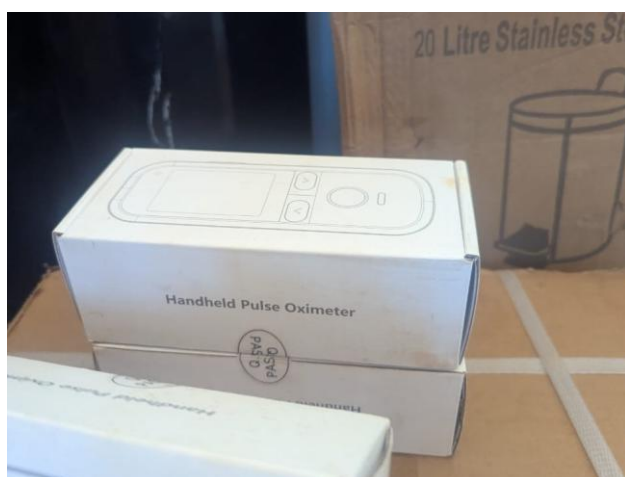
Figure 7: Boxed pulse oximeters at a health centre, Makindye-Ssabagabo Municipal Council (Buganda)

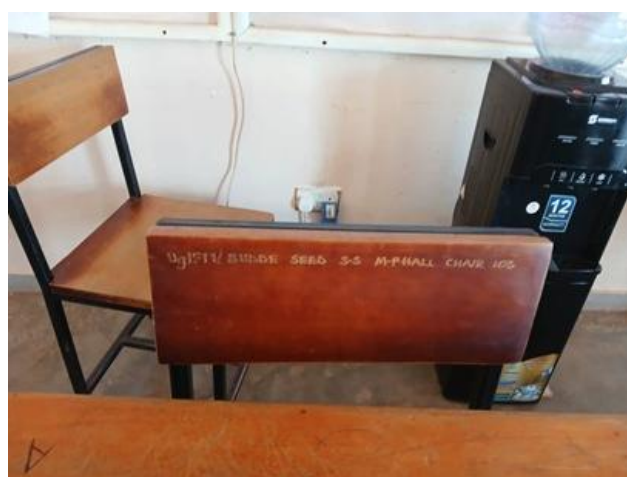
Figure 8: Programme and school engraving on a chair at Budde Seed Secondary School, Butambala District (Buganda)

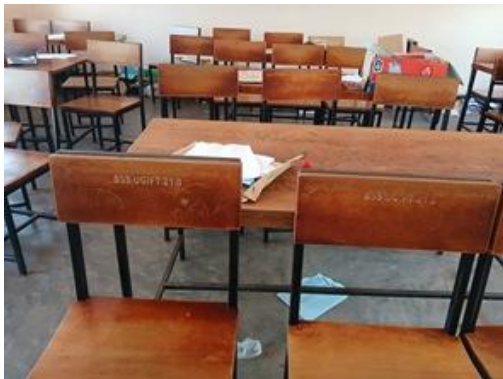
**Figure 9: Desks and chairs bearing asset identification at Budde Seed Secondary School, Butambala District (Buganda)**

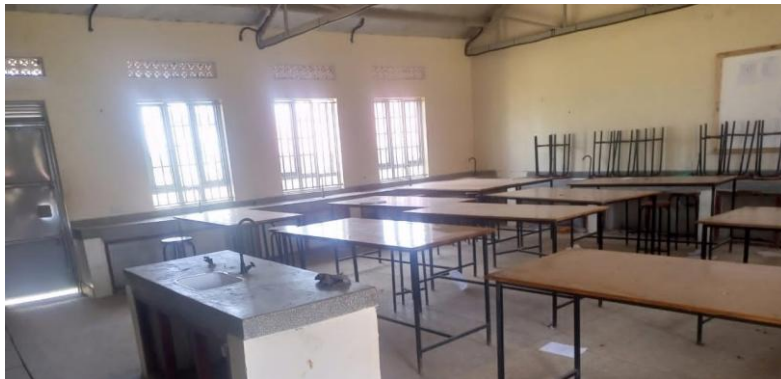
**Figure 10: Laboratory benches and sinks at Bweema Seed Secondary School, Buvuma District (Buganda)**

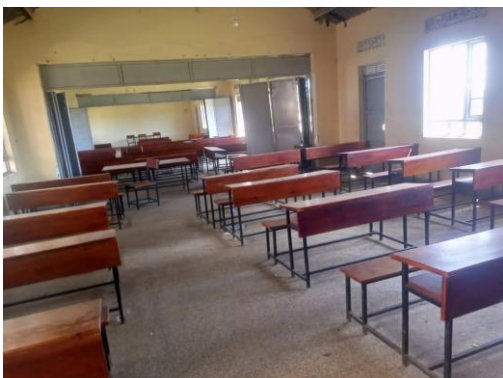
**Figure 11: Classroom desks at Bweema Seed Secondary School, Buvuma District (Buganda)**

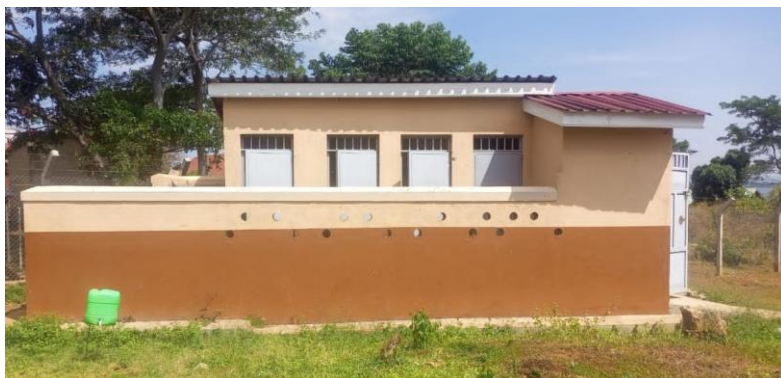
**Figure 12: Sanitation block at Bweema Seed Secondary School, Buvuma District (Buganda)**

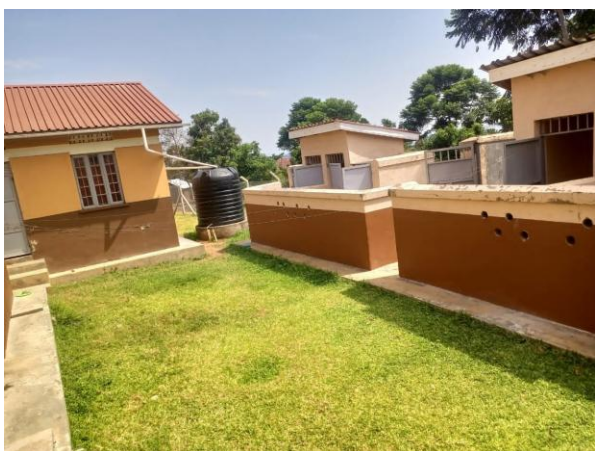
**Figure 13: Water tank and enclosed service structures at Bweema Seed Secondary School, Buvuma District (Buganda)**

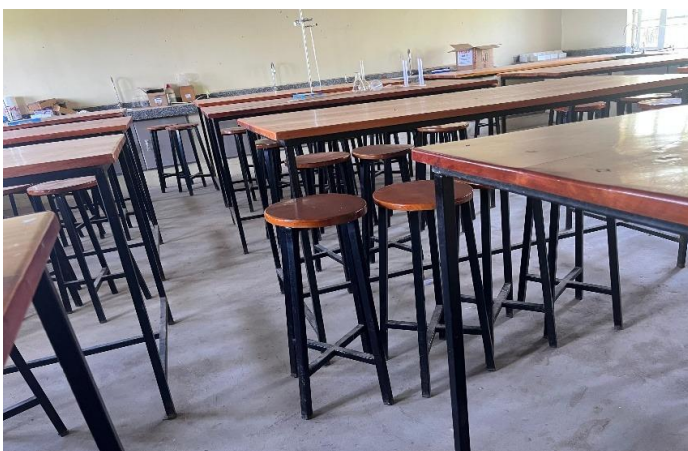
**Figure 14: Science laboratory tables and stools at a seed secondary school, Kalangala District (Buganda)**

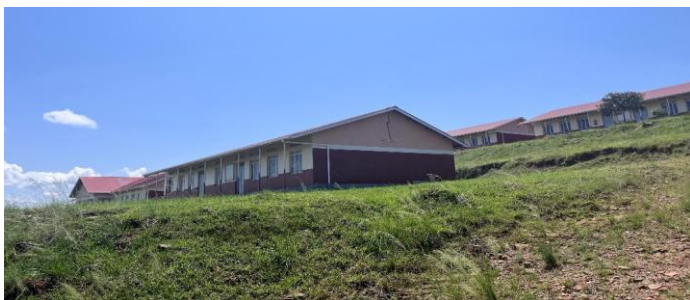
**Figure 15: School blocks at Gyagenda Memorial Seed Secondary School, Kalangala District (Buganda)**

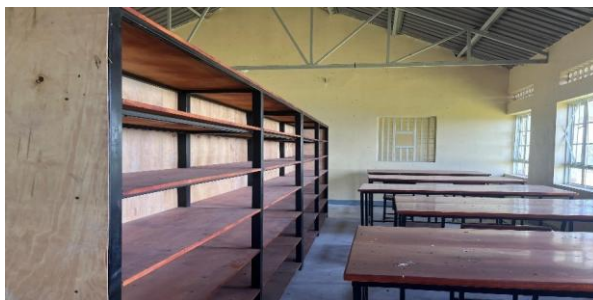
**Figure 16: Library shelves and reading tables at Gyagenda Memorial Seed Secondary School, Kalangala District (Buganda)**

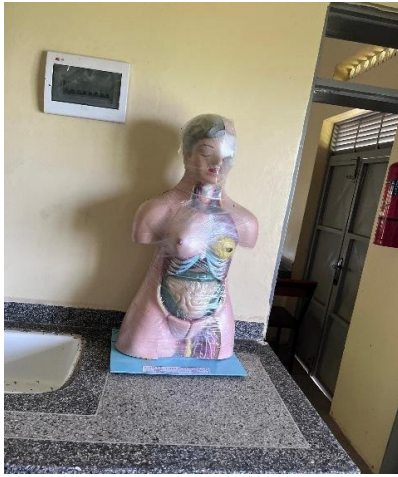
**Figure 17: Anatomical teaching model at Gyagenda Memorial Seed Secondary School, Kalangala District (Buganda)**

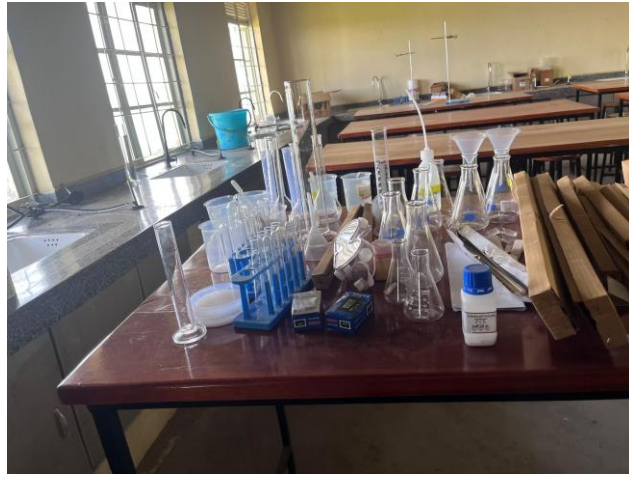
**Figure 18: Laboratory glassware and equipment at Gyagenda Memorial Seed Secondary School, Kalangala District (Buganda)**

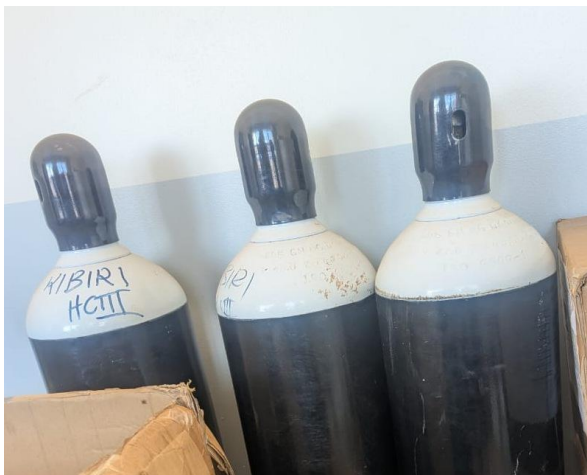
**Figure 19: Oxygen cylinders at Kibiri HC III, Makindye-Ssabagabo Municipality (Buganda)**

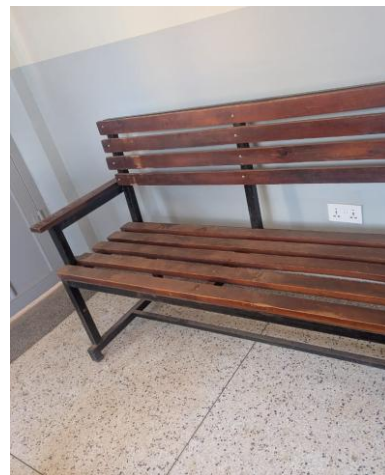
**Figure 20: Wooden waiting bench at Kibiri HC III, Makindye-Ssabagabo Municipal Council (Buganda)**

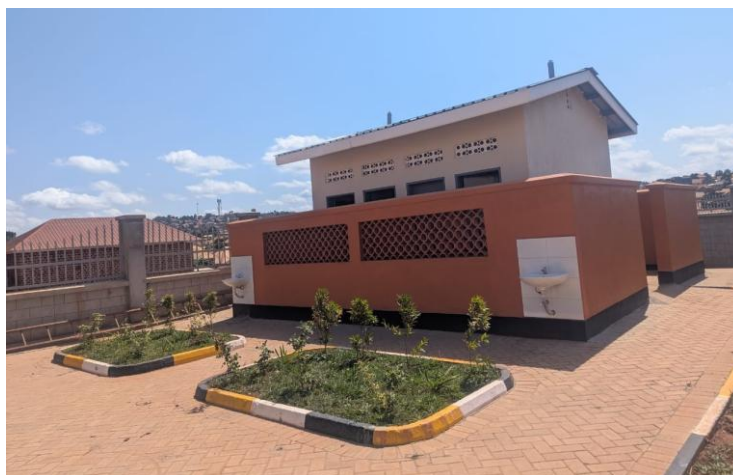
**Figure 21: Sanitation block with external handwashing basins at Kibiri HC III, Makindye-Ssabagabo Municipal Council (Buganda)**

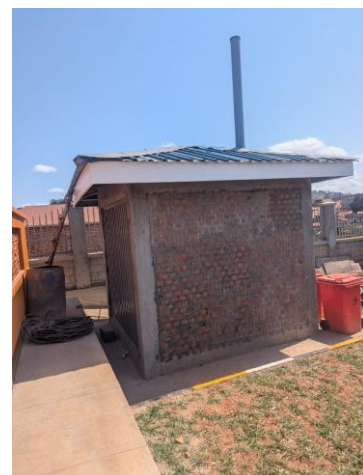
**Figure 22: Waste disposal structure at Kibiri HC III, Makindye-Ssabagabo Municipal Council (Buganda)**

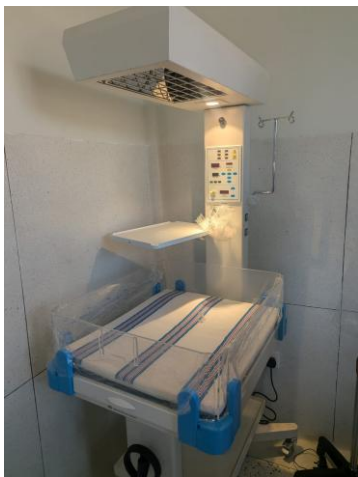
**Figure 23: Infant radiant warmer at a health centre, Makindye-Ssabagabo Municipal Council (Buganda)**

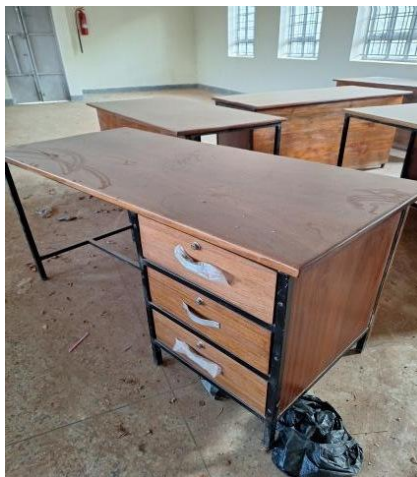
**Figure 24: Office desk and other furniture at Lwamata Town Council Seed Secondary School, Kiboga District (Buganda)**

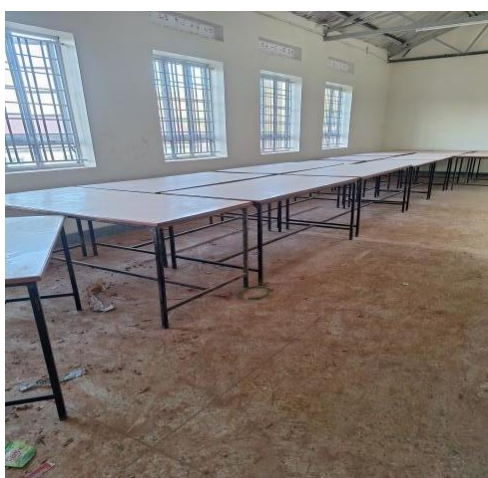
**Figure 25: Laboratory tables at Lwamata Town Council Seed Secondary School, Kiboga District (Buganda)**

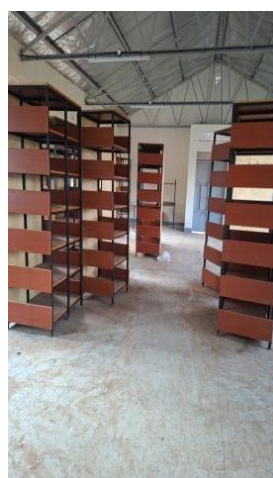
**Figure 26: Library shelving at Lwamata Town Council Seed Secondary School, Kiboga District (Buganda)**

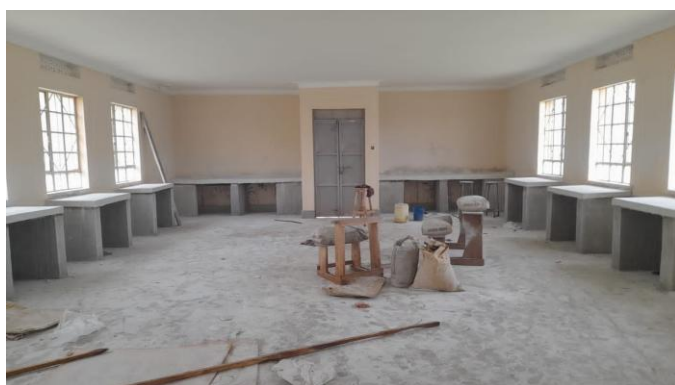
**Figure 27: ICT laboratory interior under construction at Kitawoi Seed Secondary School, Kween District (Sebei)**

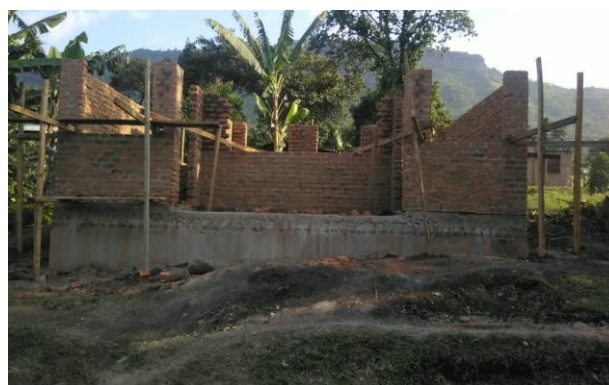
**Figure 28: Unfinished laboratory building at a health centre, Sironko District (Bugisu)**

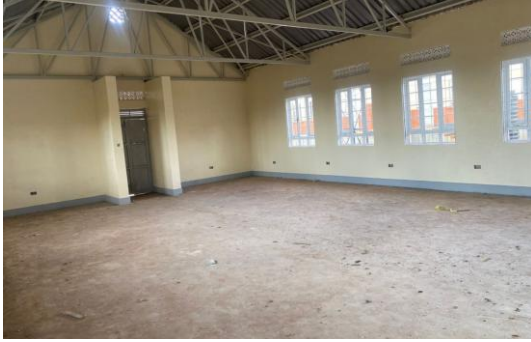
**Figure 29: Empty computer laboratory at a seed secondary school, Kween District (Sebei)**

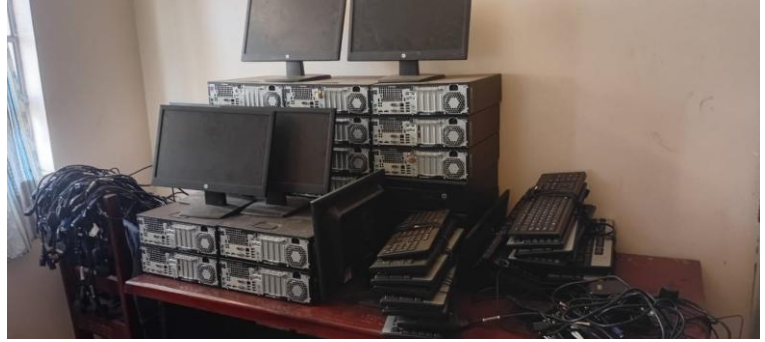
**Figure 30: Computer sets stacked in a store at Bumufuni Seed Secondary School, Bulambuli District (Bugisu)**

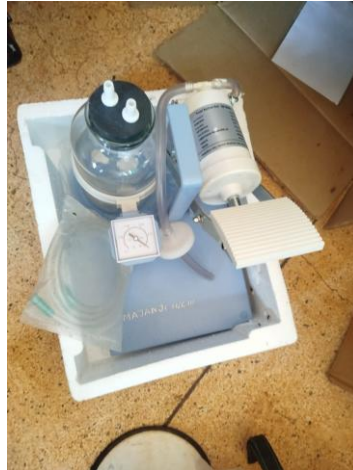
**Figure 31: Pedal suction unit in packaging at Majanji HC III, Busia District (Bukedi)**

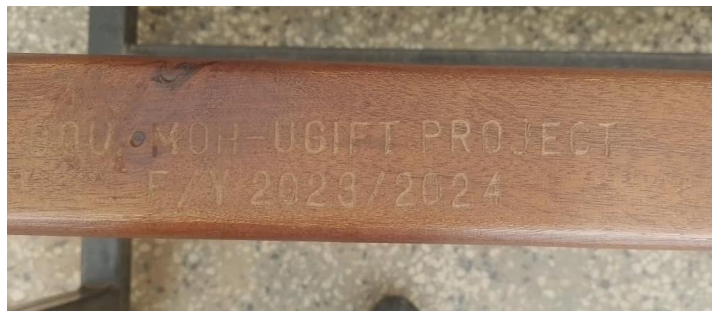
**Figure 36: UglIFT engraving on a health centre bench, Bududa District (Bugisu)**

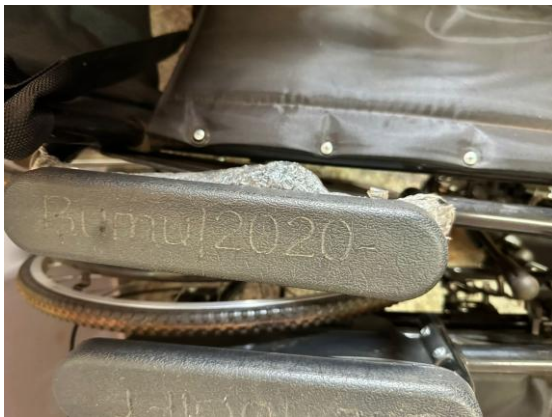
**Figure 37: Engraving on a wheelchair armrest at Bumugibole HC III, Bulambuli District (Bugisu)**

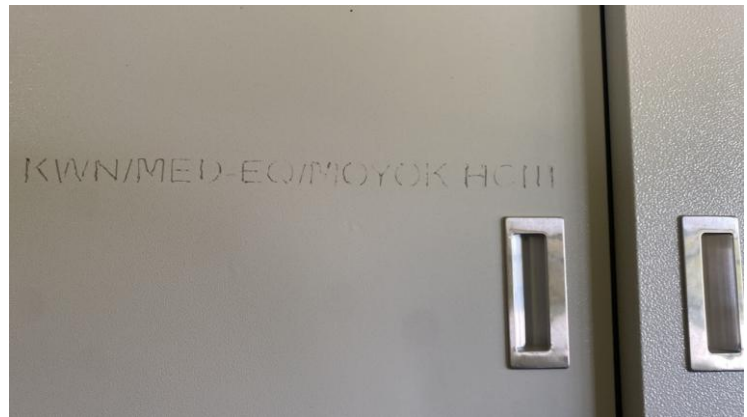
**Figure 38: Institutional engraving on equipment at Moyok HC III, Kween District (Sebei)**

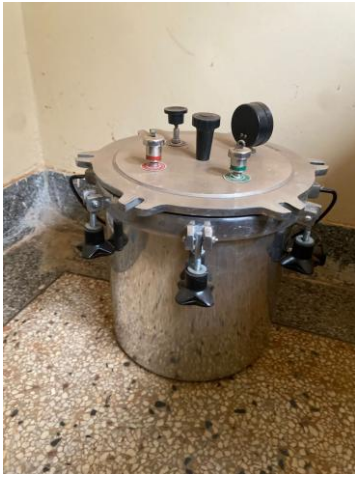
**Figure 39: Autoclave at Atar HC III, Kween District (Sebei)**

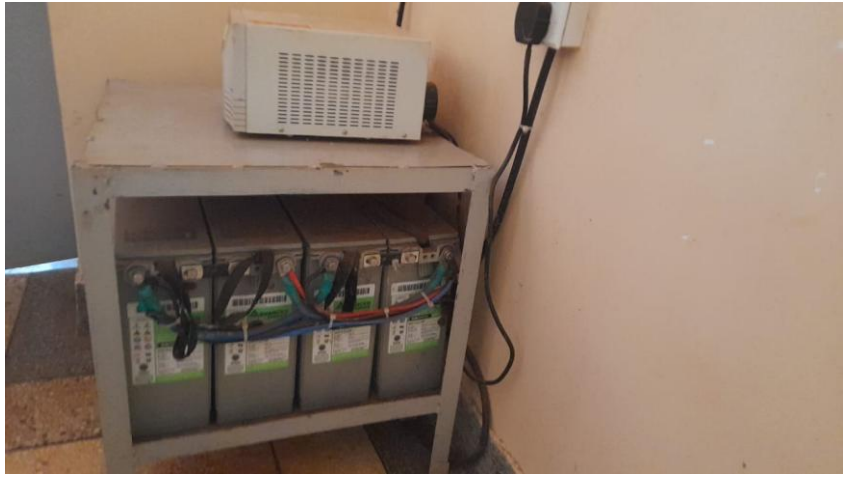
**Figure 40: Solar batteries and control equipment at Atar HC III, Kween District (Sebei)**

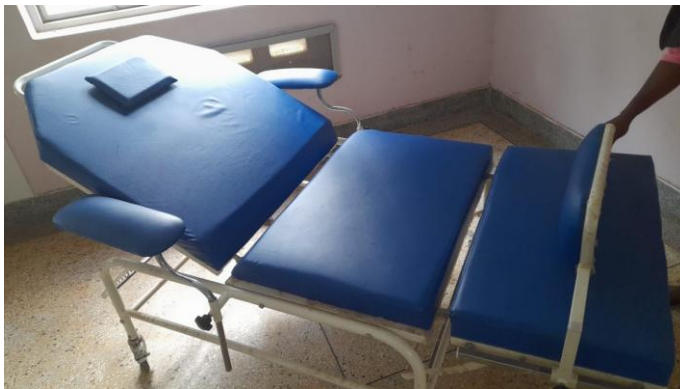
**Figure 41: Kangaroo care chair at Atar HC III, Kween District (Sebei)**

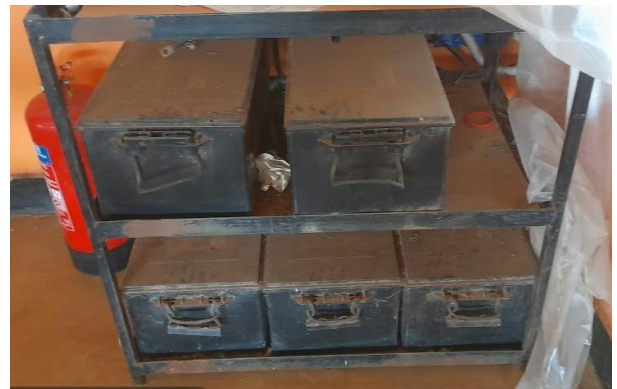
**Figure 42: Solar batteries at Bunangaka HC III, Bulambuli District (Bugisu)**

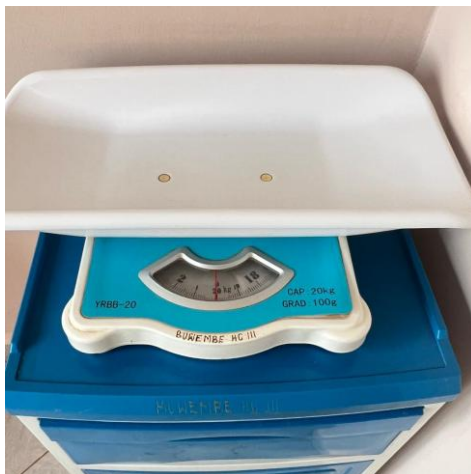
**Figure 43: Infant weighing scale at Buwembe HC III, Busia District (Bukedi)**

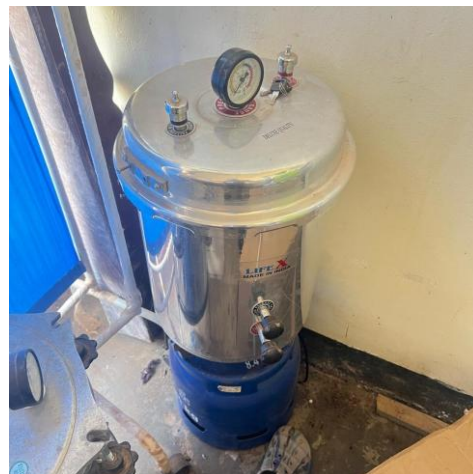
**Figure 44: Autoclave above a gas cylinder at Buwembe HC III, Busia District (Bukedi)**

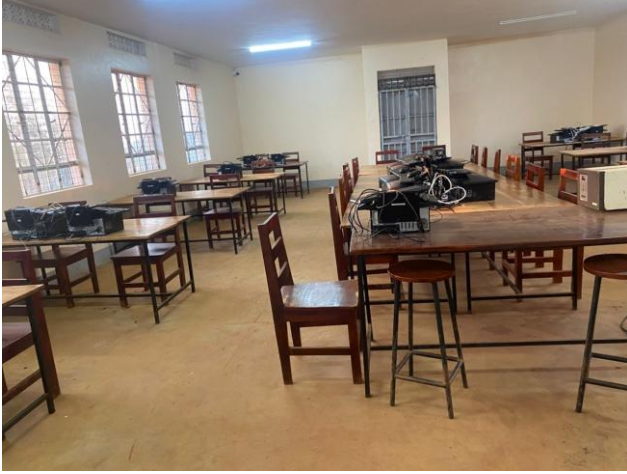
**Figure 45: Computer equipment in the school ICT room at Kabeywa Seed Secondary School, Kapchorwa District (Sebei)**

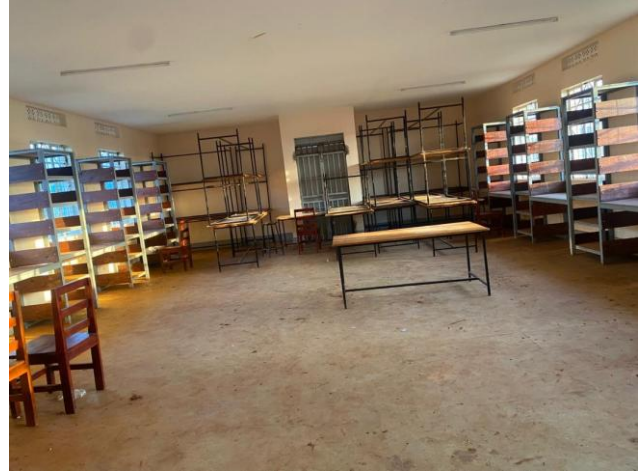
**Figure 46: Library shelving and tables at Kabeywa Seed Secondary School, Kapchorwa District (Sebei)**

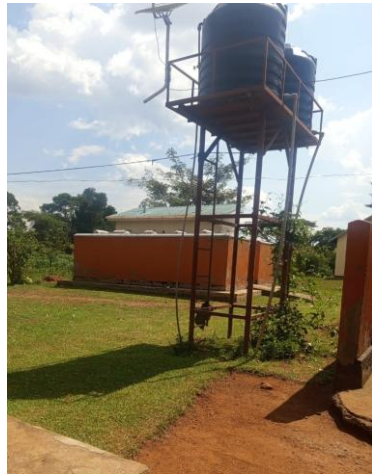
**Figure 47: Water tanks on a steel tower at Kabweri HC III, Kibuku District (Bukedi)**

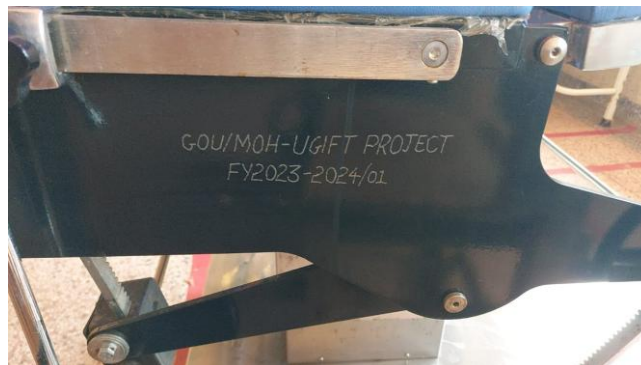
Figure 62: Programme engraving on a weighing scale at Kalemungole HC III, Moroto District (Karamoja)

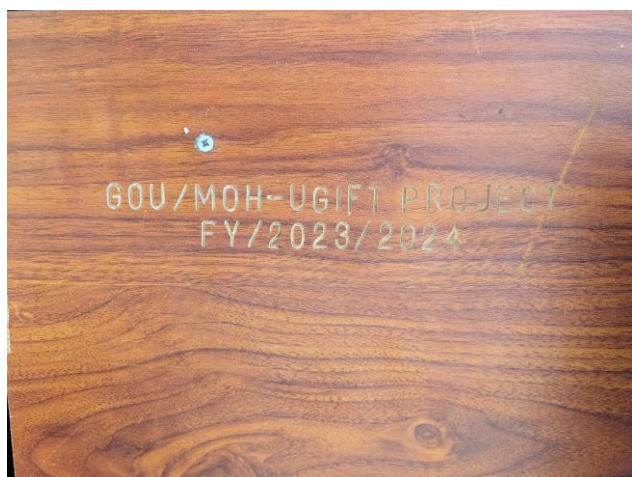
Figure 63: Programme engraving on a delivery bed at Kalemungole HC III, Moroto District (Karamoja)

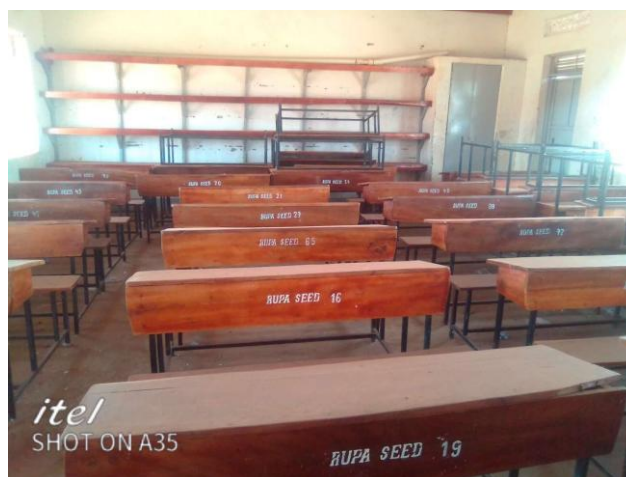
Figure 64: Programme engraving on a table at Kamoru HC III, Kotido District (Karamoja)

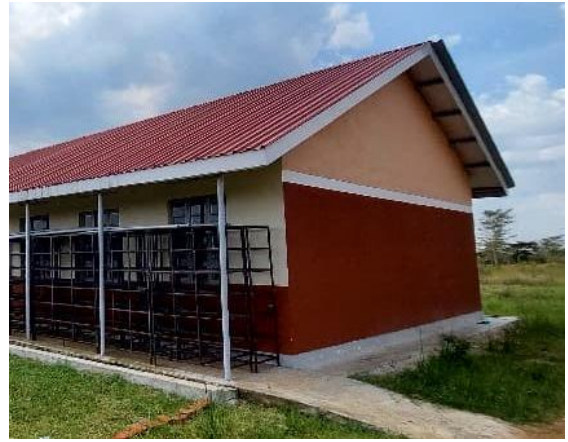
**Figure 68: Health centre building, Nwoya District (Acholi)**

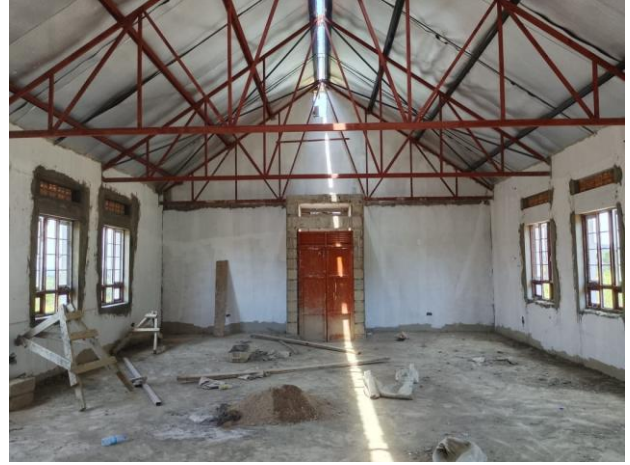
**Figure 89: Library interior under construction at Kihungya Seed Secondary School, Buliisa District (Bunyoro)**
