**CONSULTANCY SERVICES TO VERIFY AND RECORD ASSETS  
UNDER THE UGIFT PROGRAMME**

**REF: MOFPED/UGIFT/CONS/25/26/00015**

**ASSET VERIFICATION REPORT**

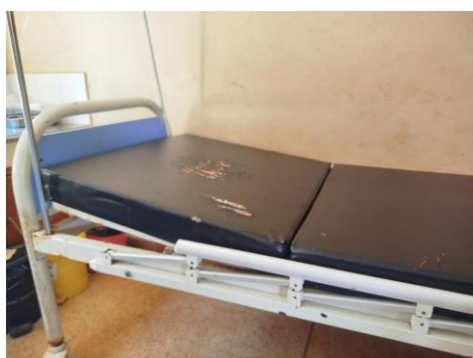
**Figure 4: Delivery bed with a torn mattress cover at a health centre, Busia District (Bukedi)**

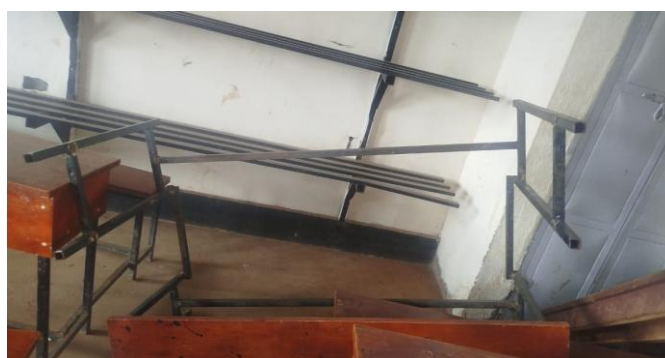
**Figure 6: Broken desk frame at a seed secondary school, Namisindwa District (Bugisu)**

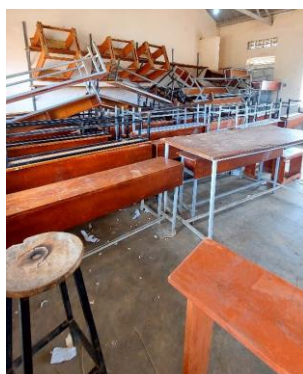
**Figure 7: Stacked desks, chairs and stools, some recorded as broken and none engraved, at Napak Seed Secondary School, Napak District (Karamoja)**

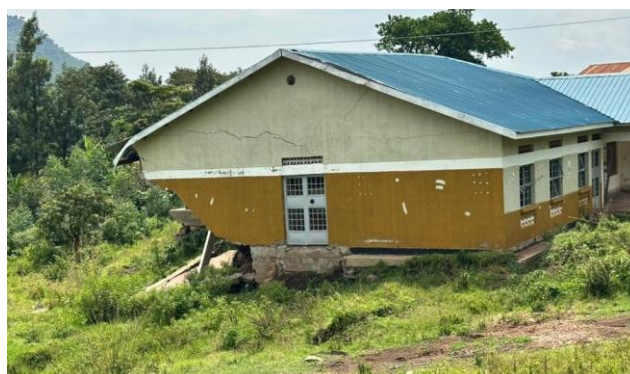
**Figure 8: Cracked health centre block above collapsed ground, Bulambuli District (Bugisu)**

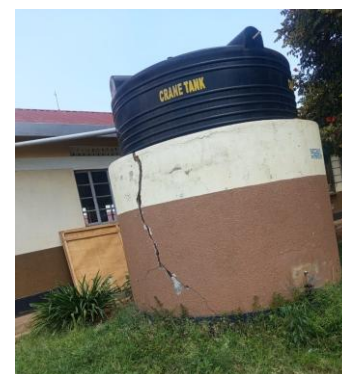
**Figure 9: Water tank on a cracked base at a seed secondary school, Kibuku District (Bukedi)**

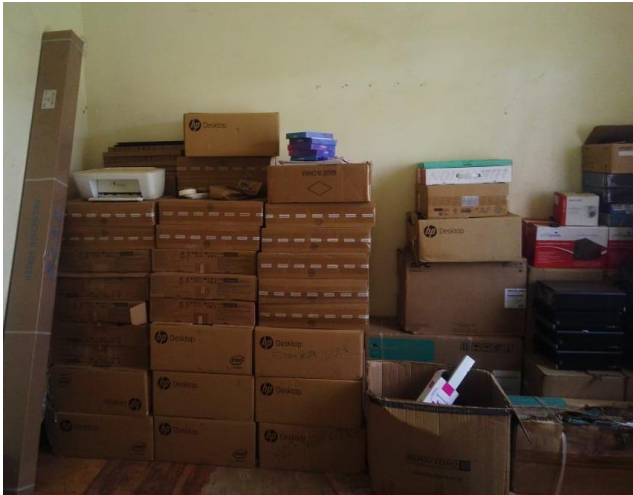
**Figure 12: Desktop computers, a printer and UPS units still boxed in the store at Lungulu Seed Secondary School, Nwoya District (Acholi), awaiting a power connection for installation**

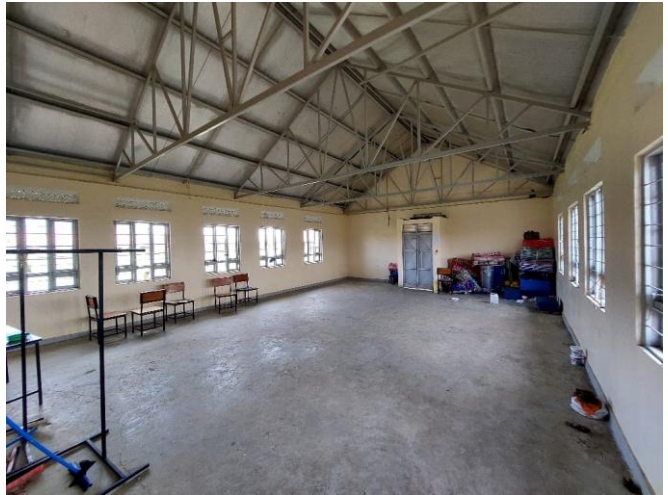
**Figure 13: Largely empty ICT and library block with a few chairs and items kept in one corner at Iriiri Seed Secondary School, Napak District (Karamoja), not yet in use while the school remained with the contractor**

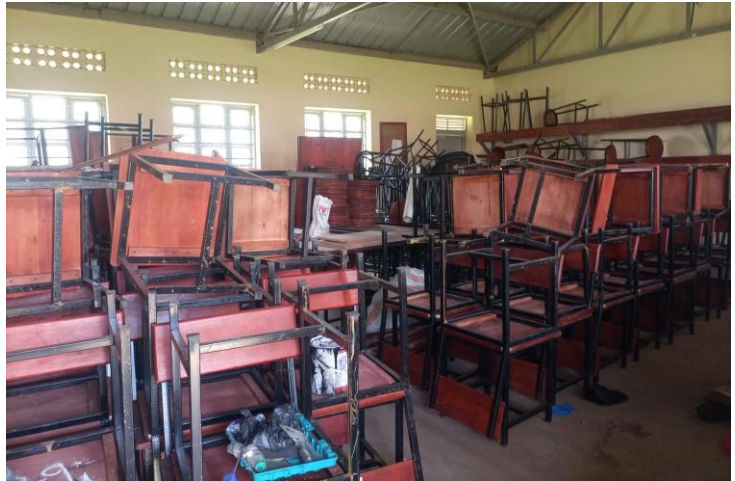
**Figure 17: Chairs, desks and laboratory stools stacked in a hall at King Solomon Seed Secondary School, Kagadi District (Bunyoro), where most assets remained in storage because the school was still under construction**

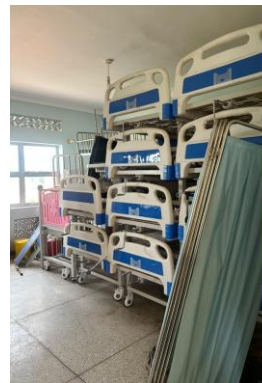
**Figure 20: Hospital beds and screens stacked in storage at a health centre, Kagadi District (Bunyoro)**

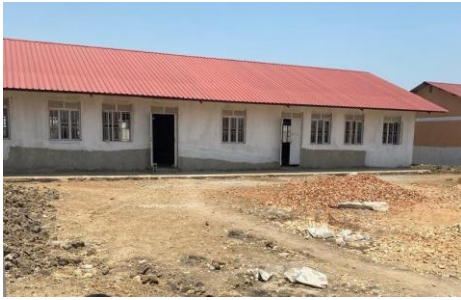
**Figure 77: School block awaiting completion at Butungama Seed Secondary School, Ntoroko District (Tooro)**

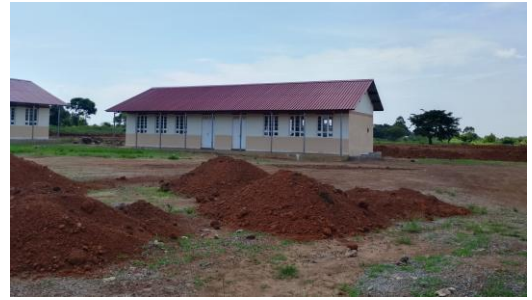
**Figure 79: Classroom block with earthworks in the foreground at Kihungya Seed Secondary School, Buliisa District (Bunyoro)**

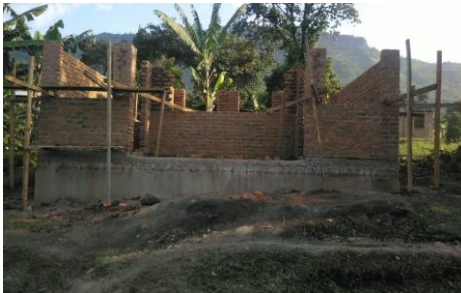
**Figure 80: Unfinished laboratory building at a health centre, Sironko District (Bugisu)**

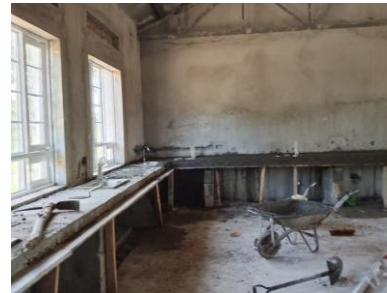
**Figure 81: Biology laboratory under construction at a seed secondary school, Buliisa District (Bunyoro)**

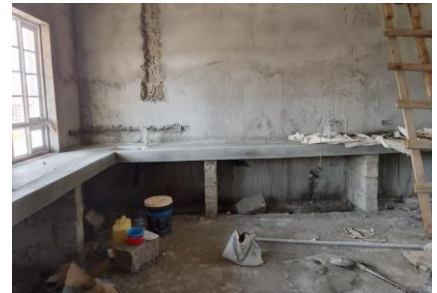
**Figure 82: Unfinished laboratory interior at Kihungya Seed Secondary School, Buliisa District (Bunyoro)**

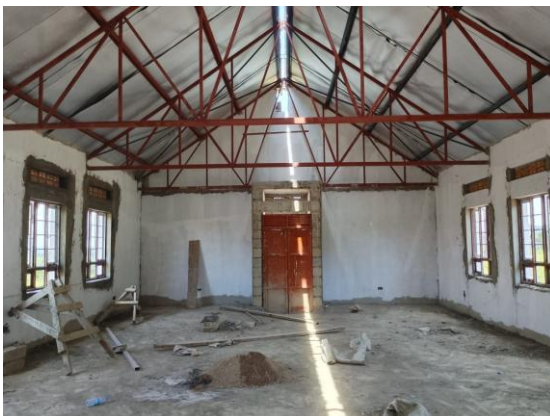
**Figure 83: Library interior under construction at Kihungya Seed Secondary School, Buliisa District (Bunyoro)**

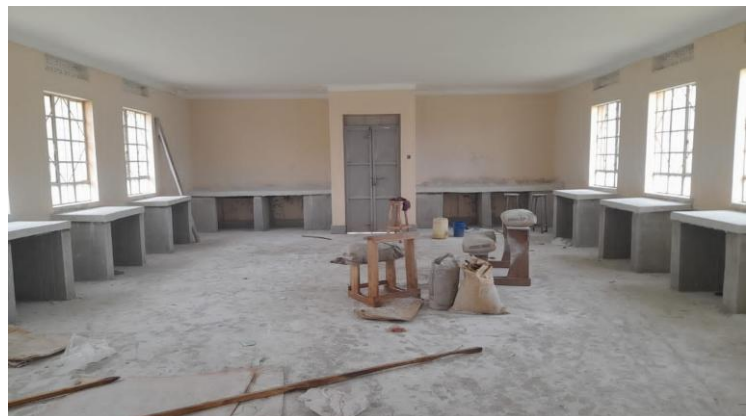
**Figure 84: ICT laboratory interior under construction at Kitawoi Seed Secondary School, Kween District (Sebei)**

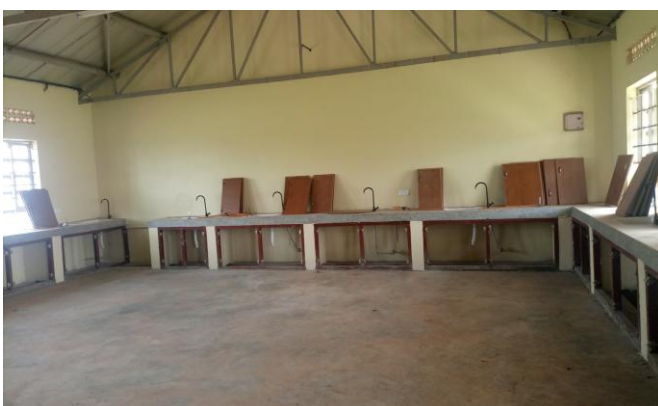
**Figure 85: Laboratory benches with cupboard doors not yet fitted, in a science laboratory block recorded as under construction, at King Solomon Seed Secondary School, Kagadi District (Bunyoro)**

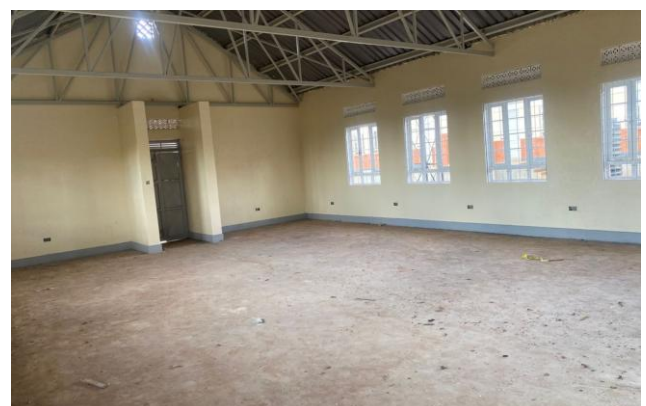
**Figure 86: Empty computer laboratory at Kaptum Seed Secondary School, Kween District (Sebei), where the buildings had not been handed over and no ICT equipment had been received**

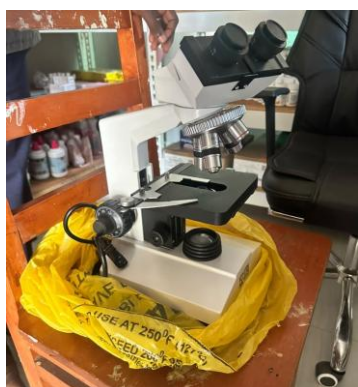
At Kihuukya Health Centre III in Hoima City, the renovated maternity block and walkways were recorded in use and a binocular microscope was seen functioning. Iruhura Health Centre III in Kabarole recorded adult weighing scales and waiting benches in use. Kamuli Health Centre III in Tororo reported improved service delivery, alongside continuing staffing and accommodation needs. Figures 88 to 92 show these health centre buildings and equipment in service.

**Figure 90: Binocular microscope at Kihuukya HC III, Hoima City (Bunyoro)**
