**CONSULTANCY SERVICES TO VERIFY AND RECORD ASSETS  
UNDER THE UGIFT PROGRAMME**

**REF: MOFPED/UGIFT/CONS/25/26/00015**

**ASSET VERIFICATION REPORT**

**September 2026**

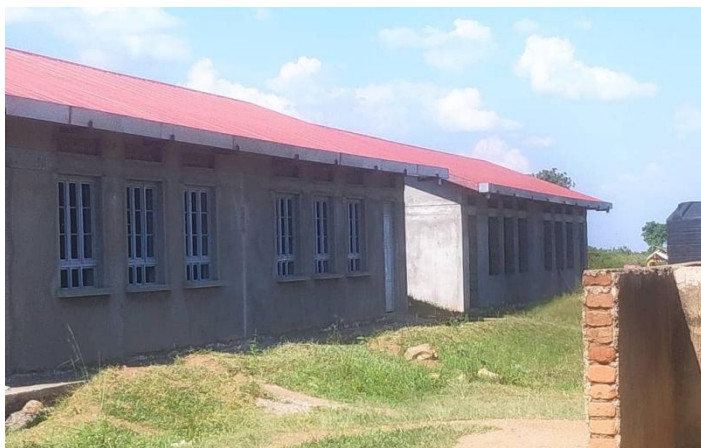
**Figure 14: Unfinished school block at Got Apwoyo Seed Secondary School, Nwoya District (Acholi)**

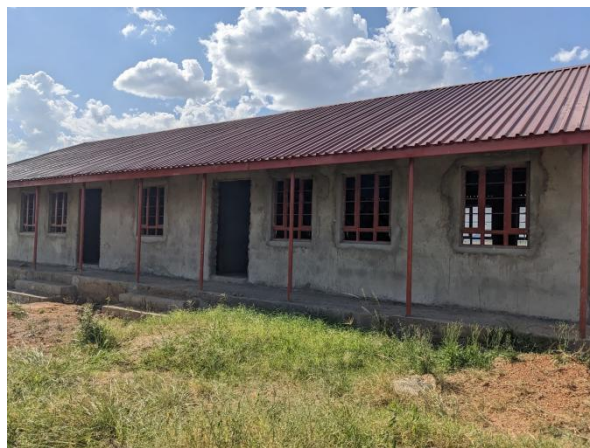
**Figure 15: Unfinished classroom block at Sidok Seed Secondary School, Kaabong District (Karamoja)**

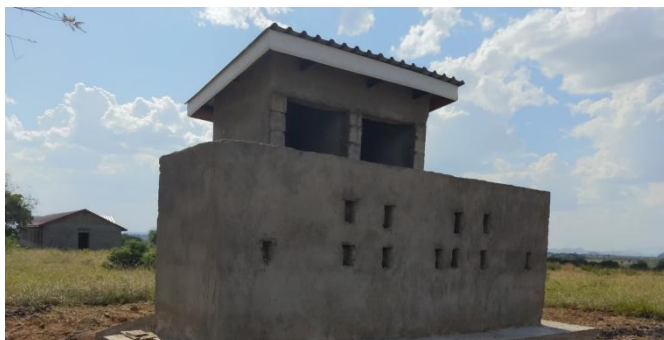
**Figure 16: Latrine block under construction at Sidok Seed Secondary School, Kaabong District (Karamoja)**

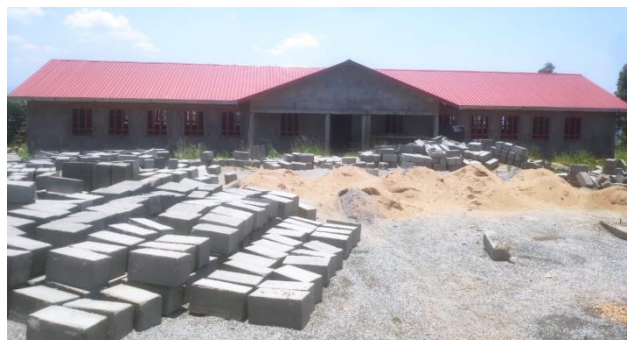
**Figure 17: Building works and construction materials at Ndheh Seed Secondary School, Nebbi District (West Nile)**

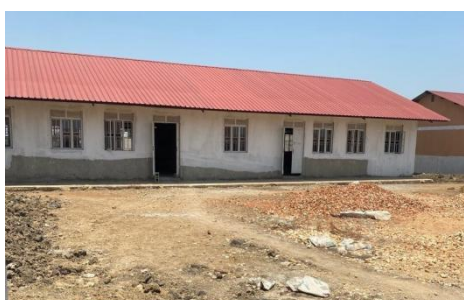
**Figure 18: School block awaiting completion at Butungama Seed Secondary School, Ntoroko District (Tooro)**

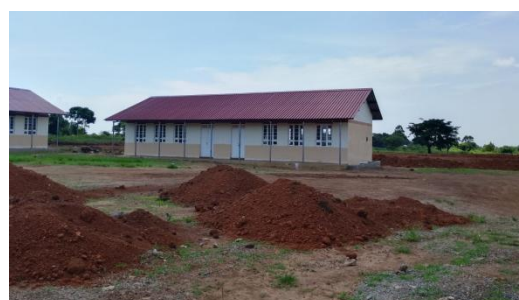
**Figure 20: Classroom block with earthworks in the foreground at Kihungya Seed Secondary School, Buliisa District (Bunyoro)**

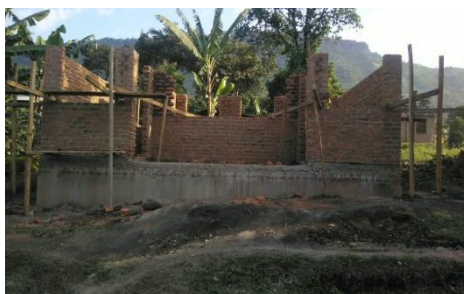
**Figure 21: Unfinished laboratory building at a health centre, Sironko District (Bugisu)**

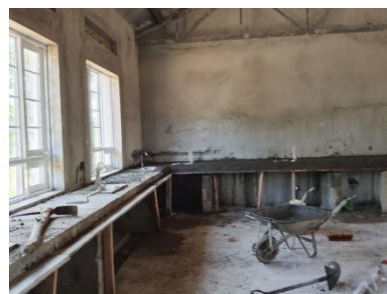
**Figure 22: Biology laboratory under construction at a seed secondary school, Buliisa District (Bunyoro)**

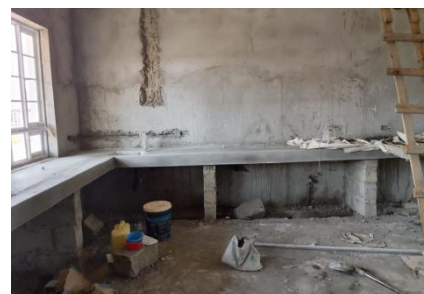
**Figure 23: Unfinished laboratory interior at Kihungya Seed Secondary School, Buliisa District (Bunyoro)**

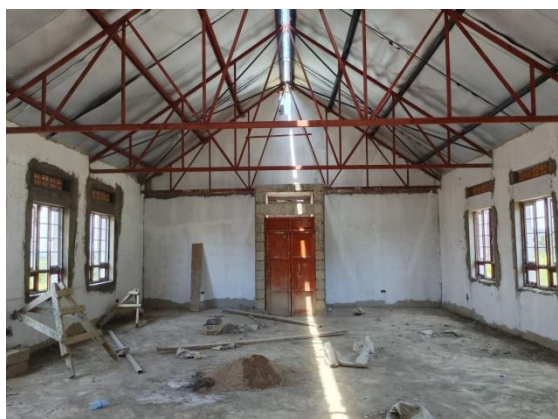
Figure 24: Library interior under construction at Kihungya Seed Secondary School, Buliisa District (Bunyoro)

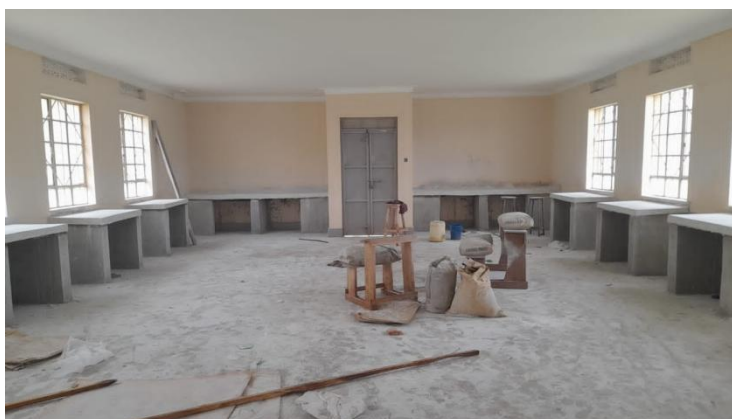
Figure 25: ICT laboratory interior under construction at Kitawoi Seed Secondary School, Kween District (Sebei)

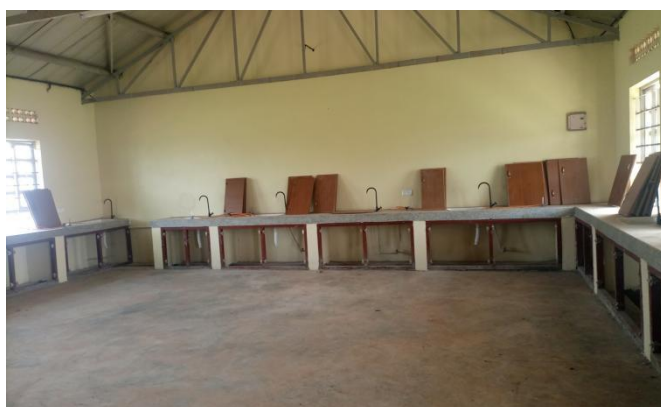
Figure 26: Laboratory benches with cupboard doors not yet fitted, in a science laboratory block recorded as under construction, at King Solomon Seed Secondary School, Kagadi District (Bunyoro)

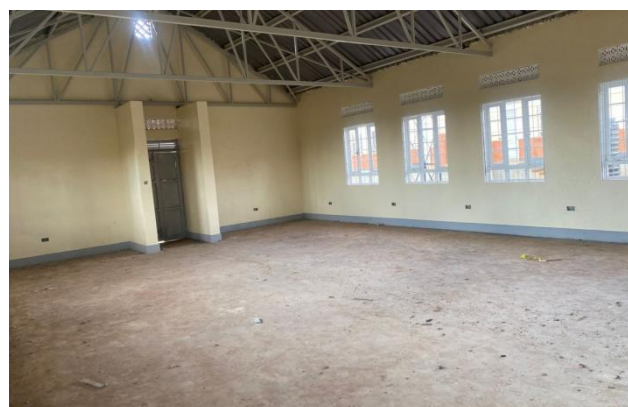
Figure 27: Empty computer laboratory at Kaptum Seed Secondary School, Kween District (Sebei), where the buildings had not been handed over and no ICT equipment had been received

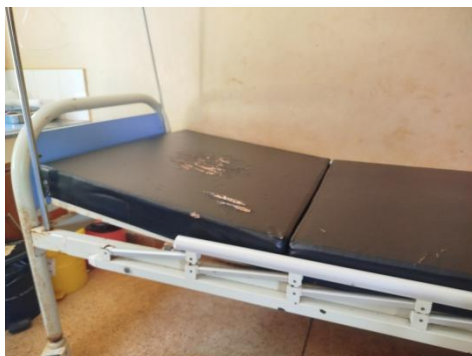
**Figure 30: Delivery bed with a torn mattress cover at a health centre, Busia District (Bukedi)**

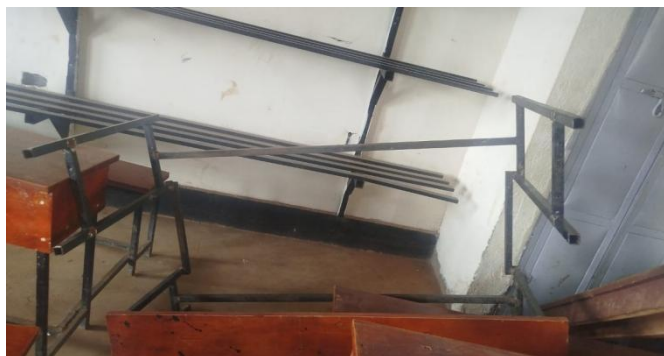
**Figure 32: Broken desk frame at a seed secondary school, Namisindwa District (Bugisu)**

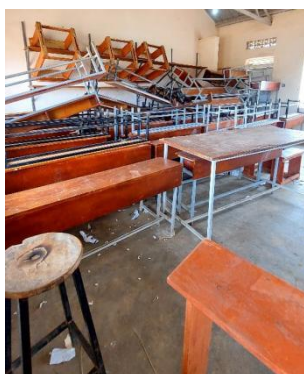
**Figure 33: Stacked desks, chairs and stools, some recorded as broken and none engraved, at Napak Seed Secondary School, Napak District (Karamoja)**

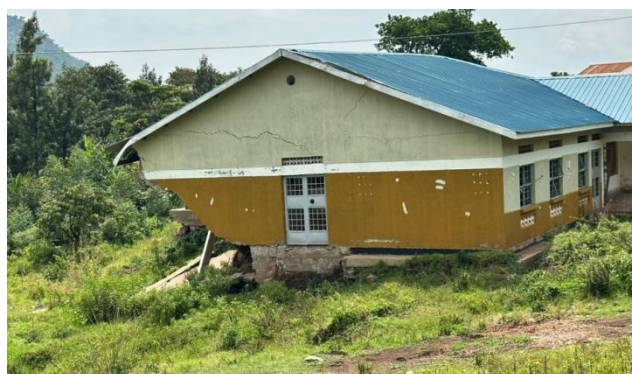
**Figure 34: Cracked health centre block above collapsed ground, Bulambuli District (Bugisu)**

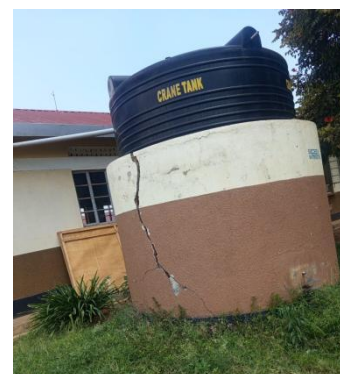
**Figure 35: Water tank on a cracked base at a seed secondary school, Kibuku District (Bukedi)**

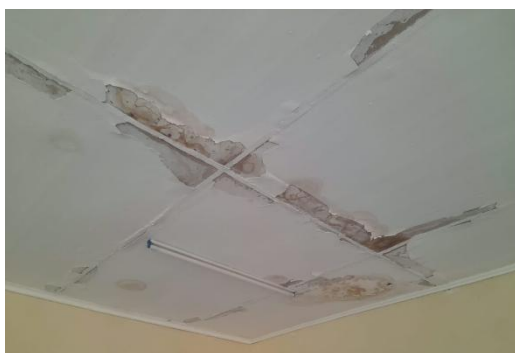
**Figure 36: Stained and peeling ceiling at a health centre, Sironko District (Bugisu)**

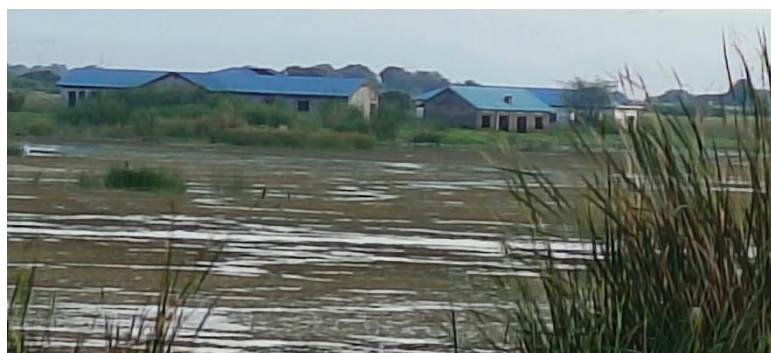
**Figure 37: Flood-affected older health facility at Butiaba, Buliisa District (Bunyoro)**

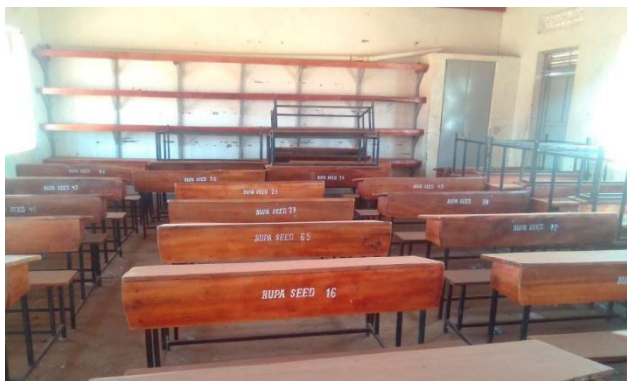
School, facility or district codes alone are not proper programme marking. Desks at Rupa Seed Secondary School in Moroto District carried the school name and serial numbers only, a steel cupboard at Moyok Health Centre III in Kween District carried a district and facility code, and furniture at King Solomon Seed Secondary School in Kagadi District carried the school name only. At Kamoru Health Centre III, a microscope carried the facility name written by hand, and at Bumugibole Health Centre III in Bulambuli District a wheelchair carried a hand-scratched code (Figures 50 to 54).

**Figure 50:** Classroom desks marked RUPA SEED with serial numbers, without a UgIFT marking, at Rupa Seed School, Moroto District (Karamoja)

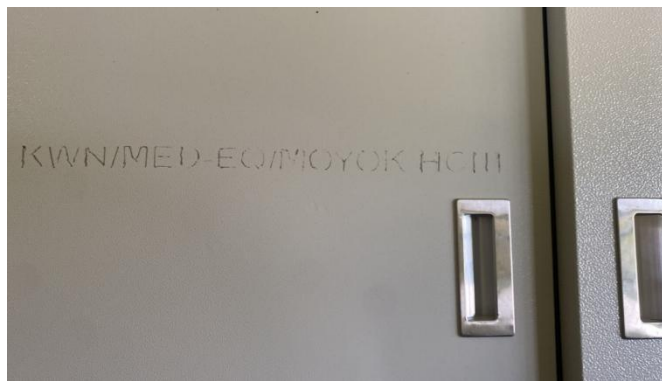
**Figure 51:** Engraving reading KWN/MED-EQ/MOYOK HCIII on a steel cupboard at Moyok Health Centre III, Kween District (Sebei)

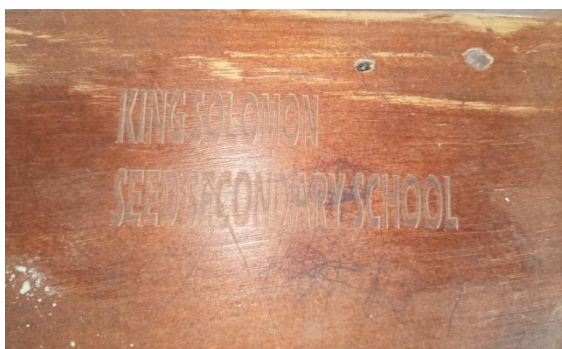
**Figure 52:** Engraving reading KING SOLOMON SEED SECONDARY SCHOOL, without a UgIFT marking, on furniture at King Solomon Seed Secondary School, Kagadi District (Bunyoro)

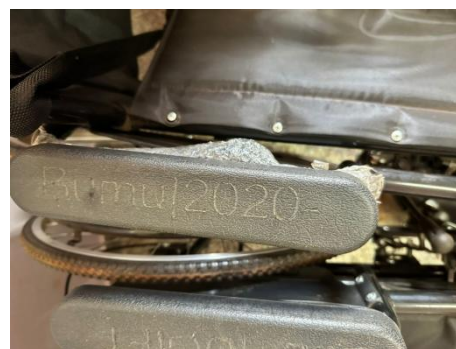
**Figure 54:** Hand-scratched marking beginning Bumu/2020- on a wheelchair armrest at Bumugibole Health Centre III, Bulambuli District (Bugisu)

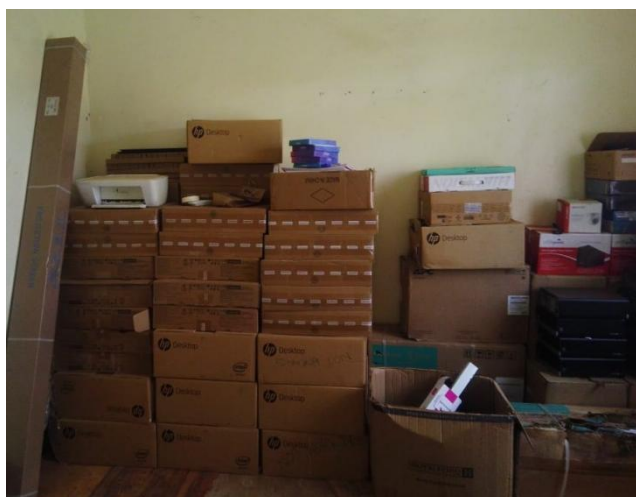
**Figure 55: Desktop computers, a printer and UPS units still boxed in the store at Lungulu Seed Secondary School, Nwoya District (Acholi), awaiting a power connection for installation**

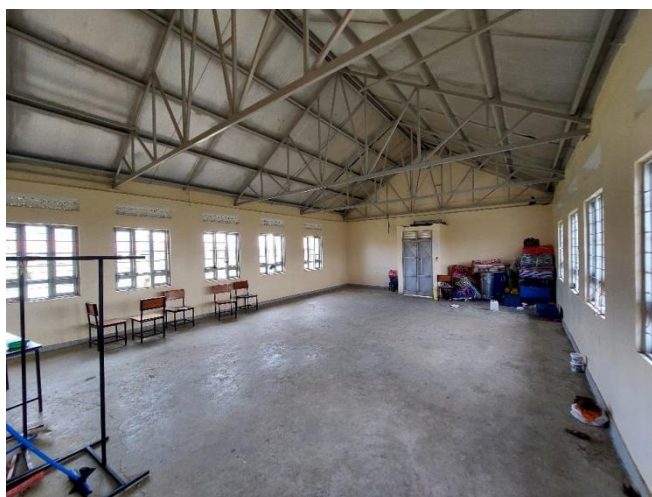
**Figure 56: Largely empty ICT and library block with a few chairs and items kept in one corner at Iriiri Seed Secondary School, Napak District (Karamoja), not yet in use while the school remained with the contractor**

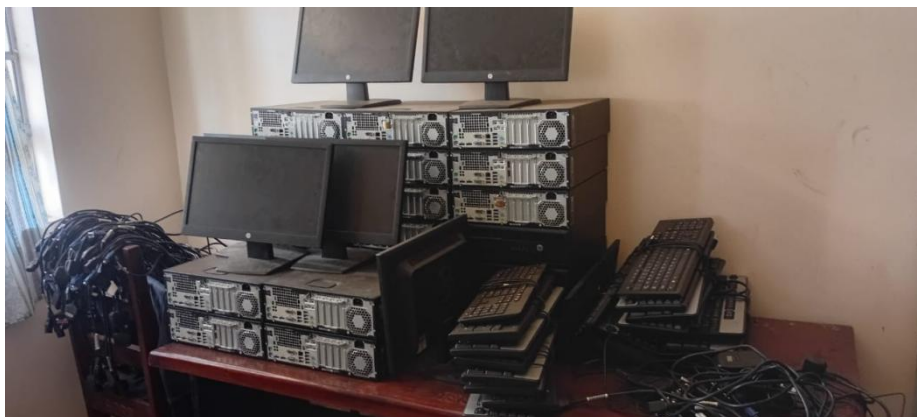
**Figure 57: HP computer sets stacked in store with cables still bundled and not installed at Bumufuni Seed Secondary School, Bulambuli District (Bugisu)**

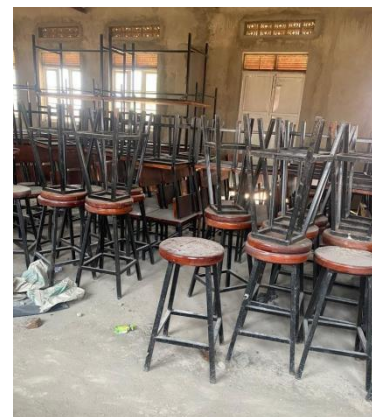
**Figure 58: Laboratory stools and desks stored and not yet in use at Butungama Seed Secondary School, Ntoroko District (Tooro), where the school buildings were still under construction**

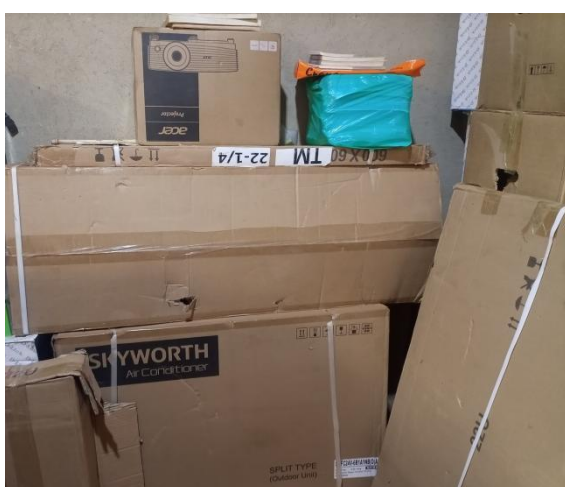
**Figure 59: Boxed projector, air conditioner and other equipment in store at King Solomon Seed Secondary School, Kagadi District (Bunyoro), kept boxed because the school was still under construction**

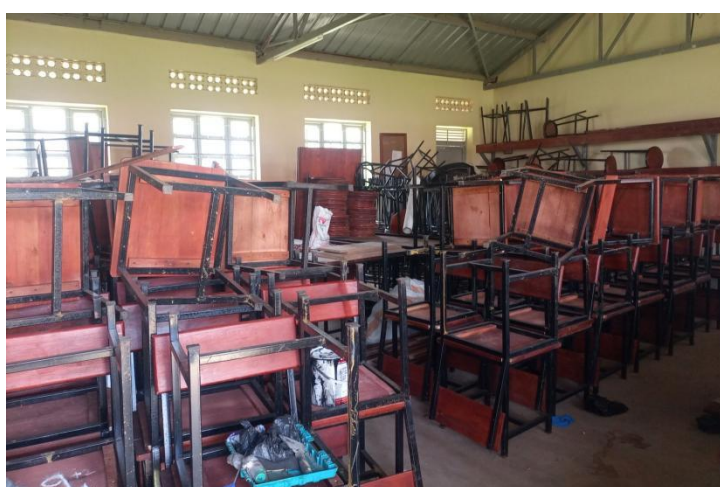
**Figure 60: Chairs, desks and laboratory stools stacked in a hall at King Solomon Seed Secondary School, Kagadi District (Bunyoro), where most assets remained in storage because the school was still under construction**

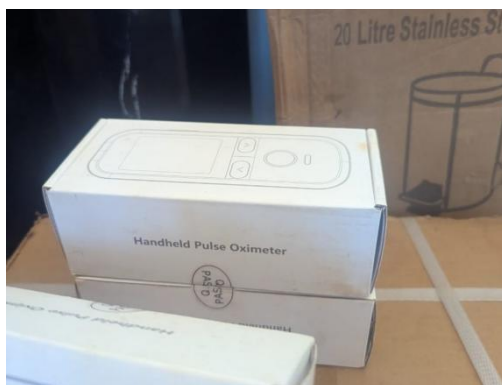
**Figure 62:** Boxed handheld pulse oximeters at Kibiri Health Centre III, Makindye-Ssabagabo Municipal Council (Buganda), where equipment was still being arranged after the facility opened on 31 August 2026

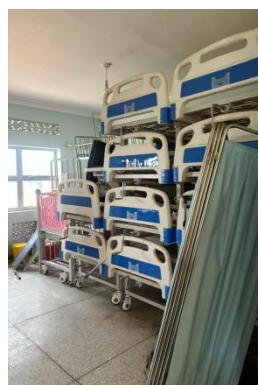
**Figure 63:** Hospital beds and screens stacked in storage at a health centre, Kagadi District (Bunyoro)

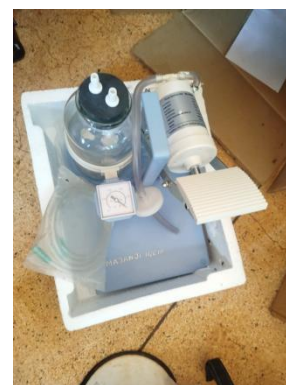
**Figure 64:** Pedal suction unit marked MAJANJI H/C III still in its packing, recorded as not in use for lack of technical knowledge, Majanji Health Centre III, Busia District (Bukedi)

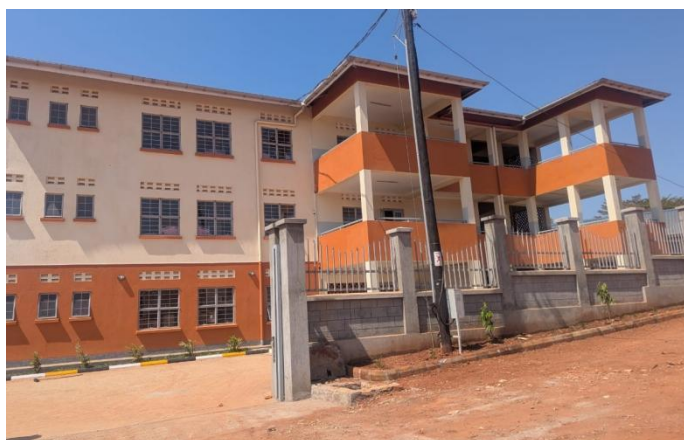
**Figure 70: Health centre building at Kibiri HC III, Makindye-Ssabagabo Municipal Council (Buganda)**

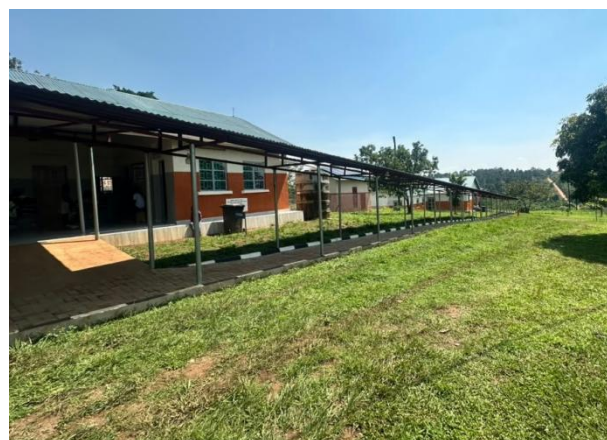
**Figure 71: Health centre buildings and covered walkway at Kihuukya HC III, Hoima City (Bunyoro)**

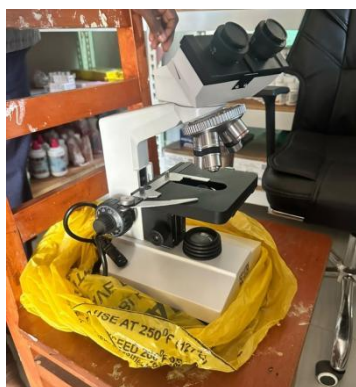
At Kihuukya Health Centre III in Hoima City, the renovated maternity block and walkways were recorded in use and a binocular microscope was seen functioning. Iruhura Health Centre III in Kabarole recorded adult weighing scales and waiting benches in use. Kamuli Health Centre III in Tororo reported improved service delivery, alongside continuing staffing and accommodation needs. Figures 70 to 74 show these health centre buildings and equipment in service.

**Figure 72: Binocular microscope at Kihuukya HC III, Hoima City (Bunyoro)**

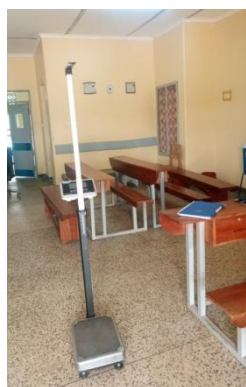
**Figure 73: Adult weighing scale with a height meter and waiting benches at Iruhura HC III, Kabarole District (Tooro)**

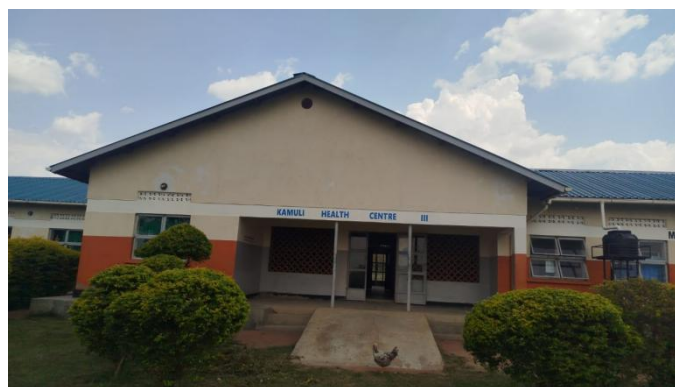
**Figure 74: Maternity block entrance and access ramp at Kamuli HC III, Tororo District (Bukedi)**
