**CONSULTANCY SERVICES TO VERIFY AND RECORD ASSETS  
UNDER THE UGIFT PROGRAMME**

**REF: MOFPED/UGIFT/CONS/25/26/00015**

**ASSET VERIFICATION REPORT**

**September 2026**

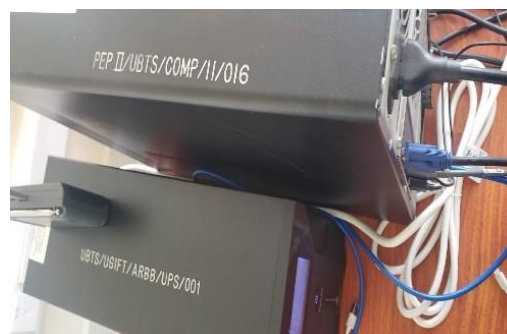
Of the 168 verified assets, 43 (25.6%) were engraved and 125 (74.4%) were not engraved. The 26 properly engraved assets (15.5%) carry the UgIFT marking and include donor couches, filing cabinets, office chairs and tables, the reception table, UPS units and the washing machine. The 17 not properly engraved assets (10.1%) carry UBTS equipment codes, mainly on laboratory equipment and desktop computers. The recorded value of the field return assets is UGX 1,045,918,115. Figures 1 to 6 show the completed building, donor couches, the markings on two uninterruptible power supplies, a blood bank refrigerator, a platelet agitator and a chest freezer.

**Figure 3: Markings PEP II/UBTS/COMP/11/016 and UBTS/UGIFT/ARBB/UPS/001 on uninterruptible power supplies at Arua Regional Blood Bank, Arua City (West Nile)**

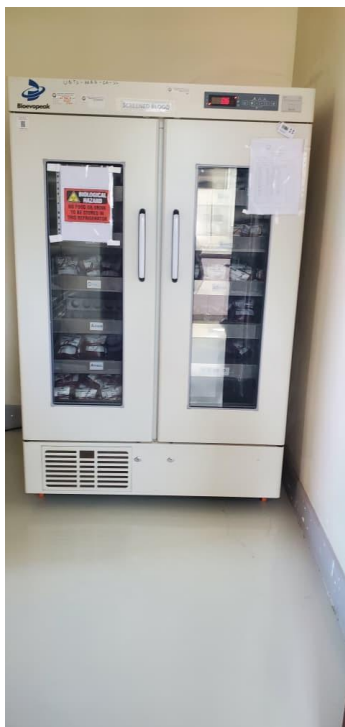
**Figure 4: Blood bank refrigerator at Arua Regional Blood Bank, Arua City (West Nile)**

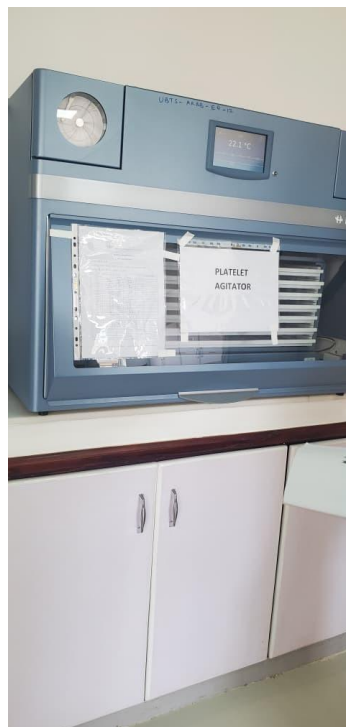
**Figure 5: Platelet agitator at Arua Regional Blood Bank, Arua City (West Nile)**

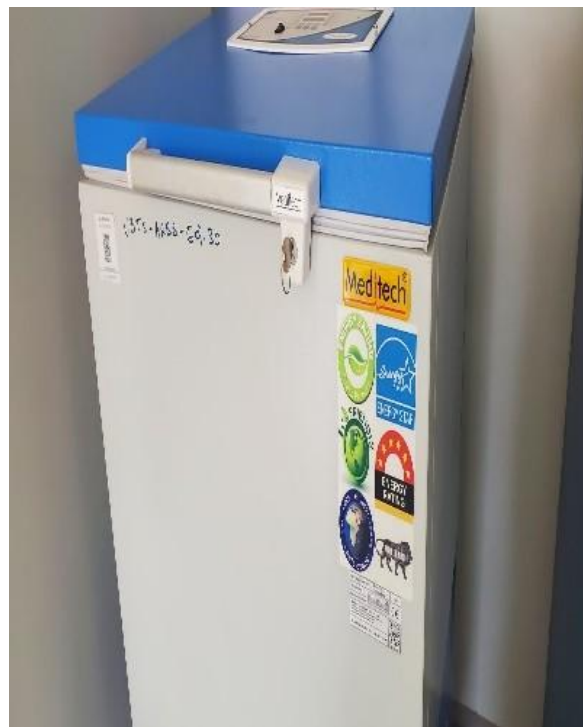
**Figure 6: Chest freezer at Arua Regional Blood Bank, Arua City (West Nile)**

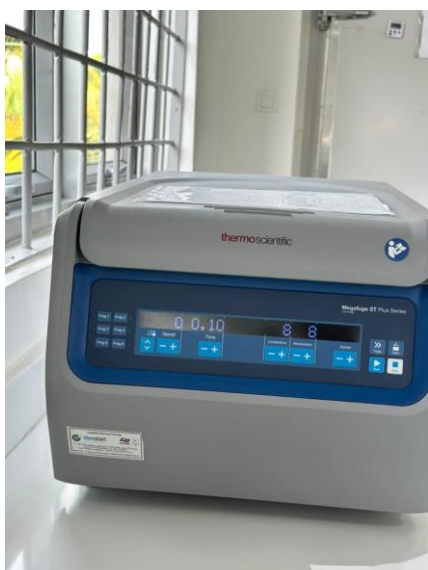
**Figure 10: Benchtop centrifuge at Hoima Regional Blood Bank, Hoima City (Bunyoro)**

The condition codes on the Hoima return describe the 52 equipment lines in more detail. Forty were good and in use; five were in good condition but not yet in use (a constant temperature incubator, a table top autoclave, a biosafety cabinet, a plasma blast freezer and a benchtop centrifuge); five were in use but needed repair (a benchtop centrifuge, two benchtop tube sealers and two double pan weighing scales); and two plasma baths were coded as not for blood bank use. The cell washer and plasma thawing bath carried the same remark. Fifteen equipment items were held in the blood bank stores.

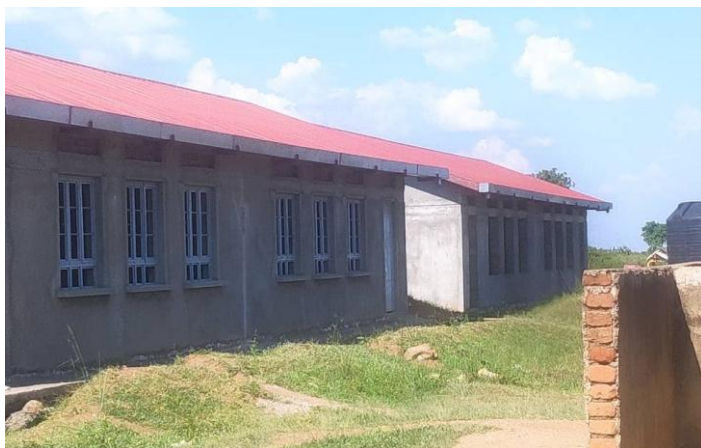
**Figure 14: Unfinished school block at Got Apwoyo Seed Secondary School, Nwoya District (Acholi)**

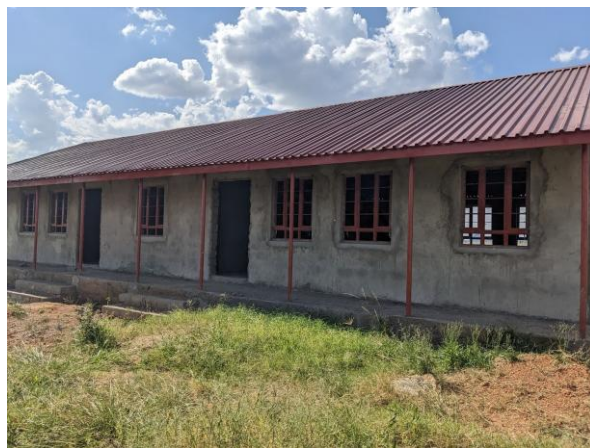
**Figure 15: Unfinished classroom block at Sidok Seed Secondary School, Kaabong District (Karamoja)**

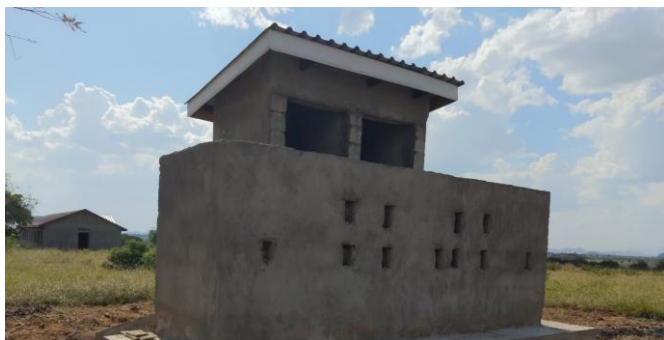
**Figure 16: Latrine block under construction at Sidok Seed Secondary School, Kaabong District (Karamoja)**

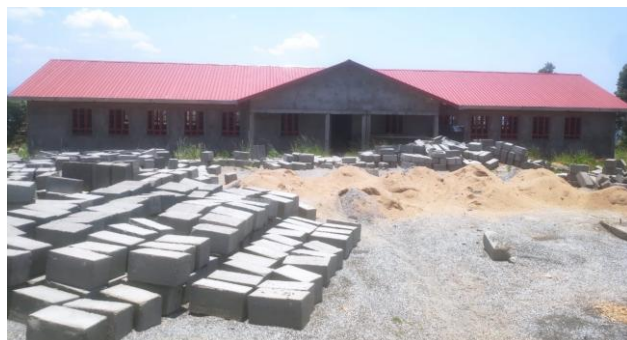
**Figure 17: Building works and construction materials at Ndheh Seed Secondary School, Nebbi District (West Nile)**

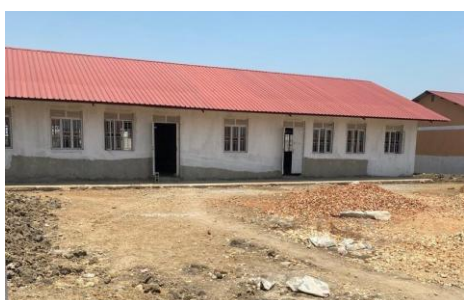
**Figure 18: School block awaiting completion at Butungama Seed Secondary School, Ntoroko District (Tooro)**

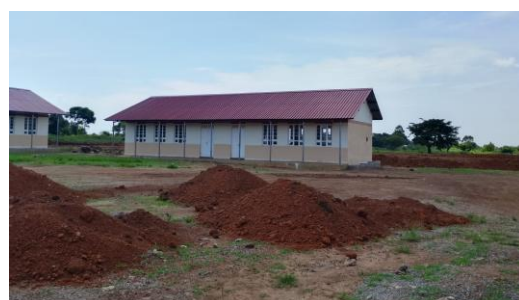
**Figure 20: Classroom block with earthworks in the foreground at Kihungya Seed Secondary School, Buliisa District (Bunyoro)**

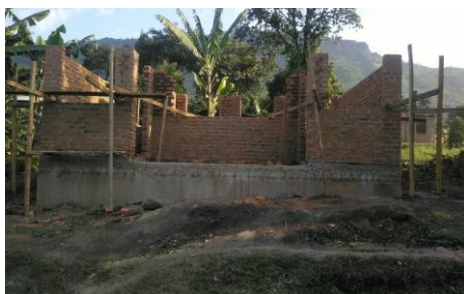
**Figure 21: Unfinished laboratory building at a health centre, Sironko District (Bugisu)**

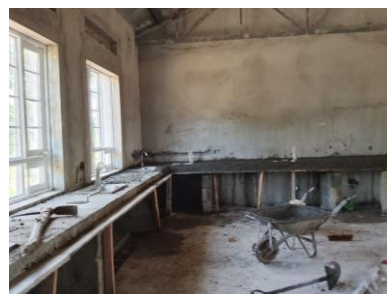
**Figure 22: Biology laboratory under construction at a seed secondary school, Buliisa District (Bunyoro)**

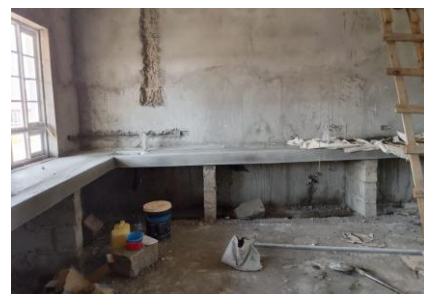
**Figure 23: Unfinished laboratory interior at Kihungya Seed Secondary School, Buliisa District (Bunyoro)**

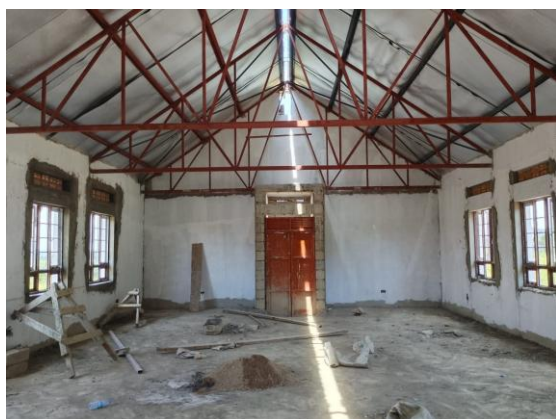
**Figure 24: Library interior under construction at Kihungya Seed Secondary School, Buliisa District (Bunyoro)**

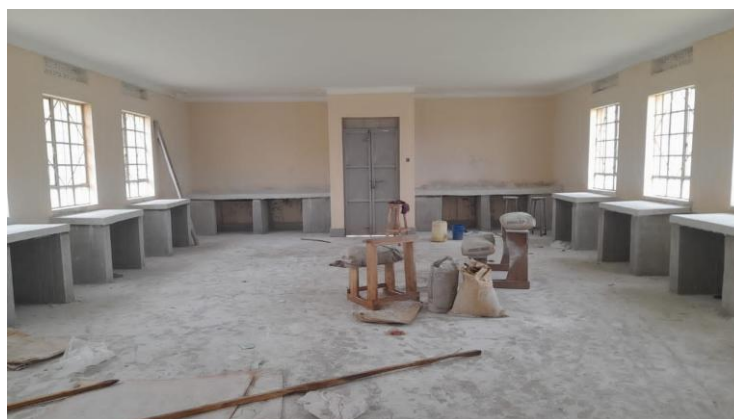
**Figure 25: ICT laboratory interior under construction at Kitawoi Seed Secondary School, Kween District (Sebei)**

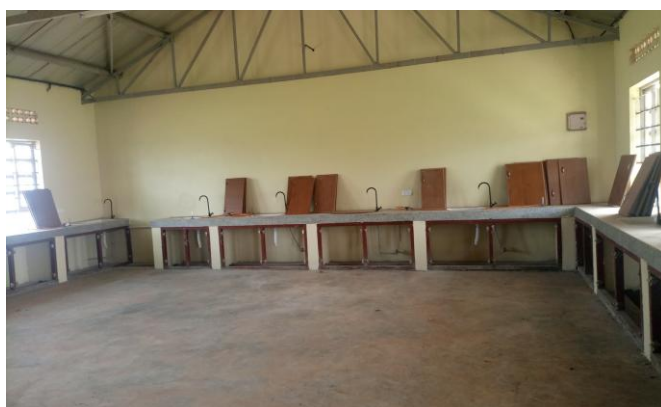
**Figure 26: Laboratory benches with cupboard doors not yet fitted, in a science laboratory block recorded as under construction, at King Solomon Seed Secondary School, Kagadi District (Bunyoro)**

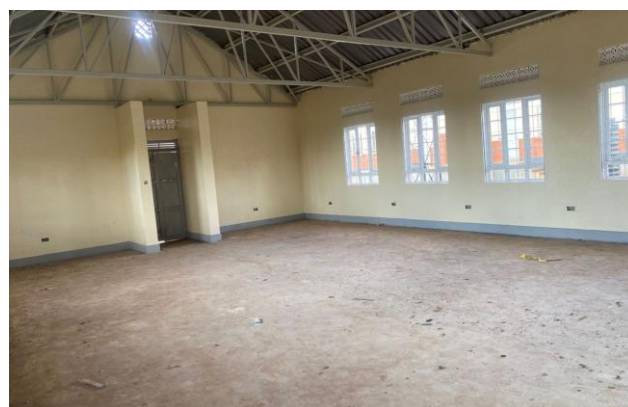
**Figure 27: Empty computer laboratory at Kaptum Seed Secondary School, Kween District (Sebei), where the buildings had not been handed over and no ICT equipment had been received**

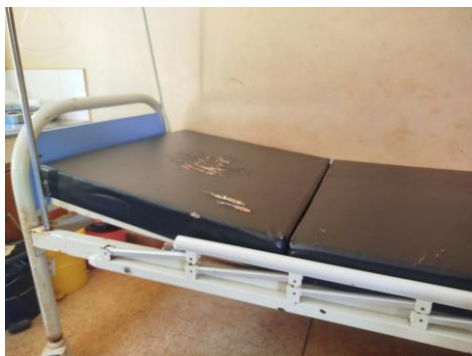
**Figure 30: Delivery bed with a torn mattress cover at a health centre, Busia District (Bukedi)**

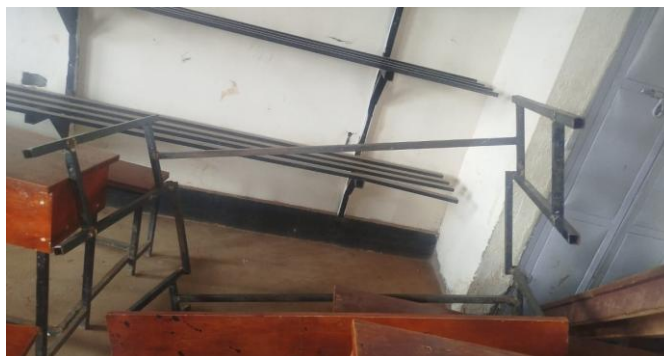
**Figure 32: Broken desk frame at a seed secondary school, Namisindwa District (Bugisu)**

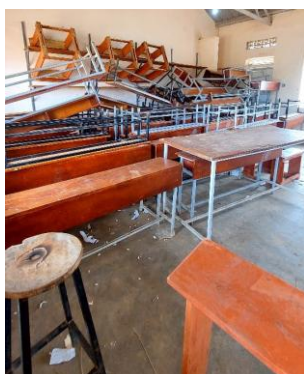
**Figure 33: Stacked desks, chairs and stools, some recorded as broken and none engraved, at Napak Seed Secondary School, Napak District (Karamoja)**

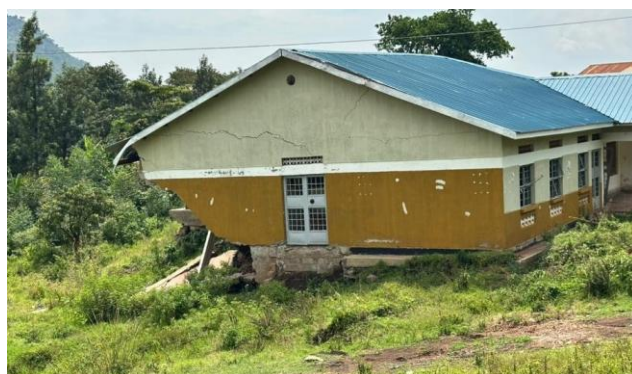
**Figure 34: Cracked health centre block above collapsed ground, Bulambuli District (Bugisu)**

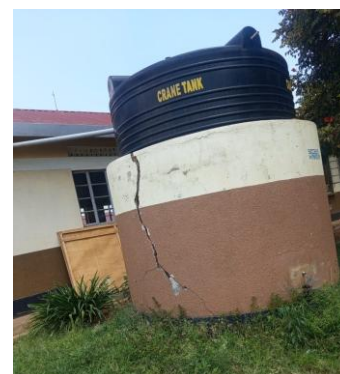
**Figure 35: Water tank on a cracked base at a seed secondary school, Kibuku District (Bukedi)**

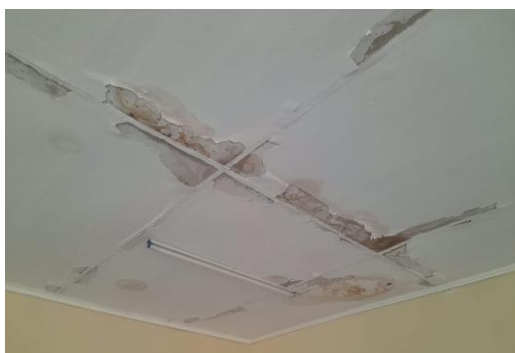
**Figure 36: Stained and peeling ceiling at a health centre, Sironko District (Bugisu)**

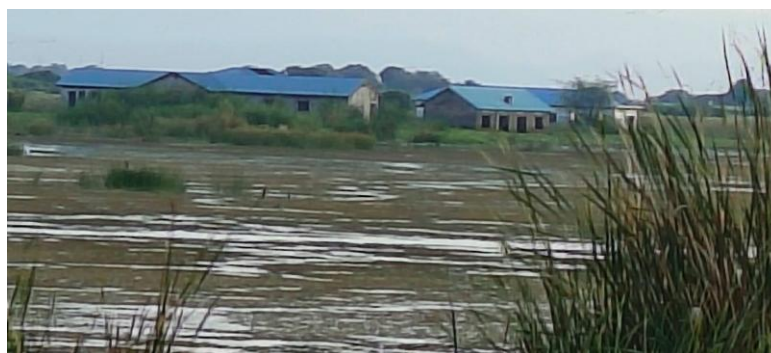
**Figure 37: Flood-affected older health facility at Butiaba, Buliisa District (Bunyoro)**

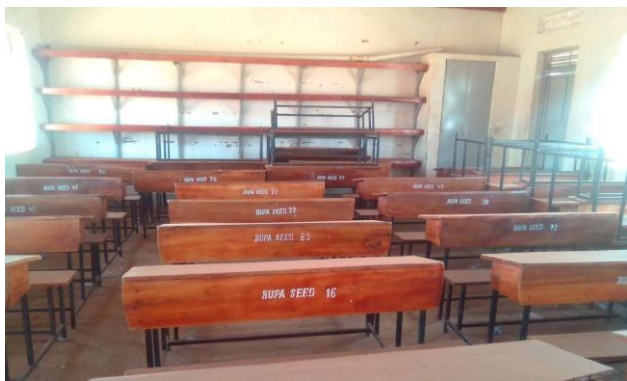
**Figure 50: Classroom desks marked RUPA SEED with serial numbers, without a UgIFT marking, at Rupa Seed School, Moroto District (Karamoja)**

School, facility or district codes alone are not proper programme marking. Desks at Rupa Seed Secondary School in Moroto District carried the school name and serial numbers only, a steel cupboard at Moyok Health Centre III in Kween District carried a district and facility code, and furniture at King Solomon Seed Secondary School in Kagadi District carried the school name only. At Kamoru Health Centre III, a microscope carried the facility name written by hand, and at Bumugibole Health Centre III in Bulambuli District a wheelchair carried a hand-scratched code (Figures 50 to 54).

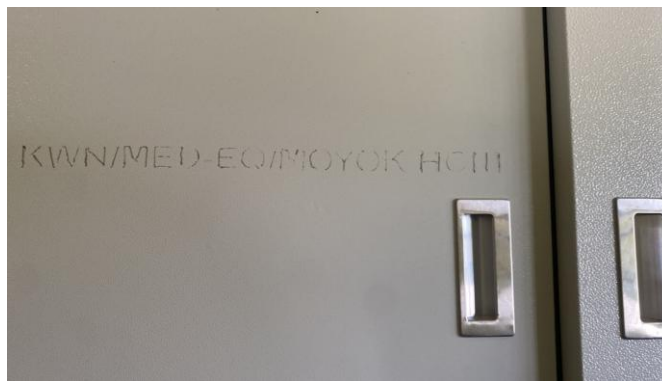
**Figure 51: Engraving reading KWN/MED-EQ/MOYOK HCIII on a steel cupboard at Moyok Health Centre III, Kween District (Sebei)**

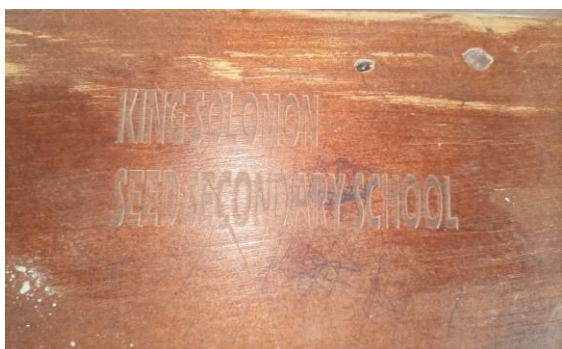
**Figure 52: Engraving reading KING SOLOMON SEED SECONDARY SCHOOL, without a UgIFT marking, on furniture at King Solomon Seed Secondary School, Kagadi District (Bunyoro)**

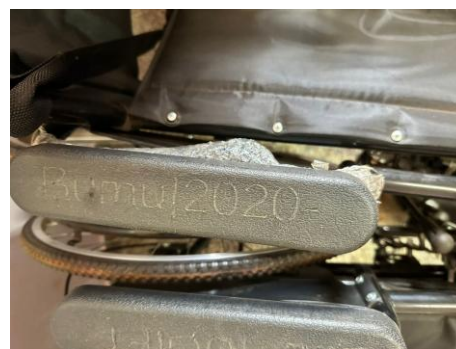
**Figure 54: Hand-scratched marking beginning Bum/2020- on a wheelchair armrest at Bumugibole Health Centre III, Bulambuli District (Bugisu)**

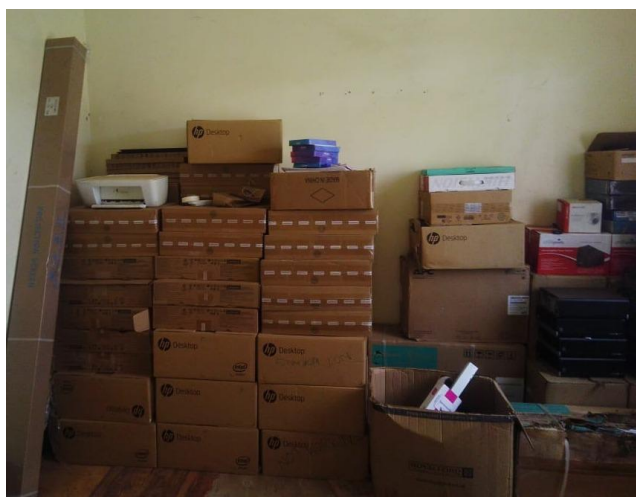
The photographs show the same pattern. At Lungulu Seed Secondary School in Nwoya District, desktop computers, a printer and UPS units remained boxed in the store because the school was awaiting a power connection, without which the equipment could not be installed (Figure 55). The other school photographs show chairs and other items kept in a largely empty ICT and library block at Iriiri Seed Secondary School in Napak District, which remained with the contractor, computer sets stacked in store with their cables still bundled at Bumufuni Seed Secondary School in Bulambuli District, and furniture and equipment stored at Butungama and King Solomon seed schools while the buildings were completed (Figures 56 to 60).

**Figure 55: Desktop computers, a printer and UPS units still boxed in the store at Lungulu Seed Secondary School, Nwoya District (Acholi), awaiting a power connection for installation**

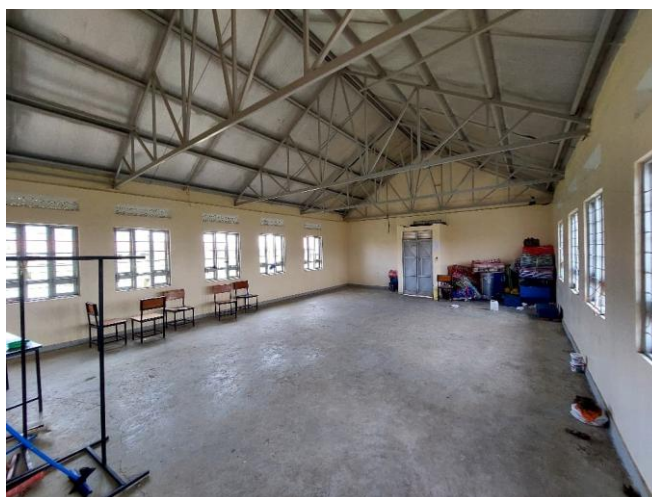
**Figure 56: Largely empty ICT and library block with a few chairs and items kept in one corner at Iriiri Seed Secondary School, Napak District (Karamoja), not yet in use while the school remained with the contractor**

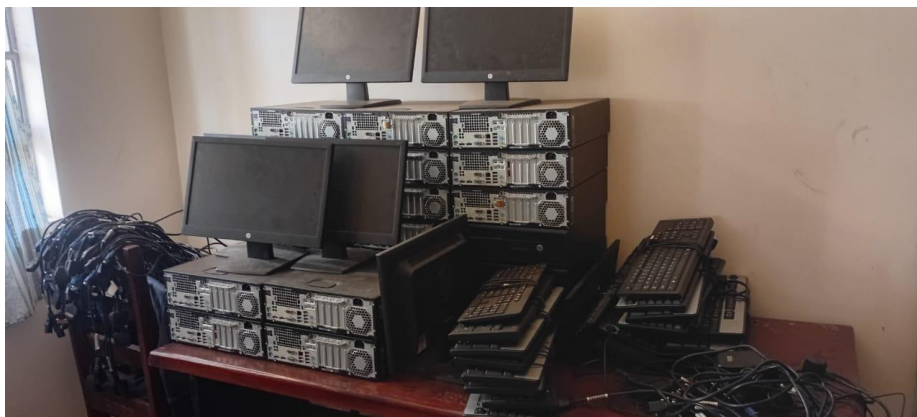
**Figure 57: HP computer sets stacked in store with cables still bundled and not installed at Bumufuni Seed Secondary School, Bulambuli District (Bugisu)**

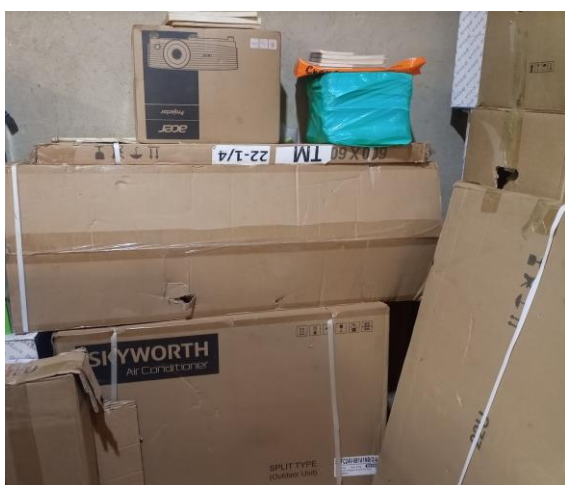
**Figure 59: Boxed projector, air conditioner and other equipment in store at King Solomon Seed Secondary School, Kagadi District (Bunyoro), kept boxed because the school was still under construction**

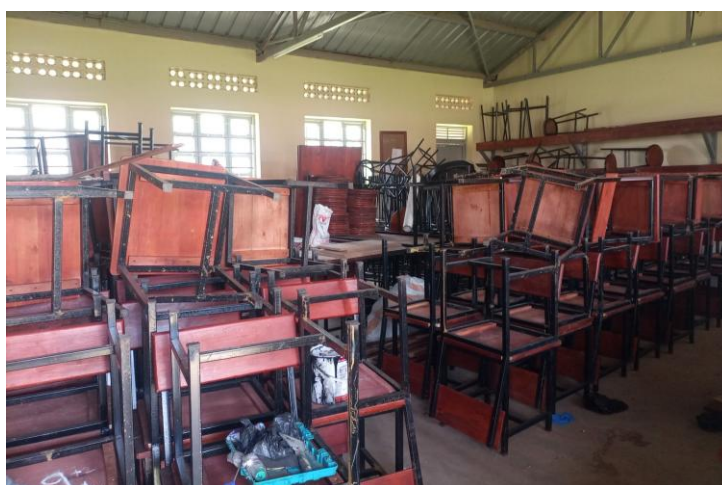
**Figure 60: Chairs, desks and laboratory stools stacked in a hall at King Solomon Seed Secondary School, Kagadi District (Bunyoro), where most assets remained in storage because the school was still under construction**

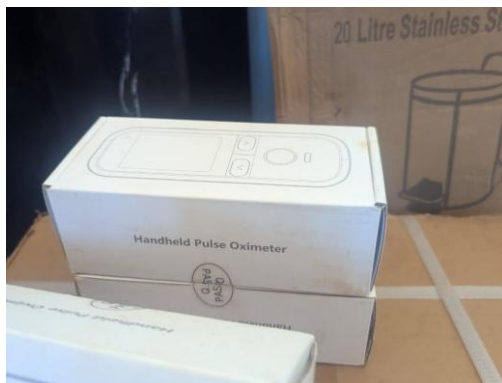
**Figure 62:** Boxed handheld pulse oximeters at Kibiri Health Centre III, Makindye-Ssabagabo Municipal Council (Buganda), where equipment was still being arranged after the facility opened on 31 August 2026

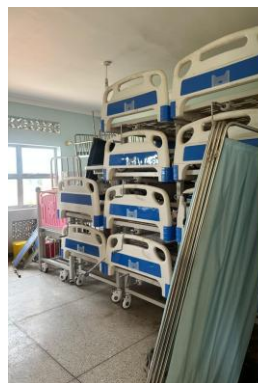
**Figure 63:** Hospital beds and screens stacked in storage at a health centre, Kagadi District (Bunyoro)

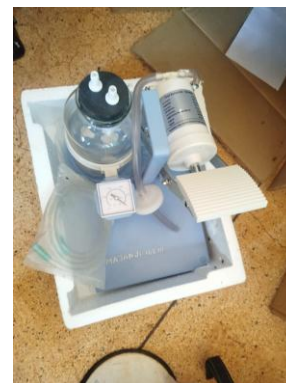
**Figure 64:** Pedal suction unit marked MAJANJI H/C III still in its packing, recorded as not in use for lack of technical knowledge, Majanji Health Centre III, Busia District (Bukedi)

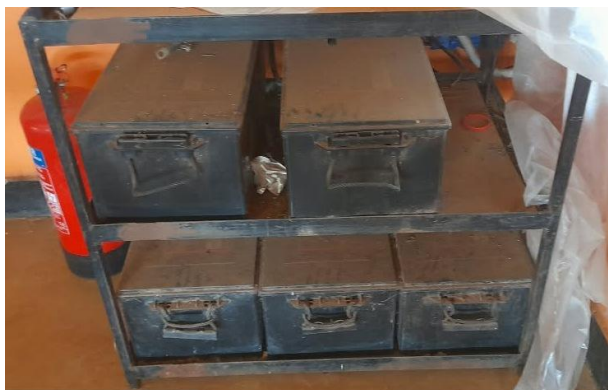
**Figure 107: Solar batteries and control equipment at Atar HC III, Kween District (Sebei)**

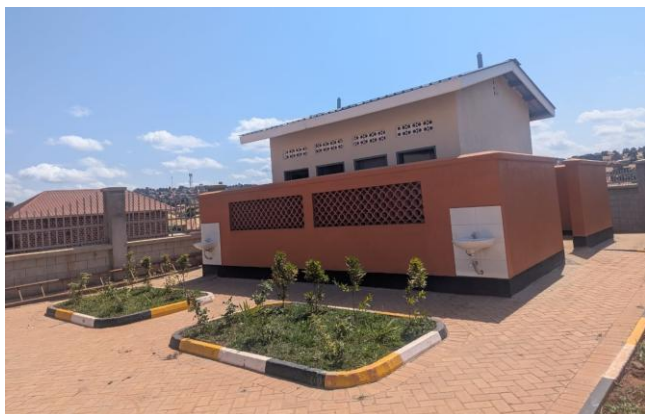
**Figure 109: Waste disposal structure at Kibiri HC III, Makindye-Ssabagabo Municipal Council (Buganda)**

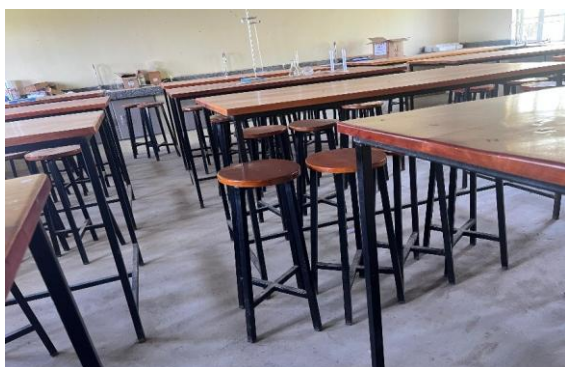
**Figure 112: Library shelves and reading tables at Gyagenda Memorial Seed Secondary School, Kalangala District (Buganda)**

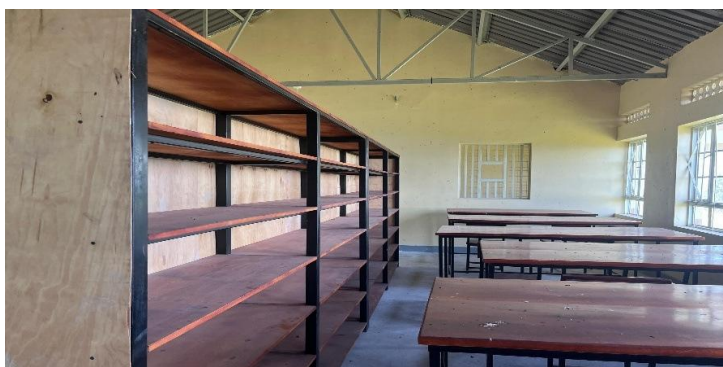
**Figure 113: Anatomical teaching model at Gyagenda Memorial Seed Secondary School, Kalangala District (Buganda)**

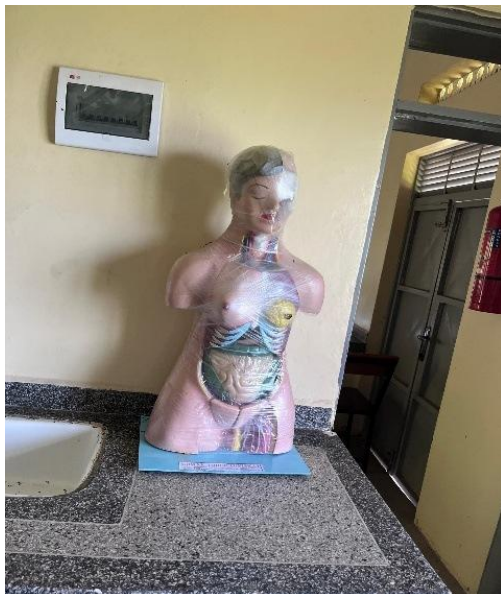
**Figure 114: Laboratory glassware and equipment at Gyagenda Memorial Seed Secondary School, Kalangala District (Buganda)**

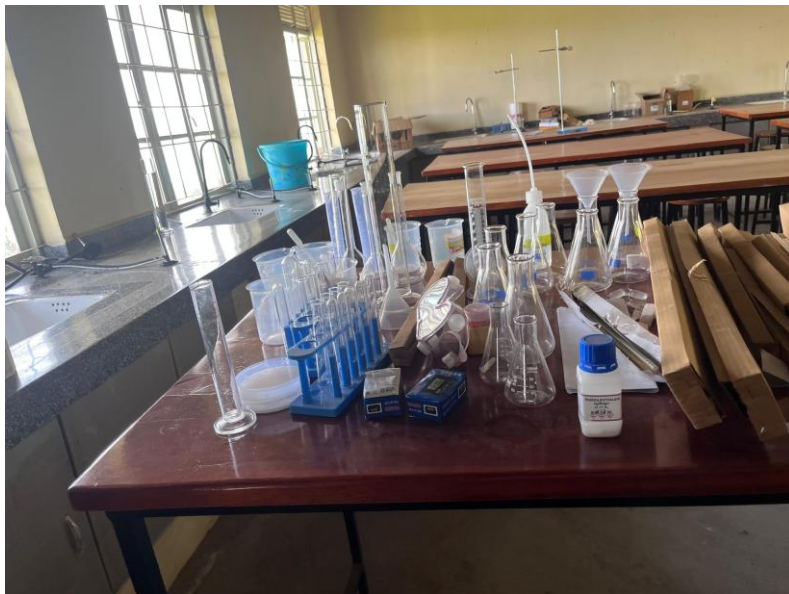
**Figure 115: Desktop computers and classroom furniture at a seed secondary school, Busia District (Bukedi)**

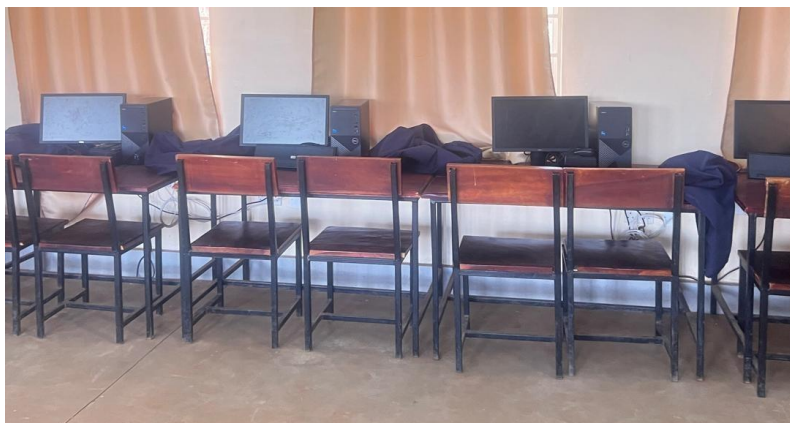
**Figure 116: Classroom desks at a seed secondary school, Ntoroko District (Tooro)**

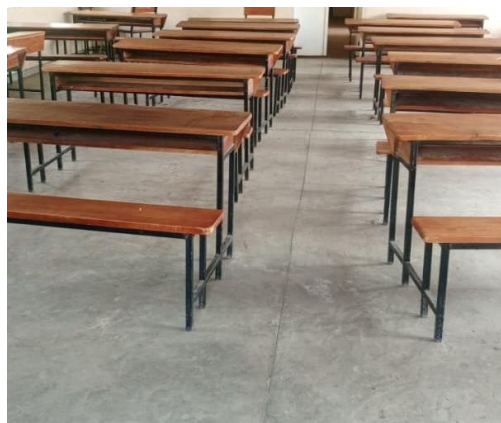
**Figure 117: Classroom desks at King Solomon Seed Secondary School, Kagadi District (Bunyoro)**

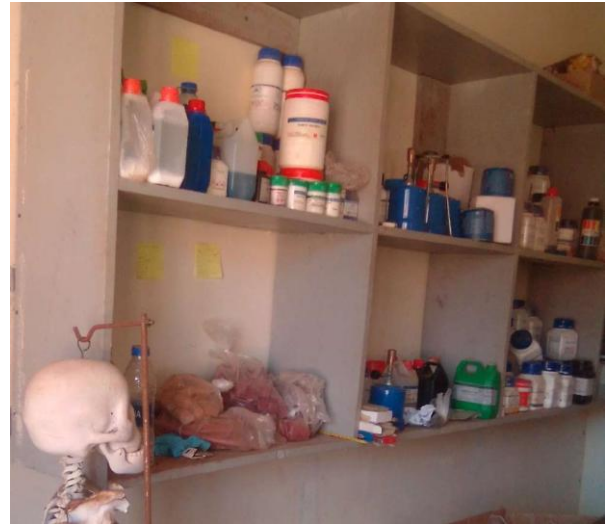
**Figure 121: Computer equipment in the school ICT room at Kabeywa Seed Secondary School, Kapchorwa District (Sebei)**

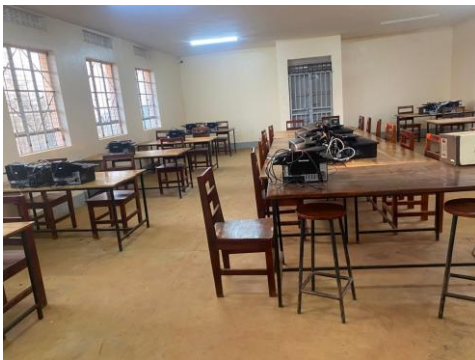
**Figure 122: Library shelving and tables at Kabeywa Seed Secondary School, Kapchorwa District (Sebei)**

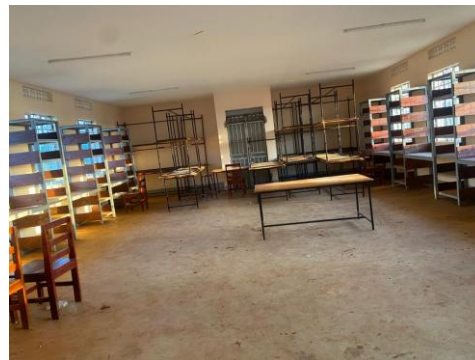
**Figure 123: Office desk and other furniture at Lwamata Town Council Seed Secondary School, Kiboga District (Buganda)**

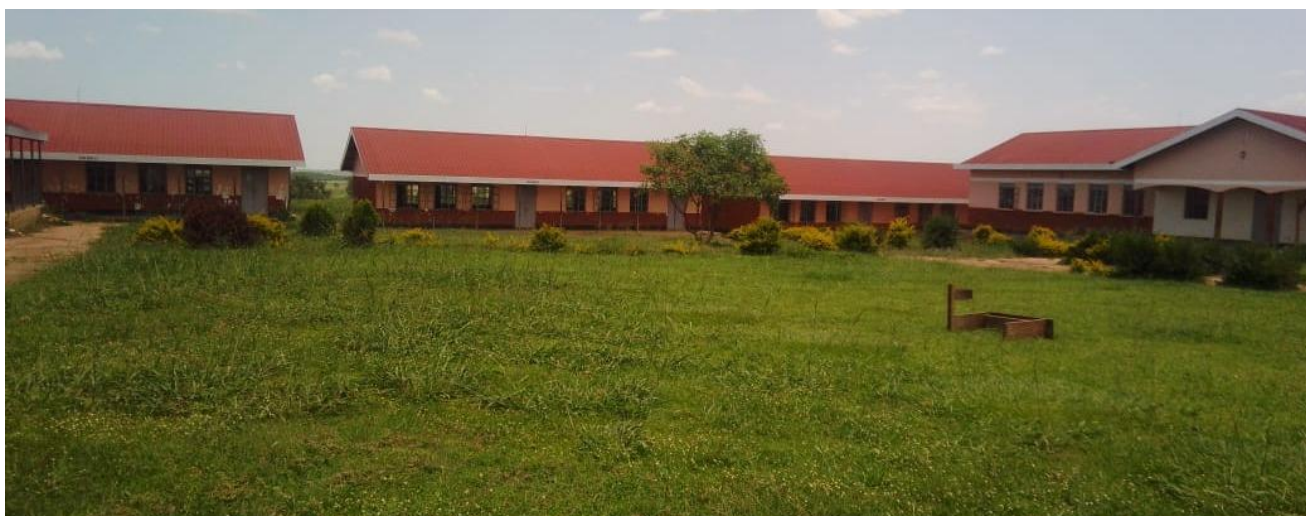
**Figure 129: Buildings at a seed secondary school, Nwoya District (Acholi)**

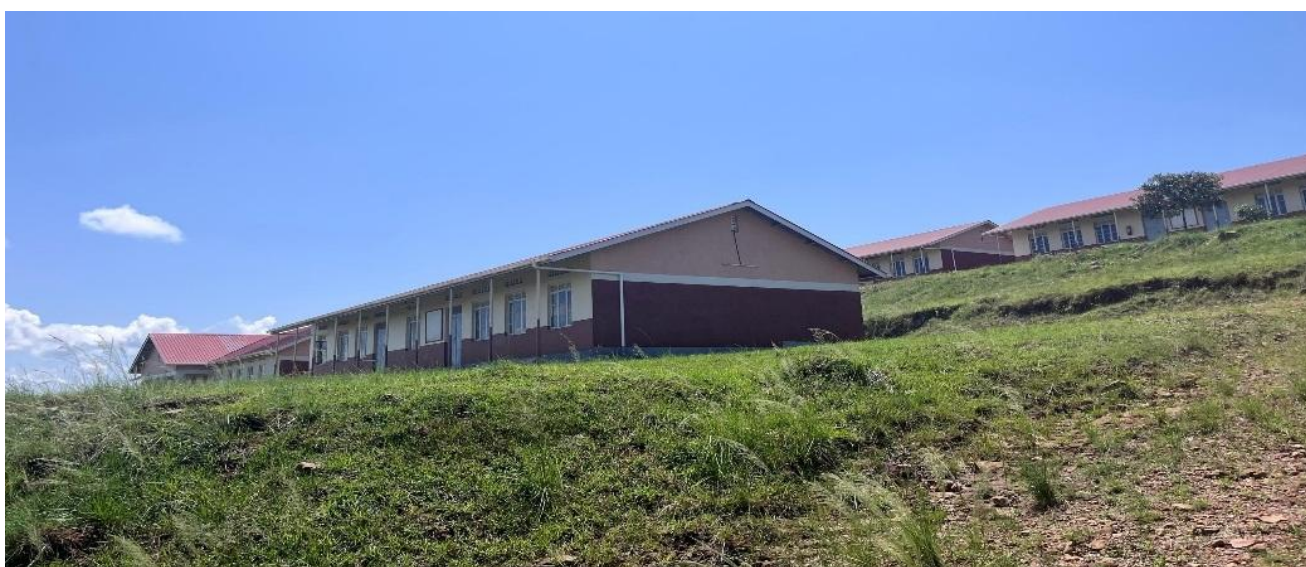
**Figure 130: School blocks at Gyagenda Memorial Seed Secondary School, Kalangala District (Buganda)**

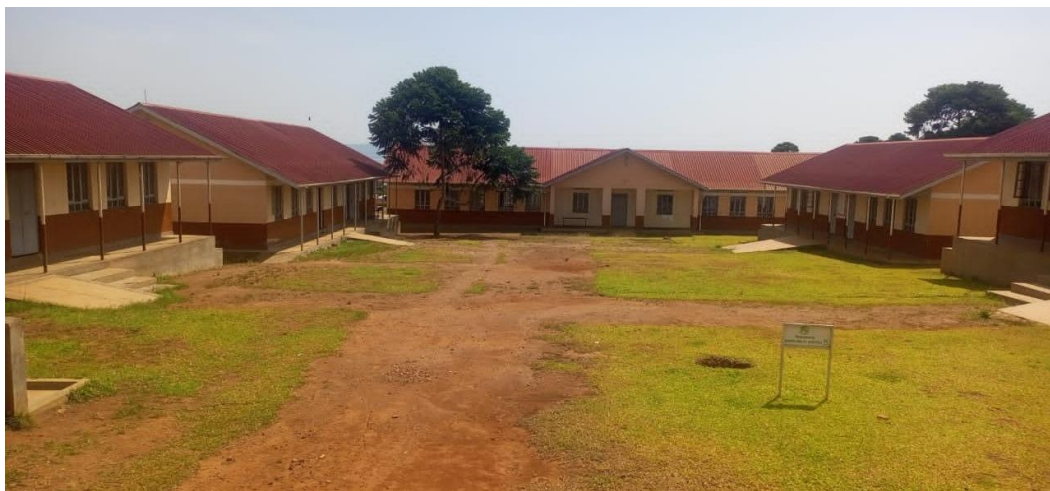
**Figure 131: School buildings and courtyard at a seed secondary school, Buvuma District (Buganda)**

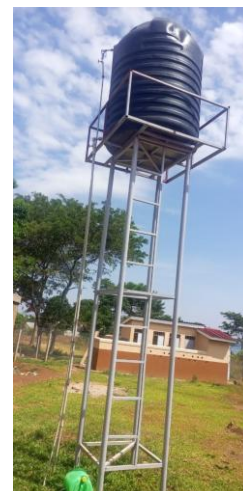
**Figure 132: Raised water storage tank at a seed secondary school, Buvuma District (Buganda)**

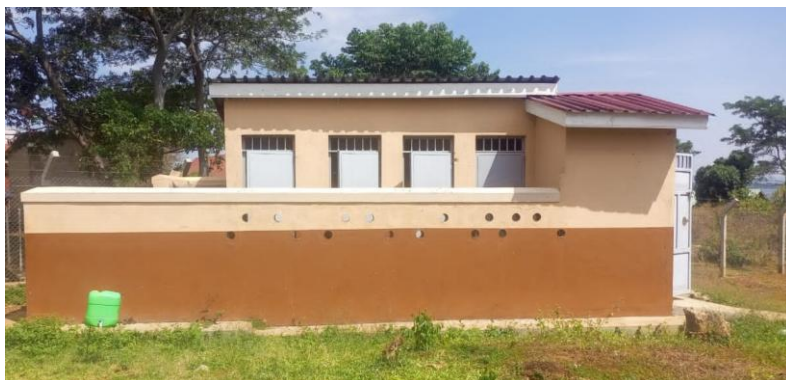
**Figure 133: Sanitation block at Bweema Seed Secondary School, Buvuma District (Buganda)**

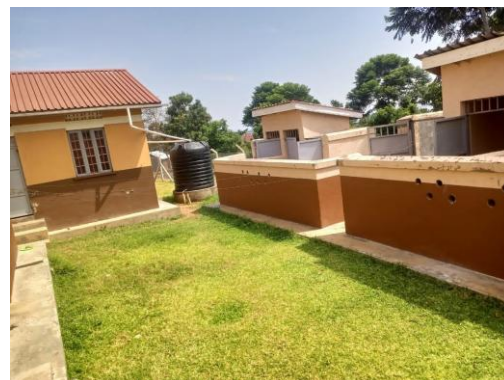
**Figure 134: Water tank and enclosed service structures at Bweema Seed Secondary School, Buvuma District (Buganda)**

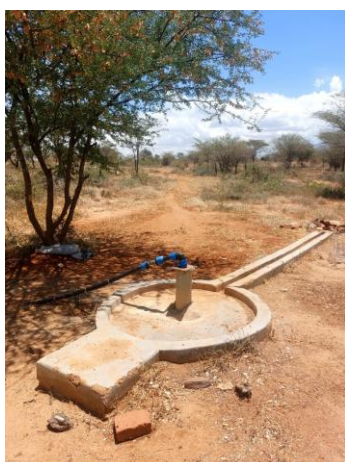
**Figure 135: Borehole apron and pipework at Katikekire Seed School, Moroto District (Karamoja)**

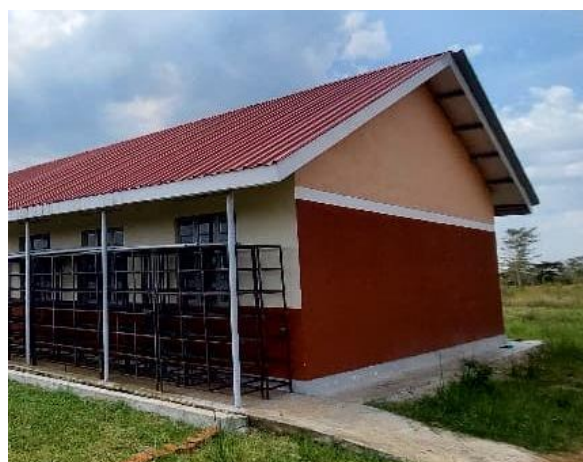
**Figure 136: Section of the science laboratory exterior at Iriiri Seed Secondary School, Napak District (Karamoja)**

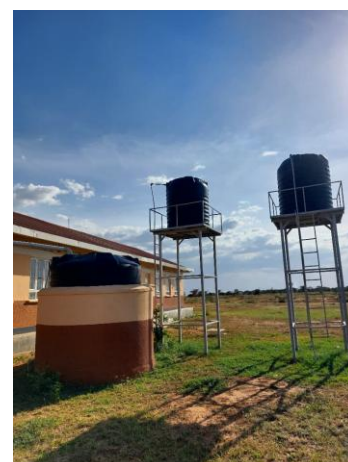
**Figure 137: Water storage tanks at Lopei Seed Secondary School, Napak District (Karamoja)**

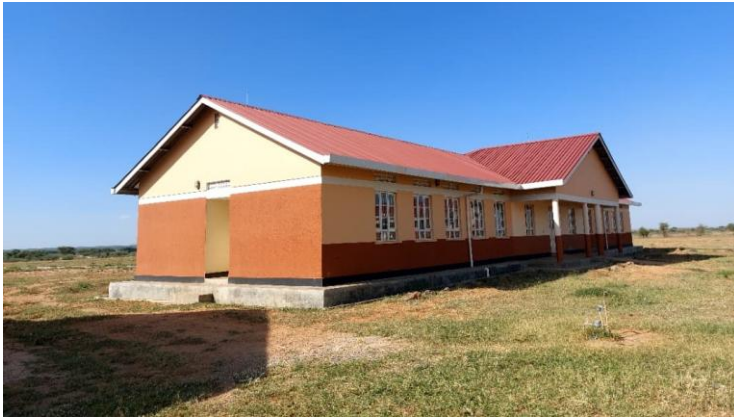
**Figure 138: Computer and library block at Lopei Seed Secondary School, Napak District (Karamoja)**

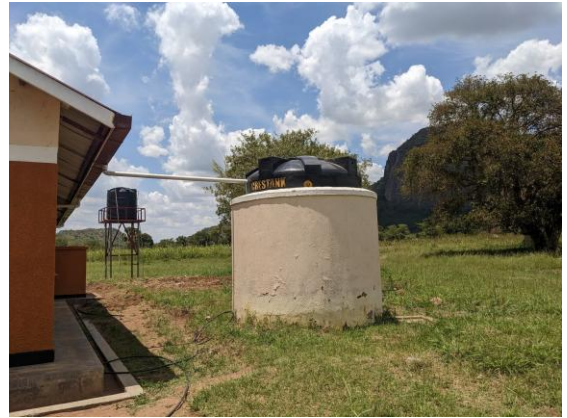
**Figure 139: Water tanks on a rendered plinth and steel tower at Alerek Seed Secondary School, Abim District (Karamoja)**

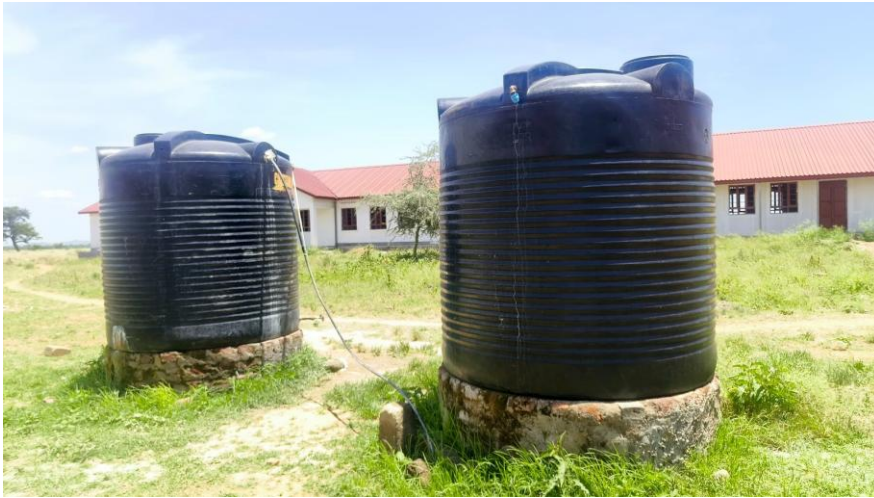
**Figure 140: Water storage tanks at Rengen Seed School, Kotido District (Karamoja)**

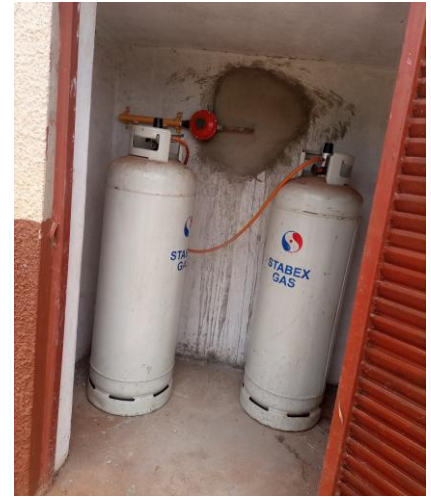
**Figure 141: Gas cylinders and pipework at King Solomon Seed Secondary School, Kagadi District (Bunyoro)**

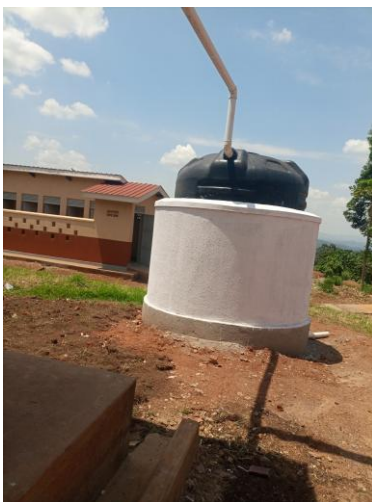
**Figure 142: Water tank on a masonry support at King Solomon Seed Secondary School, Kagadi District (Bunyoro)**

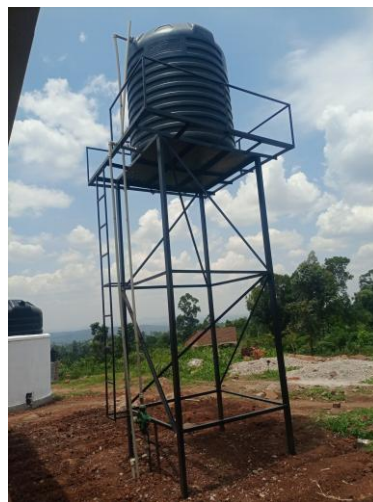
**Figure 143: Elevated water tank on a steel tower at King Solomon Seed Secondary School, Kagadi District (Bunyoro)**

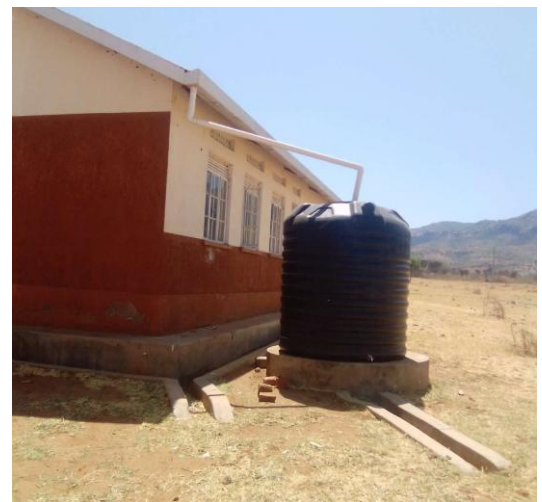
**Figure 144: Rainwater tank beside a staff house at Rupa Seed School, Moroto District (Karamoja)**
