# UgIFT Asset Verification Report

*Field findings, service gaps and recommended actions*

Ministry of Finance, Planning and Economic Development

27 September 2026

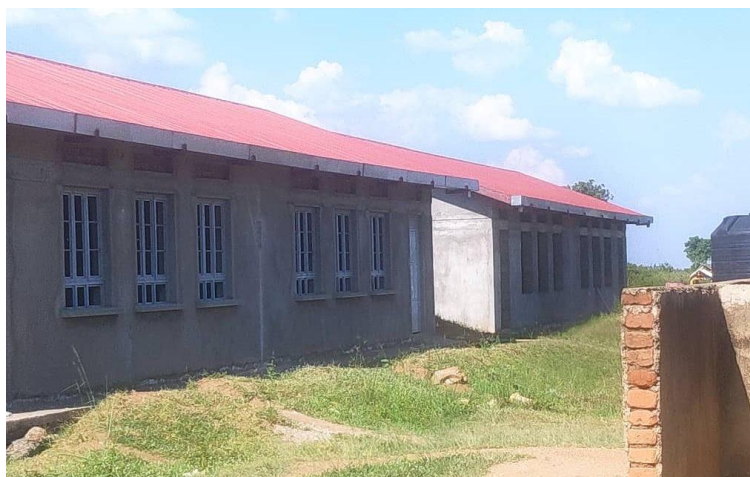
| Location | Expected position and field finding | Gap or service implication | Recommended action |
|---|---|---|---|
| Got Apwoyo Seed Secondary School, Nwoya | Expected: Got Apwoyo was intended to provide secondary education with completed buildings and installed ICT equipment.<br>Found: The team found construction continuing and the school uncommissioned. Its ICT package remained at Nwoya District headquarters, while delivered furniture and structures had not been brought into use. | The assets were not yet supporting teaching at the intended school, and custody was divided between the district and the site. | Nwoya District and the Ministry of Education should set a completion and handover plan, check the stored equipment, and arrange installation, testing and signed transfer when the school is ready. |

**Figure 2: Unfinished school block at Got Apwoyo Seed Secondary School, Nwoya District (Acholi)**

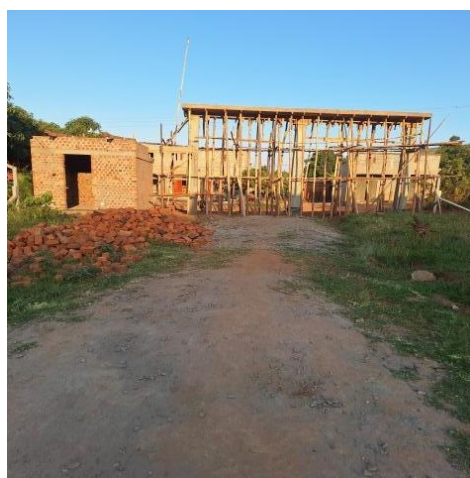
**Figure 3: Building works at a seed secondary school, Kiboga District (Buganda)**

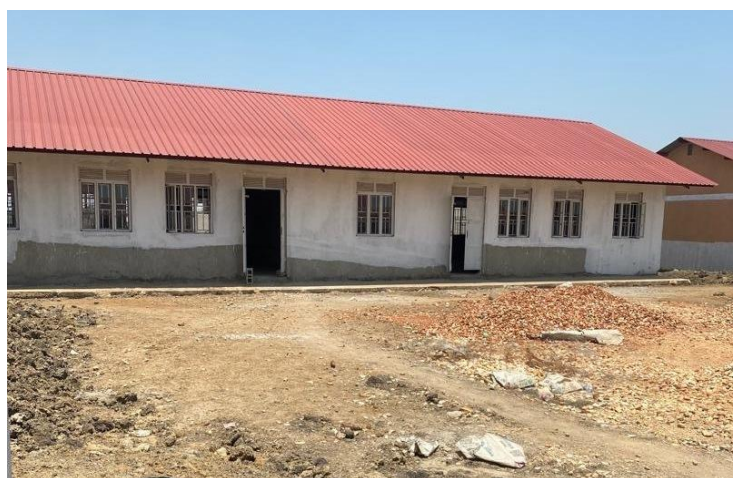
**Figure 4: School block awaiting completion at Butungama Seed Secondary School, Ntoroko District (Tooro)**

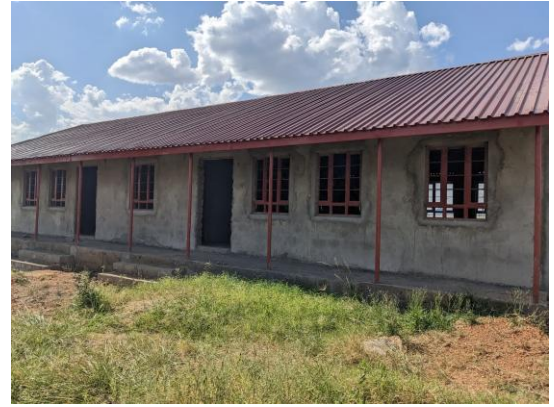
**Figure 56: Building works and construction materials at Ndhew Seed Secondary School, Nebbi District (West Nile)**

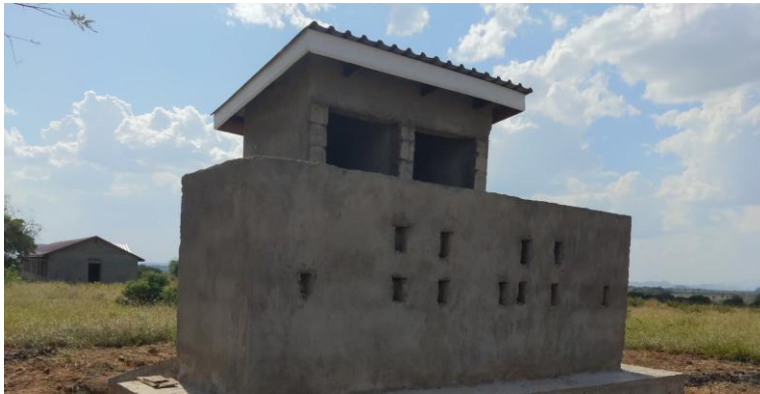
| Location | Expected position and field finding | Gap or service implication | Recommended action |
|---|---|---|---|
| Sidok Seed Secondary School, Kaabong | Expected: Sidok school needed completed buildings and checked equipment before the investment could support full operations.<br>Found: The team found blocks, a kitchen and toilets under construction, with termite workings on the plaster of two blocks. The school consignment remained unopened and its contents had not been counted. | Both unfinished works and unchecked equipment prevented a complete assessment of readiness for use. | Kaabong District should secure completion and treatment of the affected works, then arrange a witnessed opening, count and condition check of the equipment. Accepted items should be recorded, assigned to custodians and issued for use. |

**Figure 58: Latrine block under construction at Sidok Seed Secondary School, Kaabong District (Karamoja)**

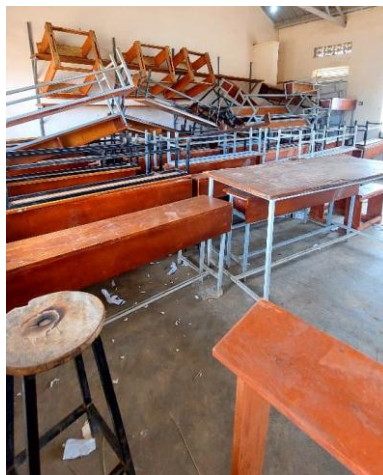
**Figure 59: Computer and library block interior with furniture and stored items at Iriiri Seed Secondary School, Napak District (Karamoja)**

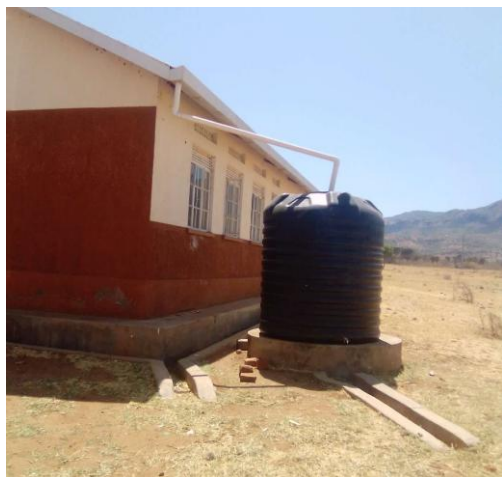
Figure 83: Water storage tanks at Rengen Seed School, Kotido District (Karamoja)

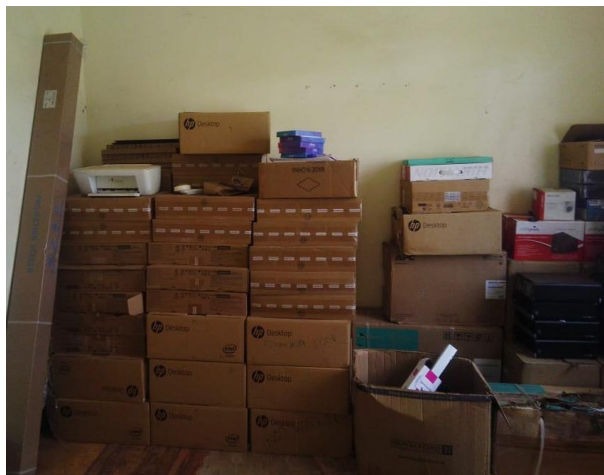
**Figure 114: Boxed computers and related equipment in a seed school store, Nwoya District (Acholi)**
