**CONSULTANCY SERVICES TO VERIFY AND RECORD ASSETS  
UNDER THE UGIFT PROGRAMME**

**REF: MOFPED/UGIFT/CONS/25/26/00015**

**ASSET VERIFICATION REPORT**

**September 2026**

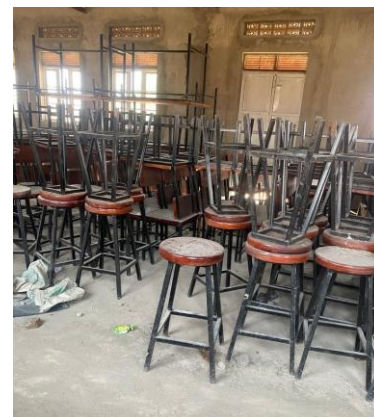
**Figure 58: Laboratory stools and desks stored and not yet in use at Butungama Seed Secondary School, Ntoroko District (Tooro), where the school buildings were still under construction**

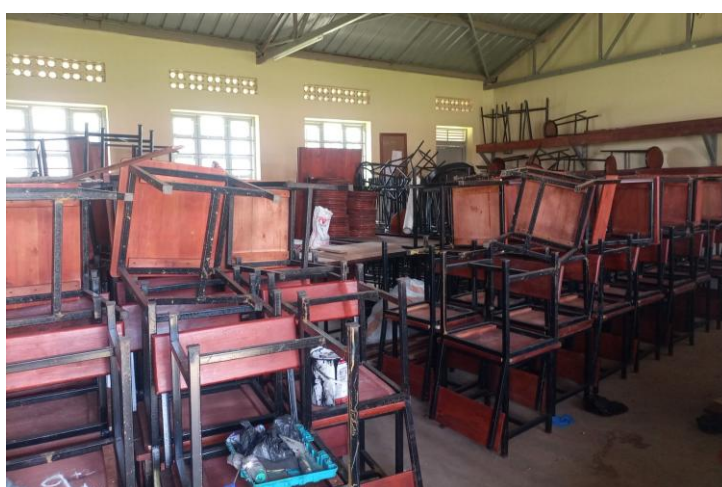
**Figure 60: Chairs, desks and laboratory stools stacked in a hall at King Solomon Seed Secondary School, Kagadi District (Bunyoro), where most assets remained in storage because the school was still under construction**

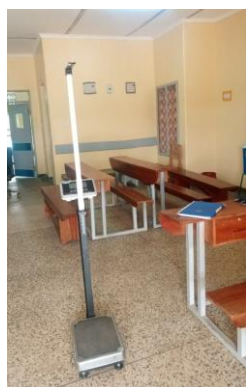
At Kihuukya Health Centre III in Hoima City, the renovated maternity block and walkways were recorded in use and a binocular microscope was seen functioning. Iruhura Health Centre III in Kabarole recorded adult weighing scales and waiting benches in use. Kamuli Health Centre III in Tororo reported improved service delivery, alongside continuing staffing and accommodation needs. Figures 70 to 74 show these health centre buildings and equipment in service.

**Figure 73: Adult weighing scale with a height meter and waiting benches at Iruhura HC III, Kabarole District (Tooro)**

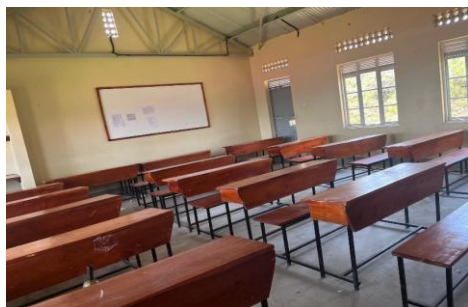
**Figure 75:** Classroom furnished with desks and a whiteboard at Gyagenda Memorial Seed Secondary School, Kalangala District (Buganda)

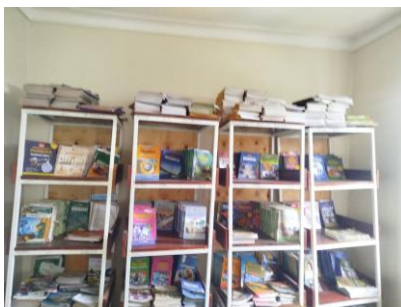
Sisiyi Seed Secondary School in Bulambuli recorded its buildings, furniture and ICT in use. Sibanga Seed Secondary School in Manafwa reported shorter distances for learners and less teenage pregnancy and school dropout, although full handover was still pending. Figures 75 to 77 show teaching spaces at Gyagenda Memorial, Sibanga and Sisiyi.

**Figure 76:** Books displayed on library shelves at Sibanga Seed School, Manafwa District (Bugisu)

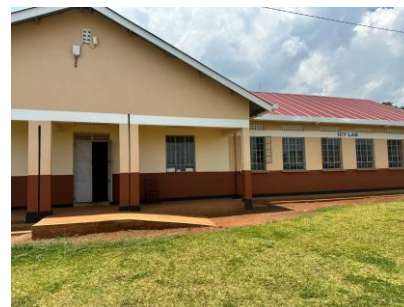
**Figure 77:** ICT laboratory block and entrance ramp at Sisiyi Seed Secondary School, Bulambuli District (Bugisu)

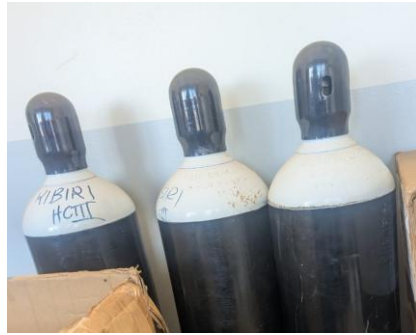
**Figure 82: Oxygen cylinders marked KIBIRI HCIII at Kibiri HC III, Makindye-Ssabagabo Municipal Council (Buganda)**

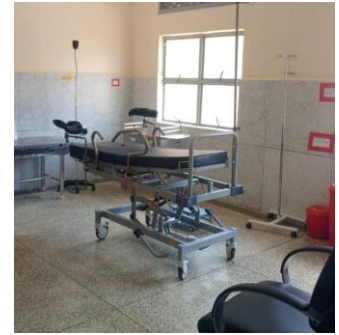
**Figure 84: Delivery bed and clinical furniture at a health centre, Kabarole District (Tooro)**

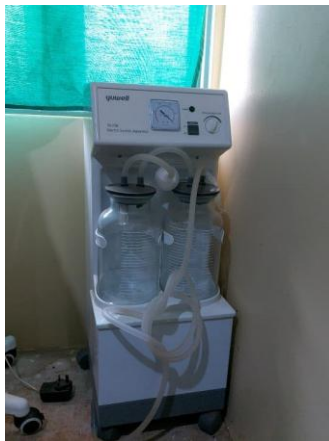
**Figure 86: Suction apparatus at Kalemungole HC III, Moroto District (Karamoja)**

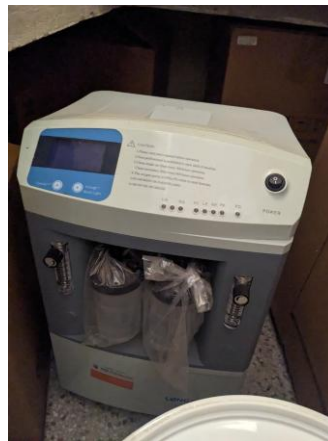
**Figure 87: Oxygen concentrator at Kamoru HC III, Kotido District (Karamoja)**

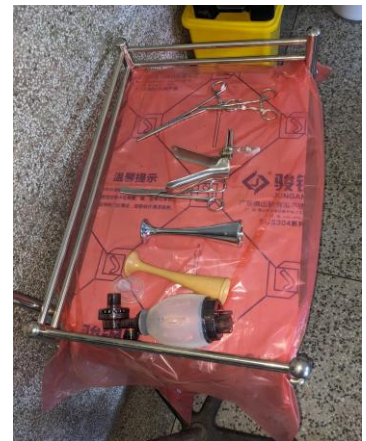
**Figure 88: Instrument trolley with delivery instruments at Kamoru HC III, Kotido District (Karamoja)**

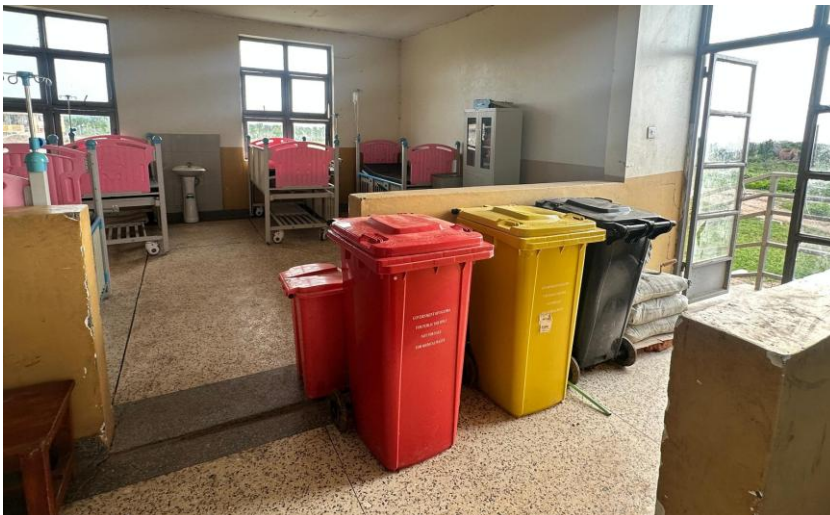
**Figure 89: Medical-waste bins and ward beds at Butiaba HC III, Buliisa District (Bunyoro)**

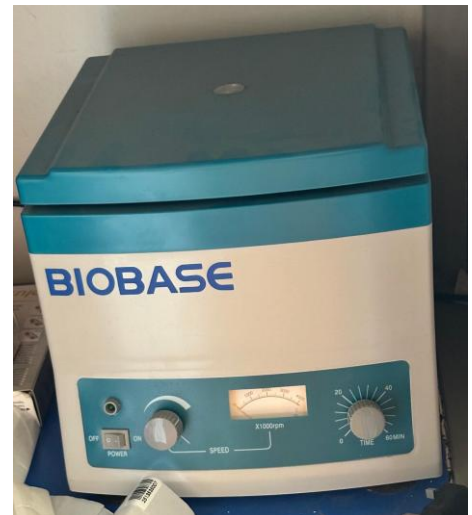
**Figure 90: Laboratory centrifuge at Butiaba HC III, Buliisa District (Bunyoro)**

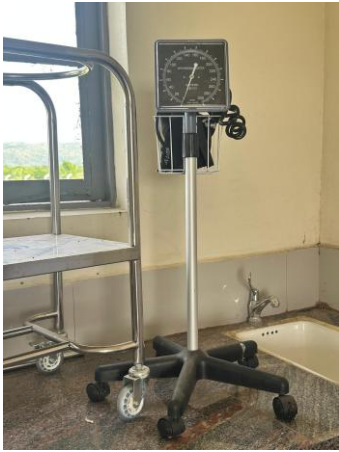
**Figure 91: Blood pressure apparatus on a mobile stand at Butiaba HC III, Buliisa District (Bunyoro)**

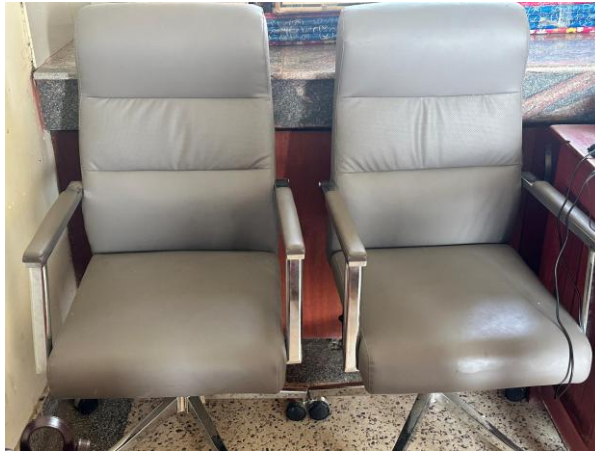
**Figure 92: Office chairs at Butiaba HC III, Buliisa District (Bunyoro)**

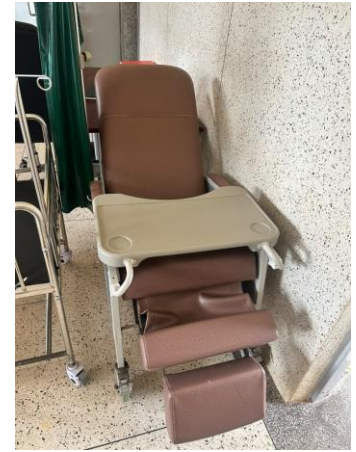
**Figure 93: Kangaroo care chair at Kyabasara HC III, Kagadi District (Bunyoro)**

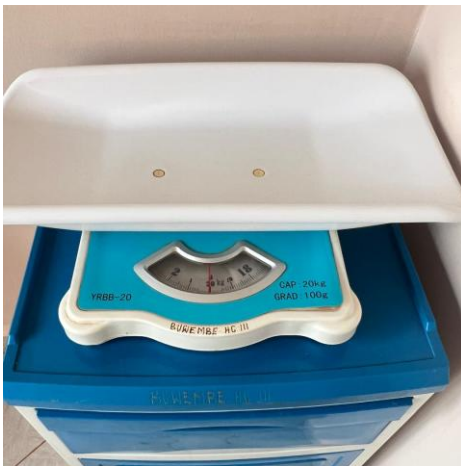
**Figure 94: Infant weighing scale at Buwembe HC III, Busia District (Bukedi)**

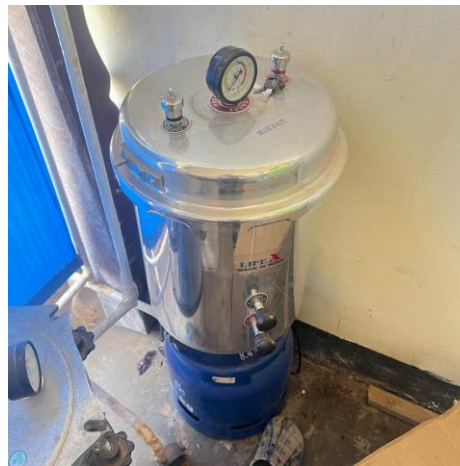
**Figure 95: Autoclave above a gas cylinder at Buwembe HC III, Busia District (Bukedi)**

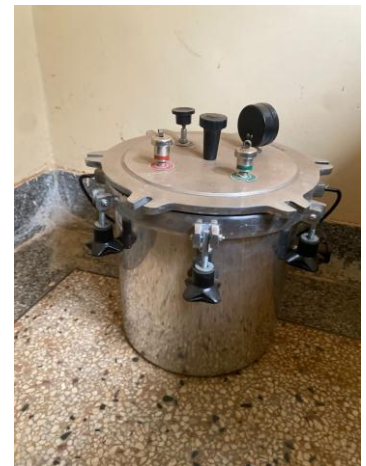
**Figure 96: Autoclave at Atar HC III, Kween District (Sebei)**

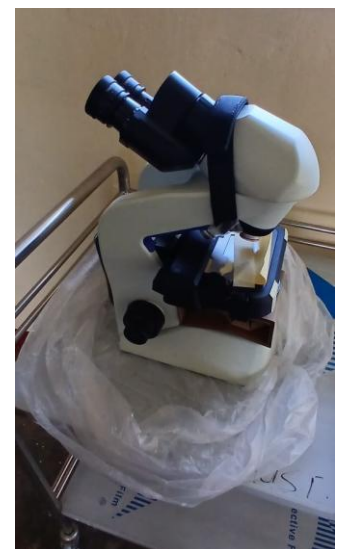
**Figure 98: Binocular microscope on a trolley at Namusita HC III, Budaka District (Bukedi)**

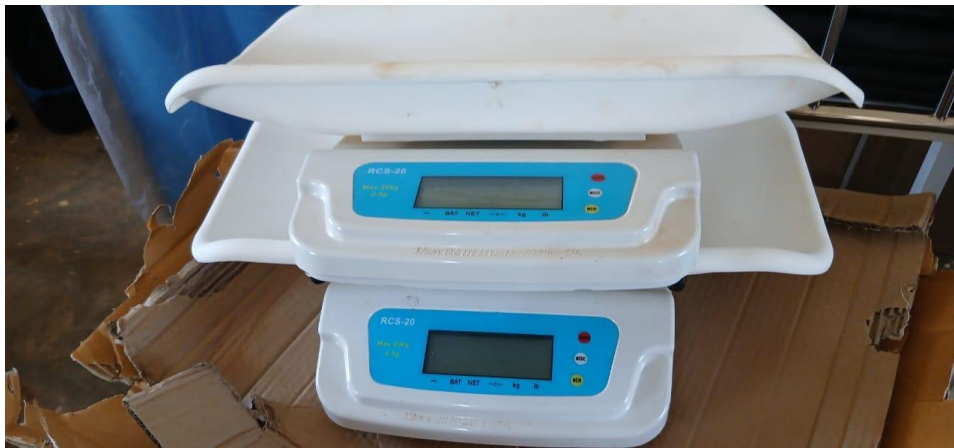
Figure 99: Infant weighing scales at Namusita HC III, Budaka District (Bukedi)

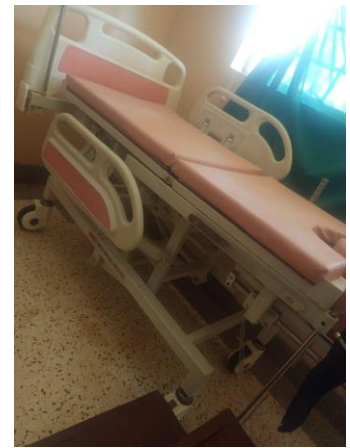
Figure 100: Delivery bed with side rails at Kabweri HC III, Kibuku District (Bukedi)

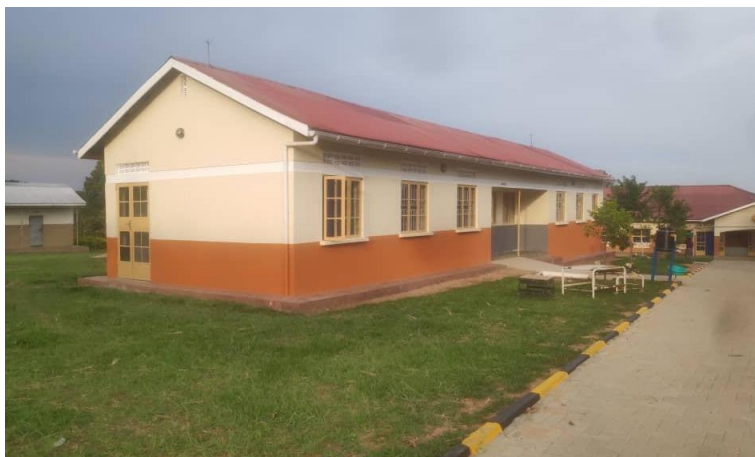
Figure 101: Health centre building, Nwoya District (Acholi)

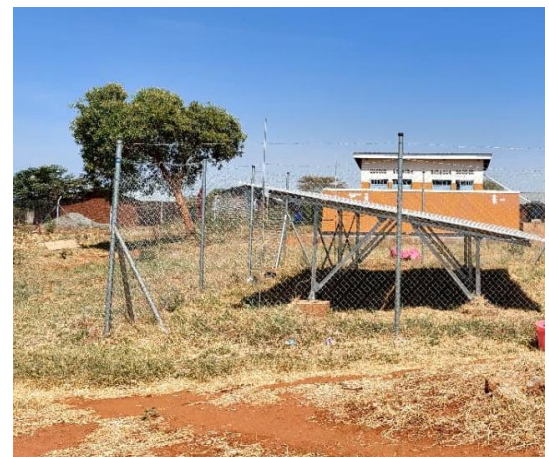
Figure 102: Solar panels at Kalemungole HC III, Moroto District (Karamoja)

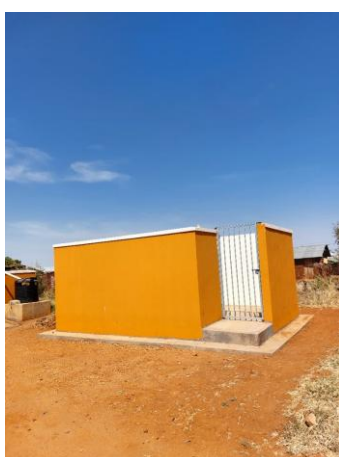
Figure 103: Patient toilet block at Kalemungole HC III, Moroto District (Karamoja)

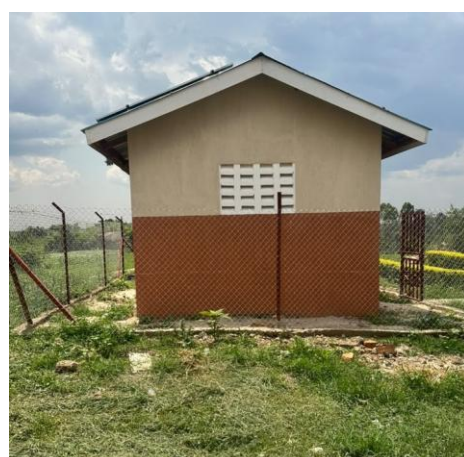
Figure 104: Power house at Kyabasara HC III, Kagadi District (Bunyoro)
