# UgIFT Asset Verification Report

*Field findings, service gaps and recommended actions*

Ministry of Finance, Planning and Economic Development

27 September 2026

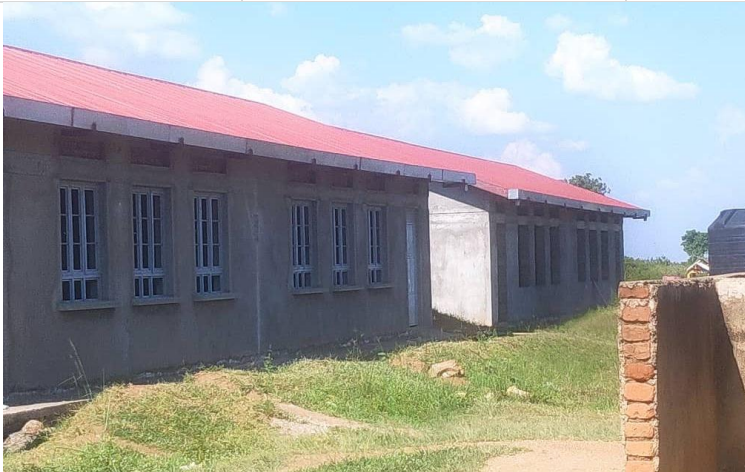
**Figure 2: Unfinished school block at Got Apwoyo Seed Secondary School, Nwoya District (Acholi)**

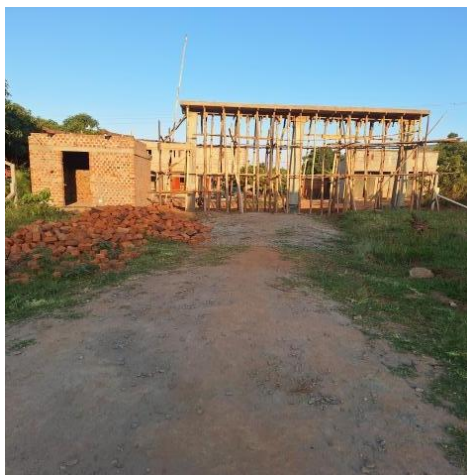
**Figure 3: Building works at a seed secondary school, Kiboga District (Buganda)**

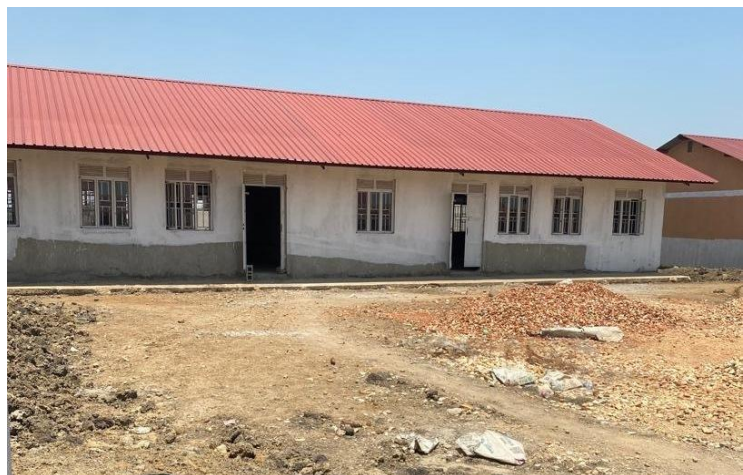
**Figure 4: School block awaiting completion at Butungama Seed Secondary School, Ntoroko District (Tooro)**

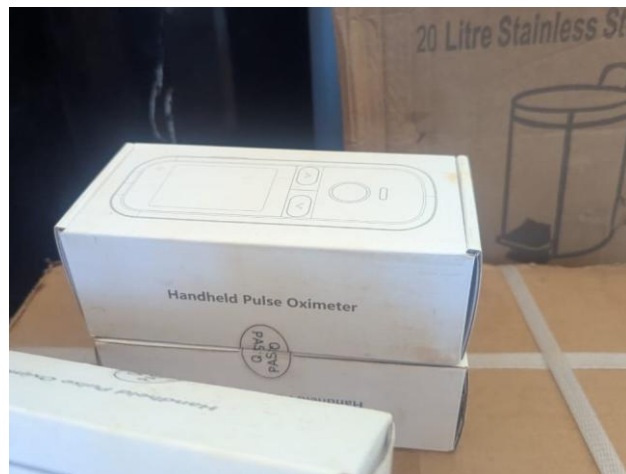
Figure 8: Boxed pulse oximeters at a health centre, Makindye-Ssabagabo Municipal Council (Buganda)

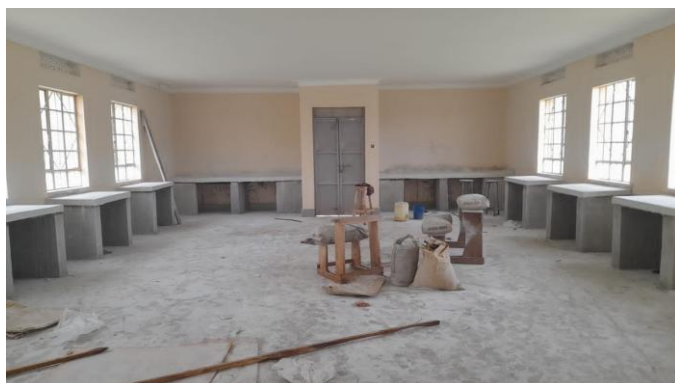
**Figure 29: ICT laboratory interior under construction at Kitawoi Seed Secondary School, Kween District (Sebei)**

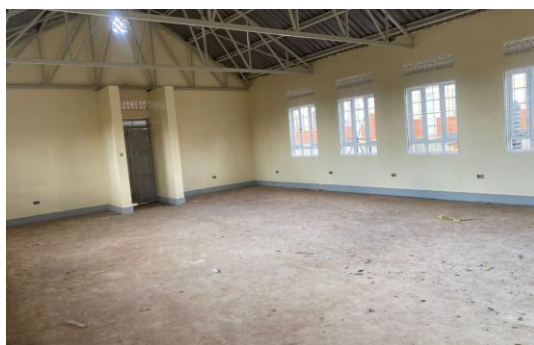
**Figure 31: Empty computer laboratory at a seed secondary school, Kween District (Sebei)**

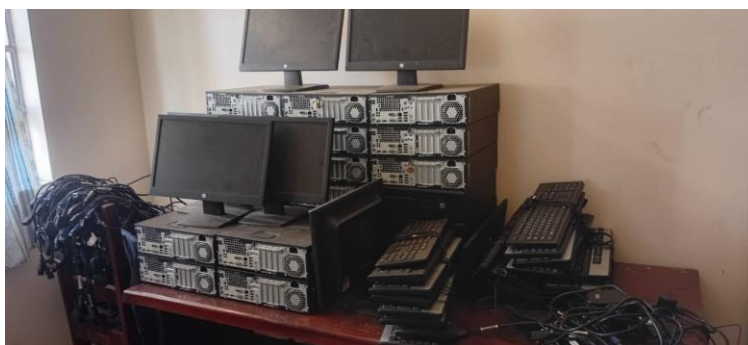
**Figure 32: Computer sets stacked in a store at Bumufuni Seed Secondary School, Bulambuli District (Bugisu)**

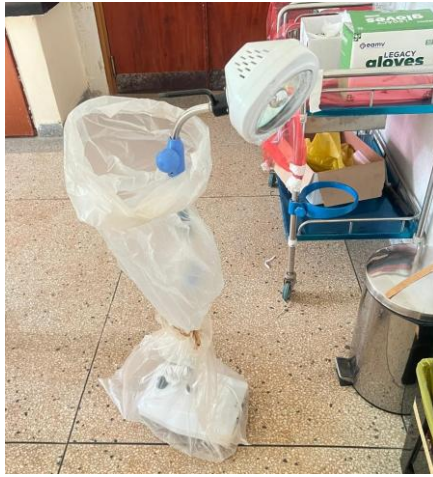
**Figure 33: Examination lamp in protective wrapping at Buwumba HC III, Busia District (Bukedi)**

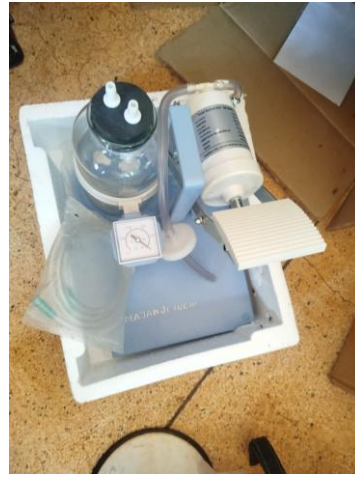
**Figure 34: Pedal suction unit in packaging at Majanji HC III, Busia District (Bukedi)**

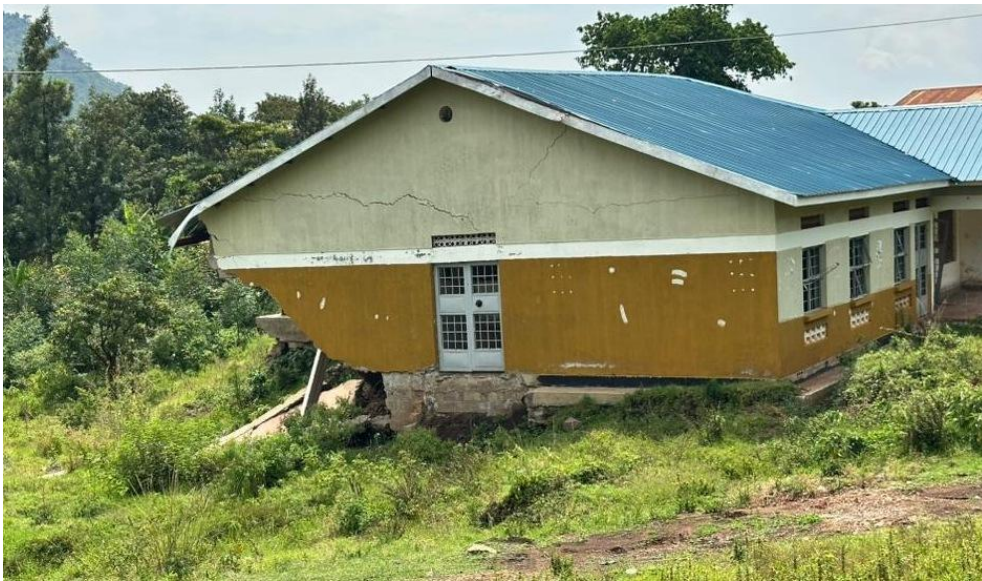
**Figure 35: Cracked health centre block above collapsed ground, Bulambuli District (Bugisu)**

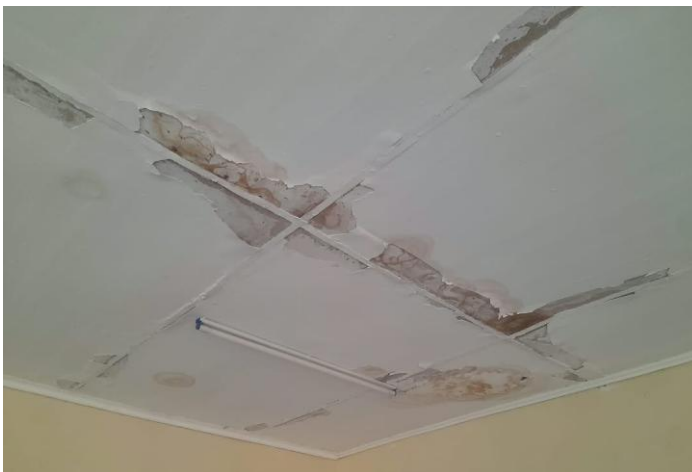
**Figure 36: Stained and peeling ceiling at a health centre, Sironko District (Bugisu)**

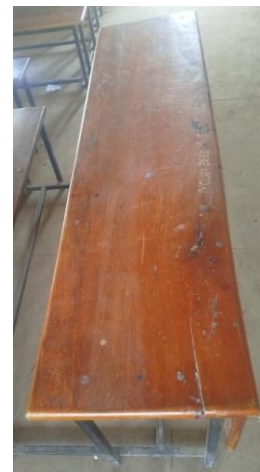
**Figure 37: Cracked desk surface bearing a school marking, Tororo District (Bukedi)**

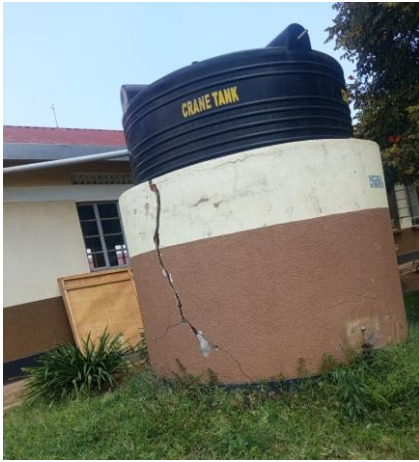
**Figure 38:** Water tank on a cracked base at a seed secondary school, Kibuku District (Bukedi)

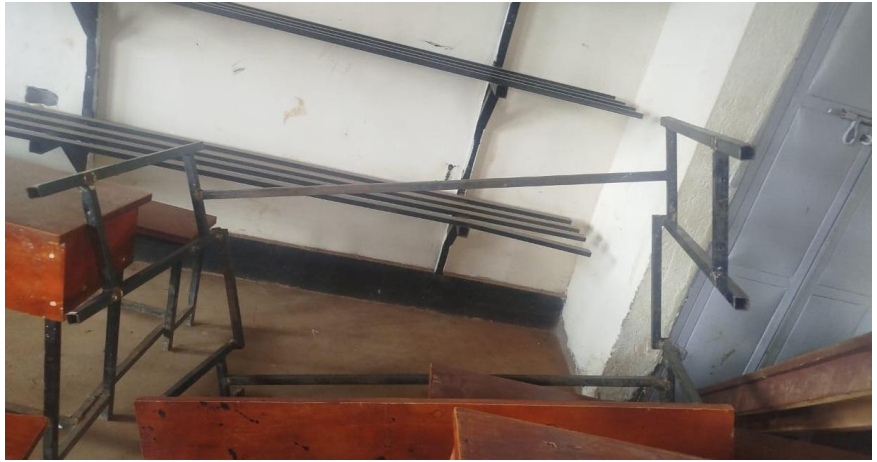
**Figure 39:** Broken desk frame at a seed secondary school, Namisindwa District (Bugisu)

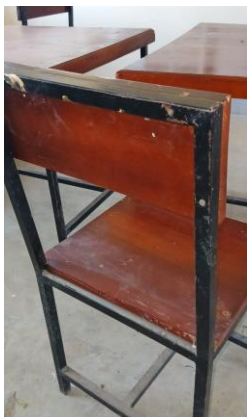
**Figure 40:** Damaged chair back joint at a seed secondary school, Budaka District (Bukedi)

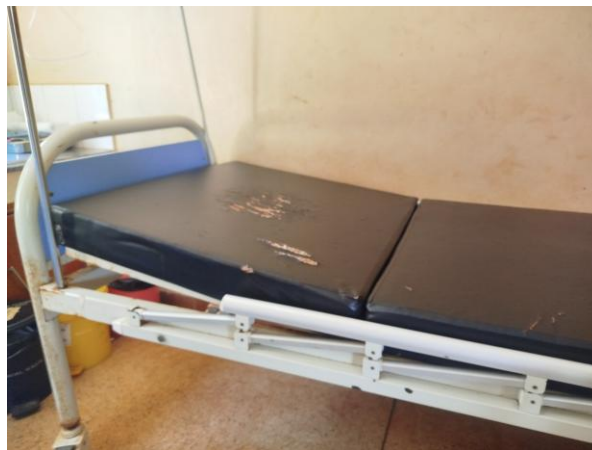
**Figure 55: Delivery bed with a torn mattress cover at a health centre, Busia District (Bukedi)**

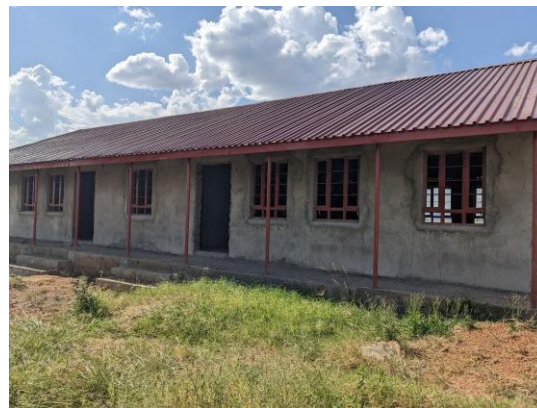
**Figure 61: Building works and construction materials at Ndhew Seed Secondary School, Nebbi District (West Nile)**

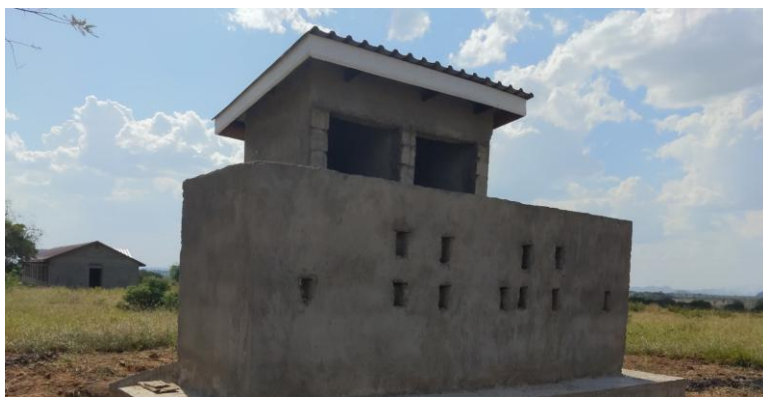
**Figure 63: Latrine block under construction at Sidok Seed Secondary School, Kaabong District (Karamoja)**

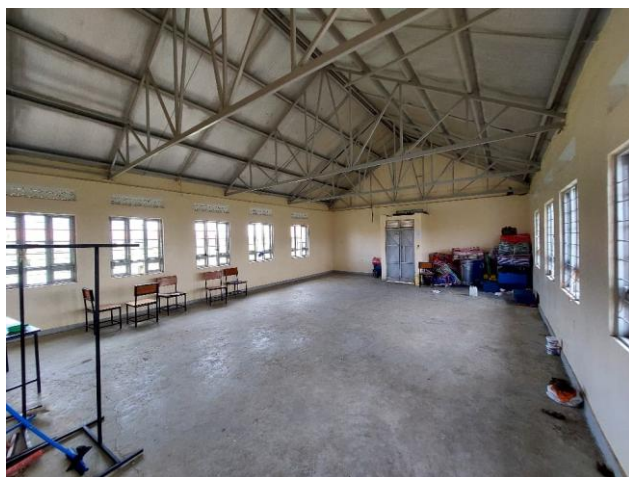
**Figure 65: Computer and library block interior with furniture and stored items at Iriiri Seed Secondary School, Napak District (Karamoja)**

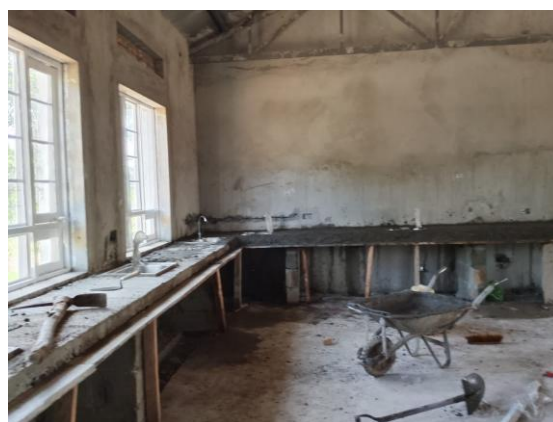
**Figure 91: Classroom block with earthworks in the foreground at Kihungya Seed Secondary School, Buliisa District (Bunyoro)**

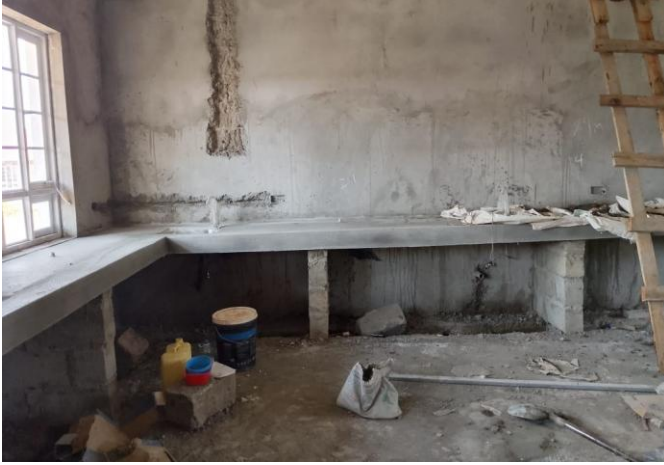
**Figure 93: Unfinished laboratory interior at Kihungya Seed Secondary School, Buliisa District (Bunyoro)**

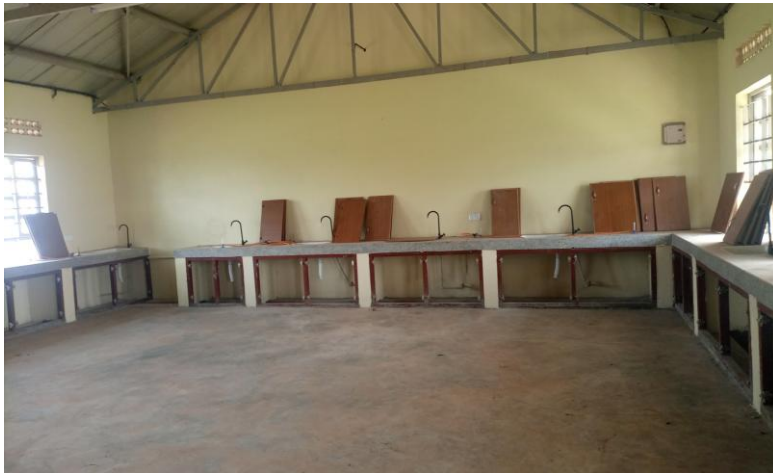
**Figure 95: Laboratory benches with cupboard doors detached at King Solomon Seed Secondary School, Kagadi District (Bunyoro)**

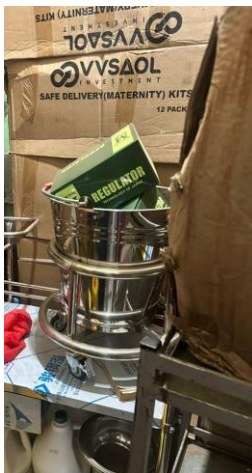
**Figure 96: Laboratory stools and other school furniture in storage, Ntoroko District (Tooro)**

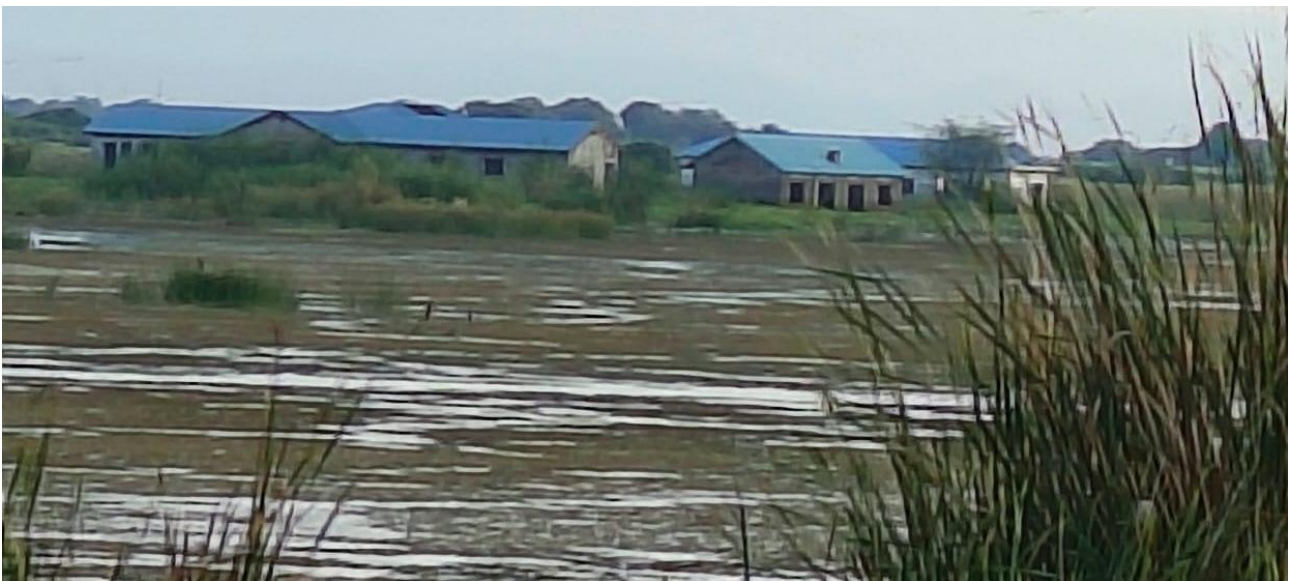
**Figure 101: Flood-affected older health facility at Butiaba, Buliisa District (Bunyoro)**

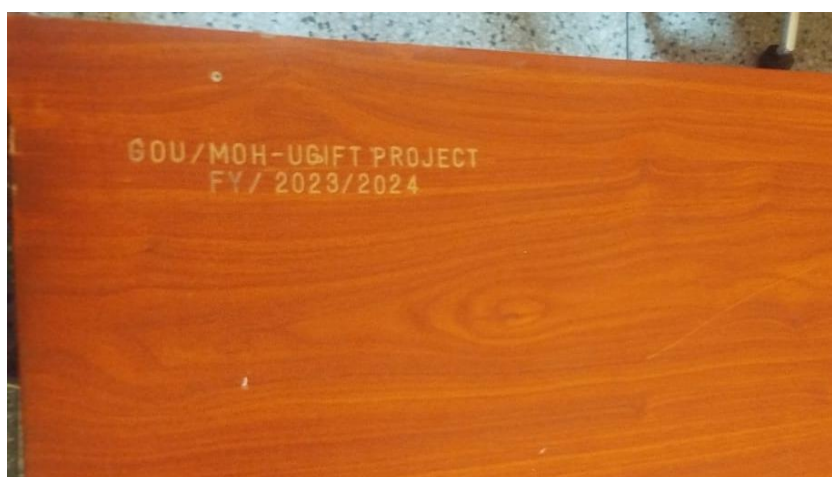
Across the programme, 49,836 of 218,715 movable assets eligible for a physical mark had an identification entry (22.8%). Of these, 20,973 carried UgIFT marking and 28,863 carried another marking. Buildings and land are tracked by location, ownership and handover records instead. Lungulu Seed Secondary School provided a specific example of equipment requiring identification.

**Figure 120: Most assets had no engraved identification**

Marking should identify the asset and the institution responsible for it. Where assets have moved, custody needs to move with them: equipment from three Busia health centres had gone to Masafu Hospital, while equipment intended for Todora in Nwoya had gone to Paraa during construction. The district should confirm the continuing allocation and retain signed handover or transfer documentation.

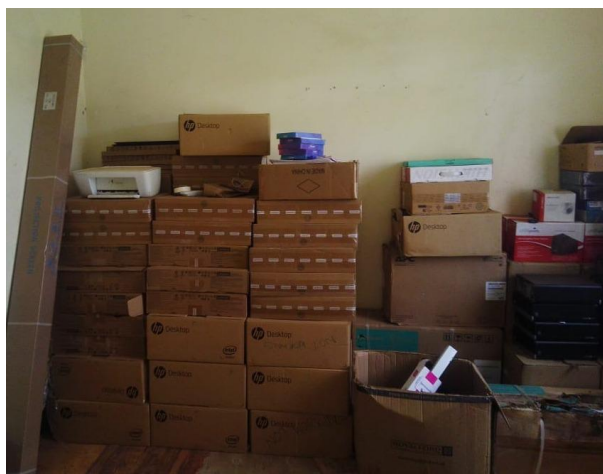
**Figure 122: Boxed computers and related equipment in a seed school store, Nwoya District (Acholi)**
