**CONSULTANCY SERVICES TO VERIFY AND RECORD ASSETS  
UNDER THE UGIFT PROGRAMME**

**REF: MOFPED/UGIFT/CONS/25/26/00015**

**ASSET VERIFICATION REPORT**

**September 2026**

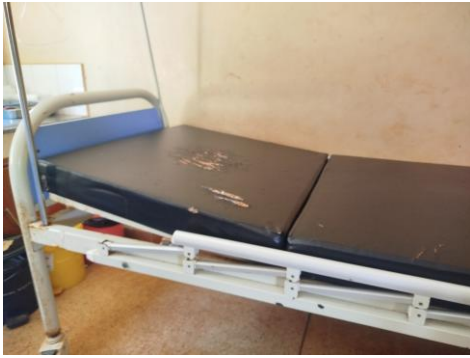
**Figure 4: Delivery bed with a torn mattress cover at a health centre, Busia District (Bukedi)**

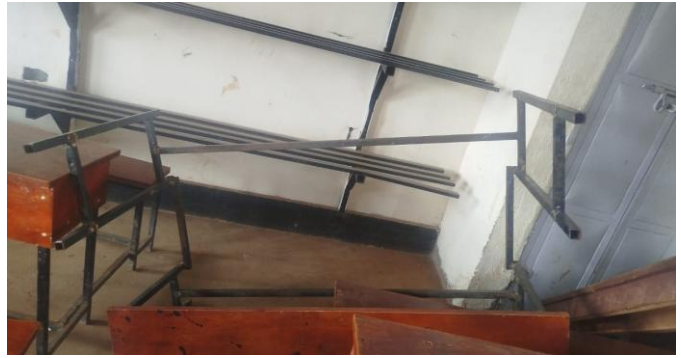
**Figure 6: Broken desk frame at a seed secondary school, Namisindwa District (Bugisu)**

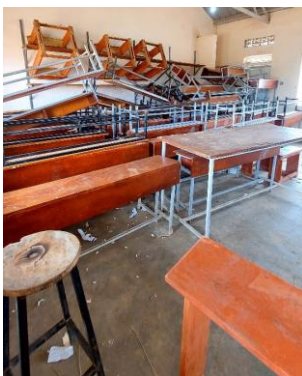
**Figure 7: Stacked desks, chairs and stools, some recorded as broken and none engraved, at Napak Seed Secondary School, Napak District (Karamoja)**

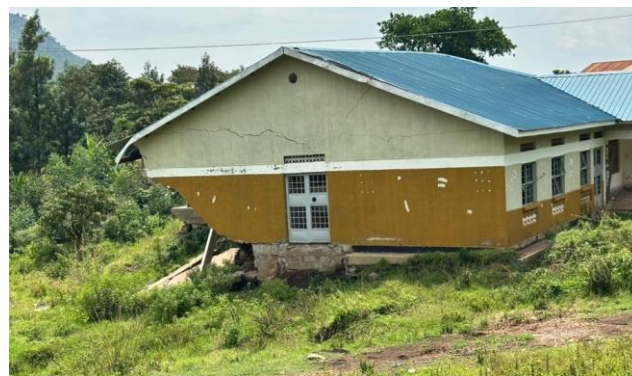
**Figure 8: Cracked health centre block above collapsed ground, Bulambuli District (Bugisu)**

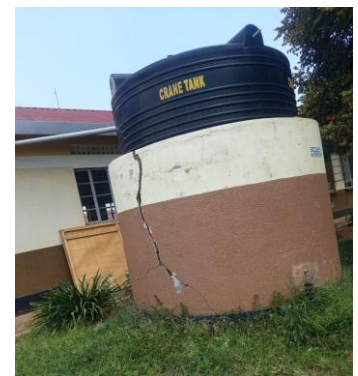
**Figure 9: Water tank on a cracked base at a seed secondary school, Kibuku District (Bukedi)**

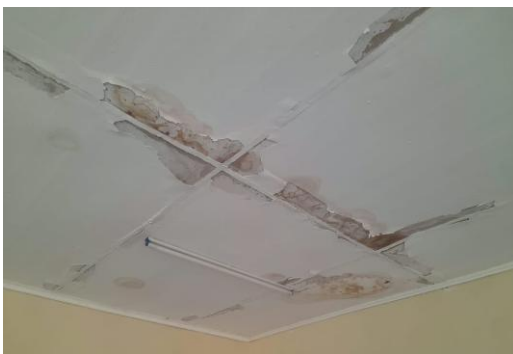
**Figure 10: Stained and peeling ceiling at a health centre, Sironko District (Bugisu)**

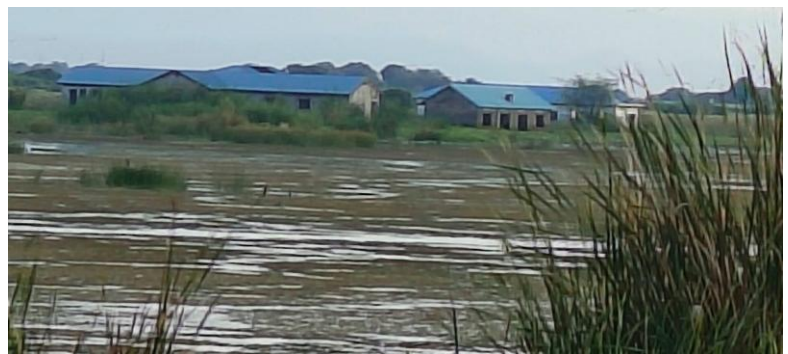
**Figure 11: Flood-affected older health facility at Butiaba, Buliisa District (Bunyoro)**

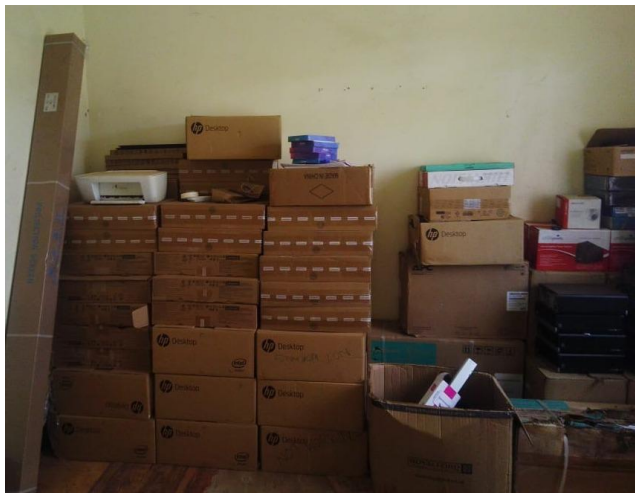
The 3,200 assets in storage were at 181 facilities, 2,681 (83.8%) of them at health centres, with clinical equipment the largest group (1,685). Of the stored assets, 190 (5.9%) were waiting for a power connection, 80 (2.5%) for a building or room and 141 (4.4%) were held at district stores or at another facility, while 519 (16.2%) were described as new, boxed or in good condition. Examples include 211 stored assets at health centres in Kabarole and 159 in Omoro, and computer equipment kept in store at Akadot Seed Secondary School in Pallisa, which has no electricity, and at Lungulu Seed Secondary School in Nwoya, which was awaiting a power connection.

**Figure 12: Desktop computers, a printer and UPS units still boxed in the store at Lungulu Seed Secondary School, Nwoya District (Acholi), awaiting a power connection for installation**

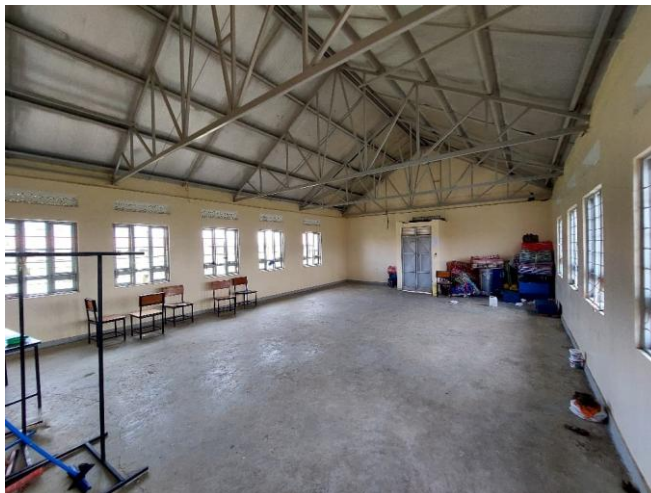
**Figure 13: Largely empty ICT and library block with a few chairs and items kept in one corner at Iriiri Seed Secondary School, Napak District (Karamoja), not yet in use while the school remained with the contractor**

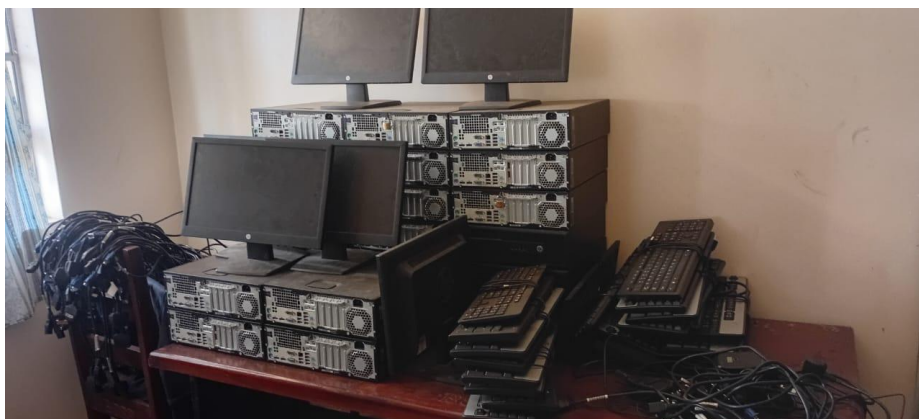
**Figure 14: HP computer sets stacked in store with cables still bundled and not installed at Bumufuni Seed Secondary School, Bulambuli District (Bugisu)**

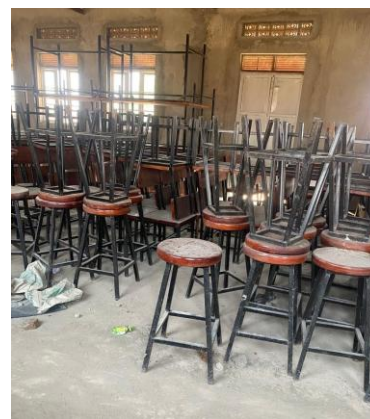
**Figure 15: Laboratory stools and desks stored and not yet in use at Butungama Seed Secondary School, Ntoroko District (Tooro), where the school buildings were still under construction**

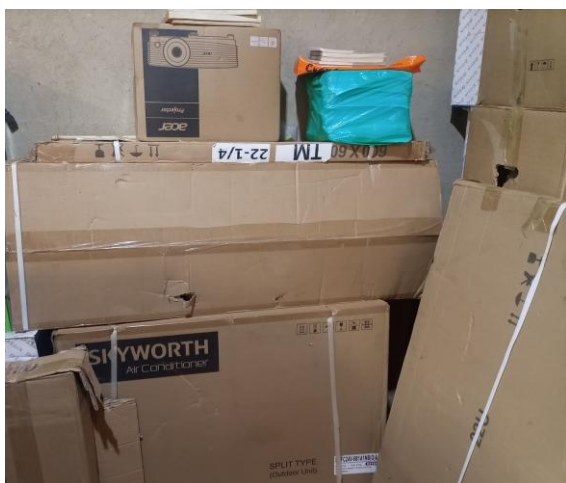
**Figure 16: Boxed projector, air conditioner and other equipment in store at King Solomon Seed Secondary School, Kagadi District (Bunyoro), kept boxed because the school was still under construction**

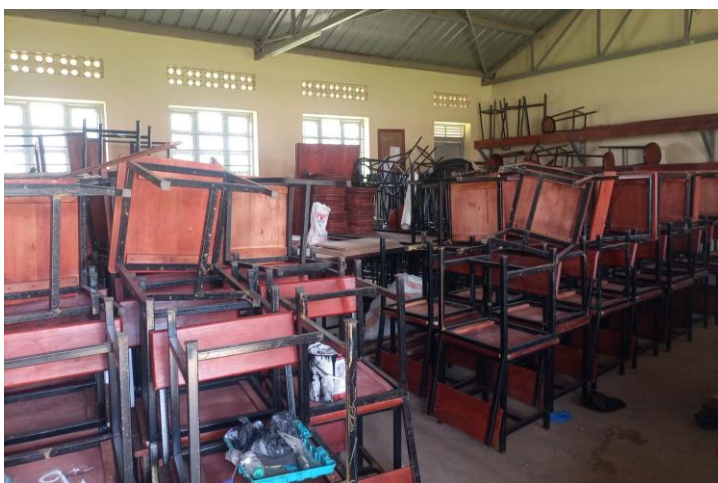
**Figure 17: Chairs, desks and laboratory stools stacked in a hall at King Solomon Seed Secondary School, Kagadi District (Bunyoro), where most assets remained in storage because the school was still under construction**

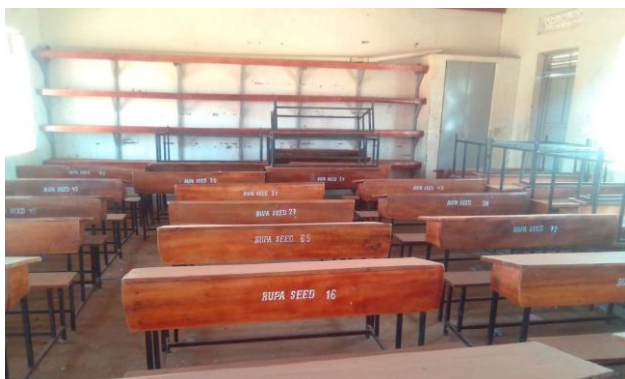
Figure 36: Classroom desks marked RUPA SEED with serial numbers, without a UgiFT marking, at Rupa Seed School, Moroto District (Karamoja)

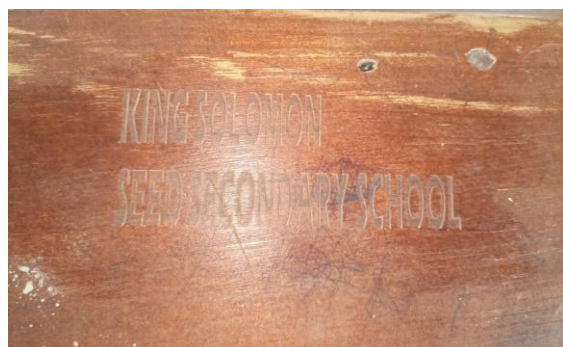
Figure 38: Engraving reading KING SOLOMON SEED SECONDARY SCHOOL, without a UgIFT marking, on furniture at King Solomon Seed Secondary School, Kagadi District (Bunyoro)

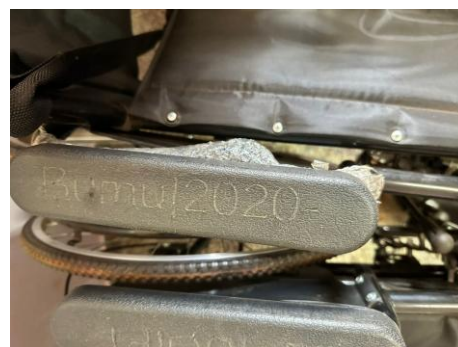
Figure 40: Hand-scratched marking beginning Bumu/2020- on a wheelchair armrest at Bumugibole Health Centre III, Bulambuli District (Bugisu)

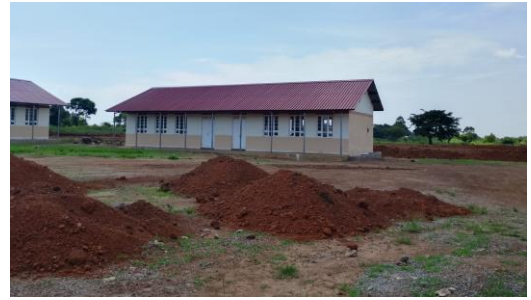
**Figure 79: Classroom block with earthworks in the foreground at Kihungya Seed Secondary School, Buliisa District (Bunyoro)**

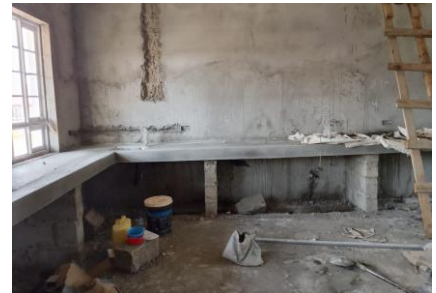
**Figure 82: Unfinished laboratory interior at Kihungya Seed Secondary School, Buliisa District (Bunyoro)**

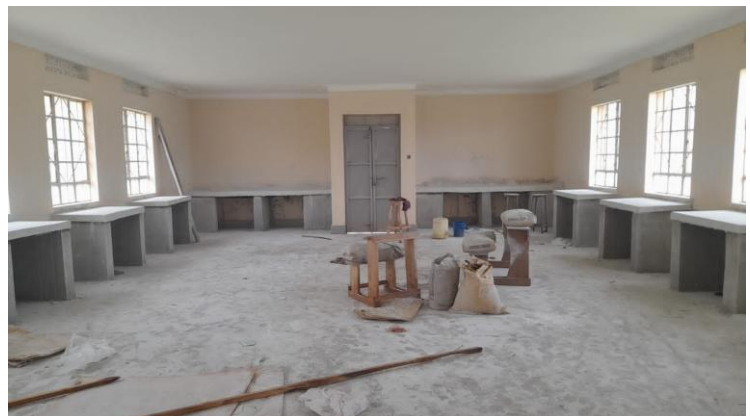
**Figure 84: ICT laboratory interior under construction at Kitawoi Seed Secondary School, Kween District (Sebei)**

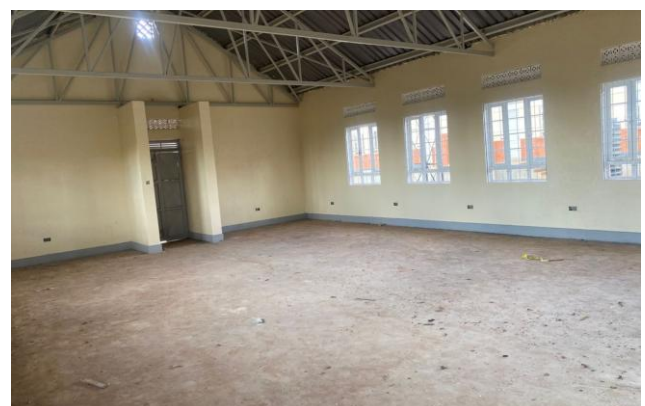
**Figure 86: Empty computer laboratory at Kaptum Seed Secondary School, Kween District (Sebei), where the buildings had not been handed over and no ICT equipment had been received**
