# UgIFT Asset Verification Report

*Field findings, service gaps and recommended actions*

Ministry of Finance, Planning and Economic Development

27 September 2026

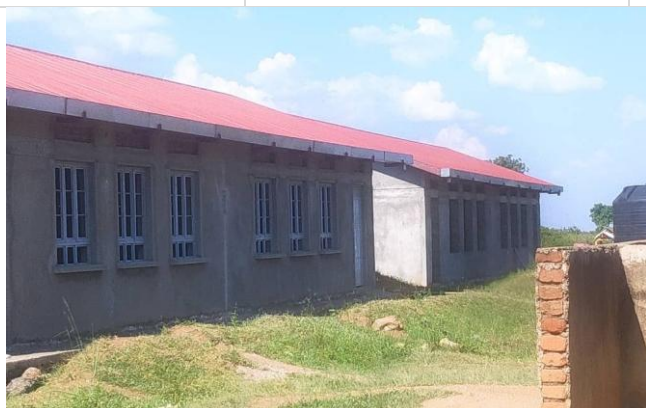
| Location | Expected position and field finding | Gap or service implication | Recommended action |
|---|---|---|---|
| Got Apwoyo Seed Secondary School, Nwoya | Expected: Got Apwoyo was intended to provide secondary education with completed buildings and installed ICT equipment.<br>Found: The team found construction continuing and the school uncommissioned. Its ICT package remained at Nwoya District headquarters, while delivered furniture and structures had not been brought into use. | The assets were not yet supporting teaching at the intended school, and custody was divided between the district and the site. | Nwoya District and the Ministry of Education should set a completion and handover plan, check the stored equipment, and arrange installation, testing and signed transfer when the school is ready. |

**Figure 2: Unfinished school block at Got Apwoyo Seed Secondary School, Nwoya District (Acholi)**

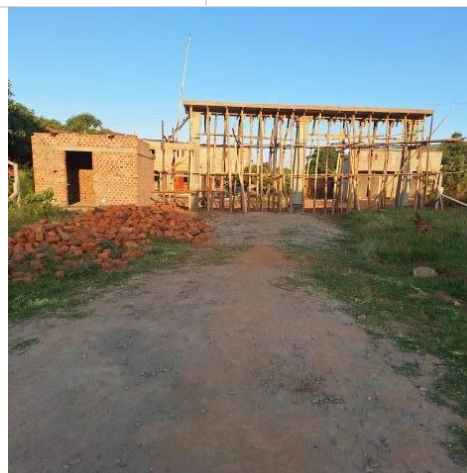
**Figure 3: Building works at a seed secondary school, Kiboga District (Buganda)**

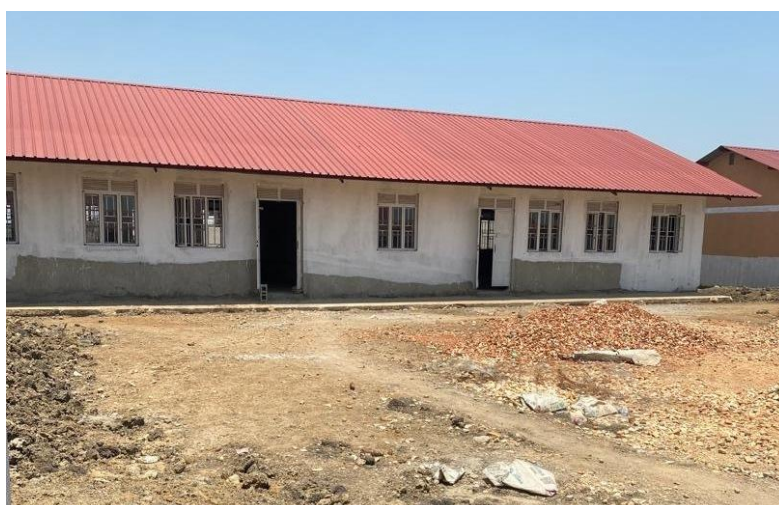
**Figure 4: School block awaiting completion at Butungama Seed Secondary School, Ntoroko District (Tooro)**

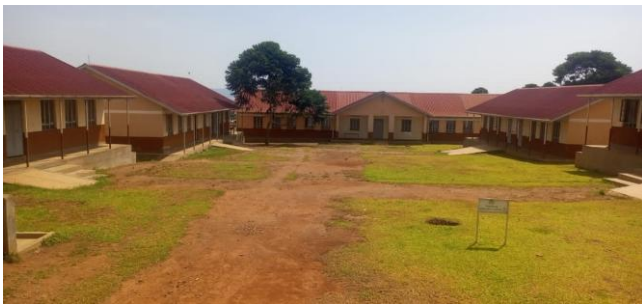
**Figure 5: School buildings and courtyard at a seed secondary school, Buvuma District (Buganda)**

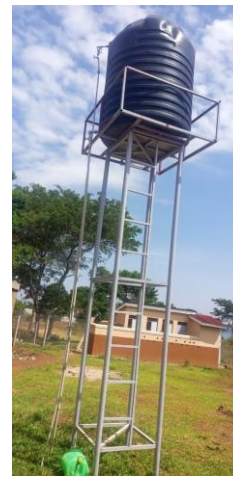
**Figure 6: Raised water storage tank at a seed secondary school, Buvuma District (Buganda)**

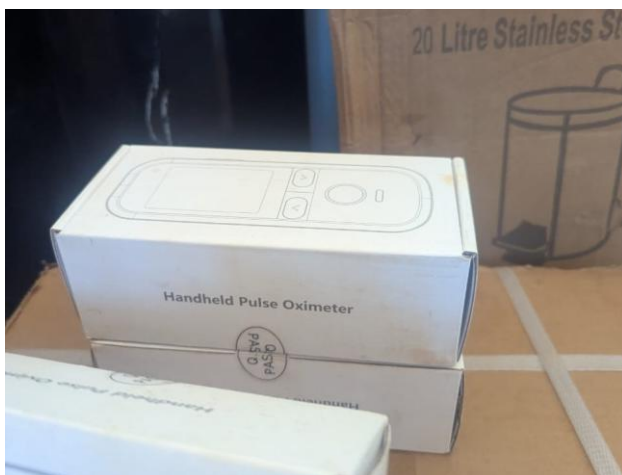
**Figure 7: Boxed pulse oximeters at a health centre, Makindye-Ssabagabo Municipal Council (Buganda)**

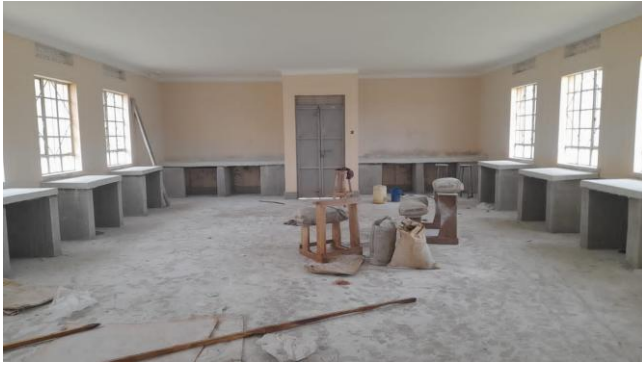
Figure 15: ICT laboratory interior under construction at Kitawoi Seed Secondary School, Kween District (Sebei)

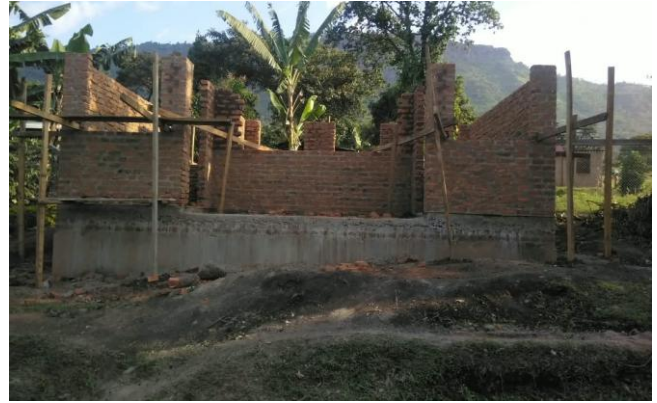
Figure 16: Unfinished laboratory building at a health centre, Sironko District (Bugisu)

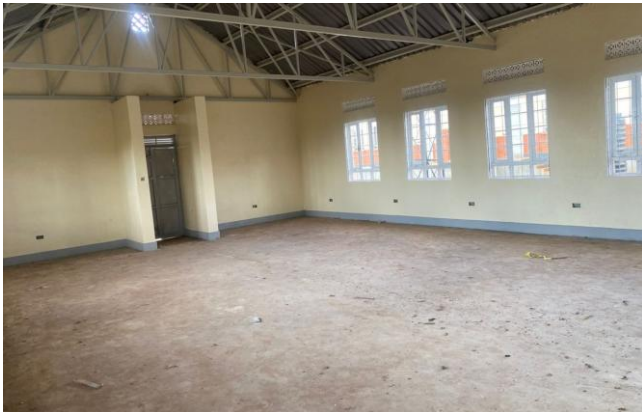
Figure 17: Empty computer laboratory at a seed secondary school, Kween District (Sebei)

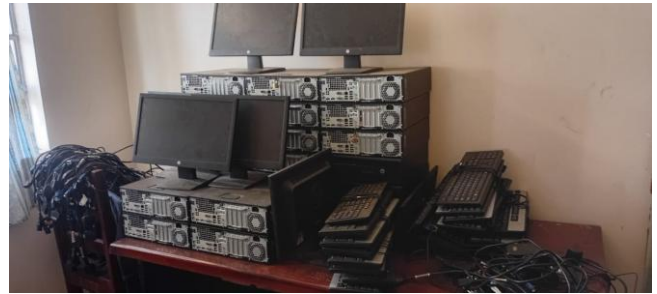
Figure 18: Computer sets stacked in a store at Bumufuni Seed Secondary School, Bulambuli District (Bugisu)

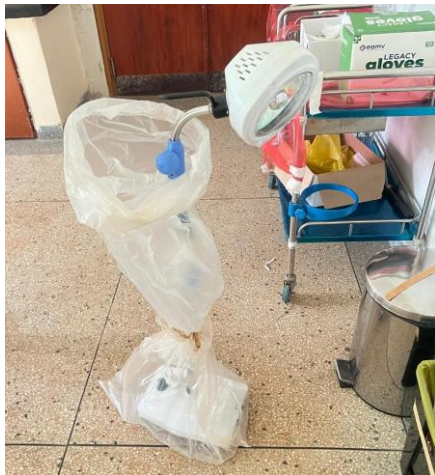
Figure 19: Examination lamp in protective wrapping at Buwumba HC III, Busia District (Bukedi)

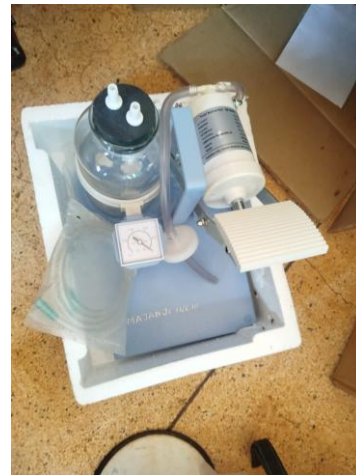
Figure 20: Pedal suction unit in packaging at Majanji HC III, Busia District (Bukedi)

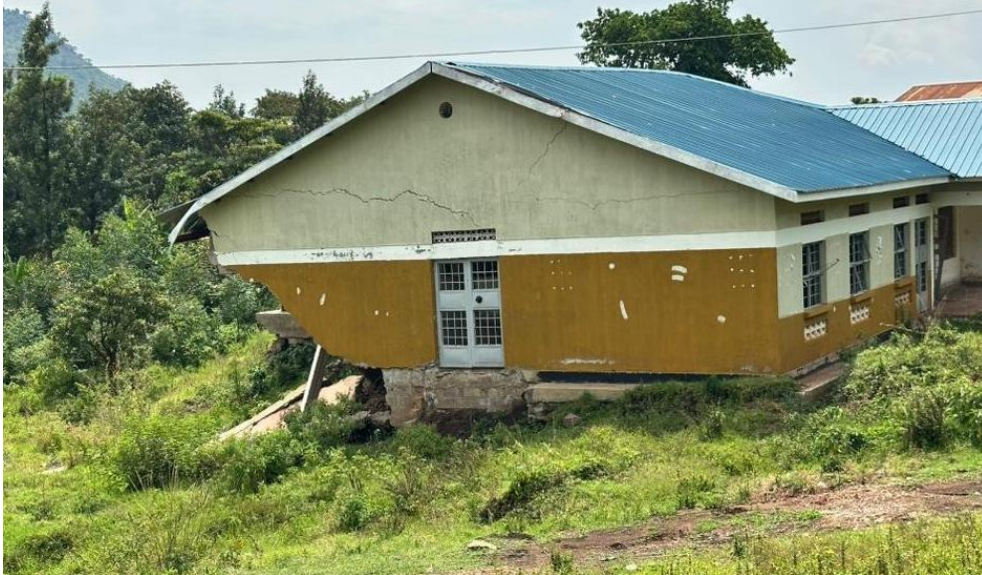
| Location | Expected position and field finding | Gap or service implication | Recommended action |
|---|---|---|---|
| Bukibologoto Health Centre, Bulambuli | Expected: Bukibologoto was listed as complete and was intended to provide care from the constructed health facility.<br>Found: The team found that mudslides had damaged the works before completion. A corner was undermined and a wall cracked. Care was being provided at Simu subcounty offices, with equipment held in district stores. | The planned facility was unavailable for its intended use, and the temporary service and storage arrangements needed a lasting solution. | Bulambuli District and the Ministry of Health should obtain an engineering assessment, decide on repair or relocation, inventory the equipment and provide for continuing care. |

**Figure 21: Cracked health centre block above collapsed ground, Bulambuli District (Bugisu)**

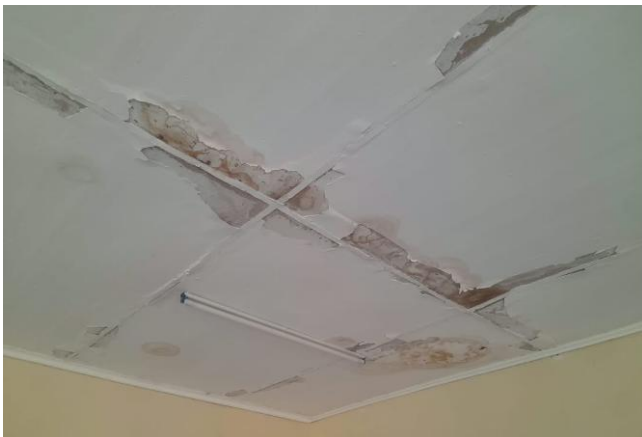
**Figure 22: Stained and peeling ceiling at a health centre, Sironko District (Bugisu)**

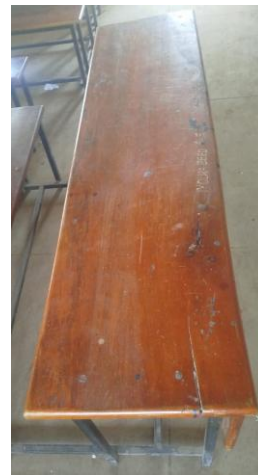
**Figure 23: Cracked desk surface bearing a school marking, Tororo District (Bukedi)**

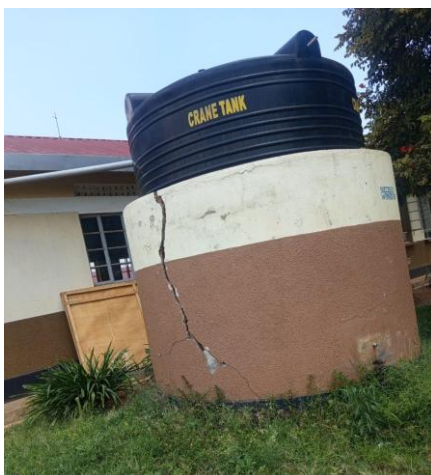
**Figure 24: Water tank on a cracked base at a seed secondary school, Kibuku District (Bukedi)**

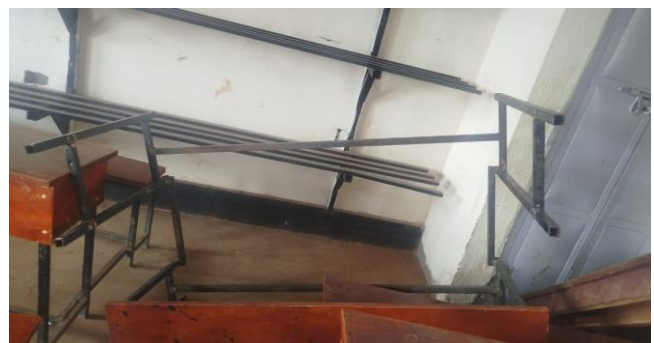
**Figure 25: Broken desk frame at a seed secondary school, Namisindwa District (Bugisu)**

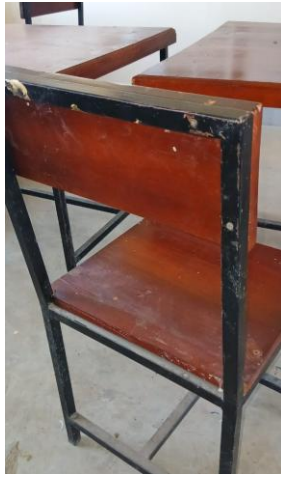
Figure 26: Damaged chair back joint at a seed secondary school, Budaka District (Bukedi)

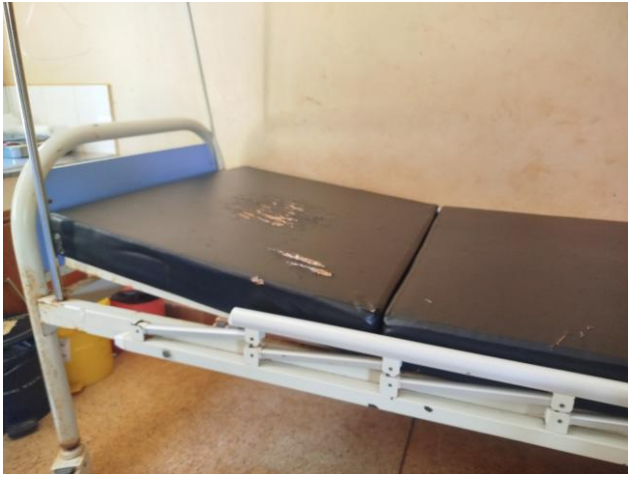
**Figure 38: Delivery bed with a torn mattress cover at a health centre, Busia District (Bukedi)**

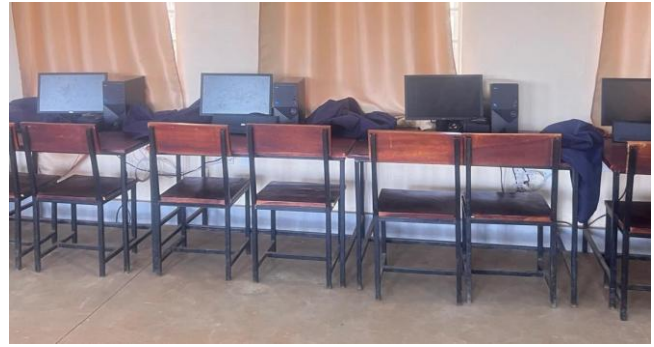
**Figure 39: Desktop computers and classroom furniture at a seed secondary school, Busia District (Bukedi)**

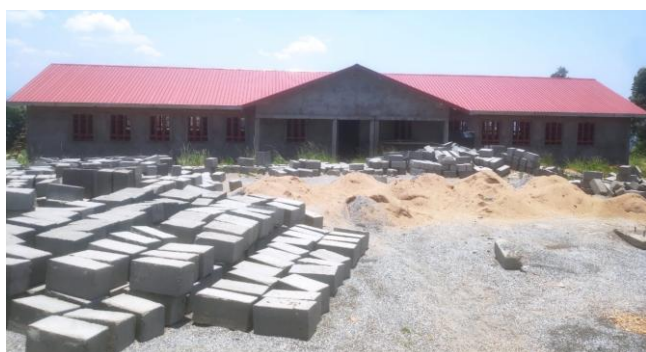
**Figure 40: Building works and construction materials at Ndheh Seed Secondary School, Nebbi District (West Nile)**

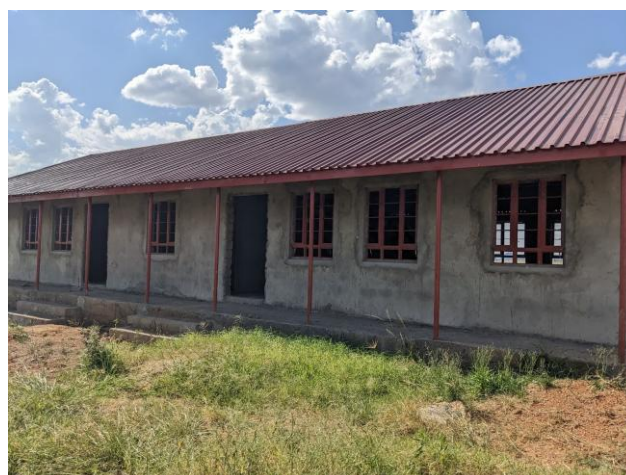
| Location | Expected position and field finding | Gap or service implication | Recommended action |
|---|---|---|---|
| Sidok Seed Secondary School, Kaabong | Expected: Sidok school needed completed buildings and checked equipment before the investment could support full operations.<br>Found: The team found blocks, a kitchen and toilets under construction, with termite workings on the plaster of two blocks. The school consignment remained unopened and its contents had not been counted. | Both unfinished works and unchecked equipment prevented a complete assessment of readiness for use. | Kaabong District should secure completion and treatment of the affected works, then arrange a witnessed opening, count and condition check of the equipment. Accepted items should be recorded, assigned to custodians and issued for use. |

**Figure 41: Unfinished classroom block at Sidok Seed Secondary School, Kaabong District (Karamoja)**

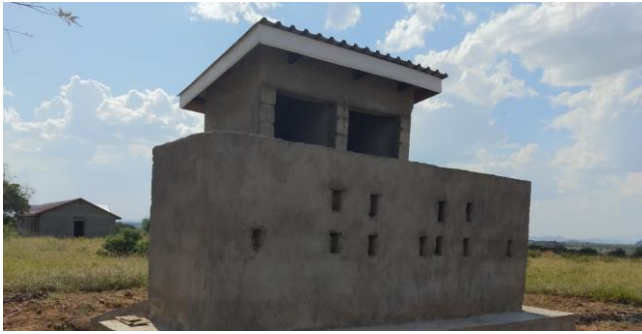
**Figure 42: Latrine block under construction at Sidok Seed Secondary School, Kaabong District (Karamoja)**

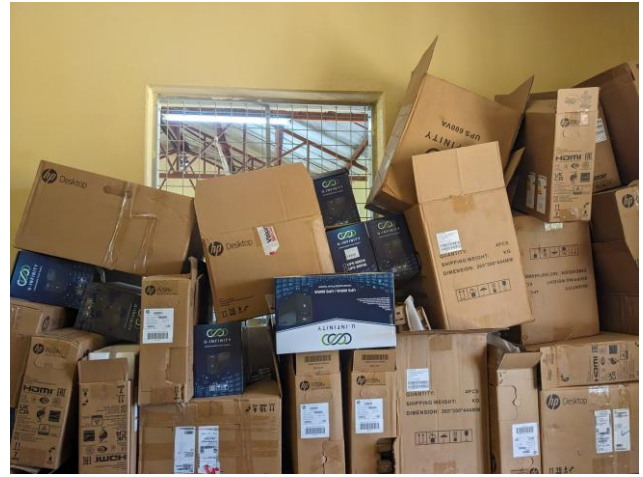
**Figure 43: Boxed desktop computers at Alerek Seed Secondary School, Abim District (Karamoja)**

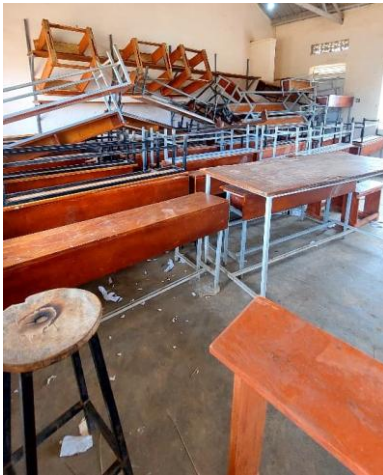
**Figure 44: Stacked desks, chairs and stools at a seed secondary school, Napak District (Karamoja)**

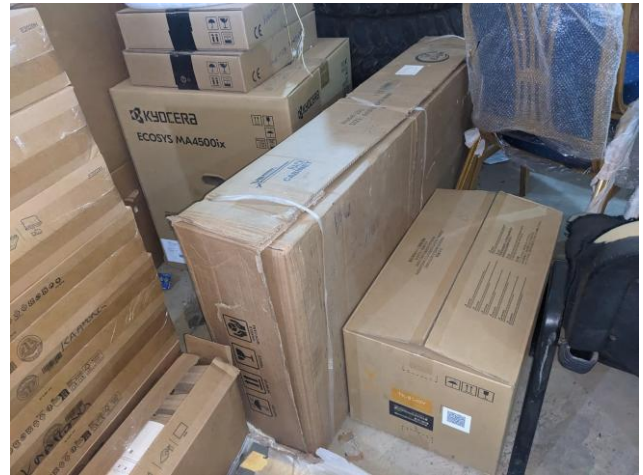
**Figure 45: Boxed printer and equipment at Sidok Seed Secondary School, Kaabong District (Karamoja)**

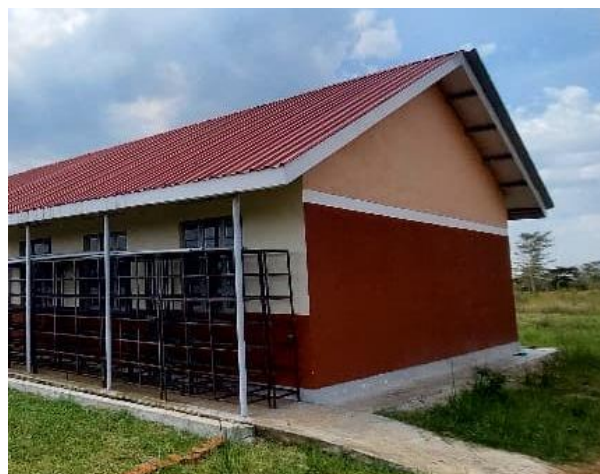
Figure 52: Health centre building, Nwoya District (Acholi)

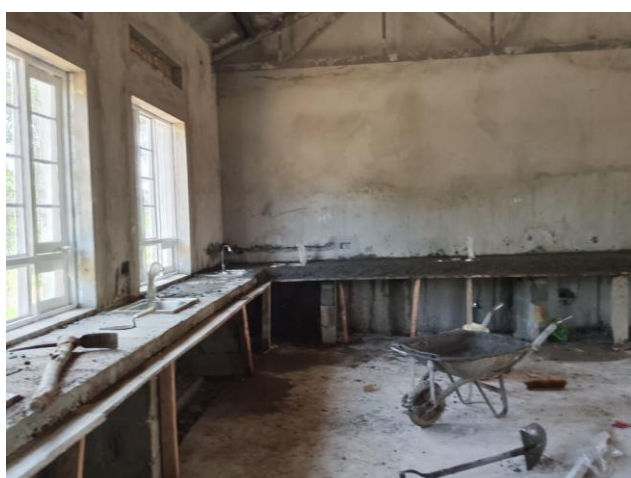
**Figure 64: Biology laboratory under construction at a seed secondary school, Buliisa District (Bunyoro)**

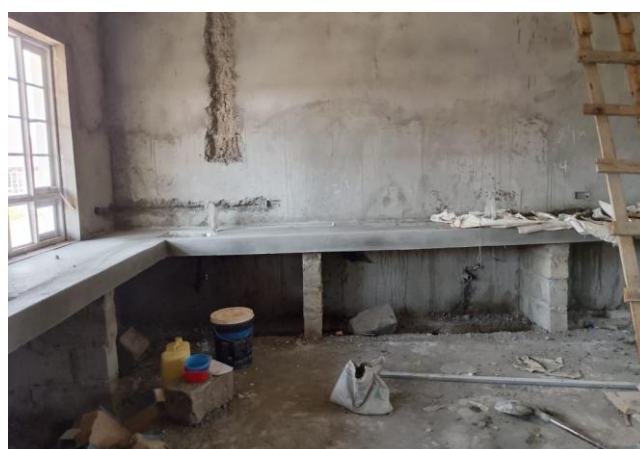
**Figure 65: Unfinished laboratory interior at Kihungya Seed Secondary School, Buliisa District (Bunyoro)**

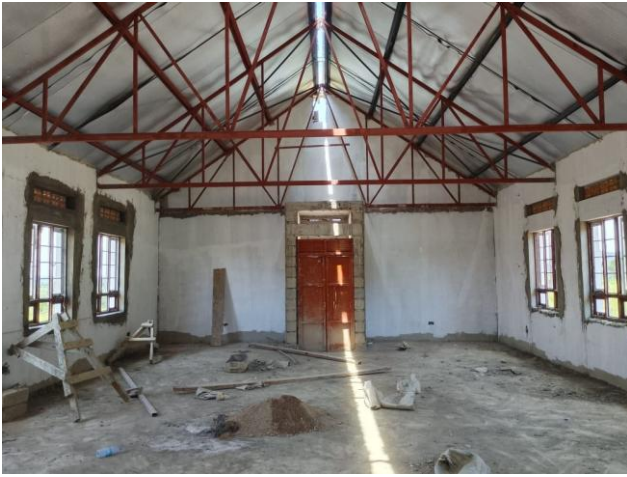
**Figure 66: Library interior under construction at Kihungya Seed Secondary School, Buliisa District (Bunyoro)**

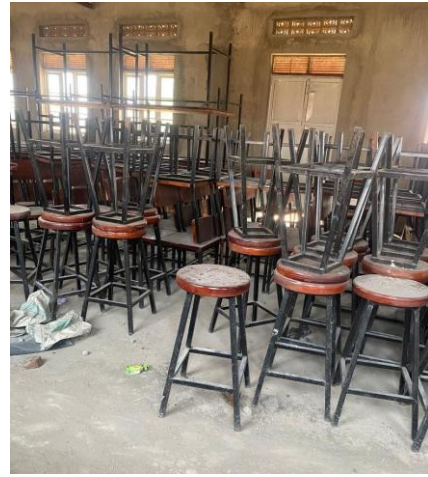
**Figure 67: Laboratory stools and other school furniture in storage, Ntoroko District (Tooro)**

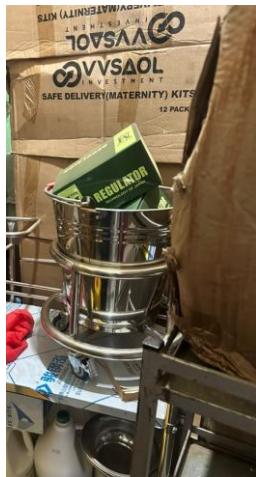
**Figure 68: Clinical equipment packed among cartons at a health centre, Hoima City (Bunyoro)**

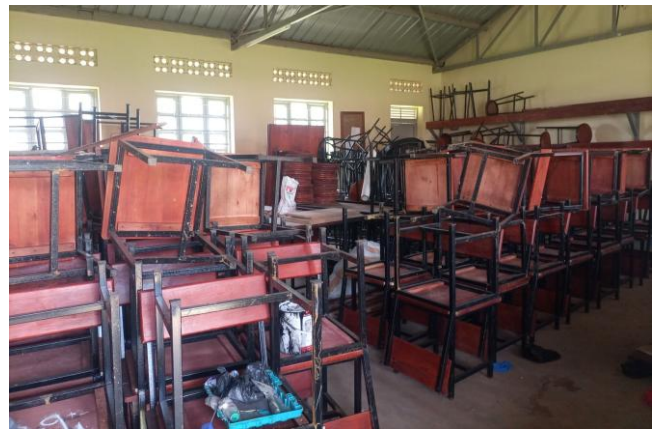
**Figure 69: Stacked classroom furniture at King Solomon Seed Secondary School, Kagadi District (Bunyoro)**

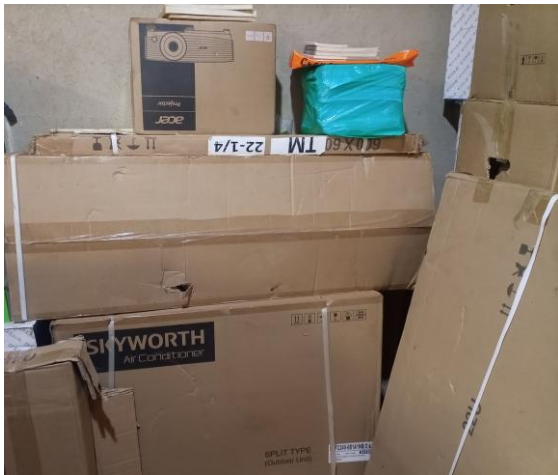
**Figure 70: Boxed projector and other equipment at King Solomon Seed Secondary School, Kagadi District (Bunyoro)**

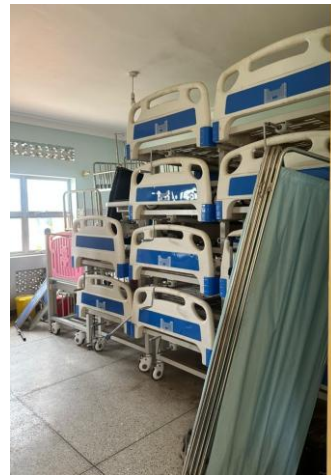
**Figure 71: Hospital beds and screens stacked in storage at a health centre, Kagadi District (Bunyoro)**

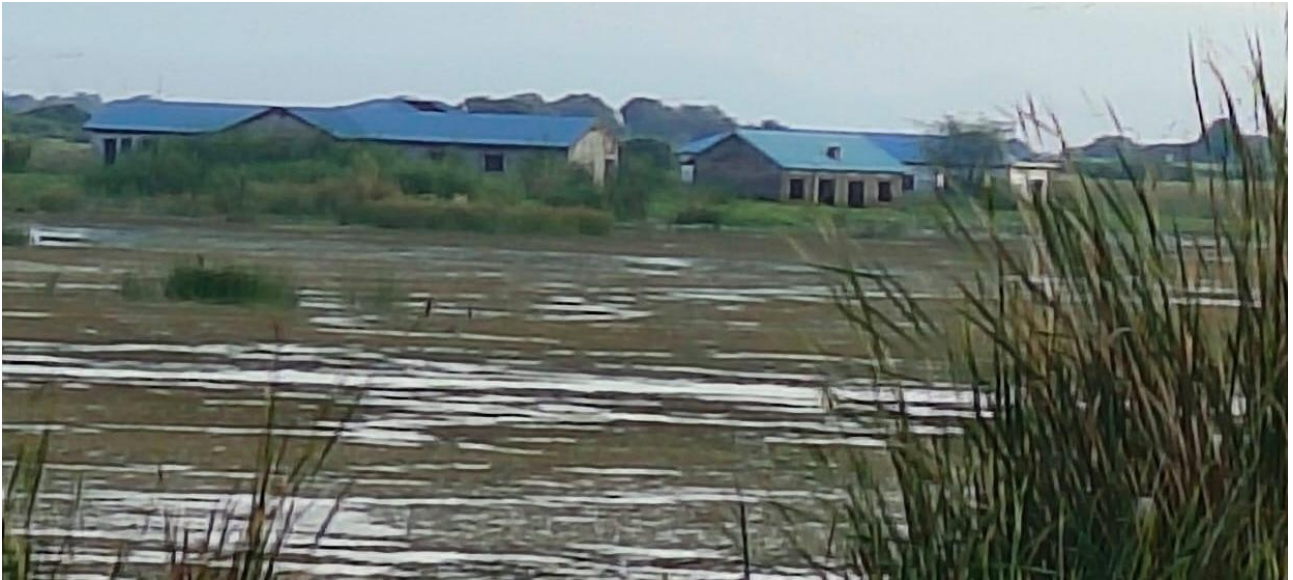
**Figure 72: Flood-affected older health facility at Butiaba, Buliisa District (Bunyoro)**

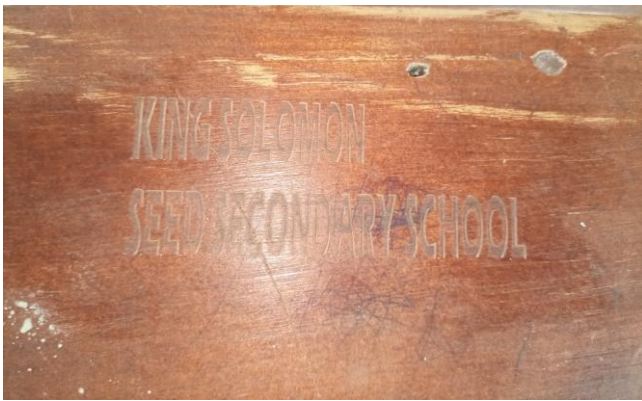
**Figure 73: School engraving on wooden furniture at King Solomon Seed Secondary School, Kagadi District (Bunyoro)**

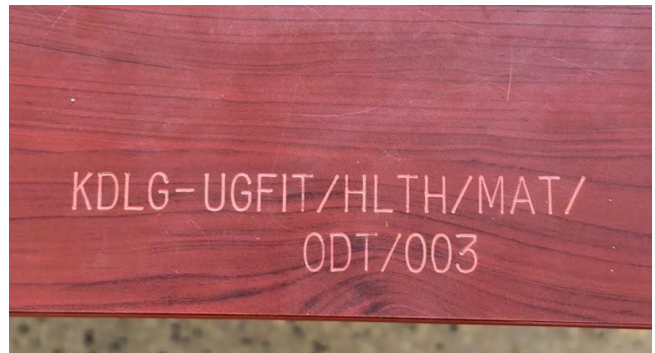
**Figure 74: Programme engraving on a table at Kyabasara HC III, Kagadi District (Bunyoro)**

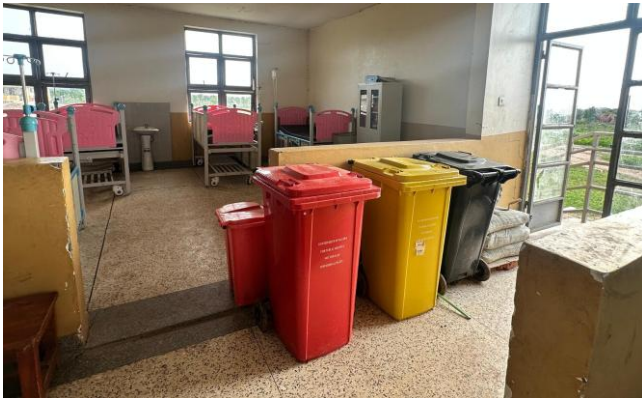
**Figure 75: Medical-waste bins and ward beds at Butiaba HC III, Buliisa District (Bunyoro)**

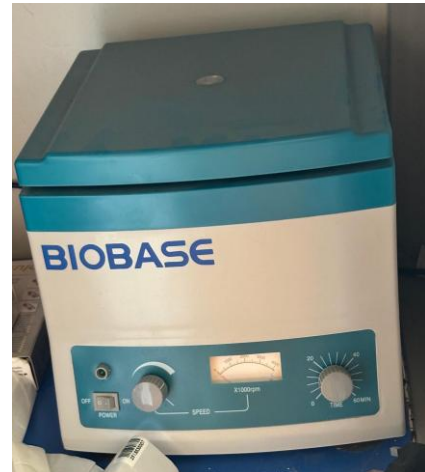
**Figure 76: Laboratory centrifuge at Butiaba HC III, Buliisa District (Bunyoro)**

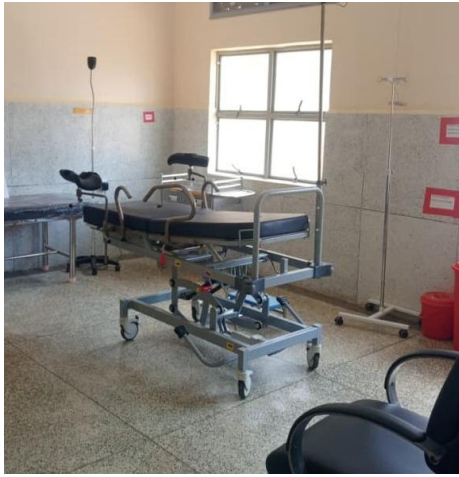
**Figure 77: Delivery bed and clinical furniture at a health centre, Kabarole District (Tooro)**

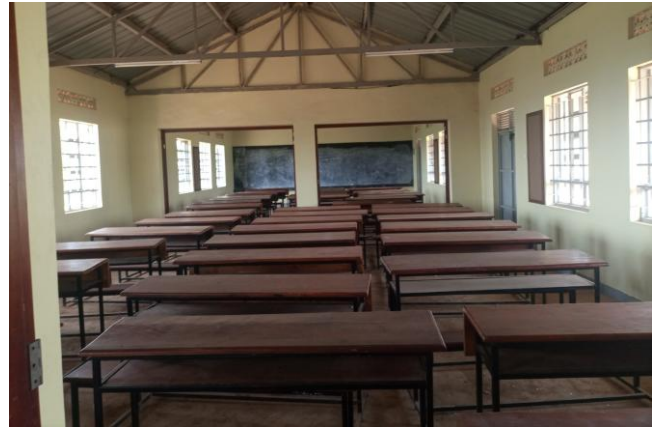
**Figure 78: Classroom desks at King Solomon Seed Secondary School, Kagadi District (Bunyoro)**

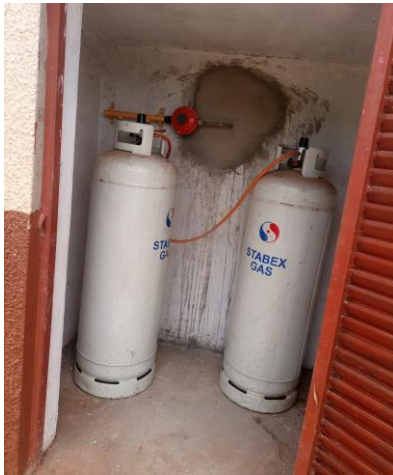
**Figure 79: Gas cylinders and pipework at King Solomon Seed Secondary School, Kagadi District (Bunyoro)**

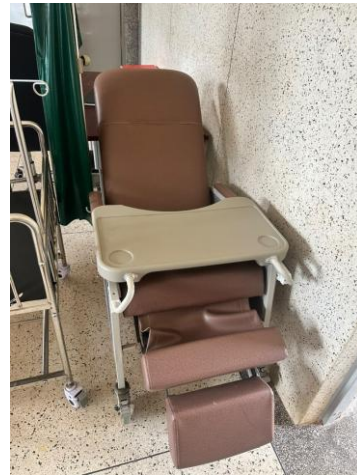
**Figure 80: Kangaroo care chair at Kyabasara HC III, Kagadi District (Bunyoro)**

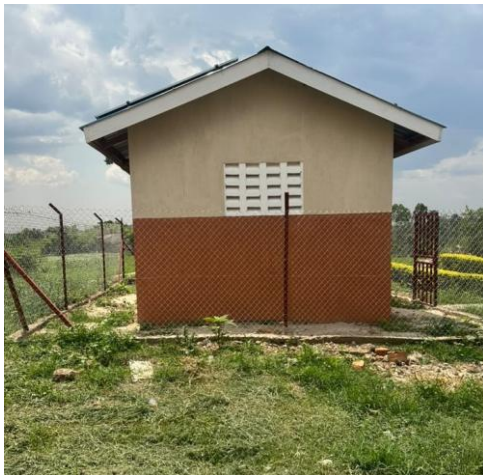
**Figure 81: Power house at Kyabasara HC III, Kagadi District (Bunyoro)**

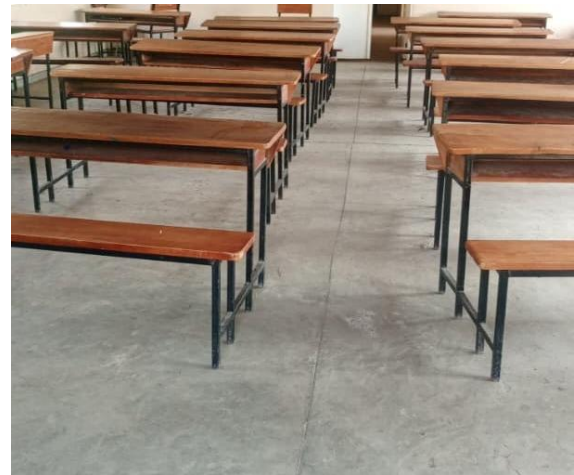
**Figure 82: Classroom desks at a seed secondary school, Ntoroko District (Tooro)**

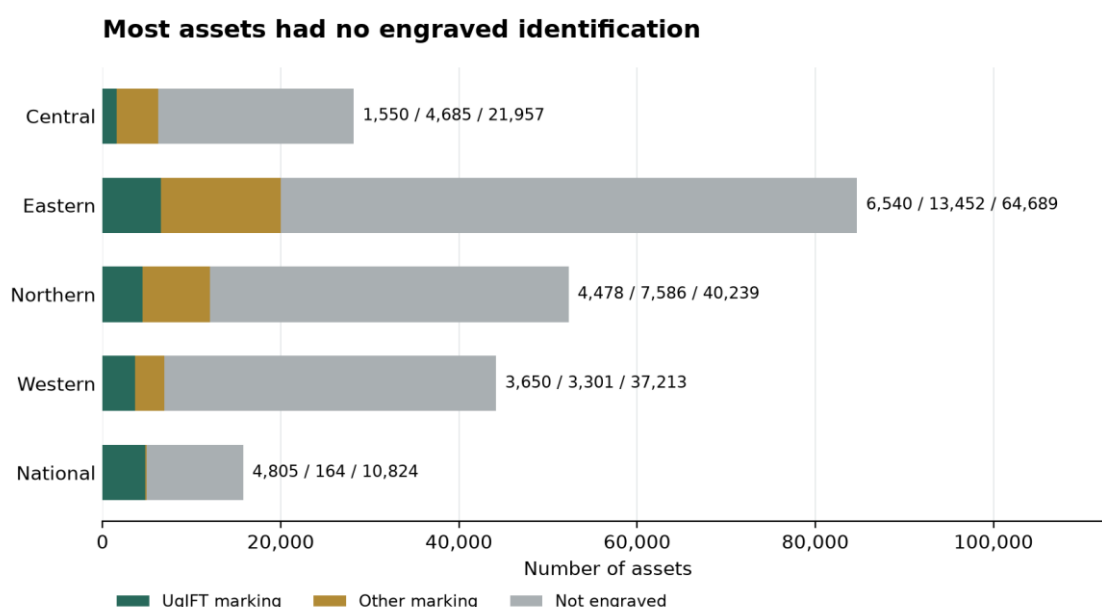
Across the programme, 50,211 assets carried identification markings, representing 22.3% of the 225,133 entries. Of these, 21,023 had UglIFT marking and 29,188 had other markings. Lungulu Seed Secondary School provided a specific example of assets requiring engraving.

**Figure 83: Most assets had no engraved identification**

Marking should identify the asset and the institution responsible for it. Where assets have moved, custody needs to move with them: equipment from three Busia health centres had gone to Masafu Hospital, while equipment intended for Todora in Nwoya had gone to Paraa during construction. The district should confirm the continuing allocation and retain signed handover or transfer documentation.

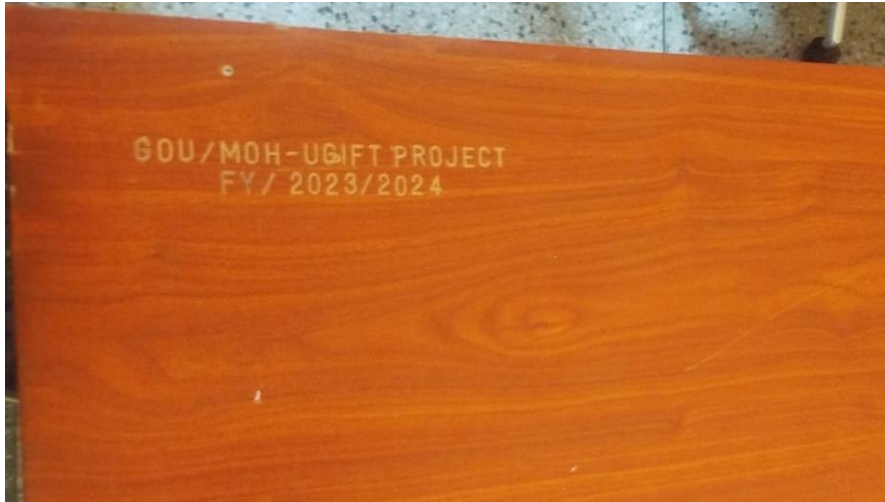
**Figure 84: UgIFT identification on a desk at a seed school, Tororo District (Bukedi)**

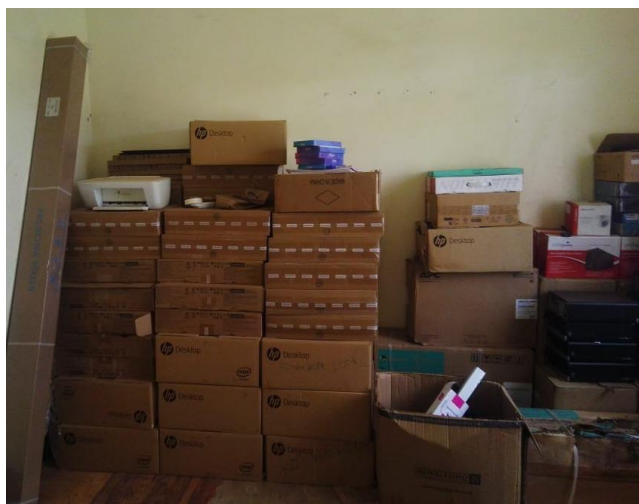
Stored equipment needs a plan for use. Lungulu needed power, Got Apwoyo needed completed buildings, and Avogera needed repair support for items it could not restore locally. Kalemungole had unopened and wrapped equipment requiring a check of readiness for installation and use.

**Figure 85: Boxed computers and related equipment in a seed school store, Nwoya District (Acholi)**
